*Report No. BC/MB/05.23.04.*

**Coal Mining Risk Assessment:  
Land Adjacent to 1 Mansfield Terrace,  
Mountain Hare, Merthyr Tydfil.**

**Monarch Architectural Services.**

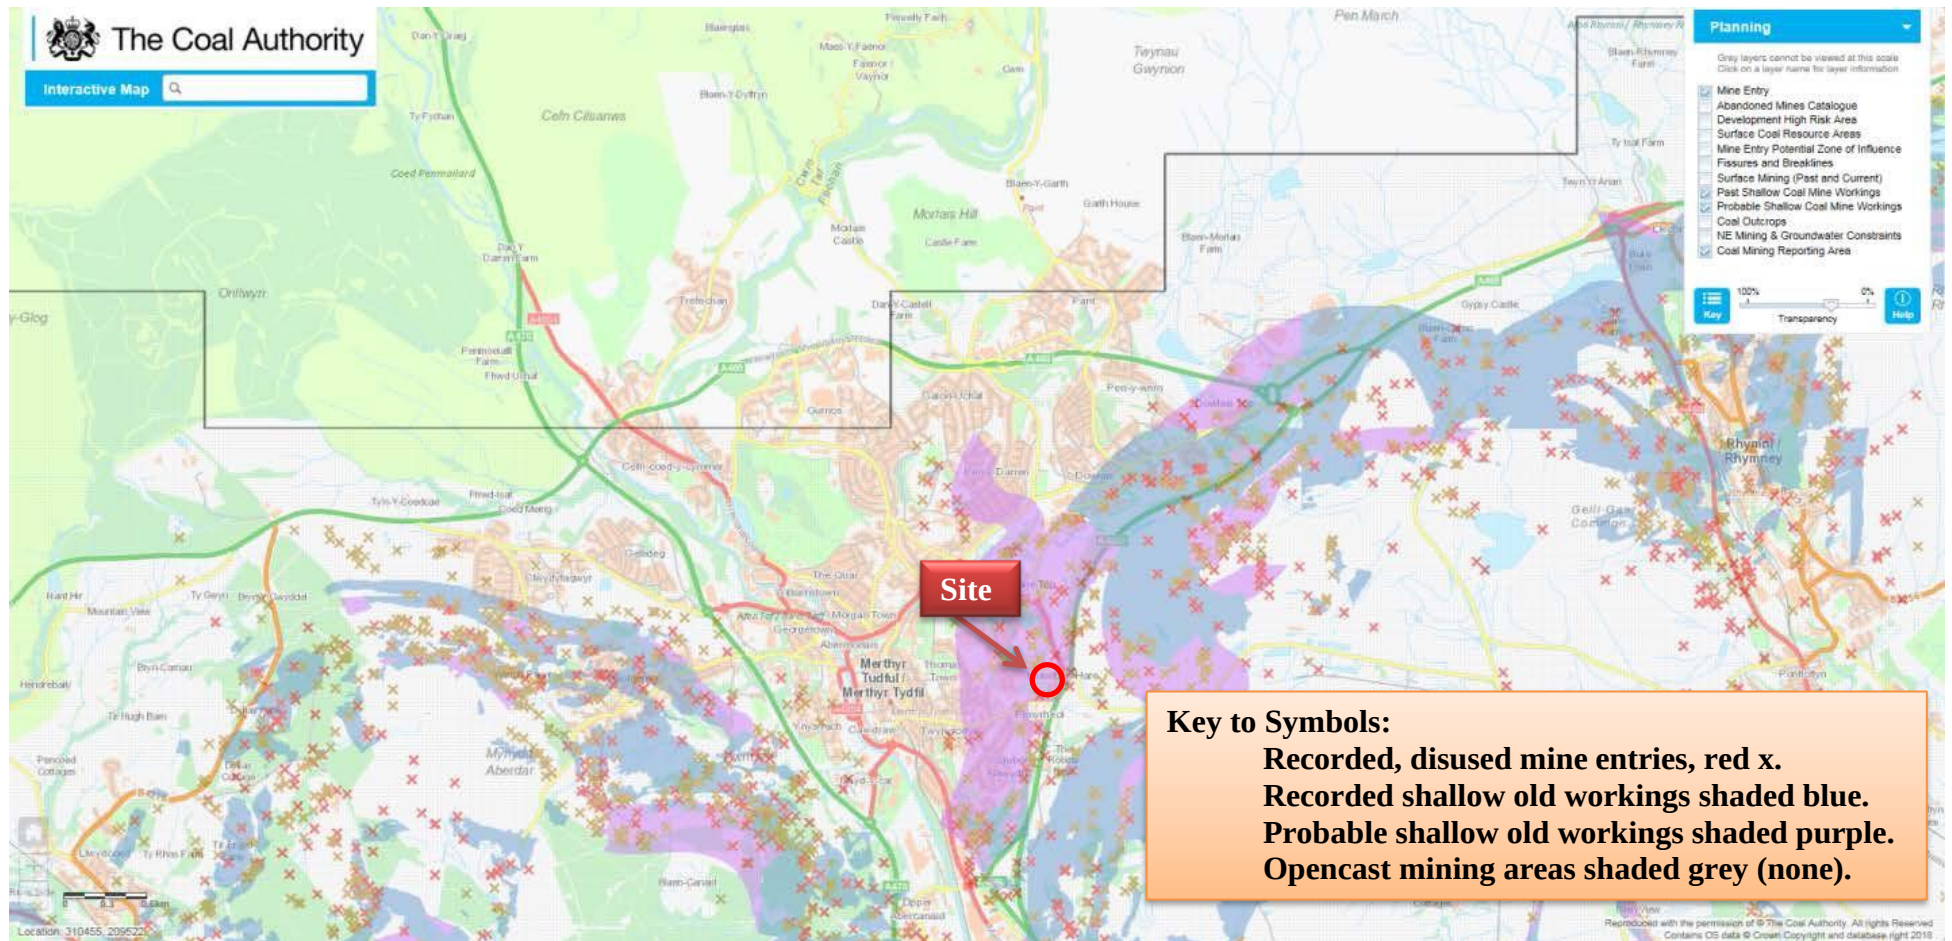
**Figure 3**  
**Print-out of The Coal Authority's Interactive Map**  
(Accessed 30<sup>th</sup> October 2023)

The general area has experienced extensive underground mining operations for coal and for ironstone dating back at least to the very earliest part of the nineteenth century. The workings were prosecuted from a number of adits driven into the valley sides at or near the outcrops of coal seams and ironstone veins and were supplemented with many shafts, principally to act as a source of air. Our searches identified that there are no records of underground mine workings within influencing distance of the Site. The mining records held by The Coal Authority are known to be incomplete, particularly in respect of older mining operations. There is a risk of shallow, unrecorded old workings underlying the Site and The Coal Authority's interactive map shows 'probable' mine workings underlying the Site i.e. unrecorded shallow mine workings.

Our searches found no record of a disused shaft or adit within the confines of the Site, a situation confirmed by The Coal Authority report no. 51002143722001. The risk of an unrecorded mine entry being present cannot be entirely discounted. The Site has not been part of an opencast coal site. The Coal Authority's mining report states that the Site has been part of an

opencast coal site. This is not the case, the boundary of the former East Merthyr Land Reclamation Scheme, Phase 2 ran along the boundary of the Site; the opencast site did not extend onto this Site. The excavations within the former opencast site would not have extended up to the boundary of the site. There are no operating collieries within influencing distance of the Site.

The locality has experienced extensive mining operations for both coal and ironstone. There are no recorded underground mine workings that could affect the structural integrity of a residential development, but there is a risk of unrecorded shallow mine workings being present beneath the Site. It is recommended that once full planning permission is obtained and the positions of the dwellings are finalised a programme of exploration boreholes are drilled beneath the footprints of the dwellings to determine the depth and nature of any shallow mine workings that may be present.

A programme of exploration boreholes should be drilled on the Site in order to examine in greater detail the risk from shallow, unrecorded mine workings; the boreholes should be monitored for the presence of mine gases. The boreholes should be designed and supervised by a Chartered Geologist and will require a permit from The Coal Authority.
