BAT SURVEY REPORT

HOOVER SITE, MERTHYR TYDFIL

Project Number	K001	
Title	Bat Survey Report	
Document Number	K001- Bat Report-V1.3	
Client	Walters	
Issue Date	29/09/2025	
Prepared by:	David Price - Consulting Ecologist 29/09/2025

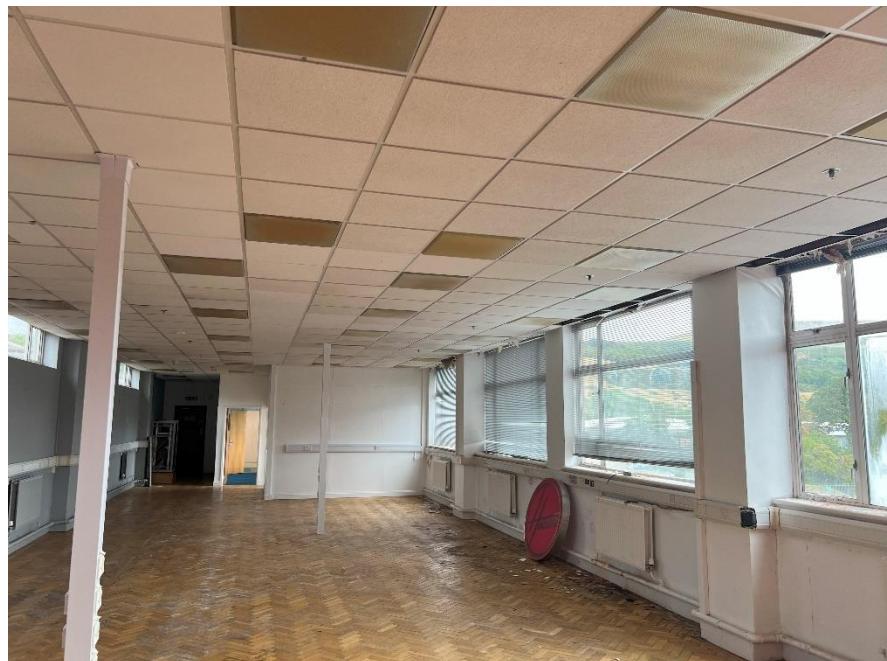
Internally the offices of building 1a are in poor condition with damp throughout. There is a suspended ceiling that offers negligible opportunities for crevice dwelling bats. The building has been empty for some time and a thick layer of dust is visible showing the building hasn't been cleaned. No evidence of bats was found within the office.

Photo 2: Example of the typical office space within building 1a.

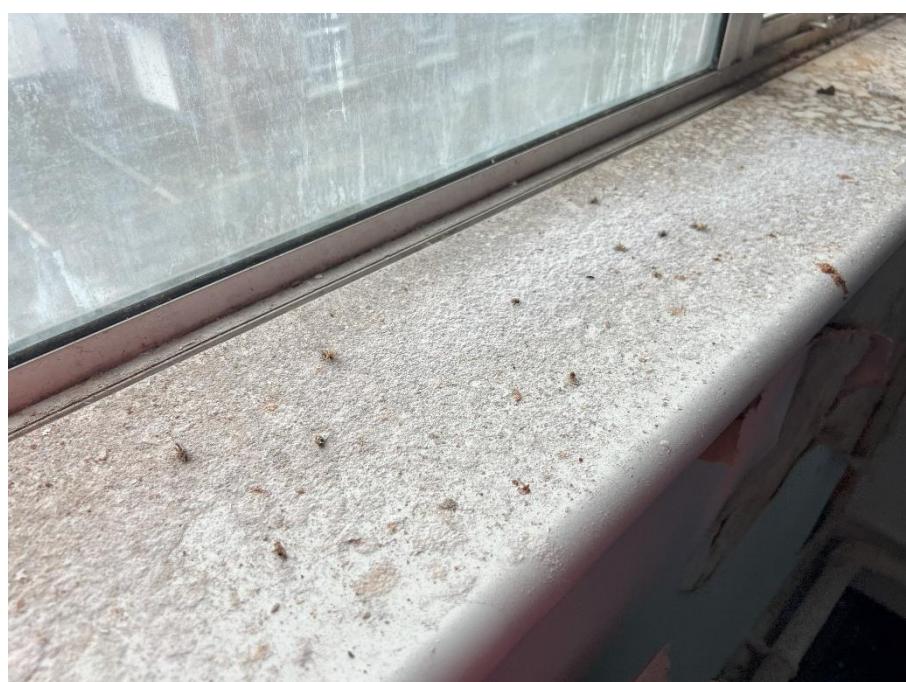
Photo 3: Uncleaned window cills with no bat evidence.

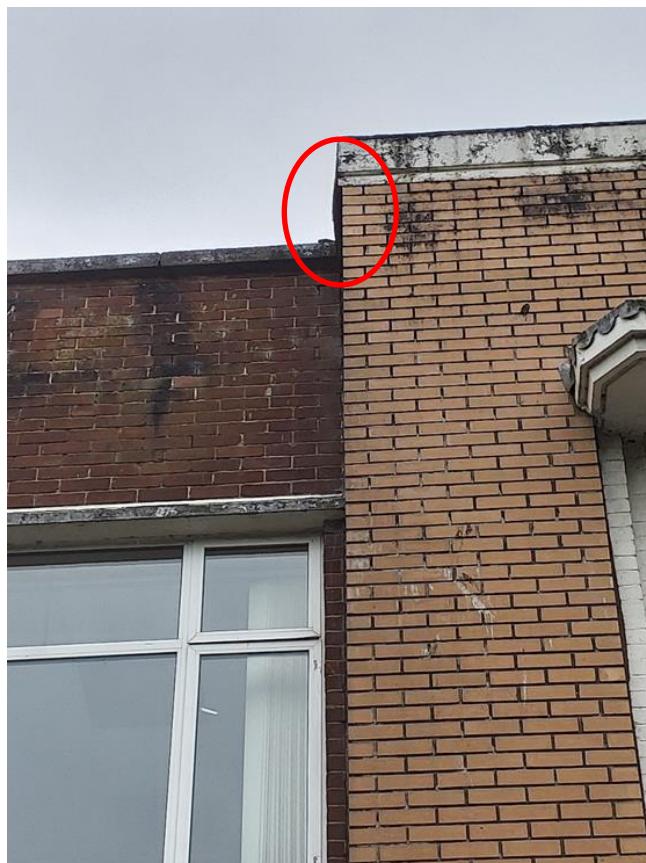
3.6 Externally the brickwork for building 1a is in relatively good condition. There were multiple areas where the roofing material had lifted to create gaps that could be utilised by crevice dwelling bats. Some small gaps were present within the brick work but likely not large enough to provide potential for roosting bats. The building is part of an area well used at night, as result it is heavily flood lit reducing its suitability for bats. Considering the size of the building and the number of possible PRFs, the building has been classified as having moderate bat potential.

Photo 4: Lifting in roof felt

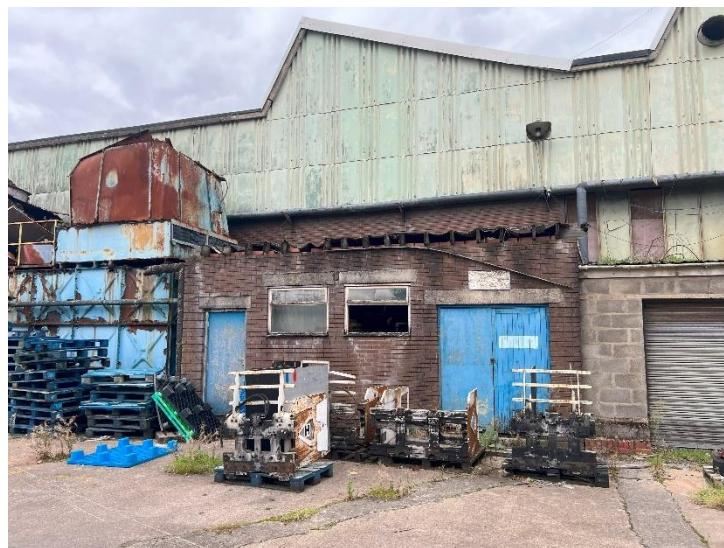
Photo 6: Example of the brick structures adjacent to the building and further examples of the steel boarding.

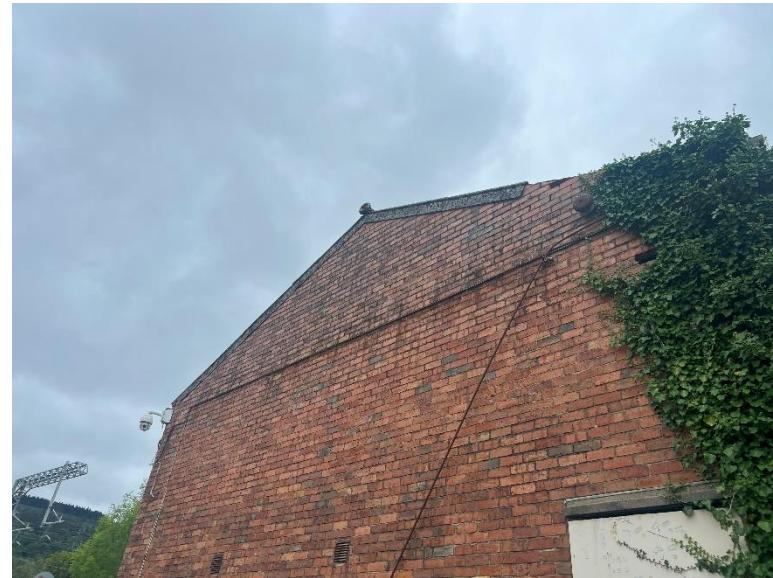
Building 3 is a brick and corrugated asbestos workshop. The building has been permanently sealed due to asbestos contamination, as a result an internal inspection wasn't undertaken. There is significant damage to the roof and some of the windows are broken allowing access into the building. There are windows all along the roof and along the top of the walls. Consequently, the building receives ample natural light during the

Photo 11: Damage to the barge boards allowing possible access for bats

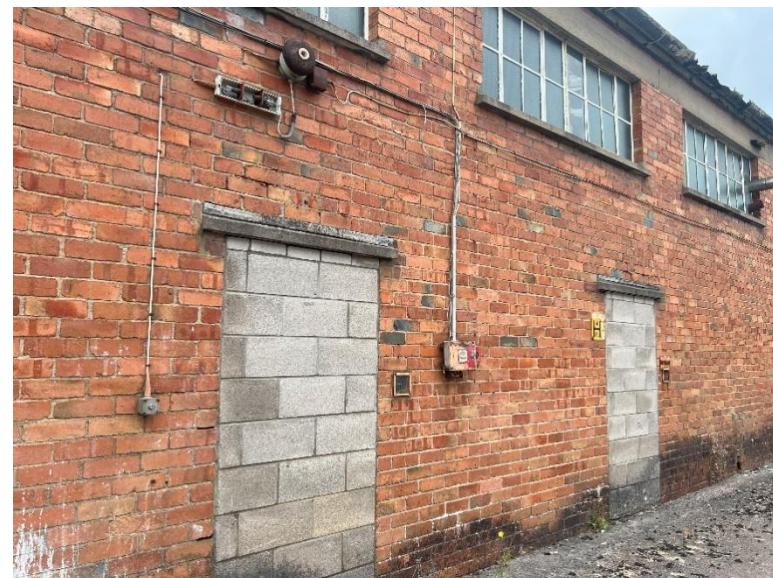
Photo 12: Shows how the building g has been closed for H&S reasons. The windows show the light levels from the roof lighting.

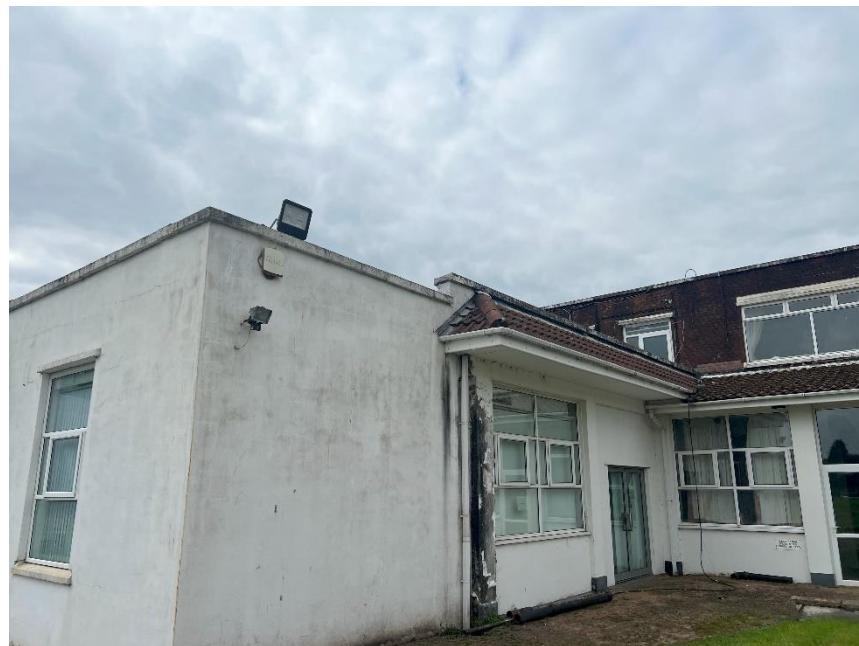
Photo 15: The flat roof is generally in good order with negligible PRFs, the small, pitched roof has lead flashing all around offering roosting opportunities.

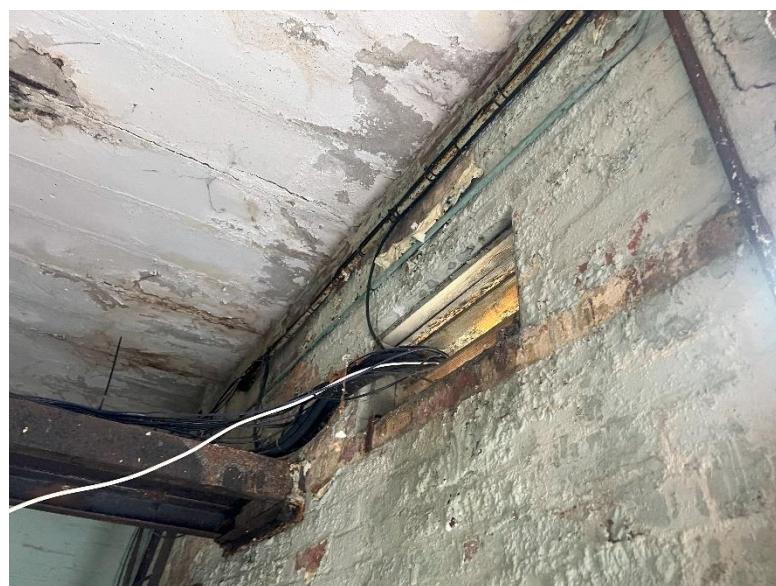
Photo 30: internal structure of building 8

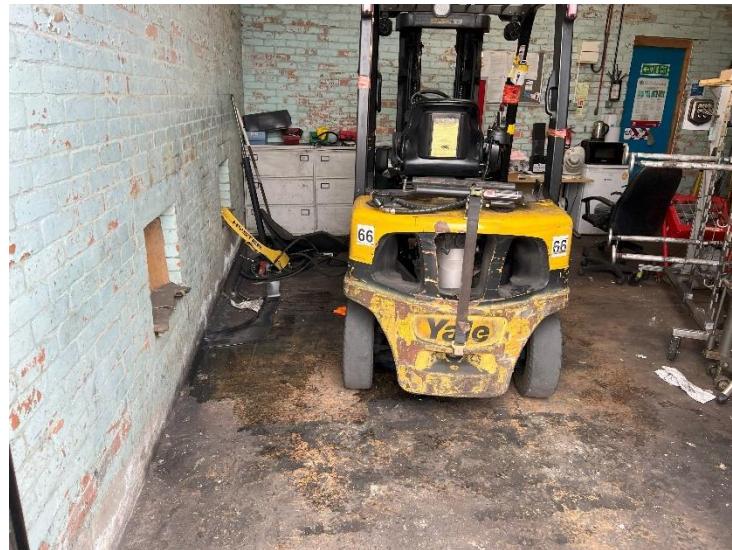
Photo 33: Internally the buildings are brick walled with no visible PRFs, the walls are damp, and no evidence of bats was found.

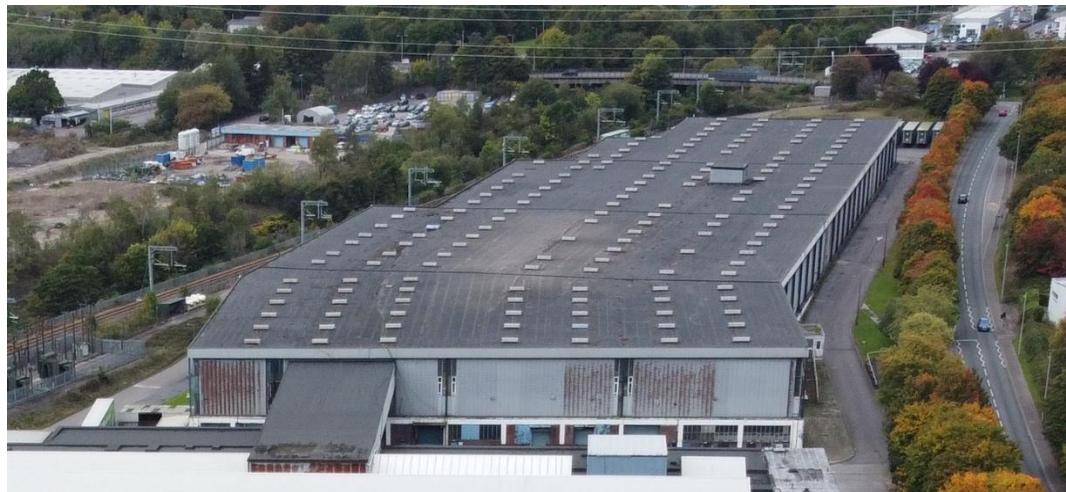
Building 11 is a large warehouse constructed of brick and breezeblock with metal panelling. The roof is corrugated steel with skylights. Internally some of the brick windows that have been bricked up and broken creating a space for bats to roost. A tough inspection with an endoscope revealed no evidence of bats. There are voids in the metal cladding that offer potential roosting opportunities for bats.

The buildings are currently in use, with internal lighting on 24hrs a day and strong floodlights at night. No evidence of bats was found within any of the structures. Considering the size of the building and the number of possible PRFs, the building has been classified as having moderate bat potential.

Photo 34: Overview of building 11.

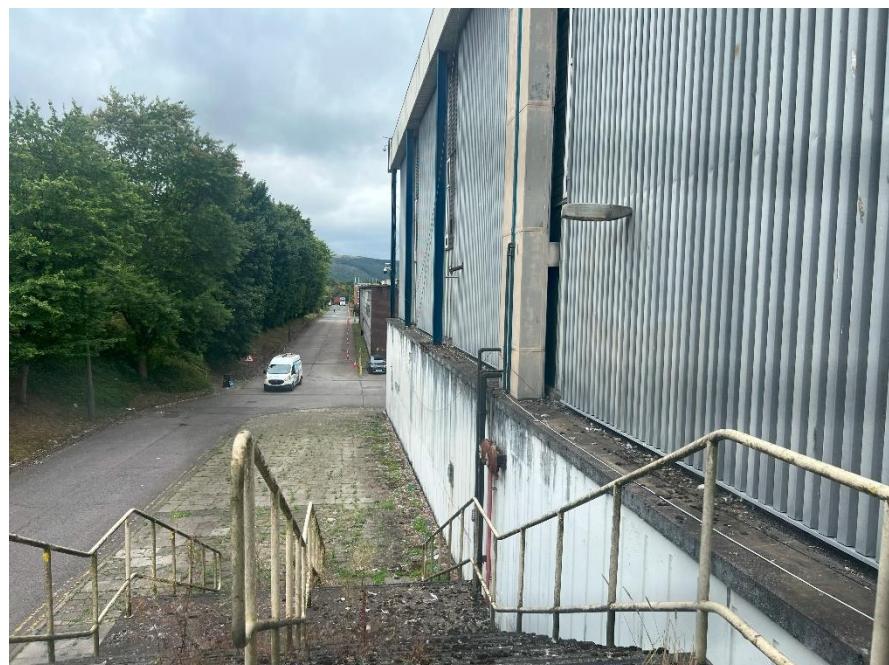
Photo 35: The external panelling is not flush to the wall and access is available throughout.

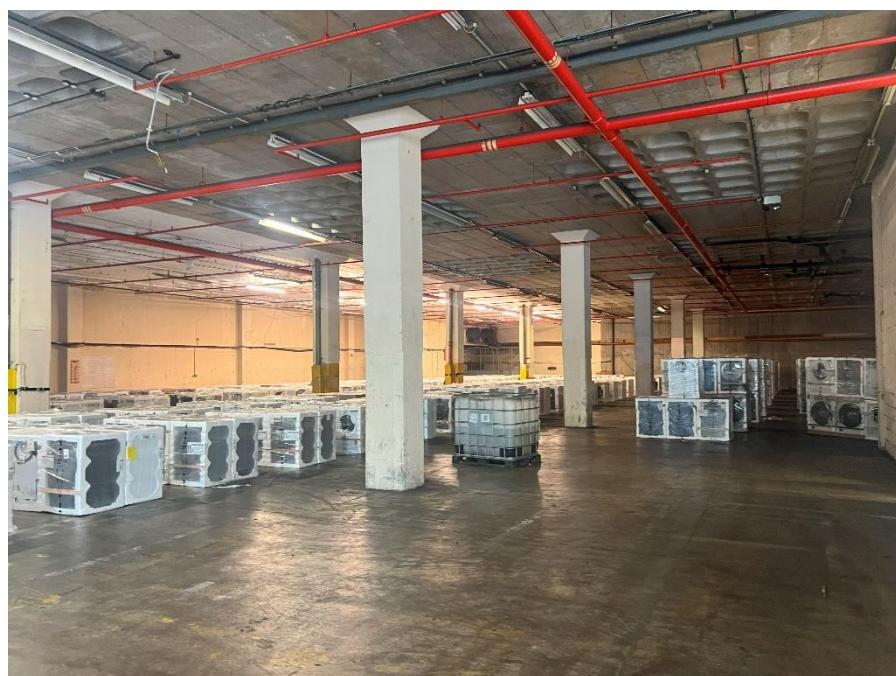
Photo 37 and 38: Warehouse is active with internal lighting 24hrs a day.
