Report No. BC/MB/12.13.01.

Mining Risk Assessment: Land at 1 Park View House, Heolgerrig, Merthyr Tydfil.

Mr J. Carter Evans.

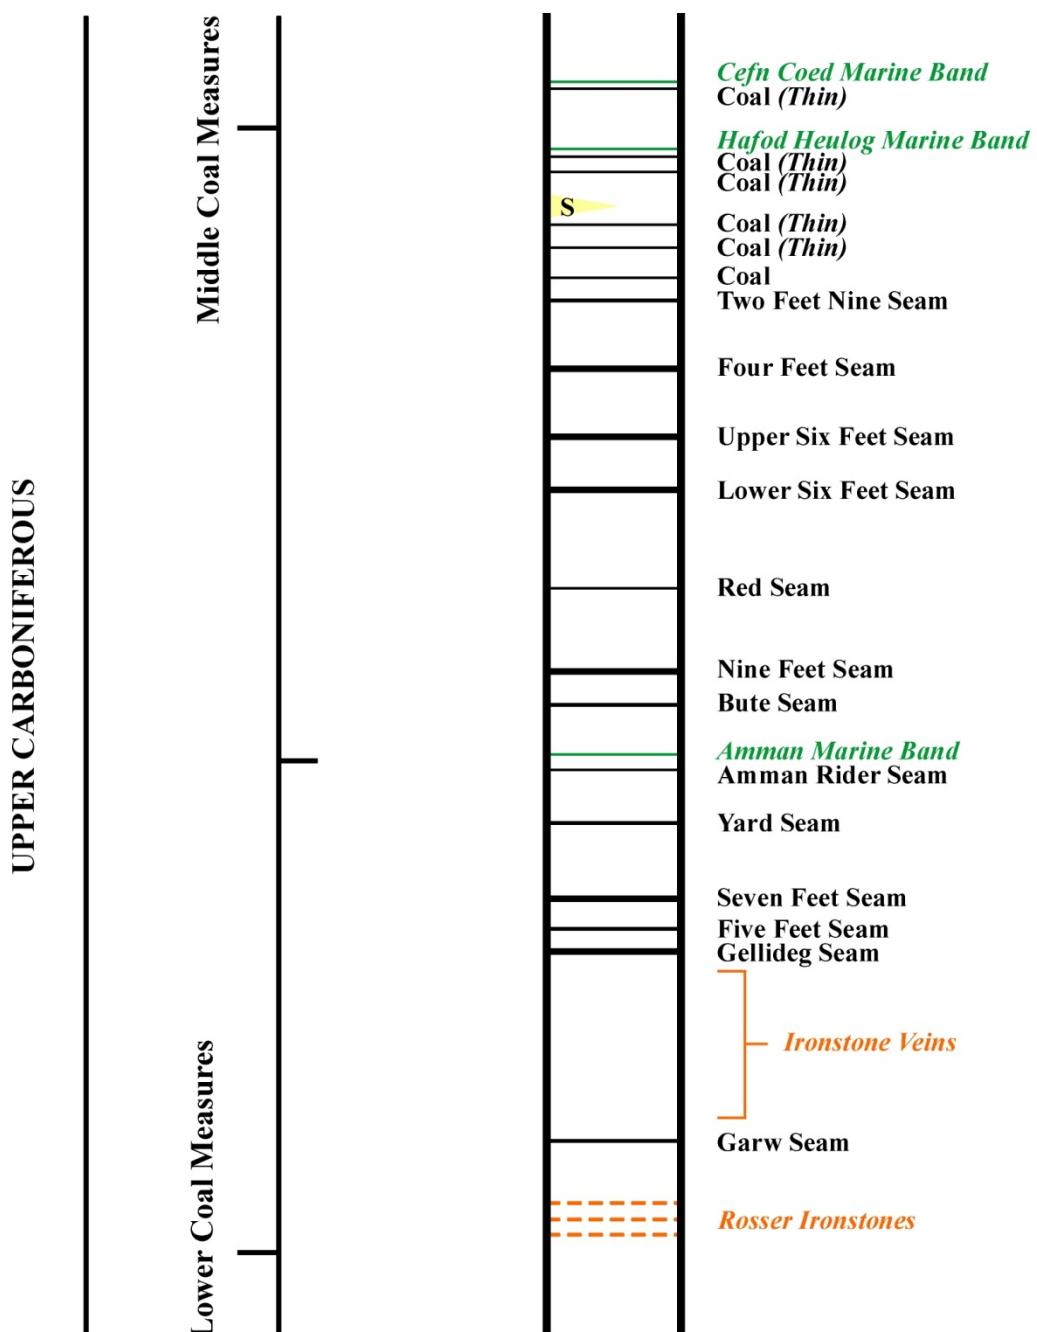
Part of the Stratigraphic Column.

When both sets of records are taken together it is apparent that the Six Feet Seam does not underlie the Site and the Nine Feet Seam underlies the Site at relatively shallow depths. A thin coal seam, the Red Seam, is sometimes present between the above two seams, but its presence has not been confirmed in this area. Exploratory drilling carried out in the surrounding area indicates that the Upper and Lower Six Feet Seams are two separate seams in some areas of

Heolgerrig and elsewhere combine to form one, thick, composite seam. Exploratory drilling immediately to the west of this Site suggests that the Six Feet Seam is represented by one, thick seam in the vicinity of the Site.

Other coal seams underlie the Site at increasing depths, the principal ones, in descending order, are the Bute, Yard, Seven Feet, Five Feet/Gellideg and the Garw Seams (see *Part of the Stratigraphic Column*, above); there are also a number of ironstone veins below the Five Feet/Gellideg Seam.

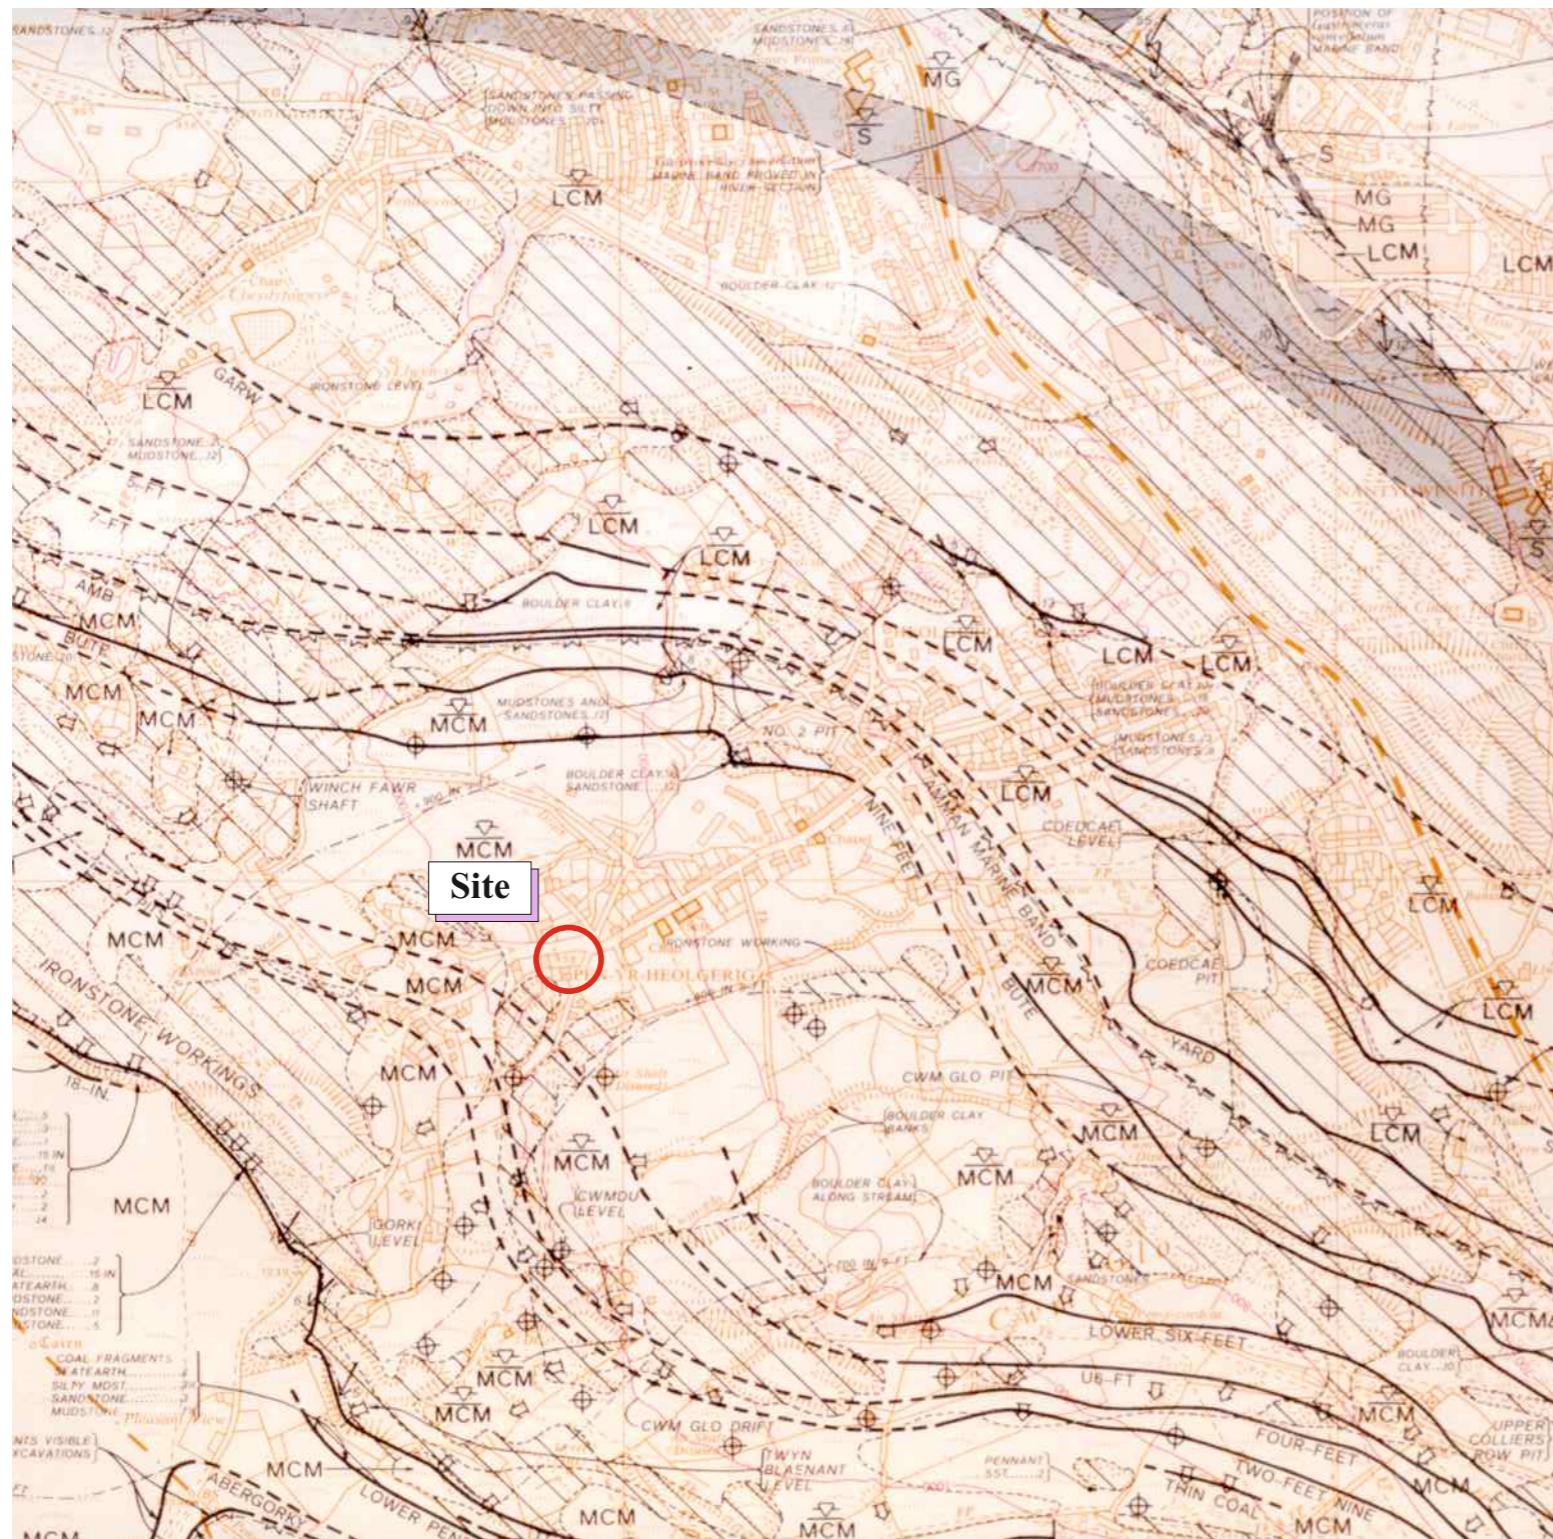
Geology Plan.

The Site is situated near the northern margin of the South Wales Coalfield and is underlain at shallow depths by strata assigned to the Middle Coal Measures, a sub-division of the Upper Carboniferous Period. The most recently published geological sheet at 1:10,560 scale (SO 00 NW) shows the inferred positions of the outcrop of the Four Feet Seam to be present approximately 100m south-west of the Site (see *Geology Plan, drawing no. BC/MB/12.13.01.02*). It can be inferred from the geological sheet that the outcrop of the Six Feet Seam will be present close to the Site. Mining records show the Six Feet Seam’s outcrop to be present immediately to the south of the Site (see *Extract from Mine Records Plan: Six Feet Seam, drawing no. BC/MB/12.13.01.04*). The published geological sheet shows the outcrop of the Nine Feet Seam to be present approximately 300m north of the Site; mining records indicate it may be a little further north than this. The average dip of the strata in the region is 1 in 13 towards the south-west.

The coal measures of the South Wales Coalfield have been affected by large faults. In the Heolgerrig area these large faults have a slightly sinuous trace at the surface and an average trend towards the north-west. The published geological sheet indicates that the Site is not affected by large scale faulting.

The published geological sheet indicates that locally the coal measures are overlain with deposits of glacial boulder clay. We have no detailed information relating to the nature and thickness of the Boulder Clay at the Site. Published geological records indicate that the Site is not affected by landslip.

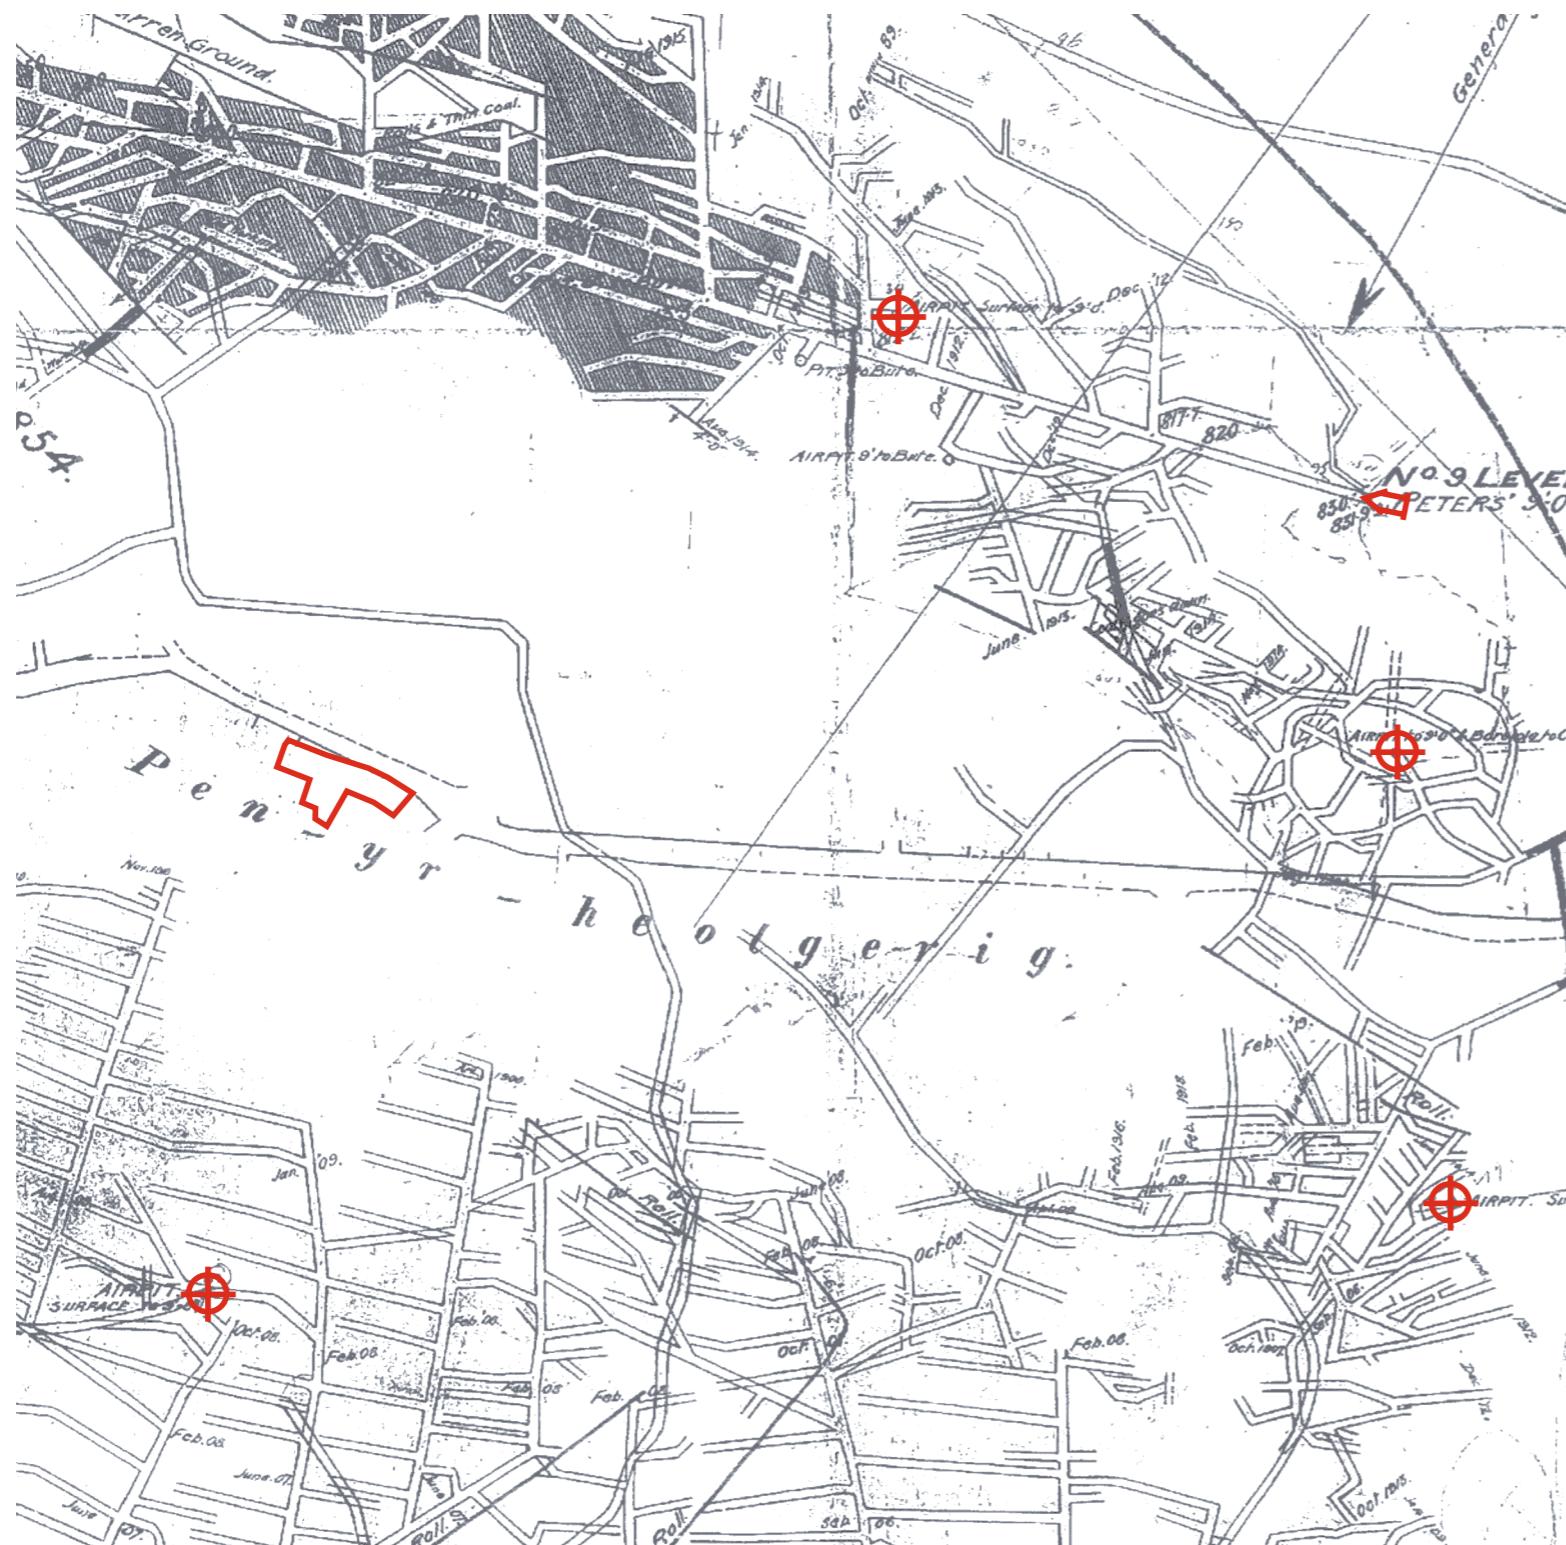
*Extract from Mine Records Plan.
- Nine Feet Seam -*

The shallowest seam underlying the Site that is thick enough to have supported underground mining operations is the Nine Feet Seam, which underlies the Site at relatively shallow depths; it is a thick coal seam of variable thickness and structure that has been mined extensively across a large area of the district in underground mining operations. Mining records show that the Seam was mined fairly intensively both to the north and south of the Site, the

former workings were prosecuted from Peter's Nine Feet Level (see *Extract from Mining Records Plan: Nine Feet Seam, drawing no. BC/MB/03.13.02.05*). The mine plan suggests that no workings took place in this seam beneath the Site, however, the mine plan does not necessarily show all the underground workings that have taken place and the possibility of further, unrecorded workings being present beneath the Site cannot be entirely discounted. Other studies in the Heolgerrig area have identified unrecorded old workings in the Six Feet and Nine Feet Seams. Other workings are present in coal seams and ironstones lower in the geological sequence and at greater depths beneath the Site. Underground mining operations in the area ceased in the late 1930s.

The area has been subject to extensive underground mining operations since at least the earliest part of the nineteenth century. The Nine Feet Seam is the shallowest coal seam underlying the Site that is thick enough to have supported underground mining operations. Whilst mining records suggest that the Seam has not been mined beneath the Site the possibility of unrecorded workings being present cannot be entirely discounted. In the Heolgerrig area the thickness of the Nine Feet Seam varies between 2.0m and 3.5m and voids of similar height have been encountered in exploration boreholes in the locality. With such large voids present in the Seam the risk of the voids collapsing to the surface and inducing subsidence is significant. The mine plan for the Seam does not include information that would permit the depth of the Seam beneath the Site to be determined nor does it indicate the thickness of the Seam beneath the Site. Consequently, the risk of surface subsidence occurring at the Site cannot be determined from the mine plans. If such subsidence were to occur it could result in structural distress to the proposed dwelling. Other old workings in coal seams and ironstone veins further down in the geological sequence are all too deep and/or are of an age such that they will not affect the structural integrity of the proposed dwelling.

There is a significant risk of unrecorded mine workings being present beneath the Site in the Nine Feet Seam with the workings at relatively shallow depths. The lack of detailed information in available mining records means that the risk of any workings present in the Seam collapsing to the surface and resulting in structural distress to the proposed dwelling cannot be determined with any precision. Old mine workings in other coal seams and ironstone veins lower in the geological sequence are of an age and are too deep beneath the Site to pose a risk and may be excluded from any further study. There is only a low risk of a disused mine entry being present on or near the Site.

The risk resulting from the mining heritage at the Site should be further explored with exploratory boreholes. It would be prudent to include monitoring in any exploration programme to assess the presence or otherwise of mine gases.

If shallow old workings are found to be present the risk from those mining relics should be reduced by means of drilling and grouting.
