*Report No. BC/MB/04.19.04.*

# **Coal Mining Risk Assessment: Proposed New Club House at the Wern Sports Ground.**

**Merthyr Rugby Club.**

## **Mining Risk Assessment: New Club House, Land at the Wern Sports Ground.**

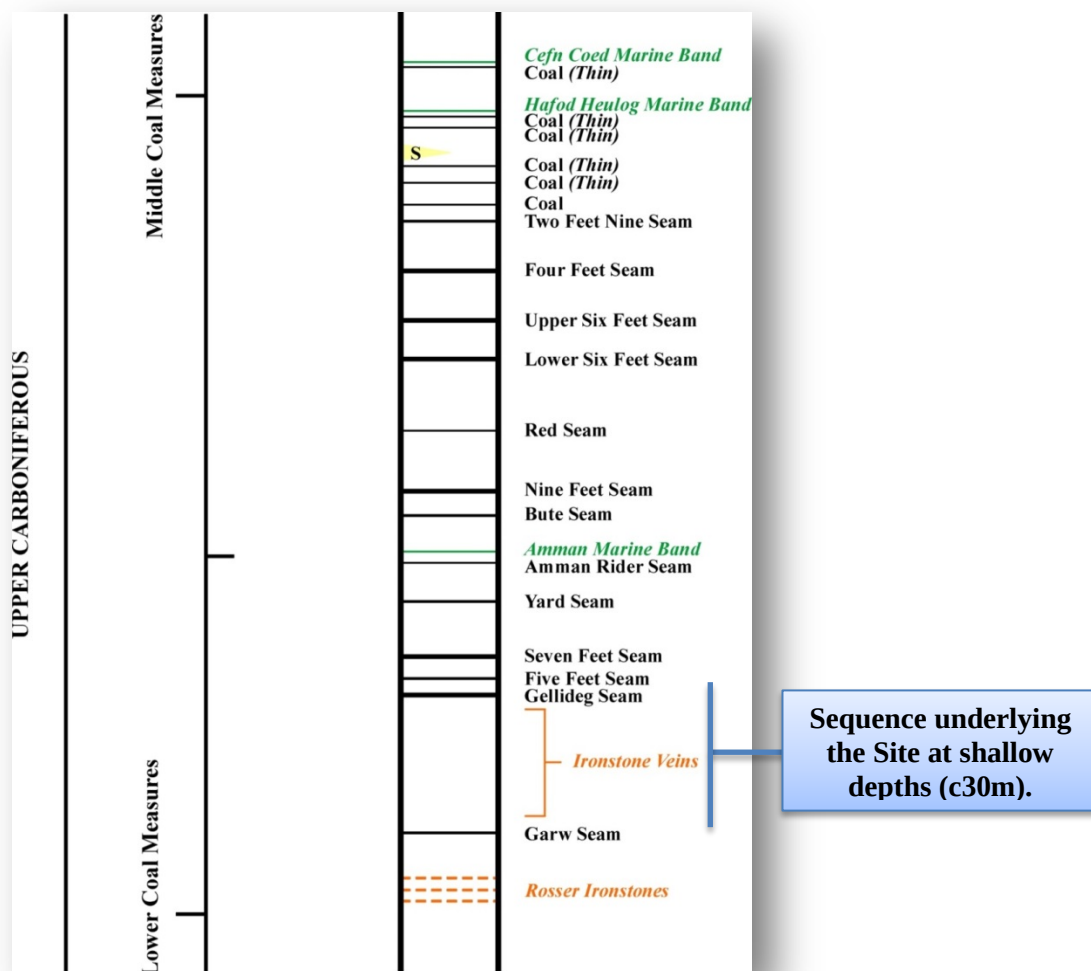
**Figure 2**  
**Part of the Stratigraphic Column.**  
 Scale: Not to Scale.

operations. Both the Five Feet Seam and the Gellideg Seam were mined underground in the immediate vicinity of the Site; although our search of coal mining records identified no record of old workings underlying the Site. The records held by The Coal Authority are not a complete record of past mining activities and the presence of unrecorded old workings cannot be dismissed, particularly in this area where extensive underground mining operations began before comprehensive records were being kept.

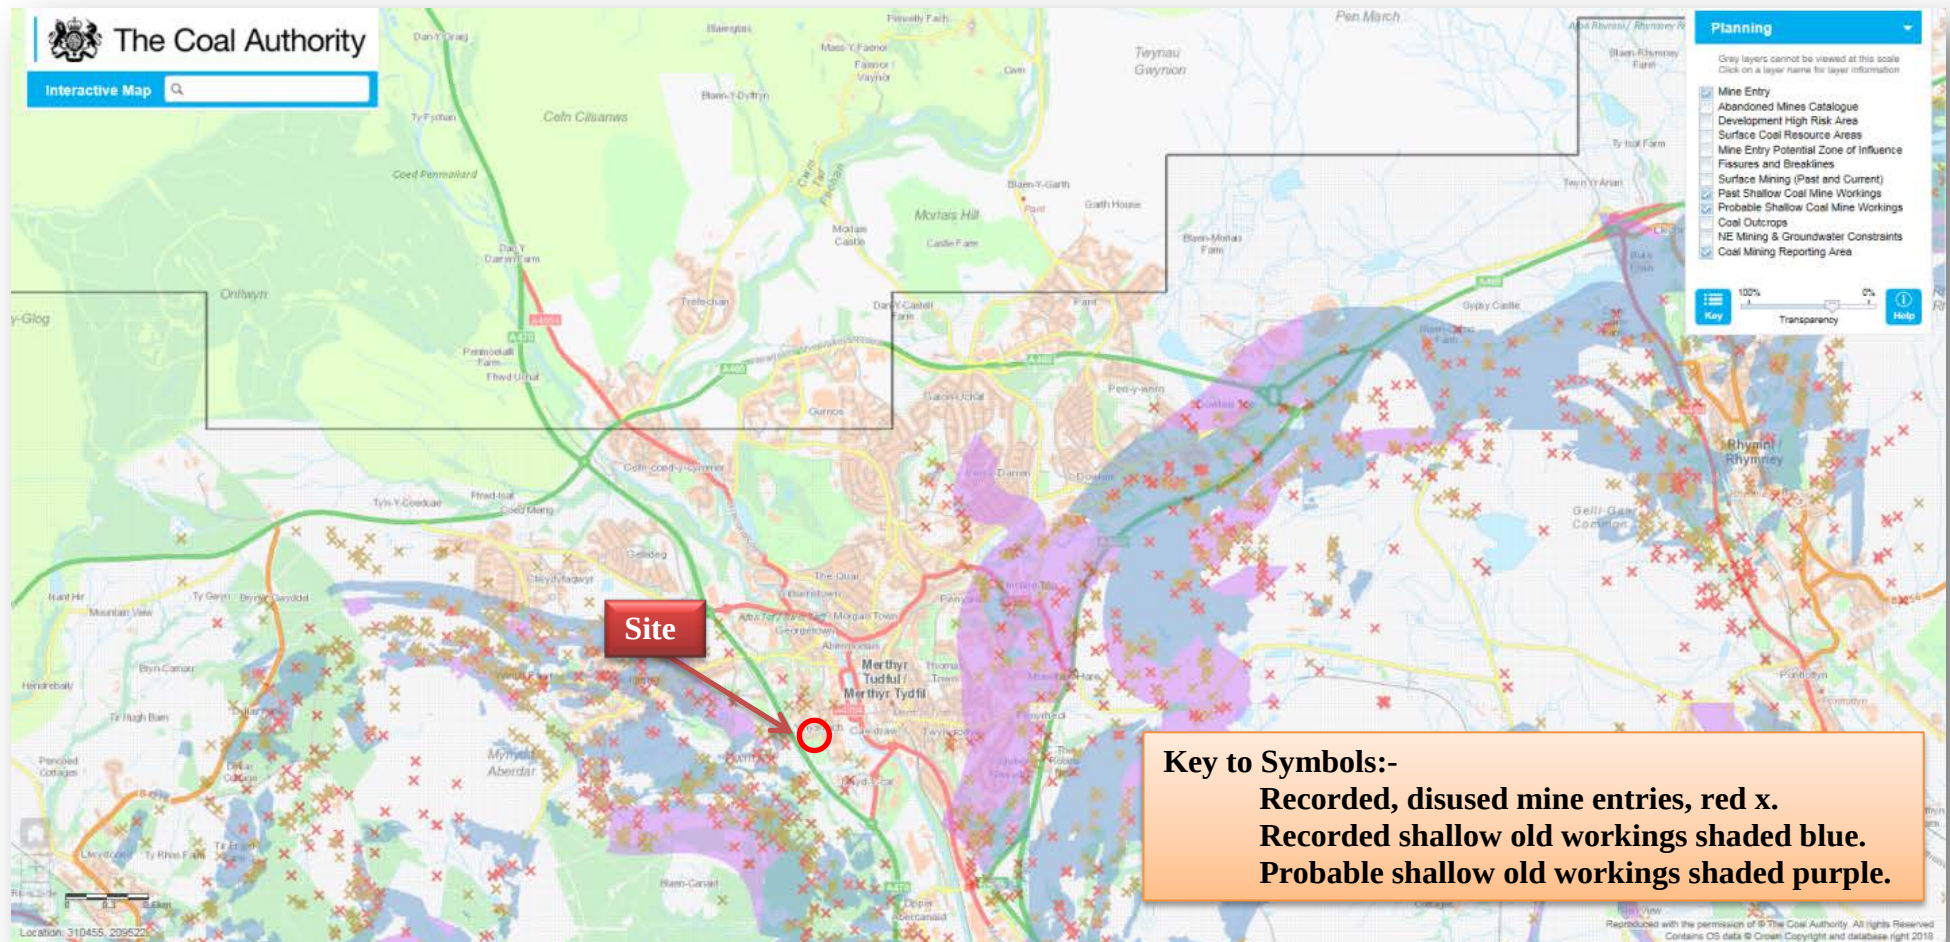
**Figure 3**  
**Print-out of The Coal Authority's Interactive Map**  
 (Accessed 25<sup>th</sup> April 2019)

Veins. The workings were prosecuted from a number of drift mine entries and shafts that were interconnected and stretched from Clwydyfagwyr southwards to Abercanaid. The Rhydycar Pit, 200m south-east of the Site, was an important part of this extensive mining operation; the underground mining operations for the ironstone veins extended across the area of the Site.

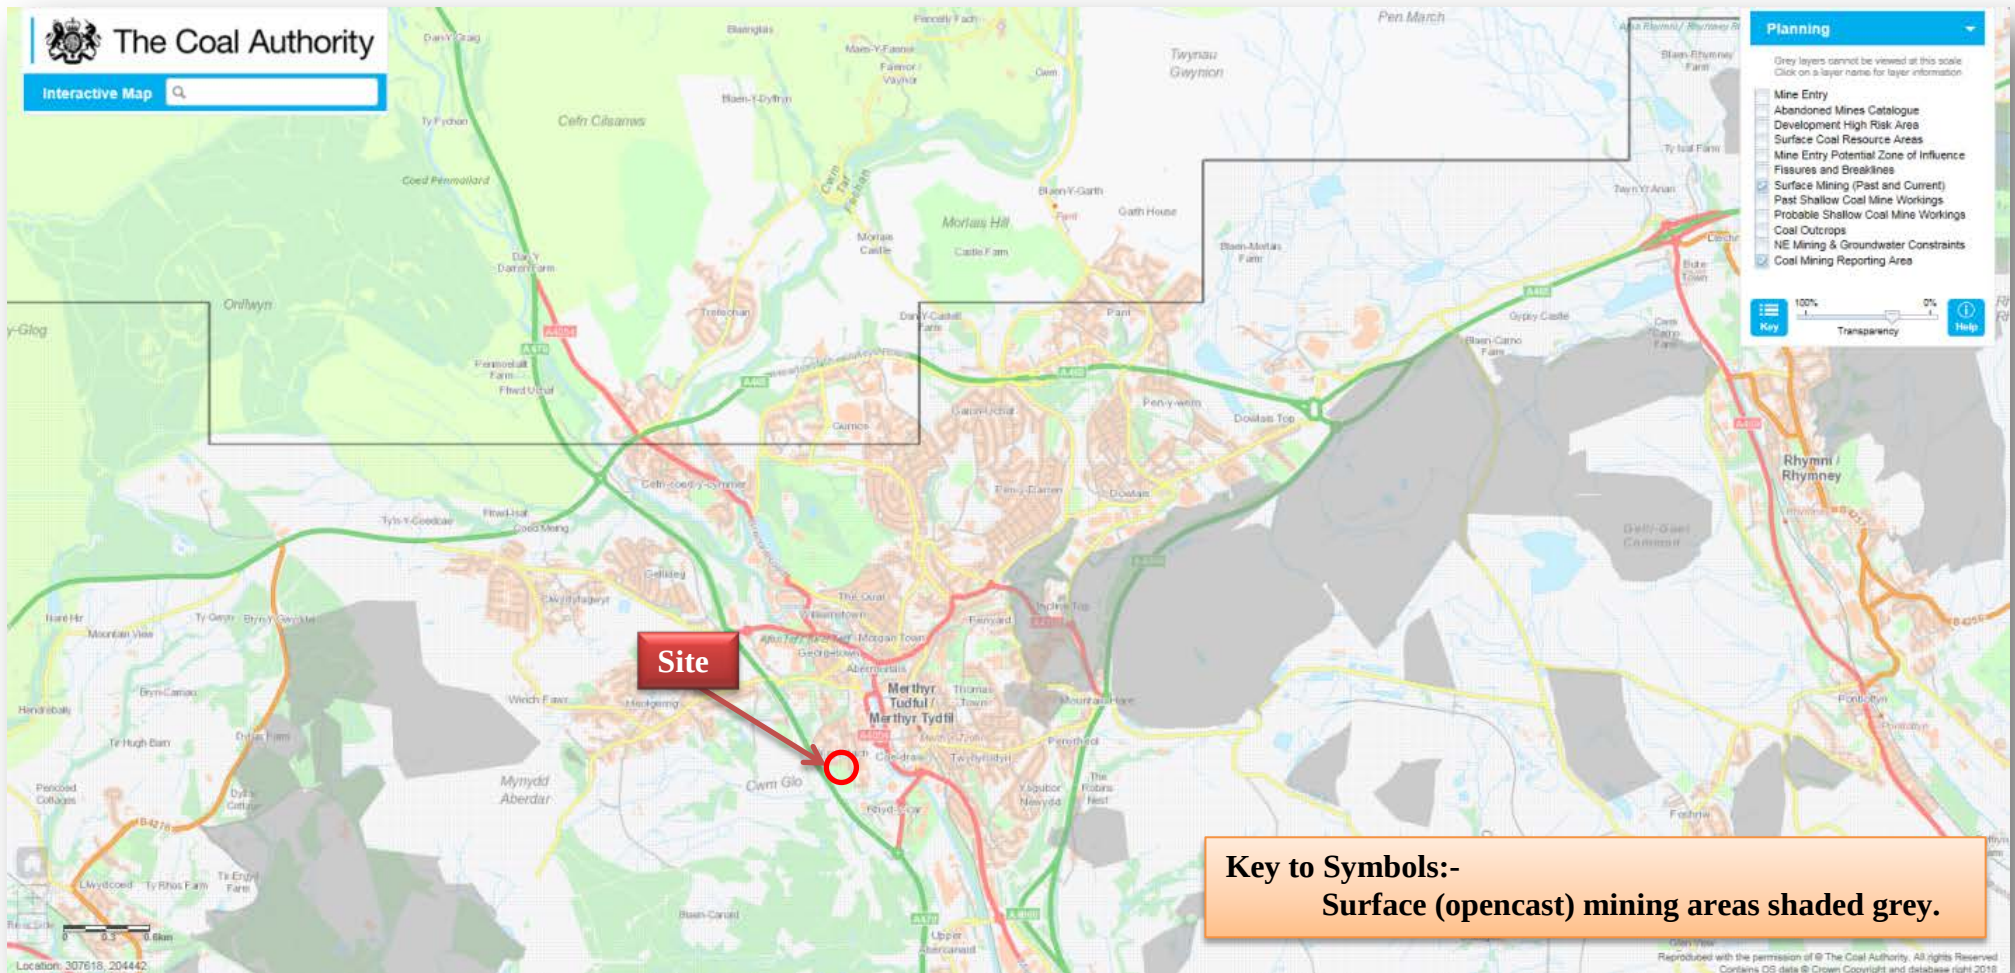
**Figure 4**  
**Print-out of The Coal Authority's Interactive Map**  
(Accessed 25<sup>th</sup> April 2019)

Our searches found no record of a disused shaft or adit within the confines of the Wern Sports Ground or within 20m of its boundary, a situation confirmed by The Coal Authority *report no. 51002046522001*. The risk of an unrecorded mine entry being present within the Site cannot be entirely discounted. The Site has not been part of an opencast coal site, and there have been no opencast mining operations close enough to the Site to affect the structural integrity of the proposed development. There are no operating collieries within influencing distance of the Site.

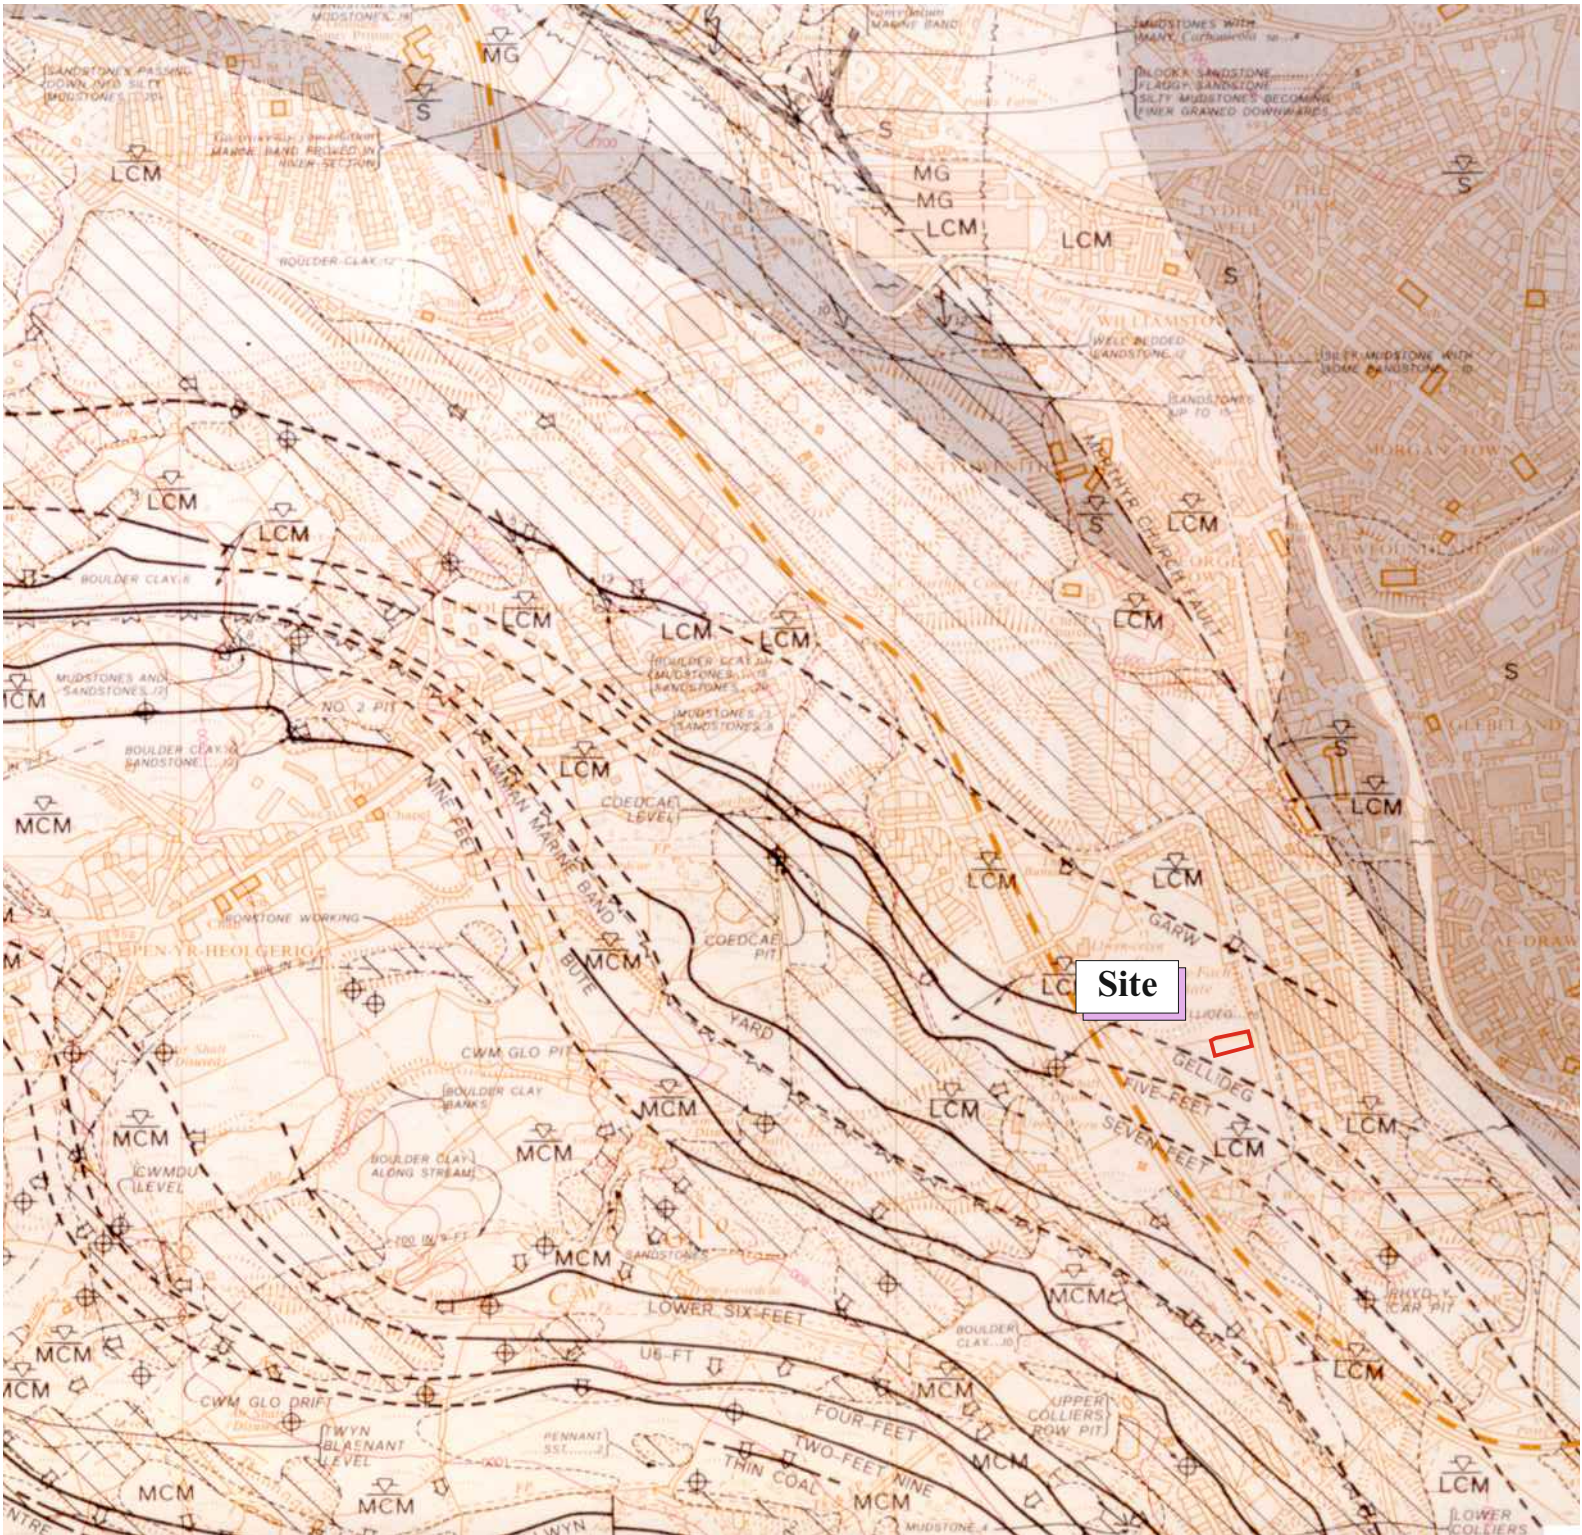
Drawing No: BC/MB/04.19.04.02.

Upper Carboniferous Period. The most recently published geological sheet at 1:10,560 scale (SO 00 NW) shows the inferred positions of the outcrop of the Five Feet and Gellideg Seams to be present beyond the south-west corner of the Site (see *Geology Plan, drawing no. BC/MB/04.19.04.02*). The next seam below the Gellideg Seam in the geological sequence is the Garw Seam; the interval between the two is approximately 30m. There are a number of ironstone bands within the coal measures lying between the two seams with two further ironstone bands, the Rosser Veins, present below the Garw Seam. The regional dip of the coal measures around the Wern is south-westwards with the result that the published geology sheet would indicate that the Five Feet and Gellideg Seams do not underlie the Site. However, earlier ground investigation carried out at the Wern indicates that the actual outcrop positions are slightly further to the north-east than are shown on the published geological sheet with the result that the Gellideg Seam underlies the Site. The shallow coal measures underlying the Site are the Gellideg Seam and the measures down to the Garw Seam, including the five ironstone bands.

The coal measures of the South Wales Coalfield have been affected by large faults. In the Ynys Fach area these large faults have a slightly sinuous trace at the surface and an average trend towards the north-west. The published geological sheet indicates that the Site is not affected by large scale faulting.

The published geological sheet indicates that locally the coal measures are overlain with deposits of glacial boulder clay. Other ground investigations at the Sports Ground have identified the presence of Made Ground across much of the area. Published geological records indicate that the Site is not affected by landslip.
