*Report No. BC/MB/11.23.01.*

# **Coal Mining Risk Assessment: Land at Dowlais Rugby Club, Blaendowlais, Merthyr Tydfil.**

***Dowlais Rugby Club***

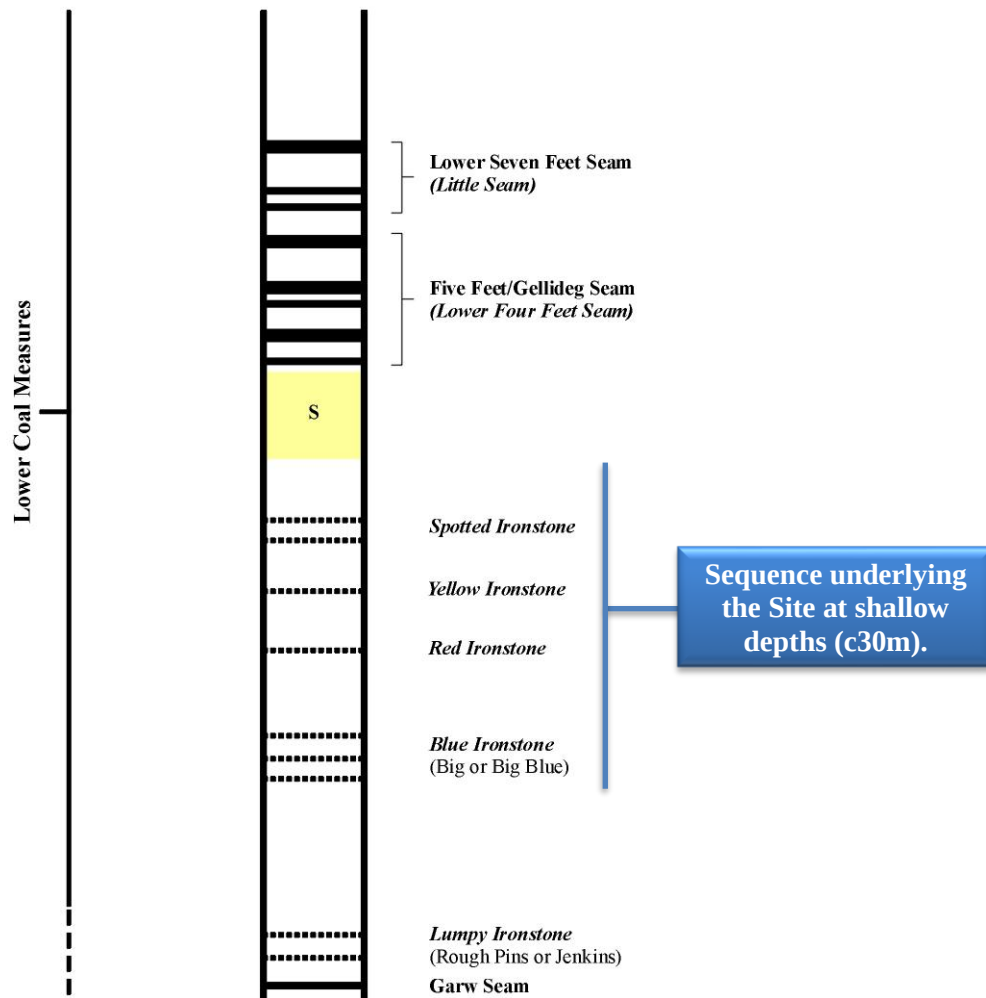
**Figure 2**  
**Indicative Stratigraphic Column.**  
(After BGS Sheet SO 00 SW)

Beneath the Gellideg Seam in the geological sequence are a series of five ironstone veins, the Garw Seam and then the Rosser Ironstones (see Figure 2, Part of the Stratigraphic Column).

Between the Five Feet/Gellideg Seam and the Garw Seam there are five ironstone veins that have been extensively mined across the Merthyr Tydfil area. The Coal Authority's mining report identifies that the Site is affected by mine workings in a number of the ironstone veins, some of them at shallow depths.

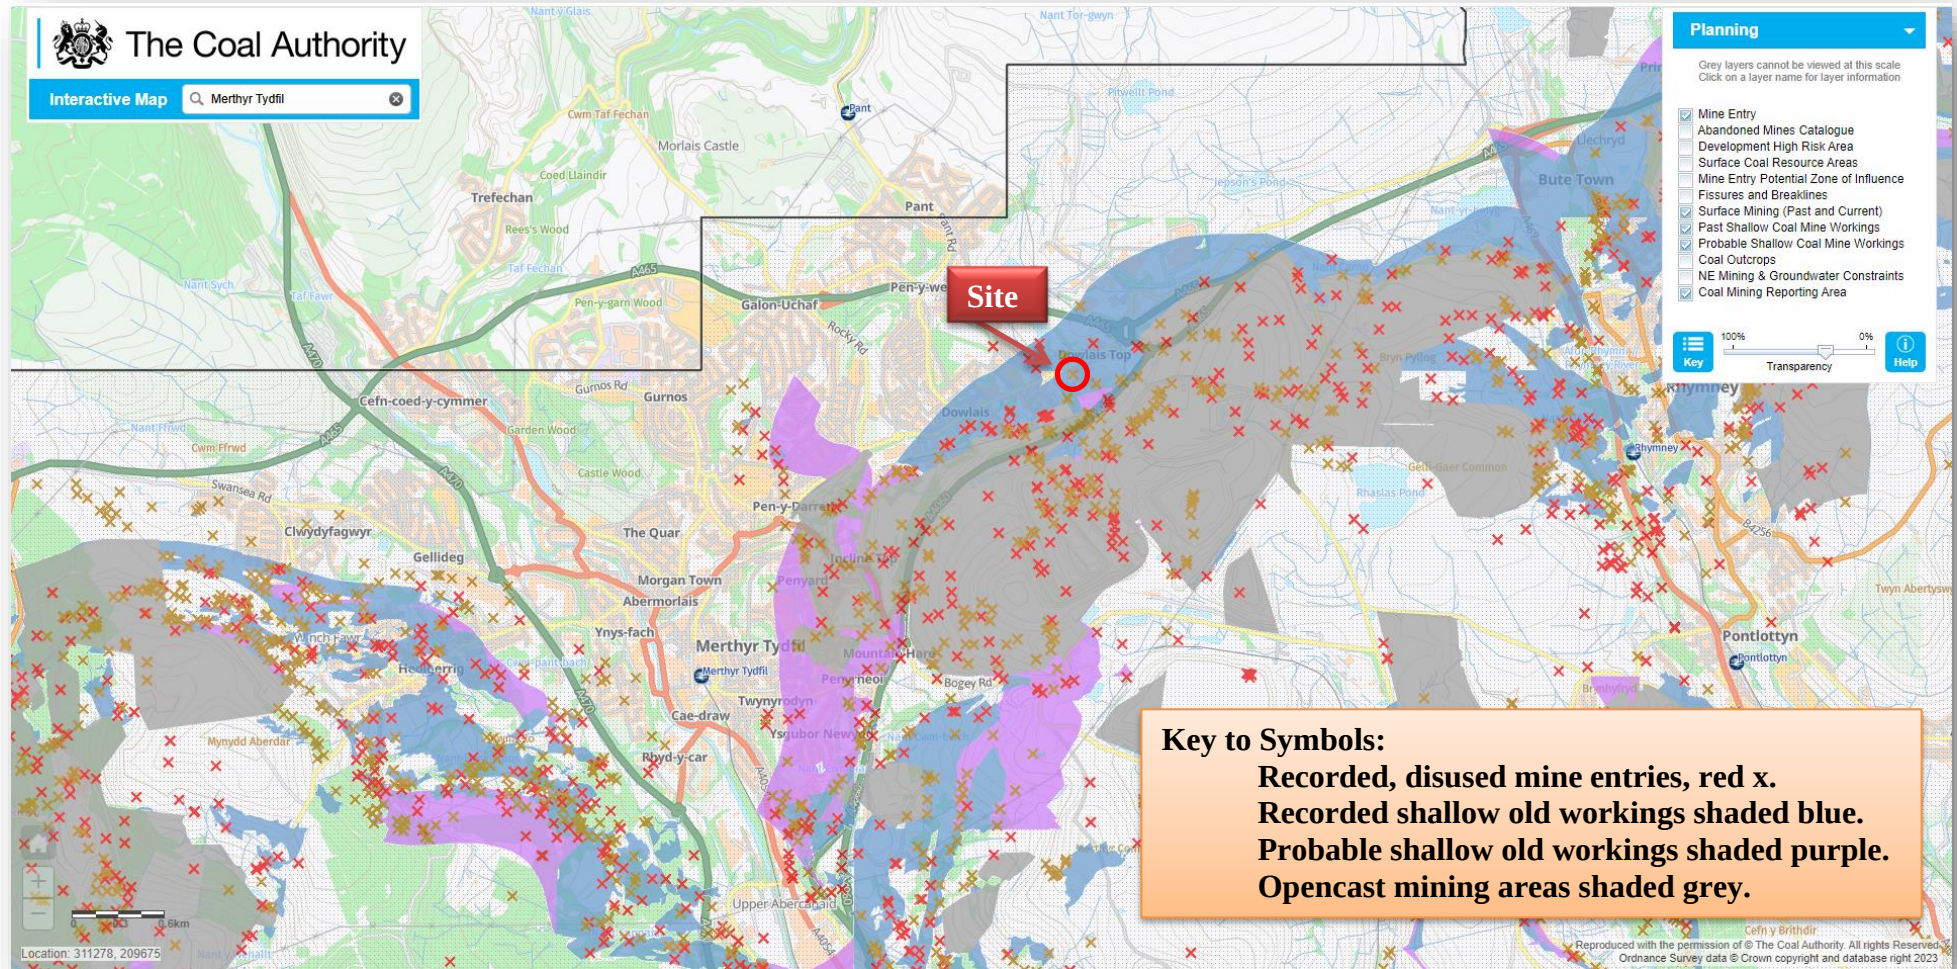
**Figure 3**  
**Print-out of The Coal Authority's Interactive Map**  
 (Accessed 9<sup>th</sup> November 2023)

The Coal Authority's interactive on-line map resource identifies that the Site lies within an area that has shallow mine workings present (see Figure 3).

The shallow ironstone workings pose a risk of surface subsidence. However, the proposed extension is of small scale (approximately 9m x 2.75m) and its foundations will be tied into the foundations of the existing Clubhouse and changing rooms that it will connect. It is understood that the two existing buildings have been constructed using raft foundations. Whether or not this is the case, the two buildings are completed and consequently there is nothing to be gained by drilling exploratory boreholes to examine the shallow mine workings.

There is a significant risk of surface subsidence resulting from recorded shallow mine workings (ironstone) that are beneath the Site. In addition, there is a risk of surface subsidence or of weak ground being present as the result of the presence of a disused mine adit beneath or in the immediate vicinity of the proposed extension.

The foundations for the proposed extension must mitigate against the risk of subsidence associated with the mine adit and/or the shallow ironstone workings, and against any weak ground that may be present as a result of the adit. It is recommended that a reinforced raft foundation is used and must be tied into the foundations of the two existing buildings.

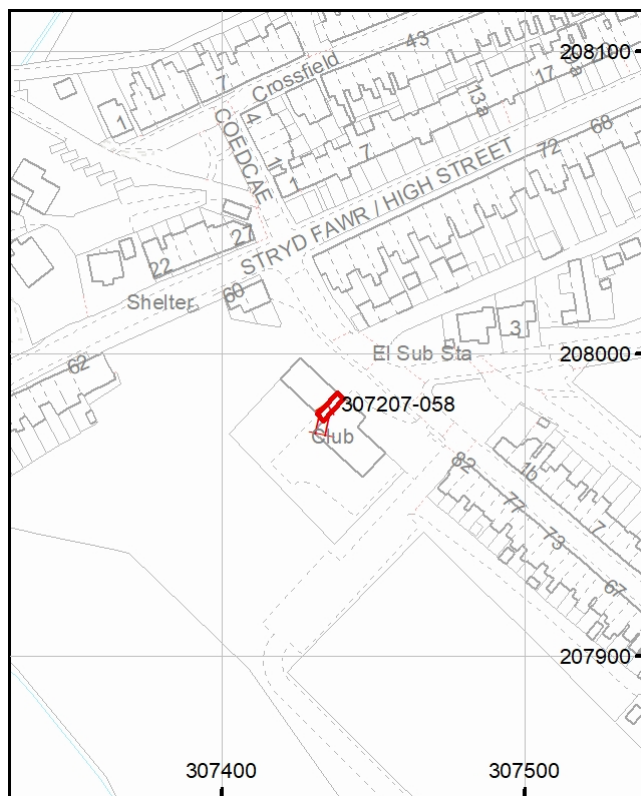
# Enquiry boundary

Our searches found a record of only one disused shaft or adit within the confines of the Site, the disused mine entry is an adit shown to be present immediately to the south of the proposed extension, the adit was driven in a northerly direction and would pass beneath the complex that is the existing buildings and the proposed extension and poses a risk of subsidence to the proposed extension or a risk of there being weak ground present.

Within, or within 20 metres of, the boundary of the property there is 1 mine entry, the approximate position of which is shown on the enquiry boundary plot. For reasons of clarity, mine entry symbols may not be drawn to the same scale as the plan.

There is no record of what steps, if any, have been taken to treat the mine entry.

Excavations during the construction of the extension **must** be carefully monitored for any evidence of the adit being present and if anything unusual is observed then the excavation work should be stopped immediately and advice sought from a Chartered Geologist or from The Coal Authority.

Excavation work on the Site **must** be carefully monitored for any evidence of the disused mine entry and if any unusual features are observed then the work must be stopped immediately, and advice sought from a Chartered Geologist or from The Coal Authority.
