## Pandy Farm, Merthyr Tydfil

### Bat Report

Report Ref: 1703 / 02a

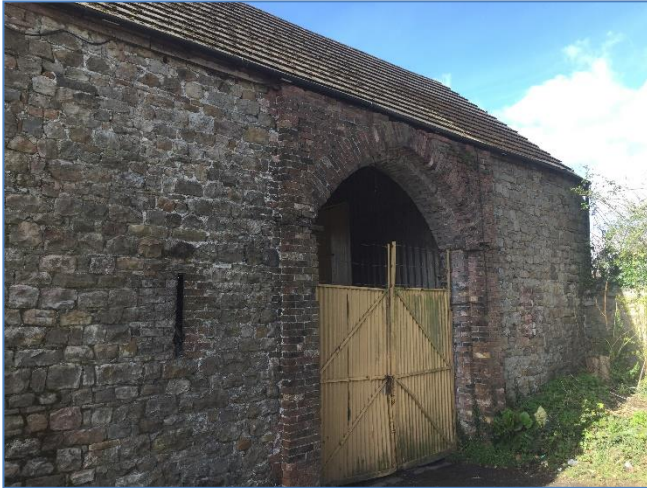
Photograph 1. Building B. The gated access on the northern elevation.

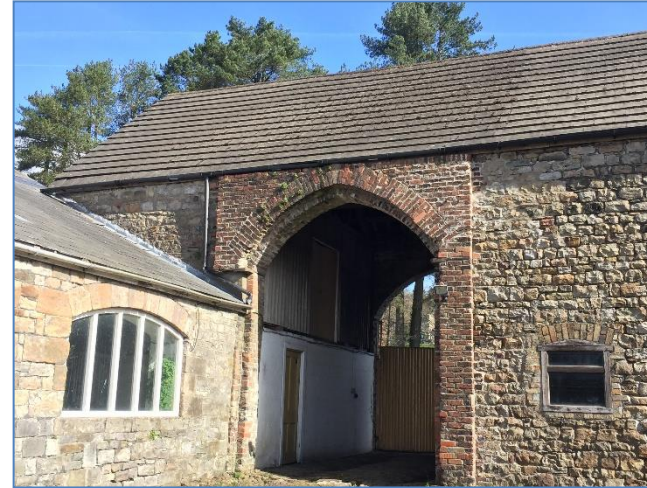
Photograph 2. Building B. The gated access on the southern elevation.

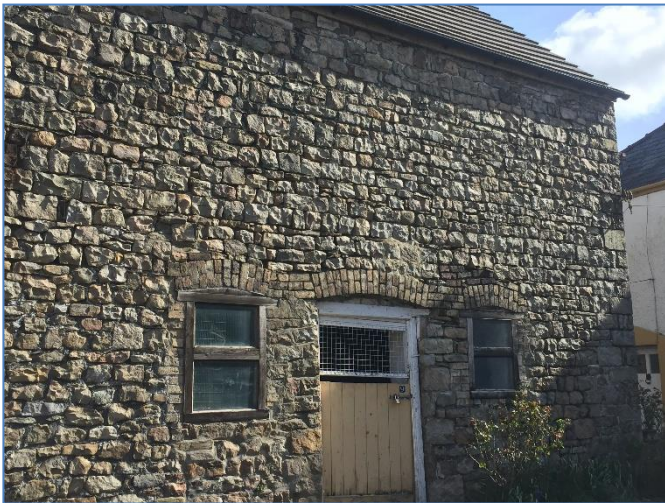
Photograph 3. Building B, eastern section. The rough stonework on the southern elevation.

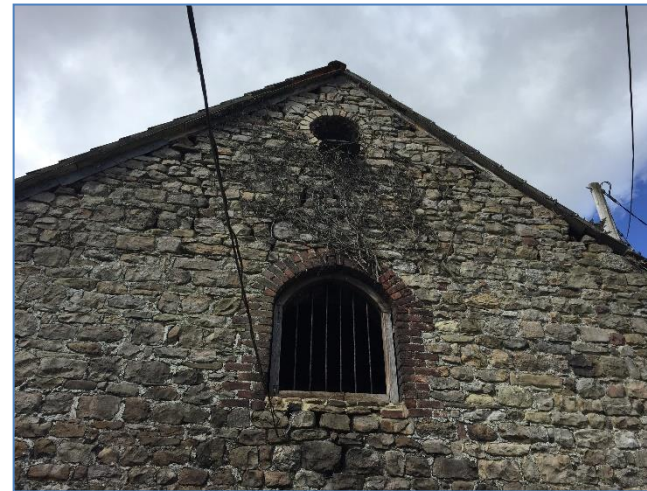
Photograph 4. Building B, eastern section. The eastern elevation with gappy verges.

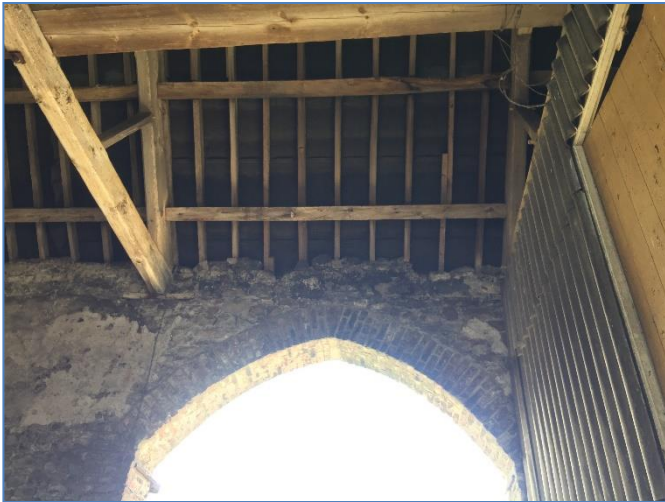
Photograph 5. Building B. The roof structure above the central gated section.

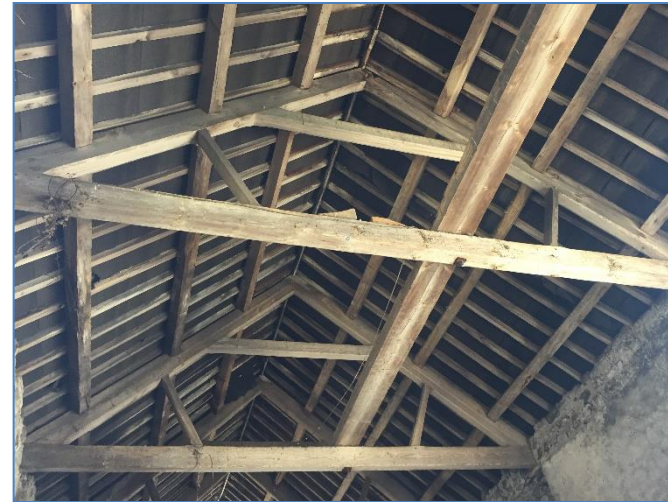
Photograph 6. Building B, eastern section. The tie and collar beam roof construction.

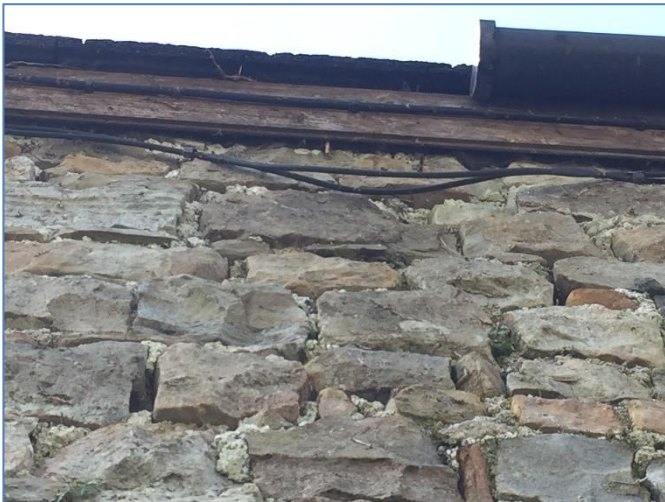
Photograph 7. Building B, eastern section. Gaps beneath fascia boards on the northern elevation.

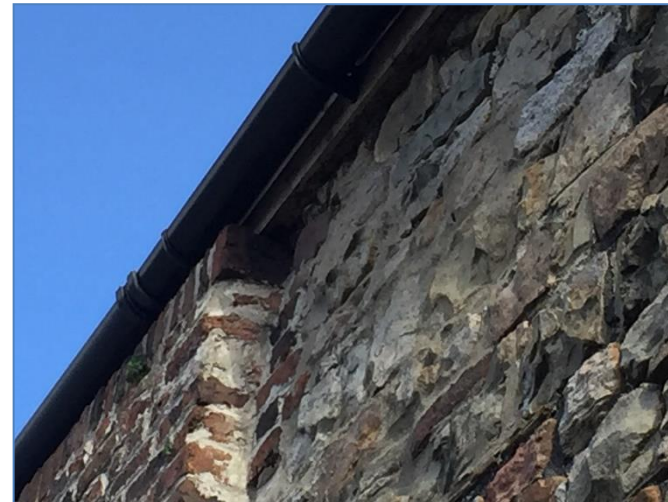
Photograph 8. Building B, eastern section. Further gaps beneath fascia boards.

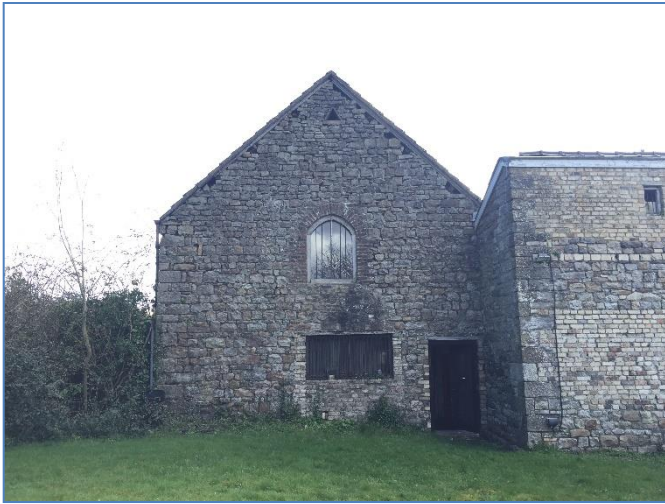
Photograph 9. Building B, western section. The western elevation (adjacent to Building C).

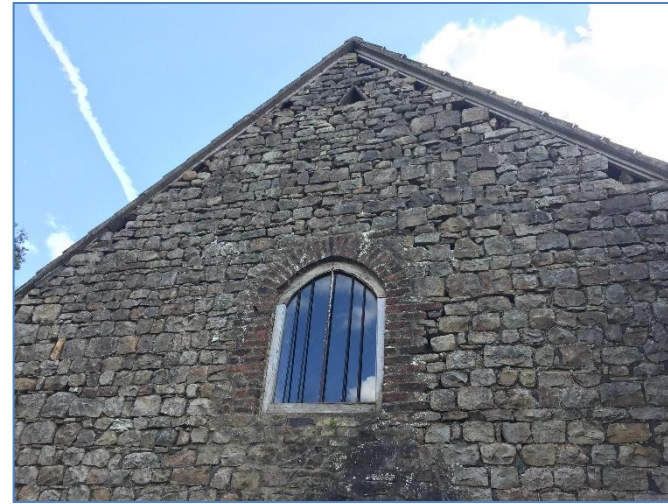
Photograph 10. Building B, western section. Gappy verges on the western elevation.

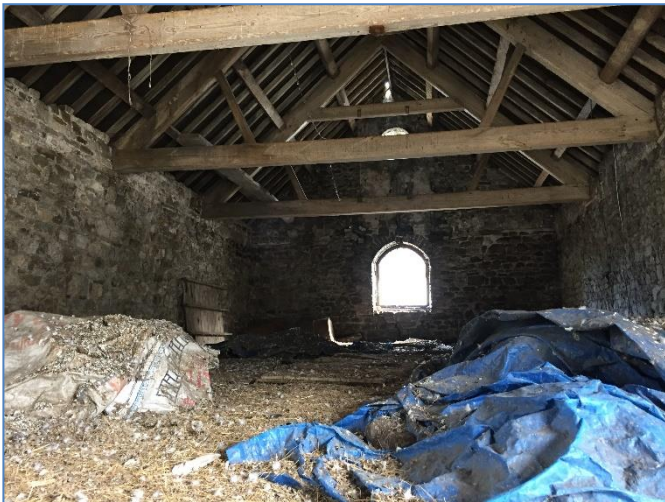
Photograph 11. Building B, western section. The first floor.

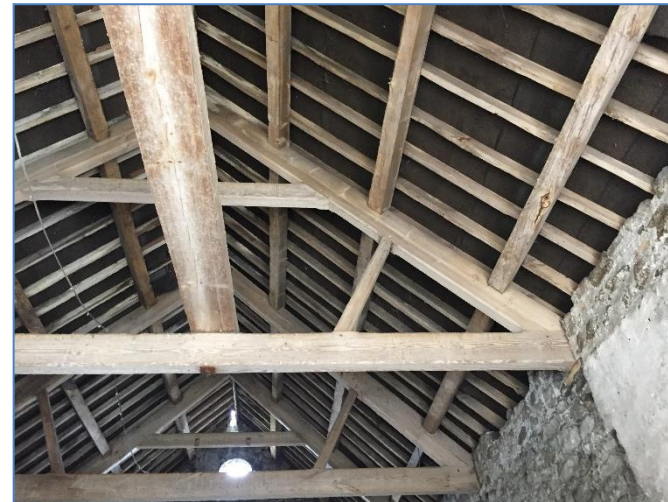
Photograph 12. Building B, western section . The tie and collar beam roof construction.

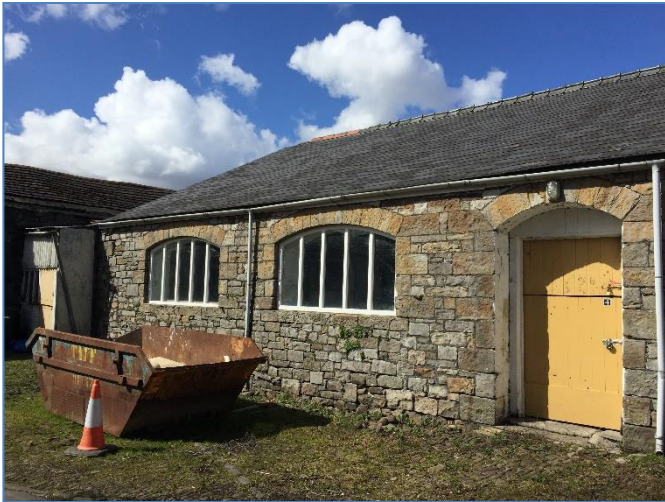
Photograph 13. Building C, southern half of the eastern elevation.

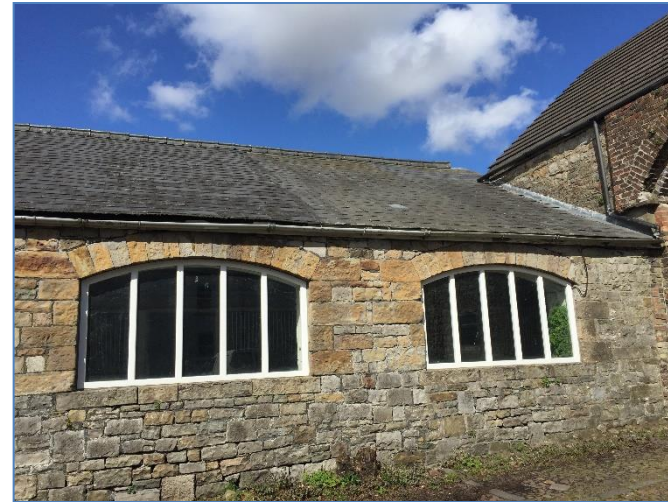
Photograph 14. Building C, northern half of the eastern elevation, with missing ridge tiles and bowing of roof visible.

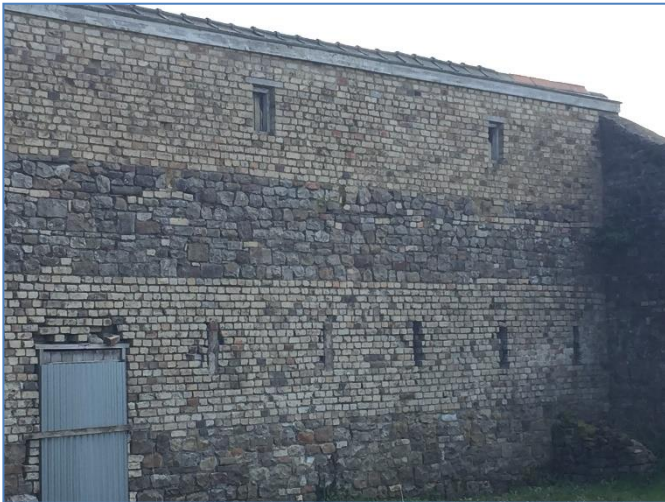
Photograph 15. Building C. The western elevation.

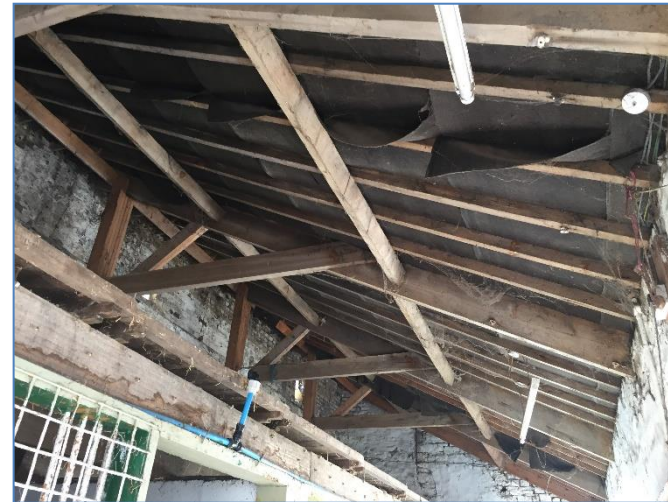
Photograph 16. Barn C. The internal roof construction and mezzanine loft.

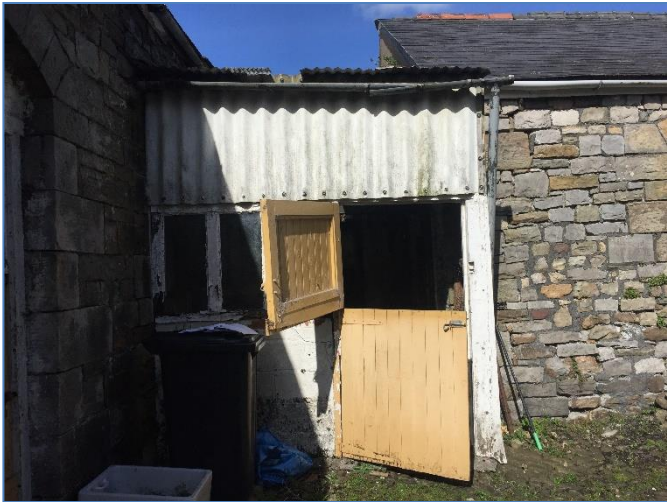
- 3.6 The entire section is single storey, although the workshop forms the main part and is in considerably better condition. The northern part comprises two small store rooms of rough stone construction that are in poor condition. There are notable deep crevices within the walls, which are very damp. The roof comprises corrugated metal and fibreboard and is significantly damaged, with some sections missing entirely.

Photograph 17. Building D. The damaged storeroom entrance on the eastern elevation.

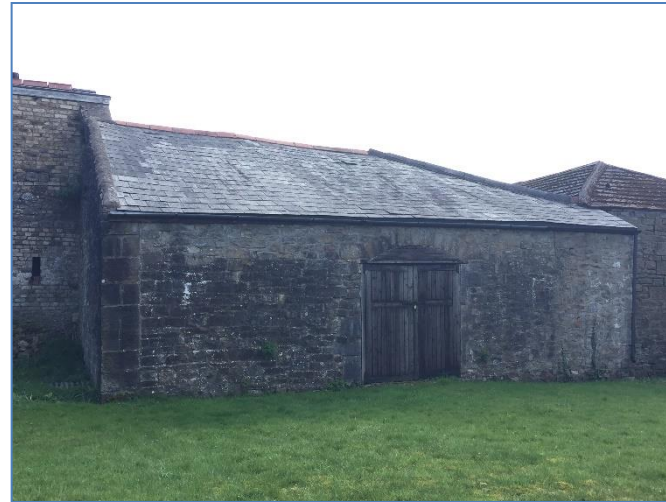
- 3.7 The workshop is a traditionally built stone building with a hipped artificial slate roof. The stonework is in good condition on the western elevation; with the north and south being formed by the adjacent buildings, and the east being the small store rooms.

Photograph 18. Building D. The western elevation.

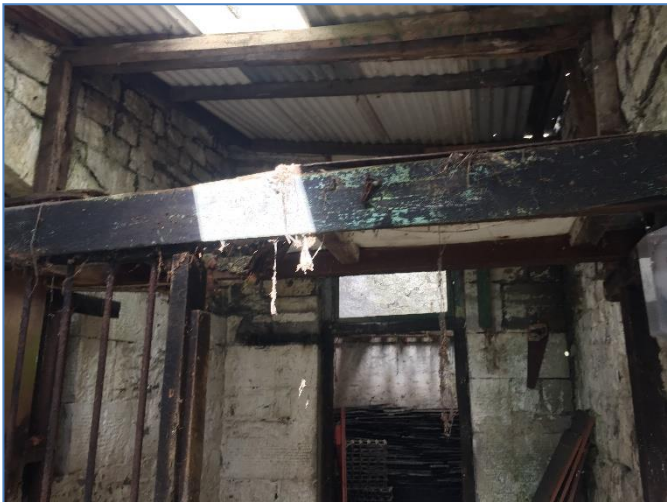
Photograph 19. Building D. The store rooms in a very poor state of repair.

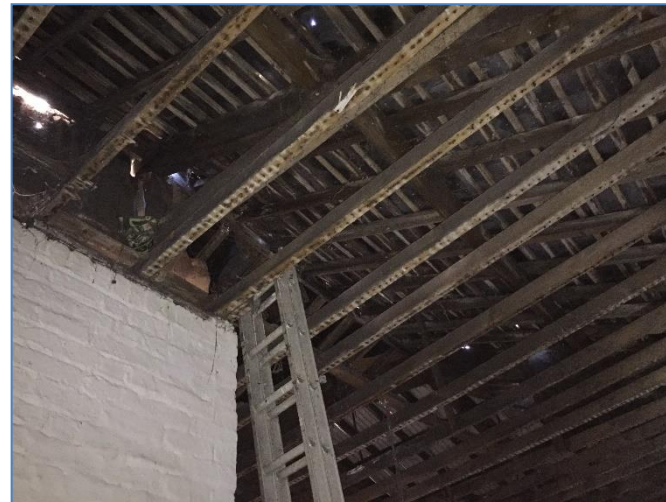
- 3.9 Internally, the workshop is open to the roof, which has a collar beam construction, and is cluttered near the apex. There is bitumen felt present in part and this is in very poor condition, being absent in places and badly torn. The timber double doors on the western elevation are not tightly fitted, and small gaps are present around them.

Photograph 20. Building D. The roof structure of the workshop, which has some sections of bitumen felt.

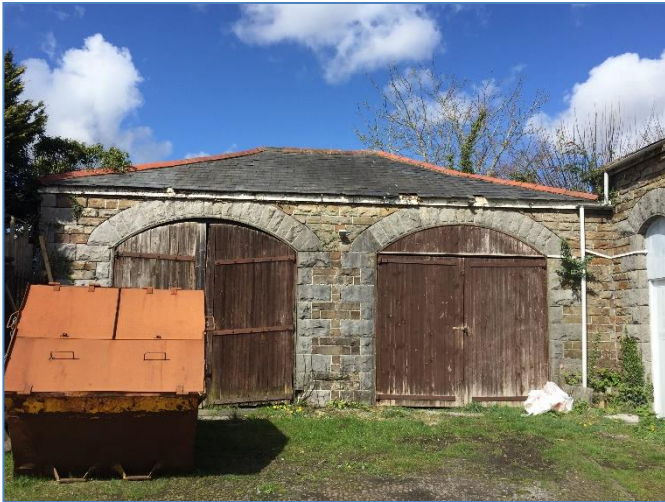
- 3.12 Building E is a single storey building of stone construction. The front, eastern, elevation is constructed of cut stone, which is well fitted and contains no obvious gaps. The other elevations

Photograph 21. Building E. The eastern elevation.

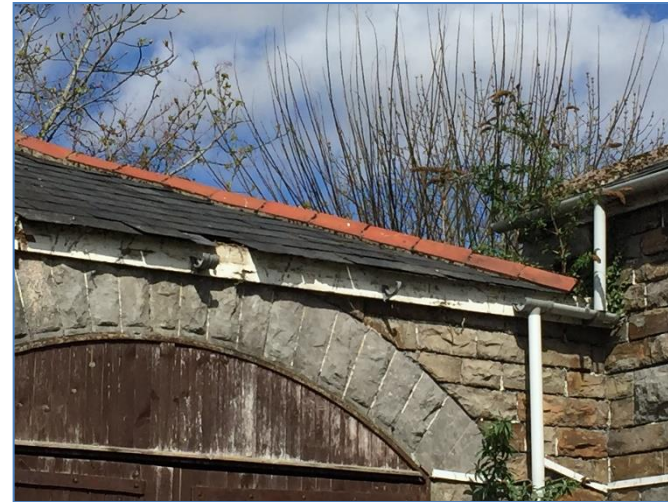
- 3.15 The roof slates are in poor condition with several raised and missing slates, particularly on the bottom course.
- 3.16 The timber fascias are all present, but choked with vegetation beneath. It is possible that gaps are present into the roof void amongst the vegetation.

Photograph 22. Building E. Missing tiles from the lower courses.

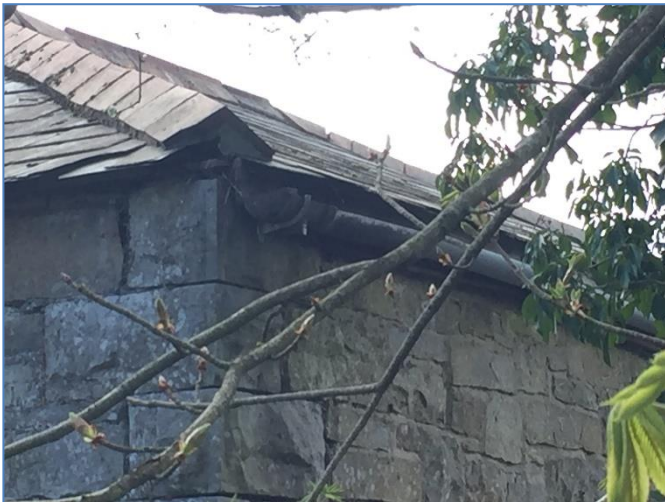
- 3.14 The pitched roof is hipped and almost square with nearly equal sized roofs on all aspects. The main north-south ridge is clad with clay tiles, one of which has been replaced with a concrete tile. The majority of tiles, whilst being uneven to appear to be sealed with concrete, as do the hips on the eastern elevation. The hips on the western elevation were only partly visible and appear to be uneven. There is missing mortar beneath the bottom tile on the north western hip.

Photograph 23. Building E. The Missing mortar from the hip.

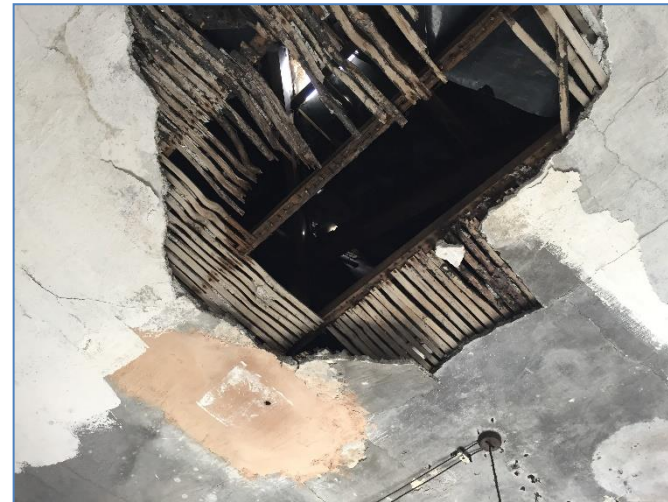
- 3.17 Internally the ground floor stonework painted throughout and in good condition.
- 3.18 There is a suspended ceiling with no access into the loft space, which will be large and over 2m in height. There is a large damaged section through which it is possible to view the underside of the roof. The loft space does not appear cluttered and it is likely to have a simple cut and pitch construction. No roofing felt was present. It was not deemed safe to use a ladder against the damaged ceiling so the loft could not be inspected for evidence of bats.

Photograph 24. Building E. Damage to the ceiling showing the unlined roof above and access through the roof.

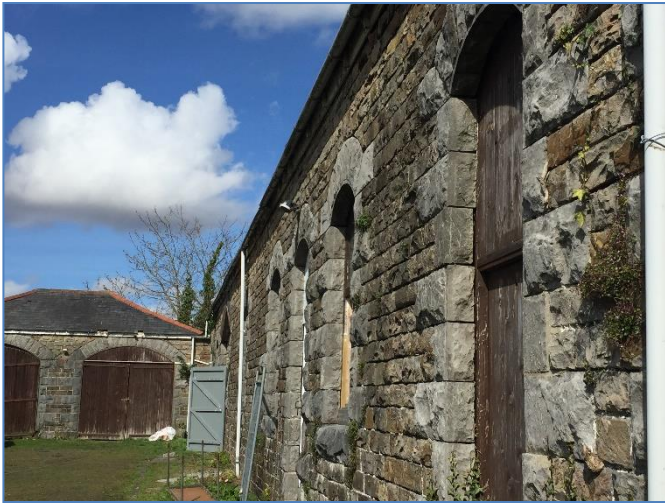
- 3.22 The southern elevation is of cut stone construction, which is in excellent condition. Similar to Building E, there are cut stone arches around all doors and windows, which are well fitted in the main. A gap is present between one of the stone window arches and timber cladding above the window. The eastern and western elevations are both of rough stone construction and in moderate condition. There are no visible gaps on the eastern elevation but large gaps at the wall tops on the west. A single window is present on both elevations, with the one on the west being gappy. The northern wall is the joining wall with Building H.

Photograph 25. Building F. The southern elevation.

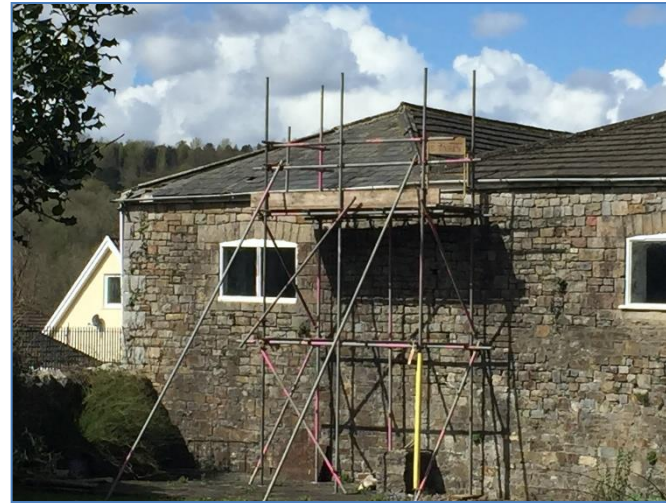
Photograph 26. Building F. The eastern elevation.

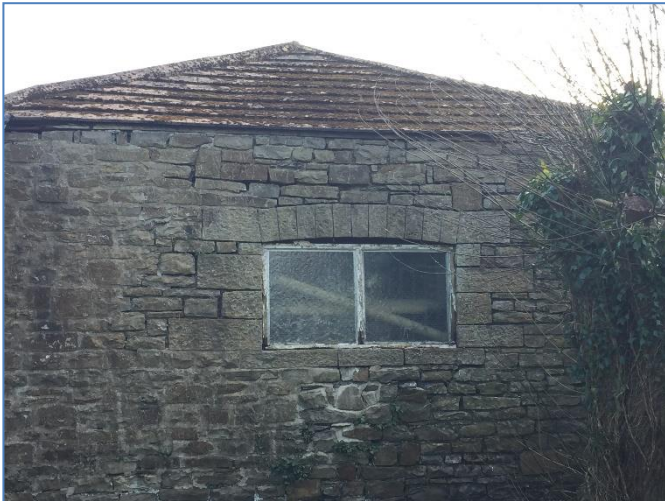
Photograph 27. Building F. The western elevation

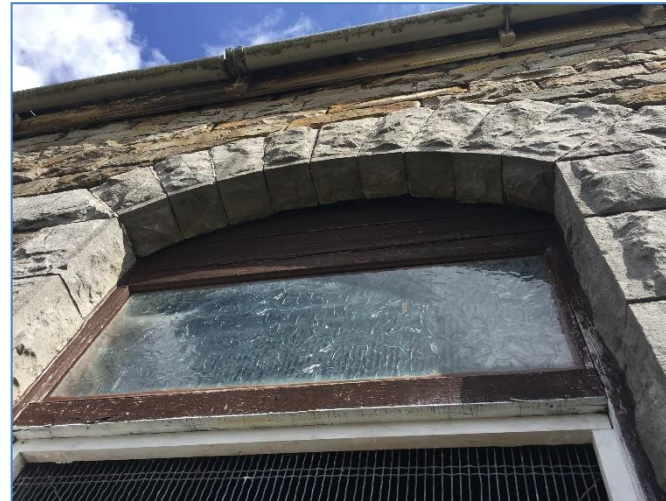
Photograph 28. Building F. Gaps present below window arches.

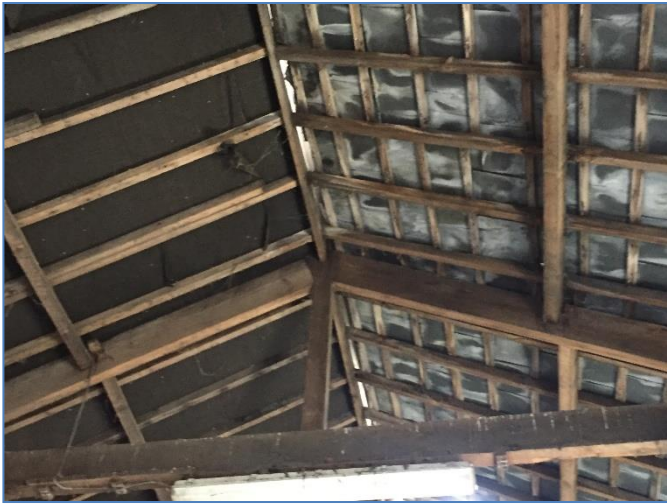
- 3.24 Internally the majority of the Building is open to the roof, which is a simple cut and pitch construction and in all areas where it is possible to view, there is bitumen felt on the northern

pitch and no felt on the southern pitch. One room contained bitumen felt on the southern pitch of the roof. The hipped roof on the western end also has a bitumen felt.

Photograph 29. Building F. The unlined slate tiles on the southern pitch and bitumen felt on the north.

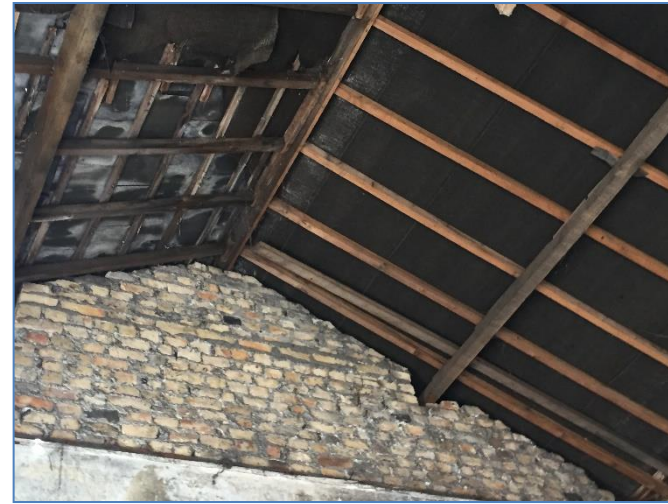
Photograph 30. Building F. Gappy internal wall tops allowing access between sections.

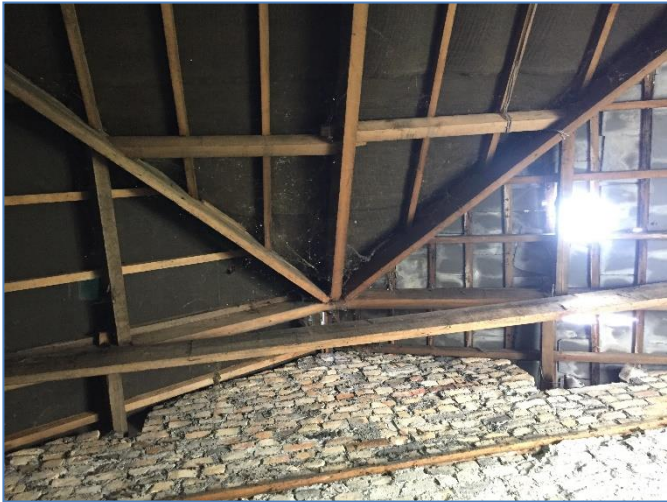
Photograph 31. Building F. Bitumen felt present on most of the western hip.

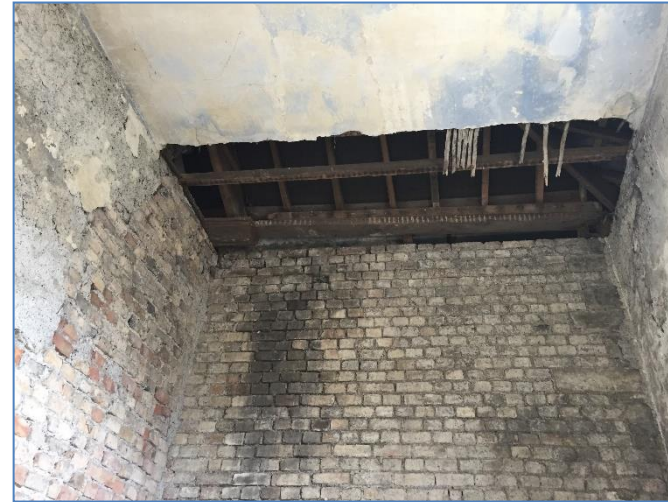
- 3.25 There are two sections with a ceiling, creating large loft voids, which will have a minimum of 2-3m at the apex. It was not possible to access the loft on the eastern end due to health and safety constraints. The central section which supports a ceiling has no access. All internal dividing walls are brick and there are significant gaps at the wall tops of each wall, allowing access between the open internal space and the loft voids.
- 3.26 No evidence of bats was recorded on the ground floor. There was significant pigeon and jackdaw activity within the eastern end. A nesting jackdaw was recorded at the wall top of the western external wall.
- 3.27 **Building F is considered to have high potential to support roosting bats.**

Photograph 32. Building F. A damaged ceiling showing loft space on the eastern end.

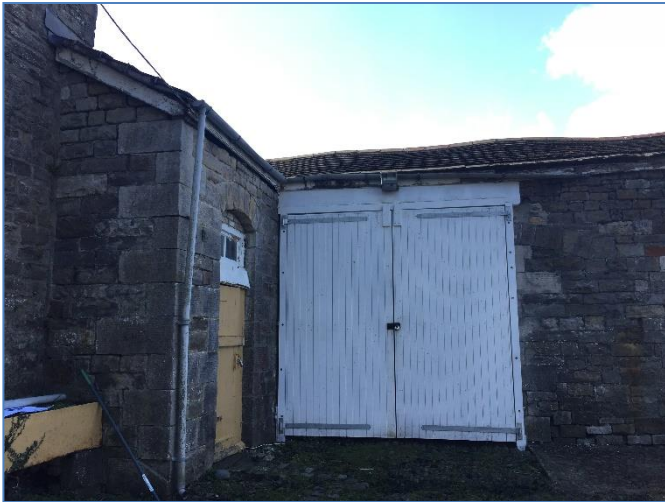
- 3.29 The roof is clad with small concrete tiles, with a concrete ridge and appears to be in good condition. There are timber fascias on the eastern and western elevations, with large gaps present beneath all.

Photograph 33. Building G. Gaps beneath fascia boards at the western corner.

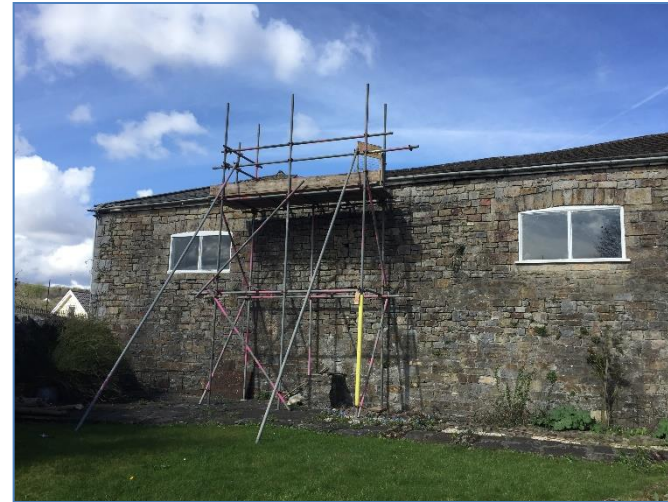
Photograph 34. Building G. The eastern elevation (right hand section of building).

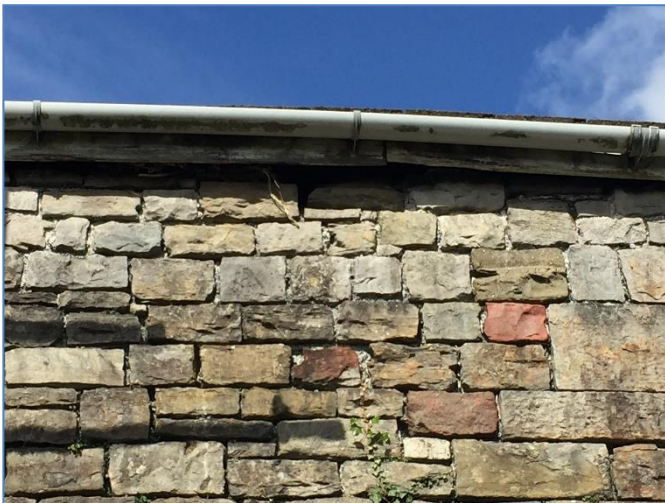
Photograph 35. Building G. Significant gaps beneath fascias on the eastern elevation.

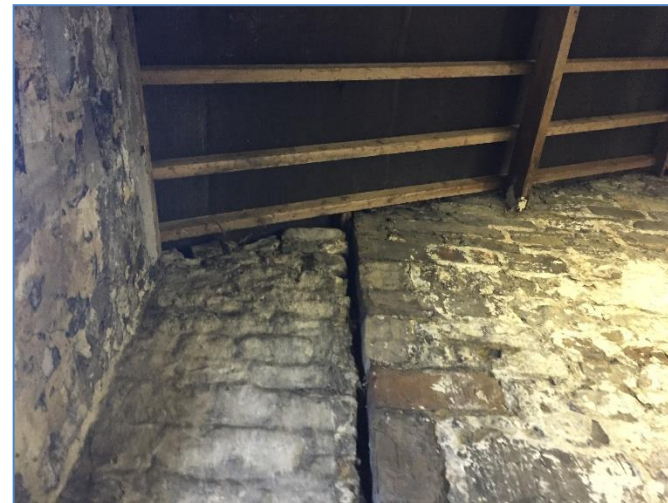
- 3.33 Ten medium segmented bat droppings were recorded near to the southern wall. A large crevice was also present in the stonework. These were not fresh and were scattered. The angled nature of the segments may be consistent with Natterer's bats. The results of DNA analysis are awaited. The droppings were sufficiently scattered to be meaningfully photographed.

- 5.2 There was no increase in the number bat droppings recorded in Building G, first noted in April 2022, by October 2022. The small number does not reflect a significant roost and is likely to be a single bat on a couple of occasions. DNA analysis is awaited and it is possible that this may be a fourth species recorded at the Site, most likely of a Natterer's or brown long-eared bat. The results of the analysis will not affect the mitigation proposed. It is clear that the roost is not regularly used and therefore the individual is not reliant on the internal space.

Photograph 36. Building G. A large internal crevice and the bitumen felt in good condition in close proximity to where bat droppings were recorded.

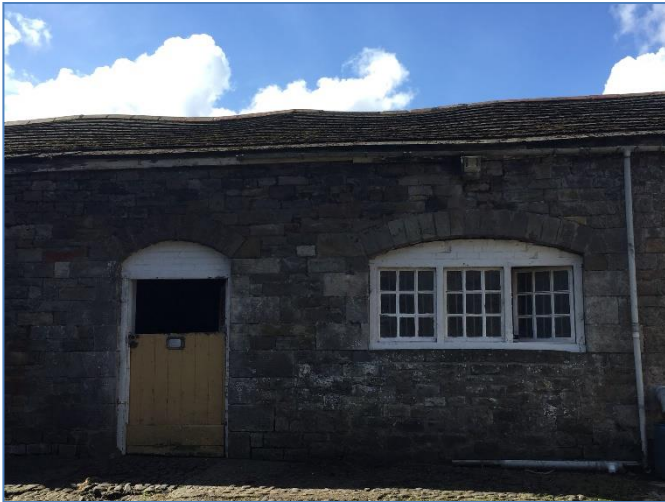
- 3.35 Building H is the main stable block, forming the southern side of the courtyard. The Building is single storey and of cut stone construction on the northern elevation, with well fitted doors and windows set into stone arches. A horse is currently occupying one stall and as such half of a stable door is kept open.
- 3.36 The simple pitched roof is clad with small concrete tiles on the northern pitch. This is in poor condition and numerous tiles have slipped on the bottom courses. The southern pitch is corrugated fibreboard with corrugated plastic light panels. This is intact and, together with the ground floor windows on the north, renders the internal space very light. It is not possible to view the exterior of the southern pitch nor the valley where the roof joins Building F.

Photograph 37. Building H. The northern elevation showing bowing of the roof and an open stable door.

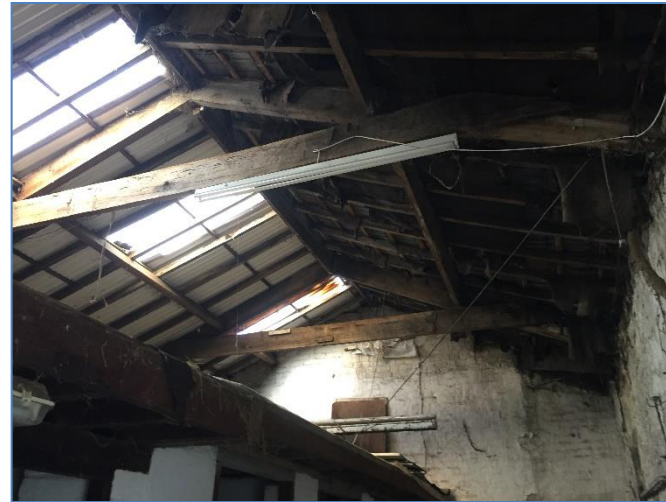
Photograph 38. Building H. The internal space showing northern pitch of roof in very poor condition.

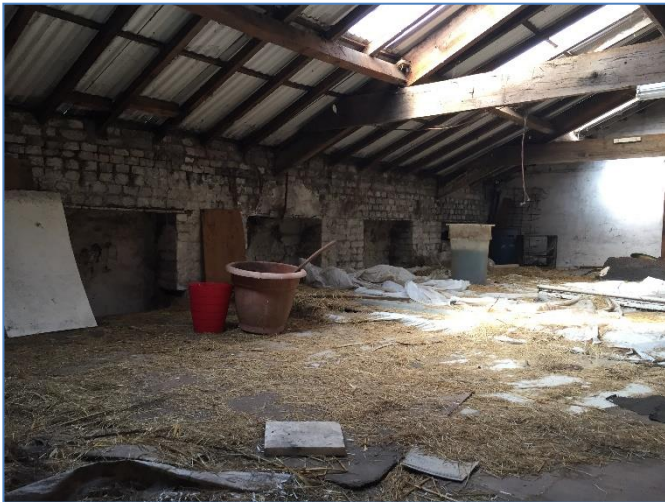
Photograph 39. Building H. The mezzanine loft level is very well lit.

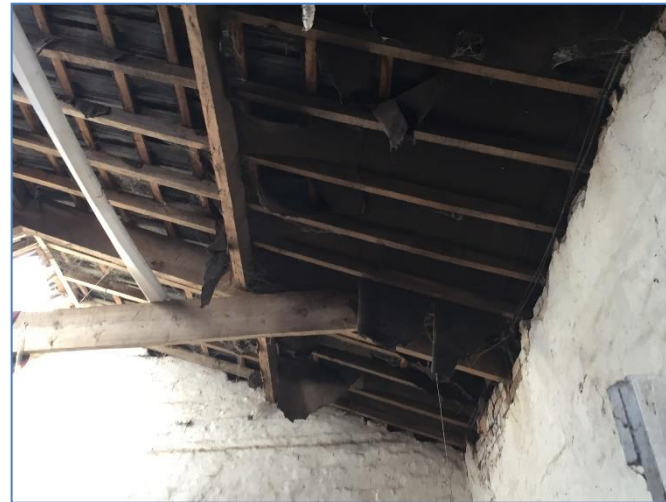
- 3.37 Internally, there is gappy brickwork on all wall tops and an internal brick dividing wall, which is also gappy at the top. The stonework is painted and offers limited potential to bats, other than the brickwork at the tops.
- 3.38 The roof is a simple collar beam construction, very similar to Building C. There is bitumen felt beneath which is in very poor condition, shredded, with large sections hanging.
- 3.39 There is a mezzanine loft along the northern edge, which was inspected. Whilst covered with hay and debris, it was possible and safe to search for evidence of bats.
- 3.40 No evidence of bats was recorded.
- 3.41 **Building H is considered to have moderate potential to support roosting bats.**

Photograph 40. Building H. Gappy brickwork visible at the wall tops.
