# **HERITAGE IMPACT STATEMENT**

## **For the Maintenance Roof Replacement and Repair at 6 Nightingale Street, Abercanaid, Merthyr Tydfil, CF48 1DX**

**Property Address:** 6 Nightingale Street, Abercanaid, Merthyr Tydfil, Cf48 1DX

**Planning Application Number:** P/25/0218

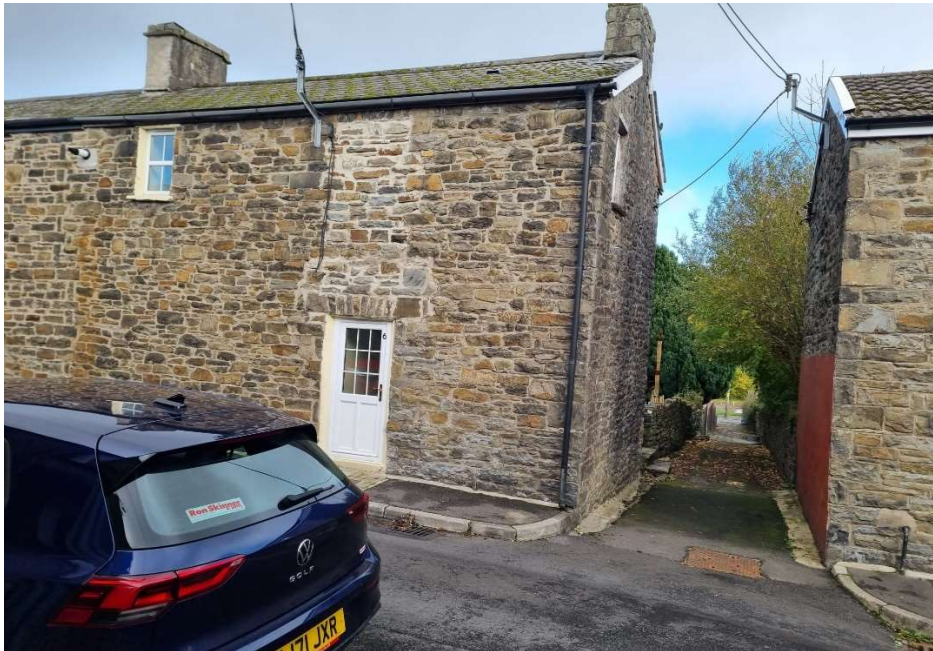
**Photograph 1:** Street side façade view; 6 Nightingale (at left of pic). Right side of pic is corner of 7 Nightingale, where the shoddy installation of fascia panels creates an aesthetically 'ugly' result.

It is noted in a comment from HB&P (forwarded to the Applicant by MT planning's Marlene Ferreira), that states *"The adjacent listed building at no 7 has used uPVC fascia boards and this is clearly an anachronistic and detracting appearance to the historic character of that building"*. Having visited the actual Nightingale Street listed terrace properties, the Applicant would generally agree with that comment. However, the Applicant disagrees that the fault of the apparent ugliness of the currently installed fascia panels at 7 Nightingale, lies with the materials selection of PVC fascia. The 'ugliness' fault is the resultant of very poor fascia panels installation practises and shoddy installation workmanship, particularly apparent at the end of terrace (lane) side of the building. At that side white fascia panels have been installed in a very shoddy and incomplete fashion, and they don't match with the fascia panels at the front / street-side of the property, nor are they joined at the corner of the building. HB&P, quoting this one example in isolation seems an unfairness, to the selection of PVC fascia material. Whereas, at 12 Nightingale Street the fascias at side, front and back appear as a cohesive, good quality and complete installation and the aesthetic value is a vast improvement compared to the No. 7 property. The contractor for the proposed works at 6 Nightingale will complete a high-quality installation of the proposed fascia panels ensuring they are all joined property and this will provide an adequate visual and aesthetic aspect.

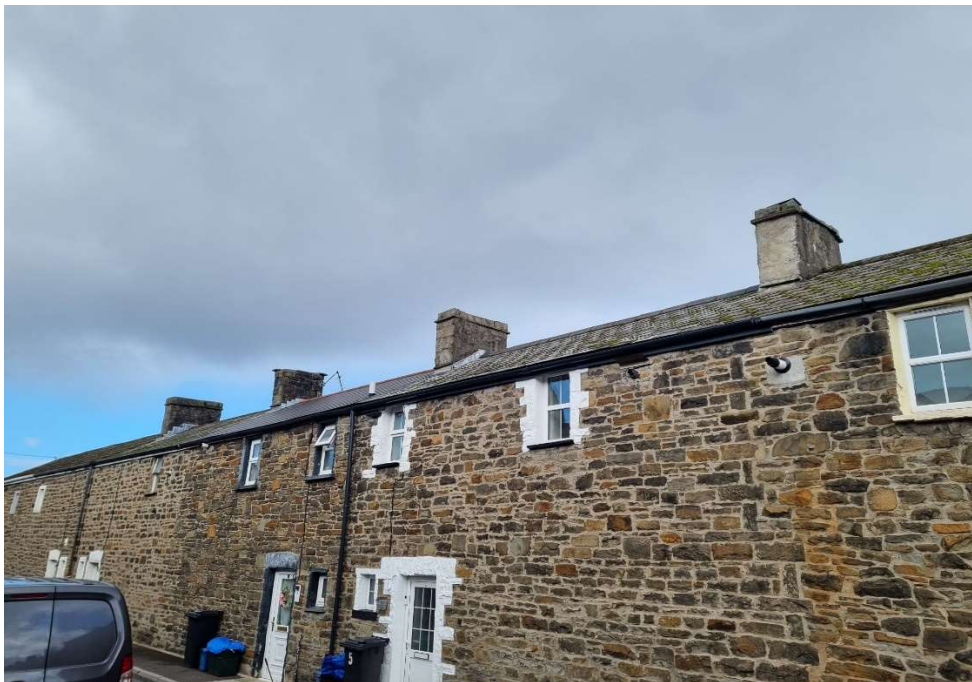
**Photograph 2:** Street side view of facades and rooflines of 1 to 6 Nightingale Street.

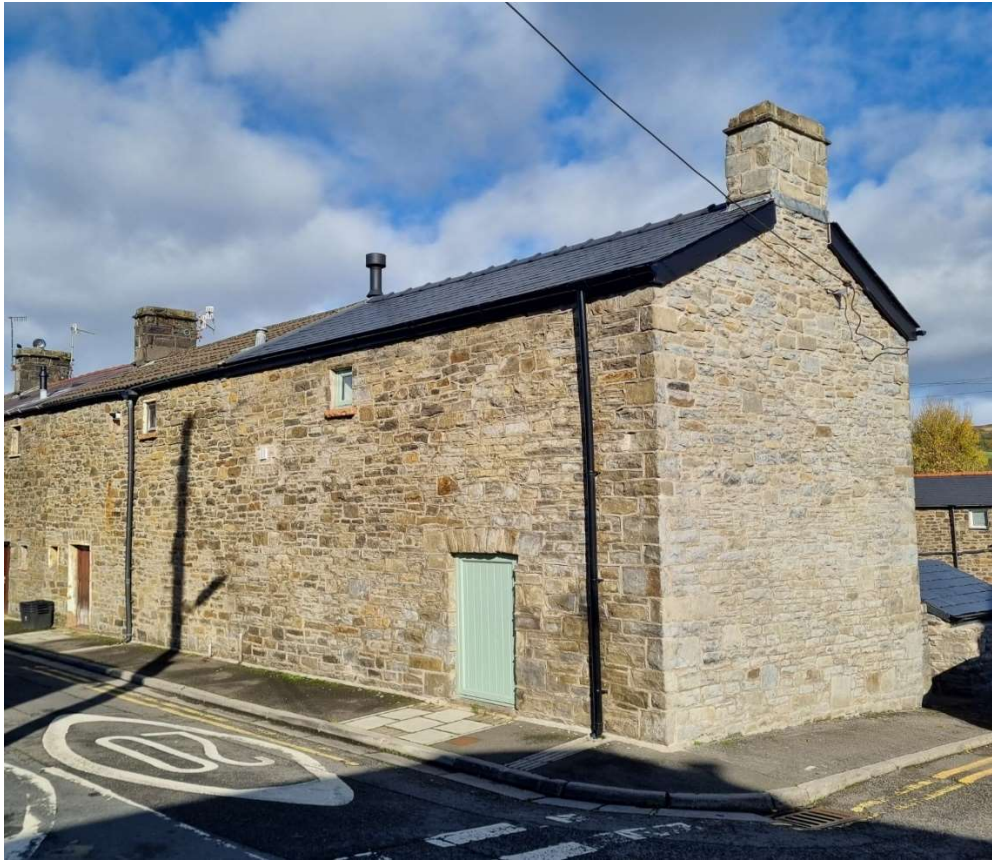
**Photograph 3:** Street side view of the front façade and recent new roof, fascia panels and rainwater system of 12 Nightingale. An example of good quality roof materials and installation.

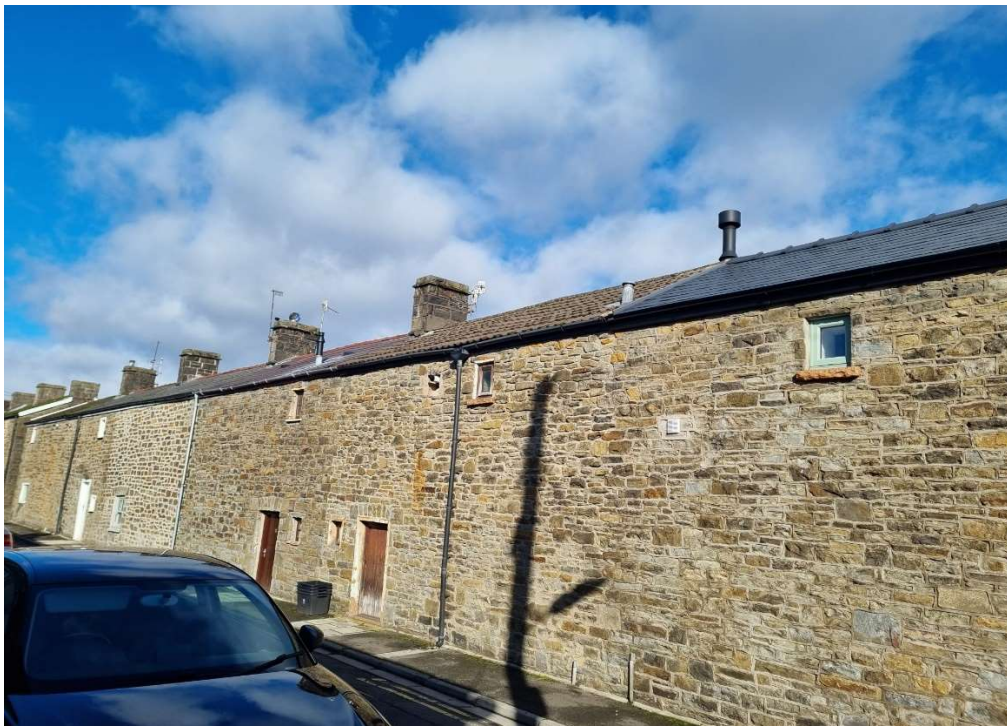
**Photograph 4:** Street side view, facades and roof lines of 7 to 12 Nightingale Street
