**Ffos-y-Fran, Merthyr Tydfil**

**Baseline and Preliminary Water Framework  
Directive Compliance Assessment**

**January 2025**

| Project Information | |
|---|---|
| File Ref: | 15840-WFD-03 |

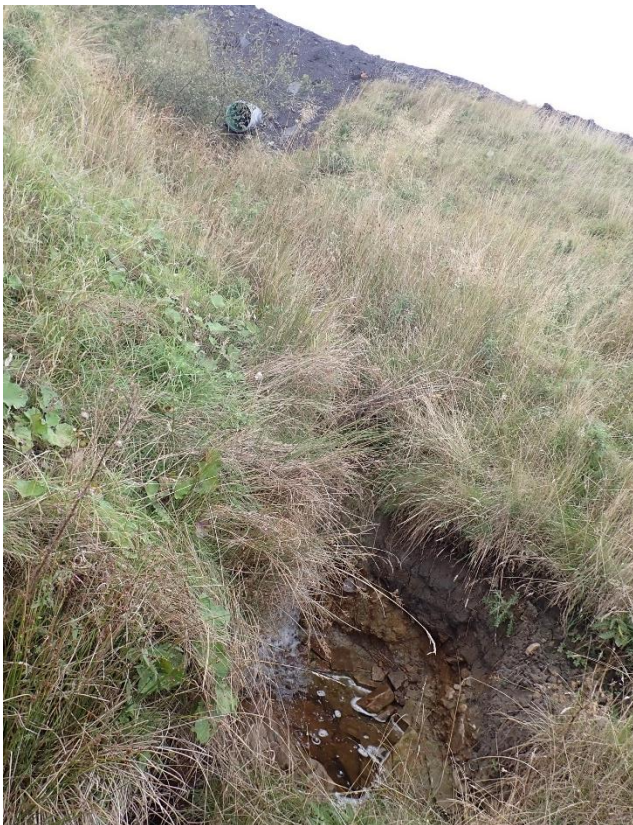
| Photo No. 2 | 15840 – Ffos Y Fran |

| <b>Date: 11/09/2024</b><br><b>Description:</b><br><br>The upstream are of the watercourse at approximate NGR: 308831, 206278.<br><br>Some iron staining observed. | |

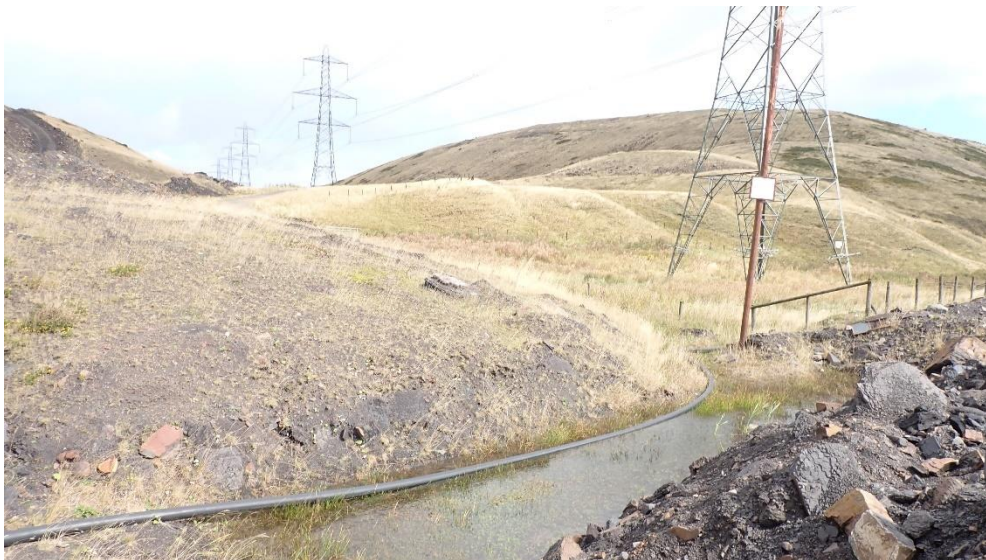
| <b>Photo No.7</b> | <b>15840 – Ffos Y Fran</b> |

| <b>Date: 11/09/2024</b><br><b>Description:</b><br><p>Watercourse upstream.<br/>Water ponding before entering a culvert.</p> <p>Approximate NGR:<br/>308142, 206510 (facing north-east)</p> | |

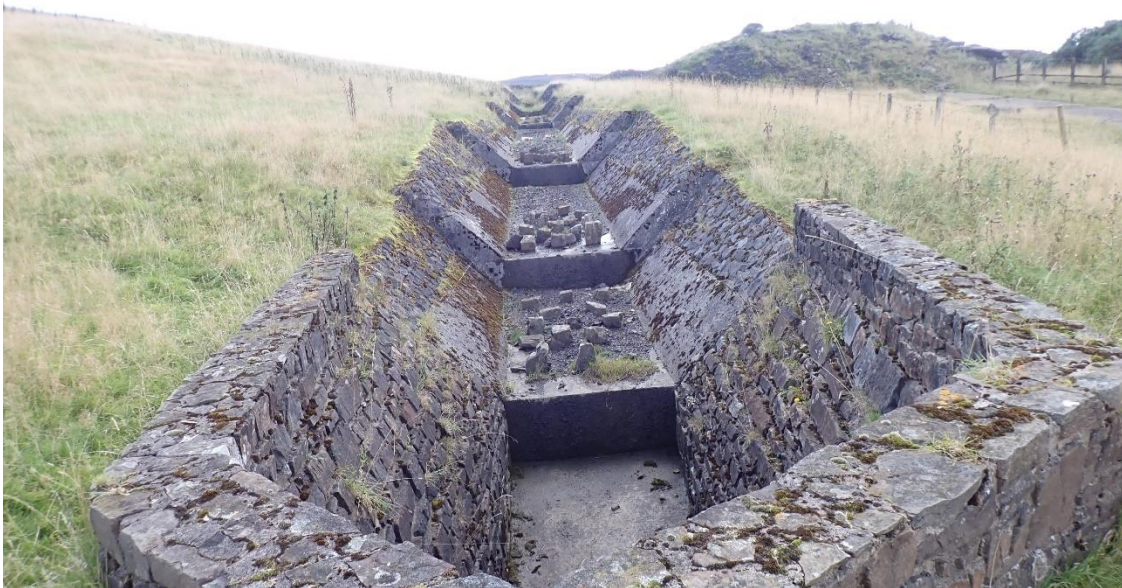
| Photo No. 14 | 15840 – Ffos Y Fran |

| <b>Date: 11/09/2024</b><br><b>Description:</b><br><p>Concrete channel. Dry at time of visit.</p> <p>Photo taken at approximate NGR: 307543, 207631</p> | |

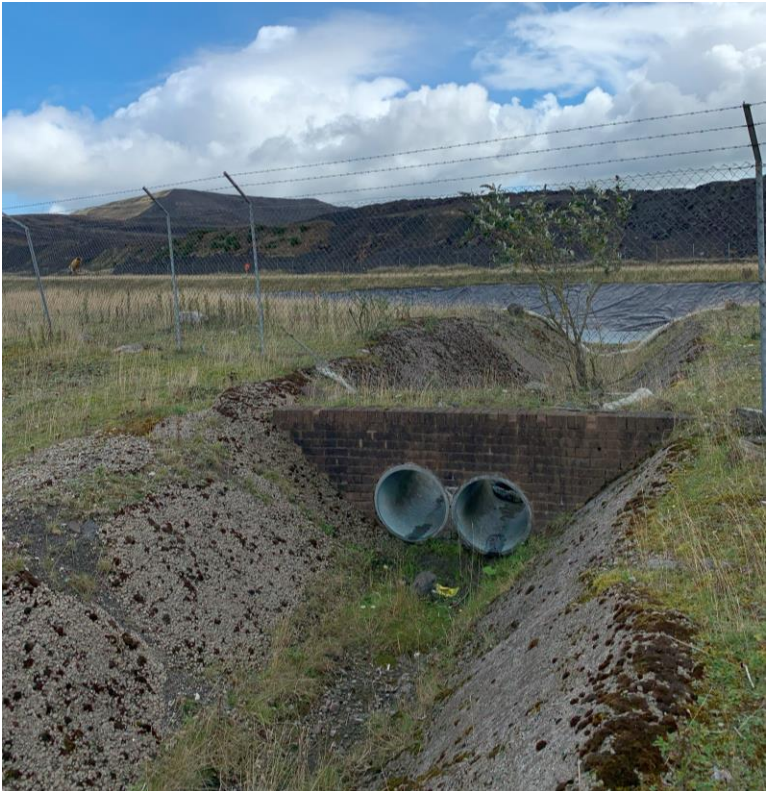
| <b>Photo No. 18</b> | <b>15840 – Ffos Y Fran</b> |

| <b>Date: 11/09/2024</b><br><b>Description:</b><br><p>Overflow pipe from WB. Discharge to ditch along the northern boundary.</p> <p>Approximate NGR: 306778 , 207301</p> | |

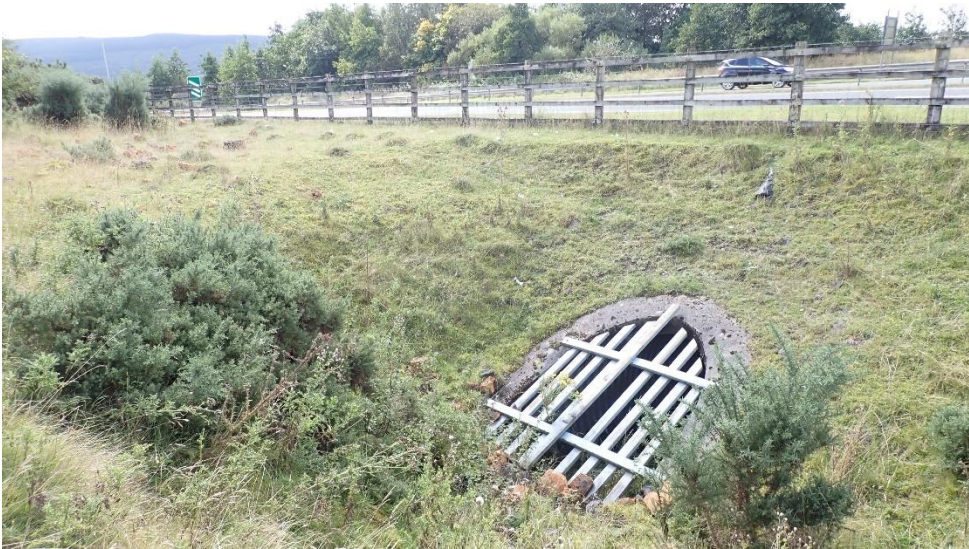
| <b>Photo No. 22</b> | <b>15840 – Ffos Y Fran</b> |

| <b>Date: 11/09/2024</b><br><b>Description:</b><br><br>Potential overflow culvert at approximate NGR: 306361, 206561 | |

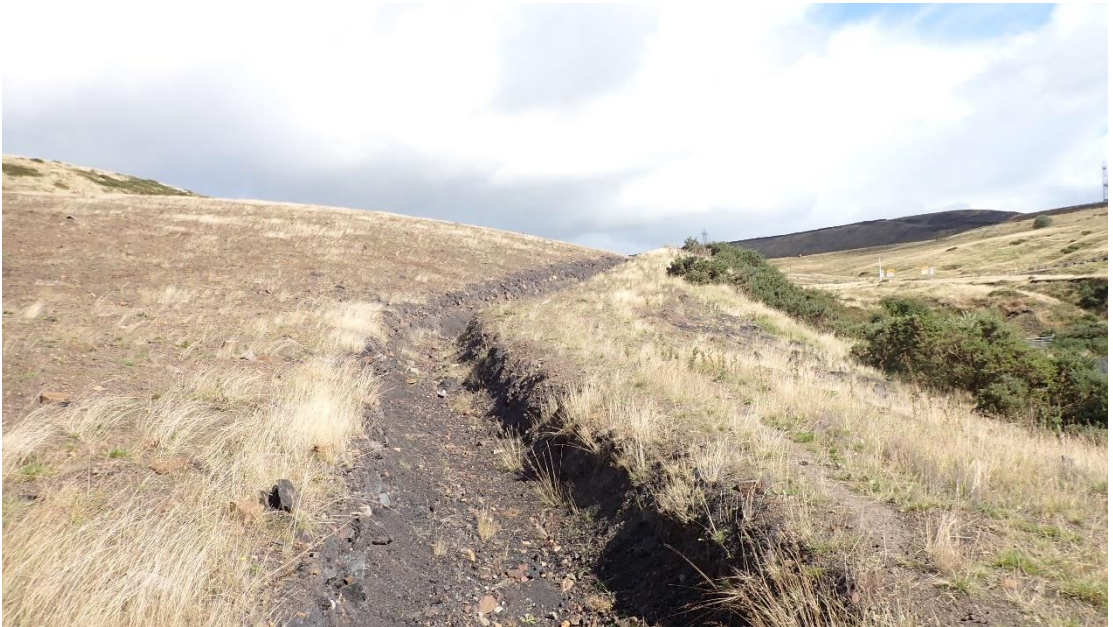
| <b>Photo No. 26</b> | <b>15840 – Ffos Y Fran</b> |

| <b>Date: 11/09/2024</b><br><b>Description:</b><br><p>Excavated channel (dry at time of visit) at approximate NGR: 307099, 206061</p> | |

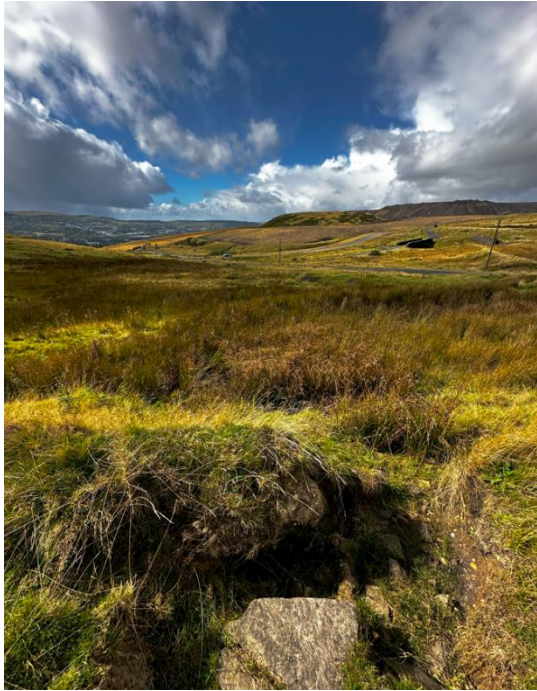
| <b>Photo No.41</b> | <b>15840 – Ffos Y Fran</b> |

| <b>Description:</b><br><br>Photograph showing breach location to the west of Sarn Howell Pond.<br><br>Approximate NGR: 307510, 205935 | |

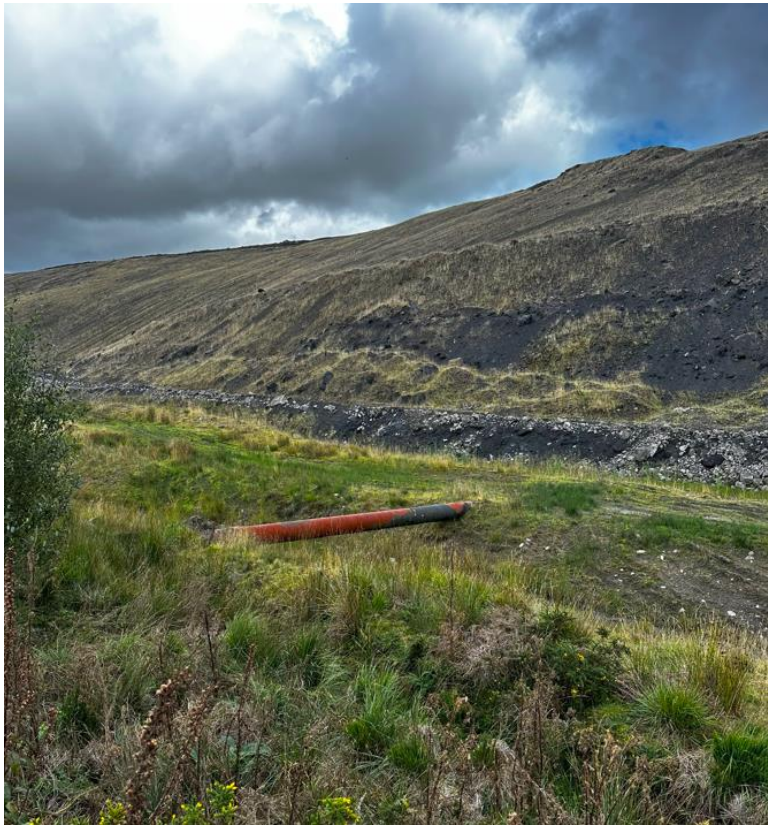
| <b>Photo No.42</b> | <b>15840 – Ffos Y Fran</b> |

| <b>Description:</b><br><br>Photograph showing assumed culvert which discharges towards the Bargoed Taff.<br><br>Approximate NGR: 307675, 205810 | |
