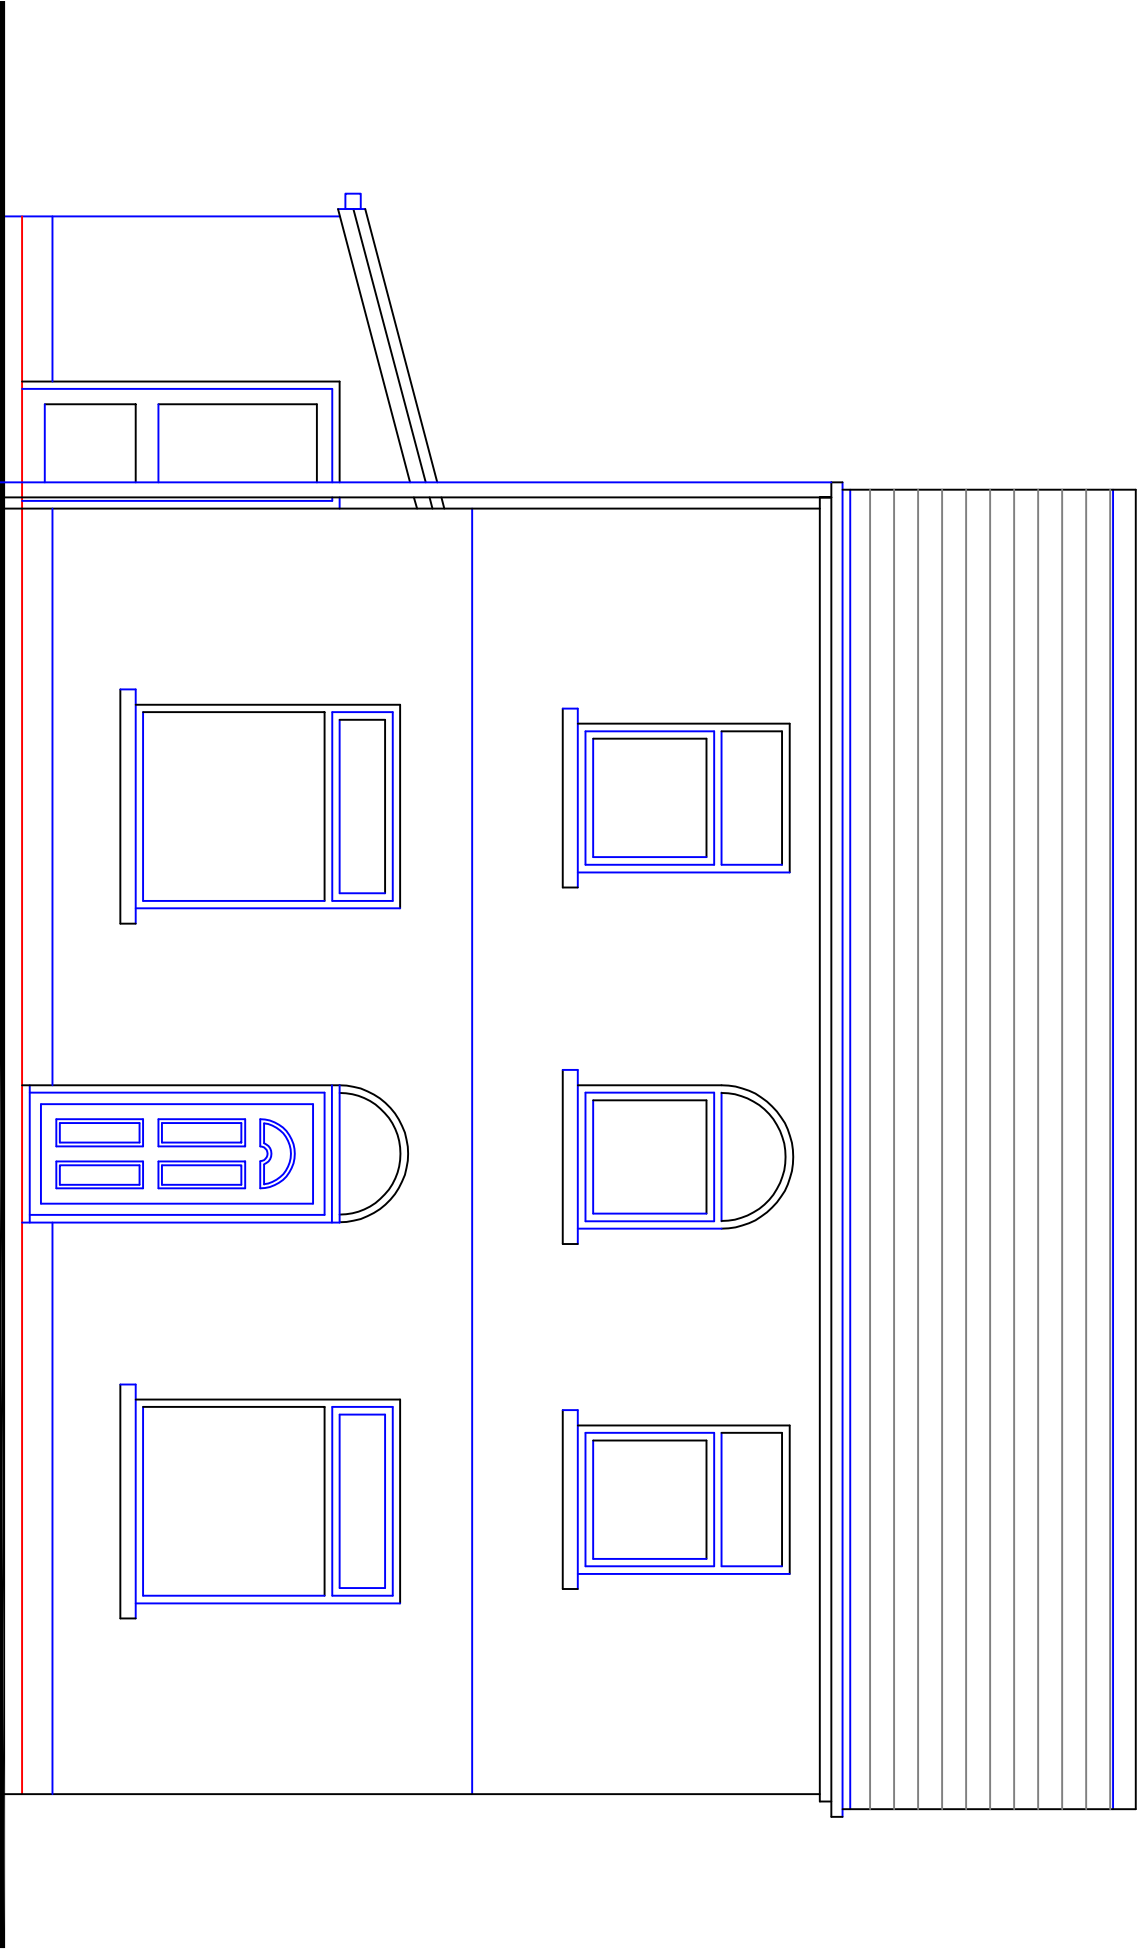
# Existing Front Elevation

Existing front elevation windows and doors damaged by fire to be replaced with new coloured UPVC double glazed units. External cills and surrounds to be rubbed down, made good and redecorated.

Existing pebble dashed render to be cleaned, repaired and made good as required to ensure weatherproof finish.

Existing roof timbers to be thoroughly inspected and repaired as required to ensure structurally sound and weather tight roof to original dwelling dual pitch roof arrangement.  
New insulation supplied and fitted throughout existing roof area.
