# Abercynon Feeder Pipe Bridge Replacement Arboricultural Impact Assessment V6 Report for Baker Hicks

| <b>Job Number</b> | <b>7028</b> | | |
| V6.0 | Henry Bates | Jacqueline Waring (Principal) | 06/03/2024 |

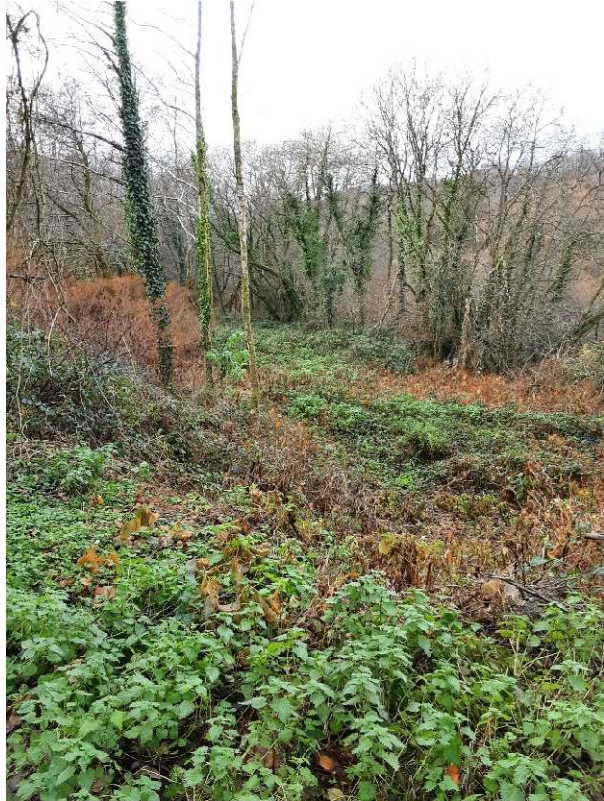
**Photograph 1**

View looking towards G4, with  
T35, T36, T37

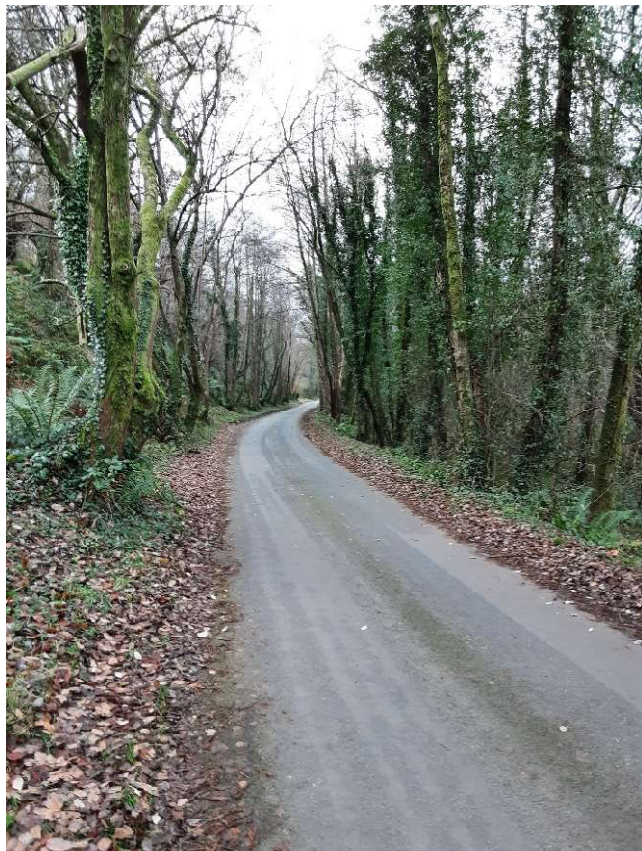
**Photograph 2**

View along road with T19 in  
the left of picture.

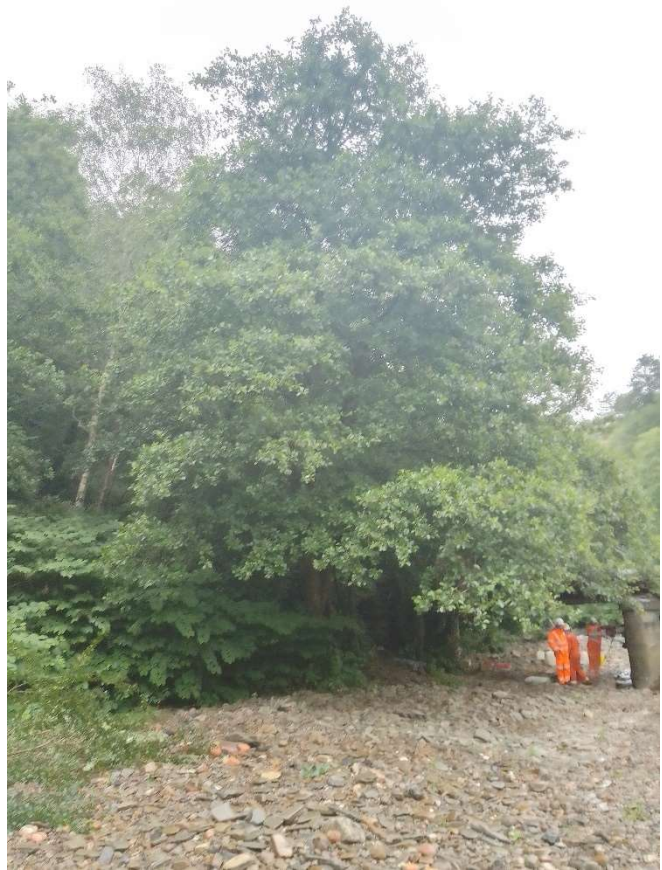
**Photograph 3**

View looking towards T62

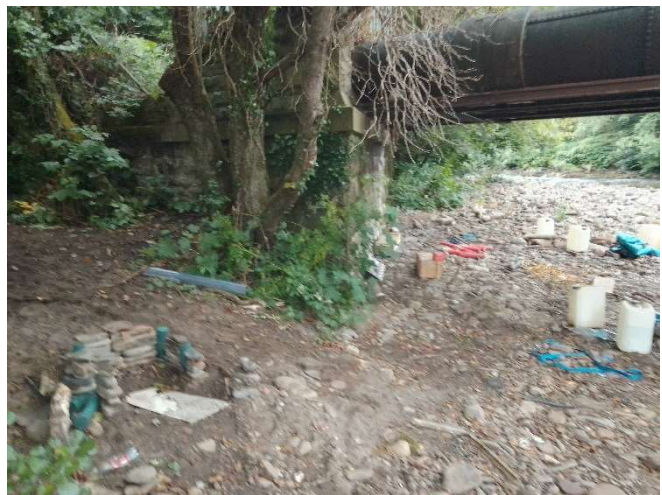
**Photograph 4**

View looking towards T89

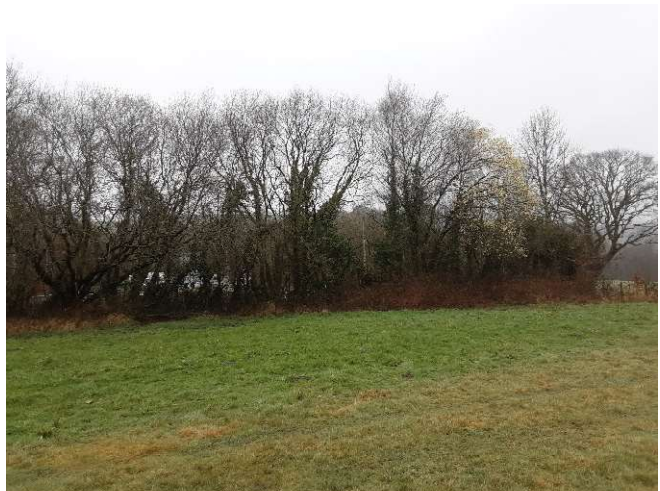
### Photograph 5

View looking towards G8.

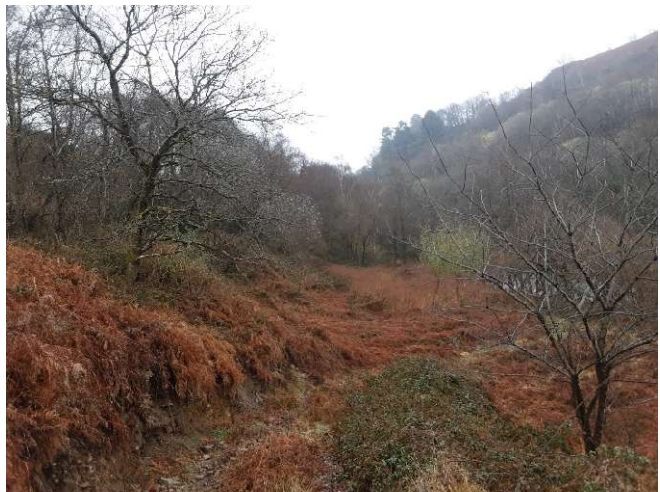
### Photograph 6

View looking down proposed access rout, T49 left T48 right.

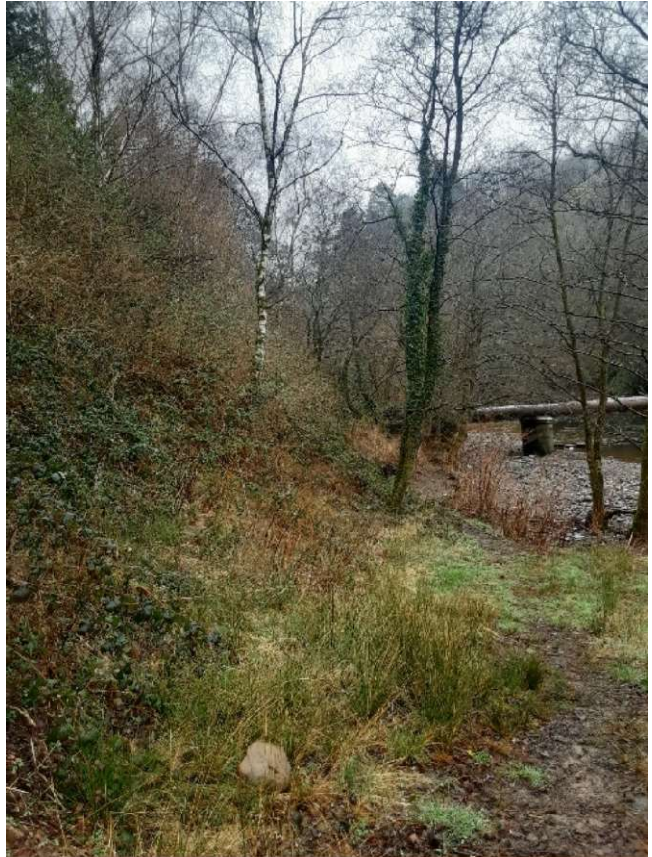
**Photograph 7**

View looking upstream towards  
bridge on north side of river.
