Appendix D - sets out a series of photographs to illustrate the change in the character of the area:

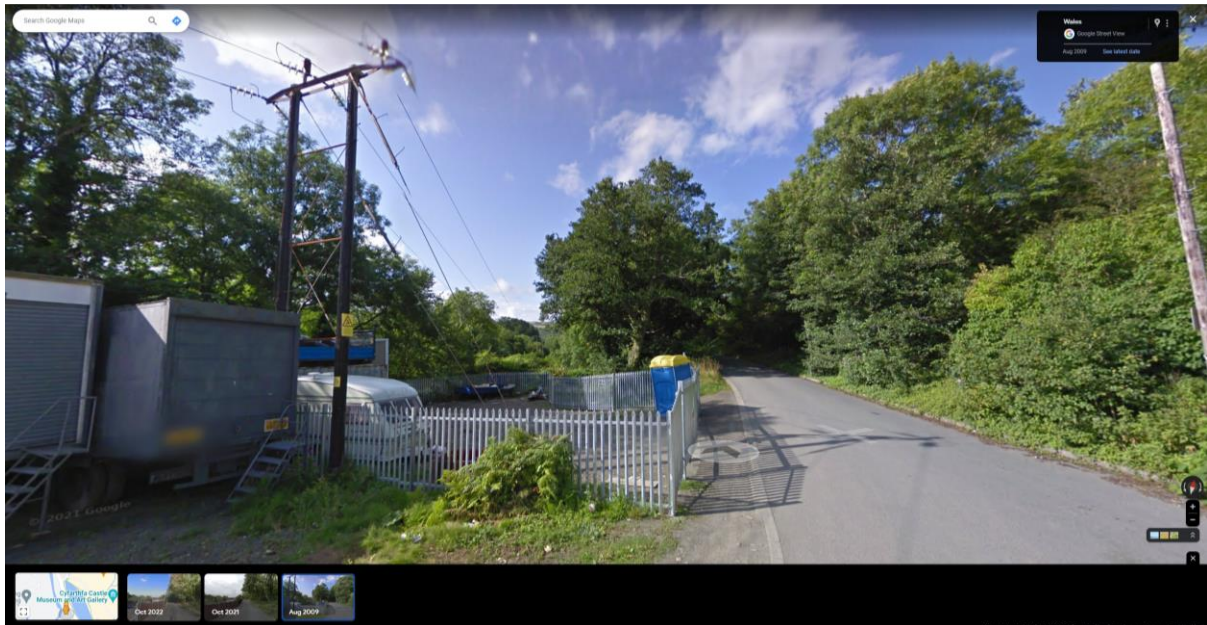
Below in 2009 – Illustrates the extent of mature trees and vegetation along the eastern embankment of the site with limited development in the area.

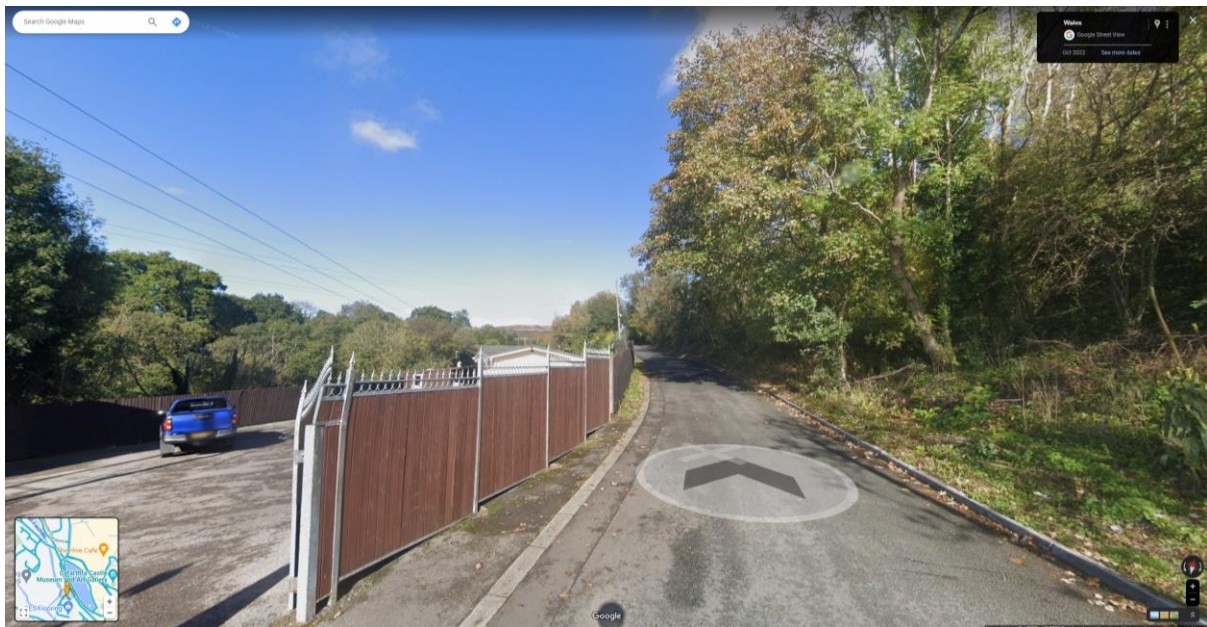
Below in 2022 – The significant loss of trees and vegetation is clearly evident.

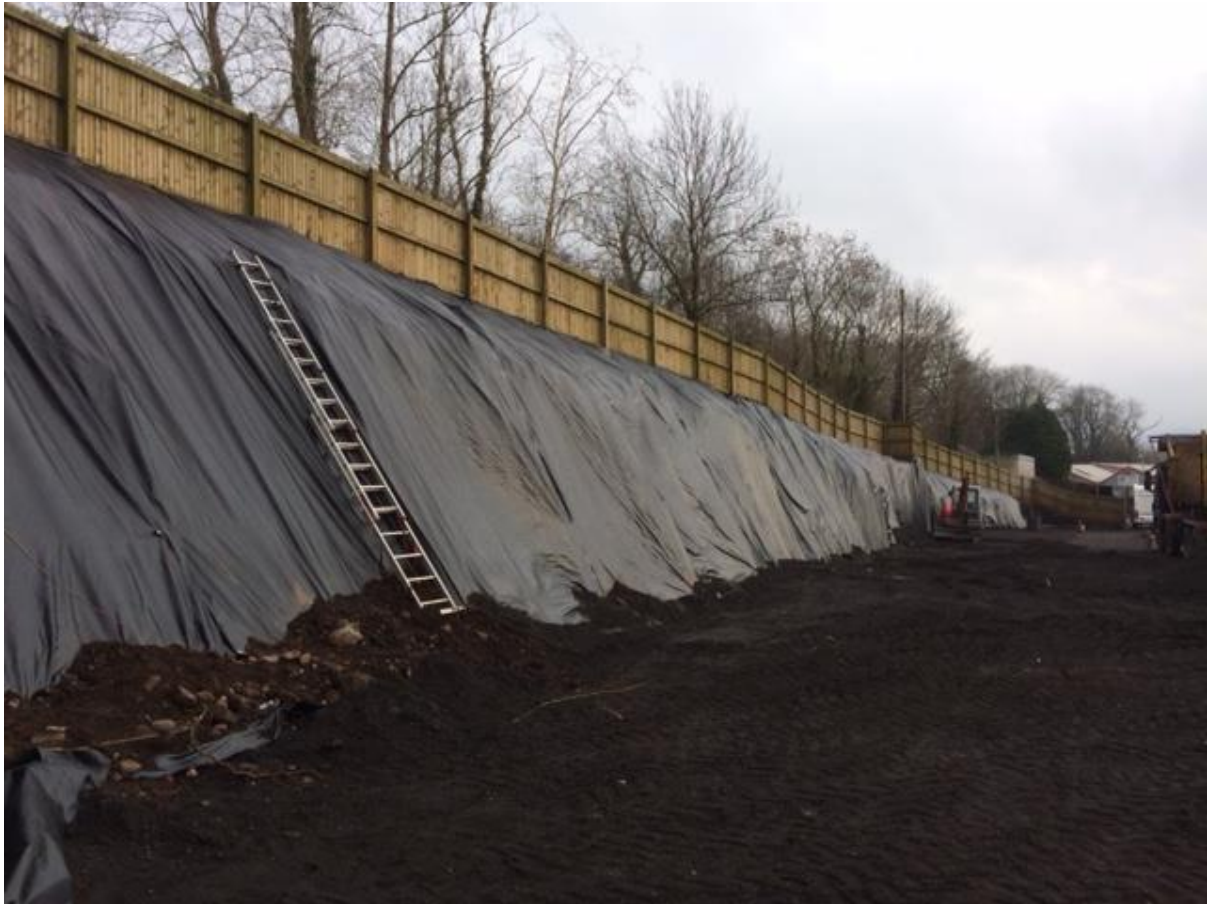
The photograph below (01.2017) was taken at a time when the embankment has been excavated and the trees/vegetation removed.

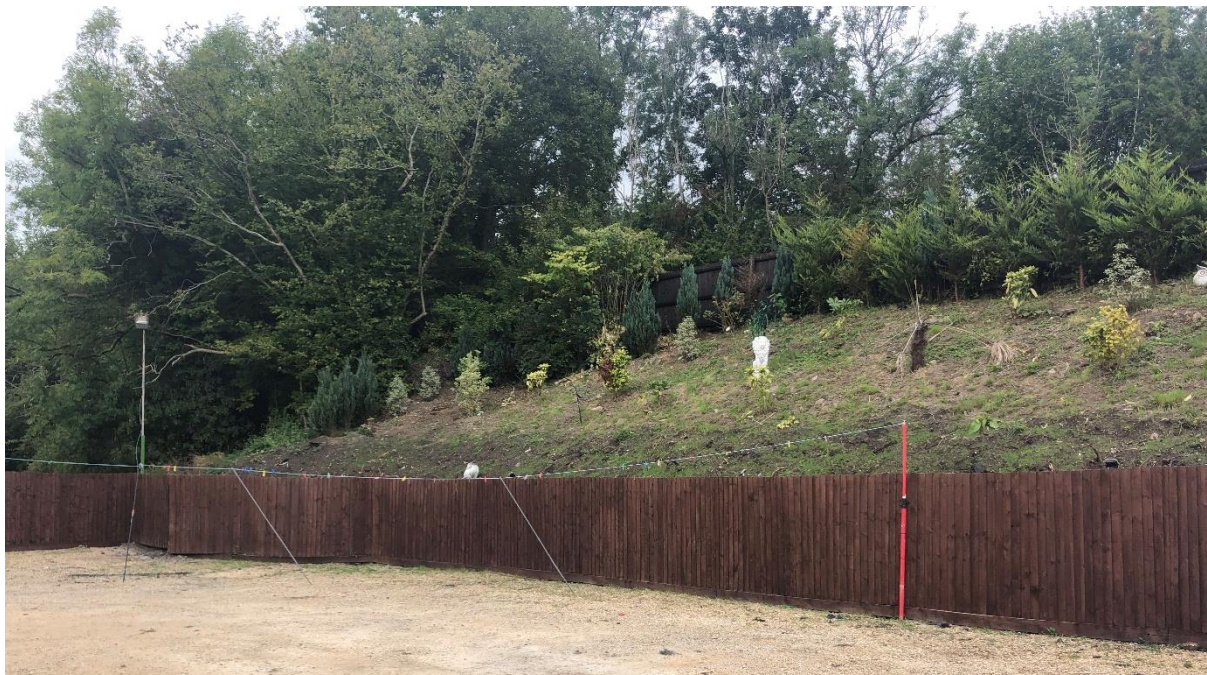
The photograph below (taken in 09.2022) illustrates the reconstruction of the embankment from the fence line at the top to the bottom fence line. Its design and construction is unclear. The embankment has been planted with conifer trees which does not reflect the native broadleaved trees in the area. This consequently has a negative impact on the quality and character of the Special Landscape Area/Conservation Area.

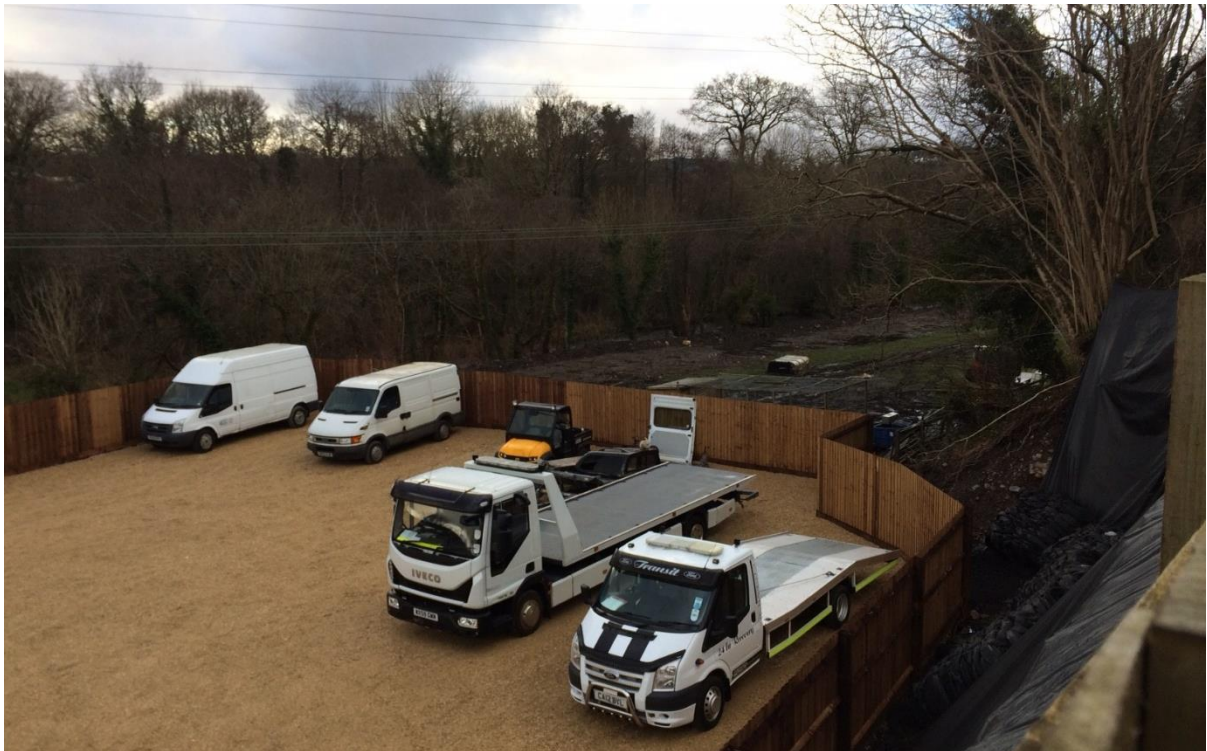
The photo below (03.2017) illustrates the commercial use of the northern part of the site.

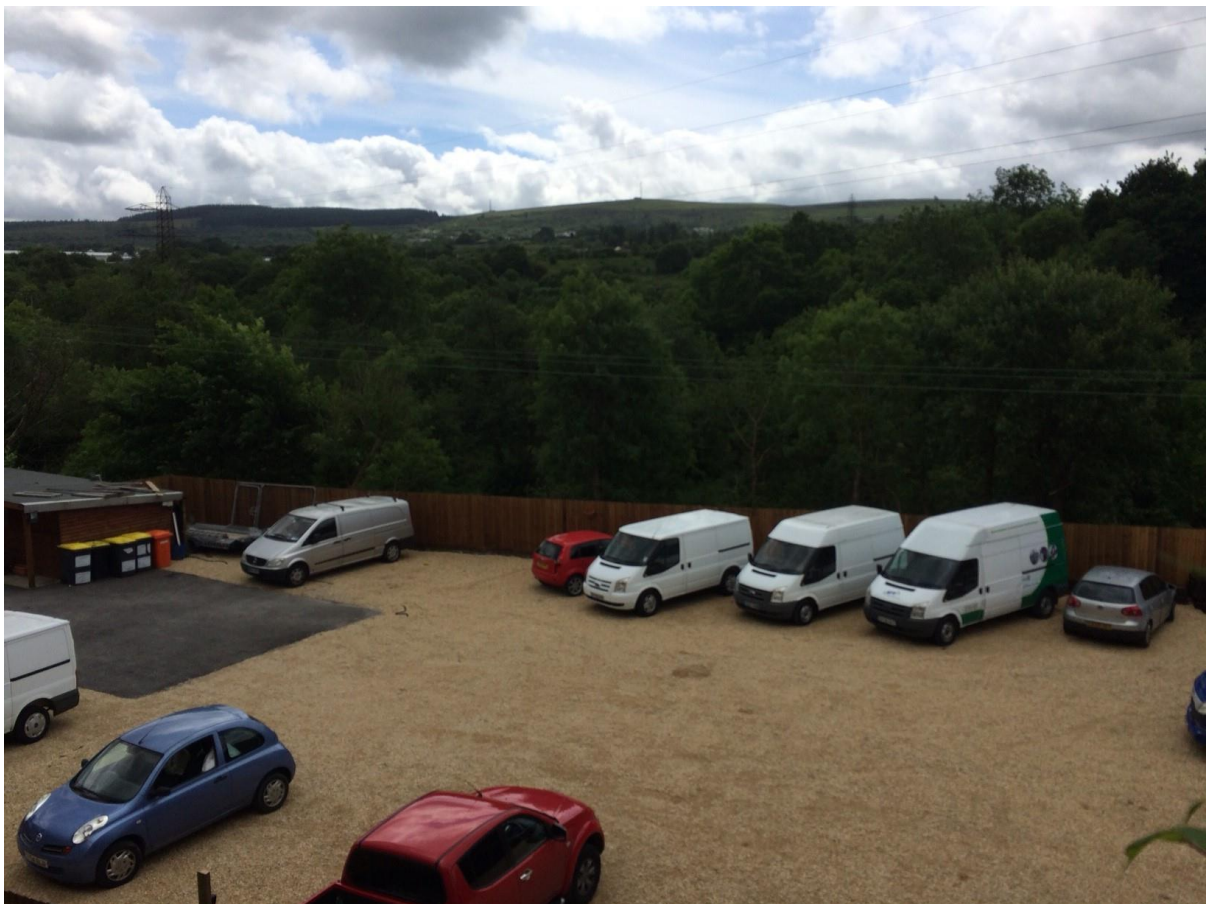
The photo below (06.2017) illustrates the commercial use for parking of vehicles.

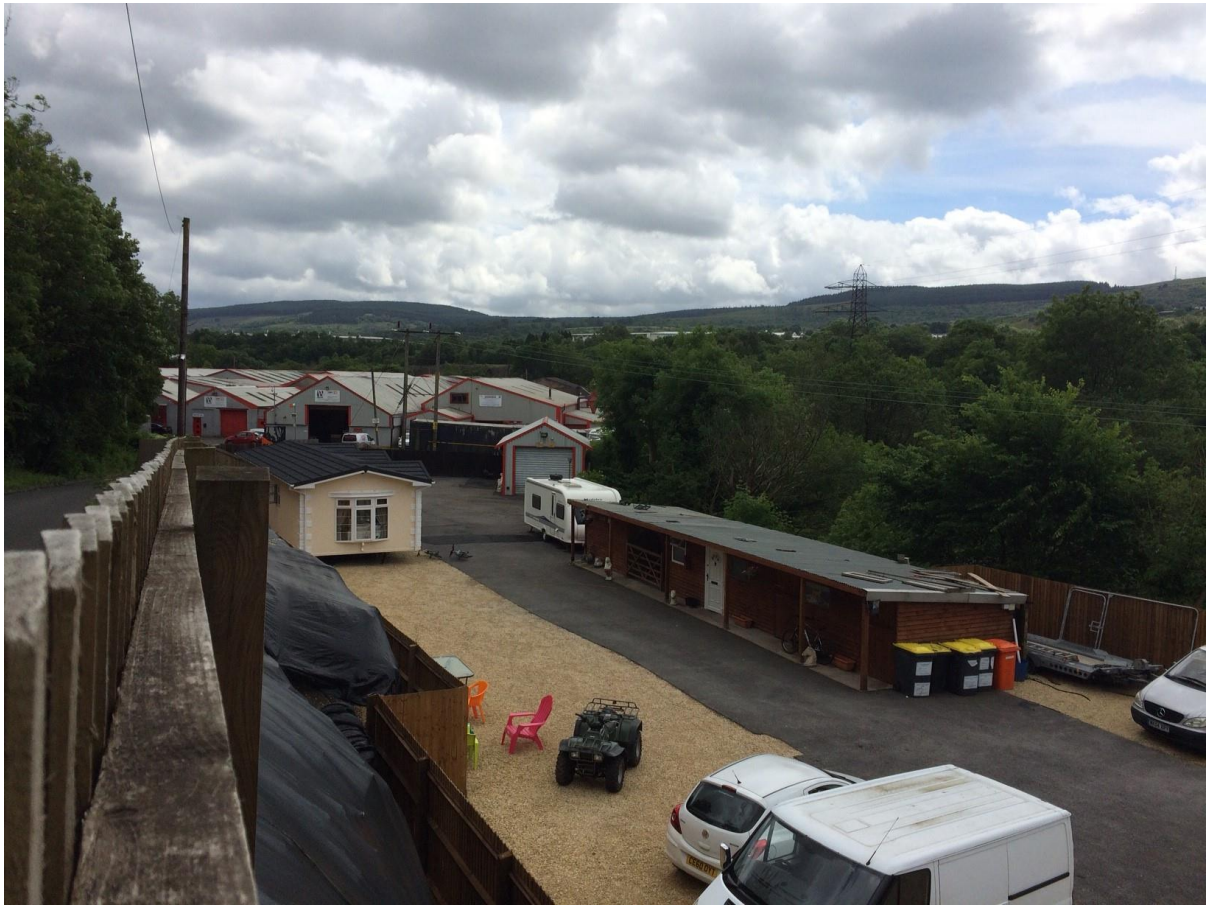
The photo below (06.2017) illustrates the area of land around the mobile home that has already been increased in size following the removal of the embankment and trees/vegetation.
