## Bats & Trees Survey Report

Project: Bishop Hedley Catholic School

Instructed by: Wilmott Dixon Construction Ltd

Reported by: Ecological Services Ltd  
10 Mount Pleasant, Llanelly Hill, Abergavenny, Monmouth NP7 0NT  
Reported by

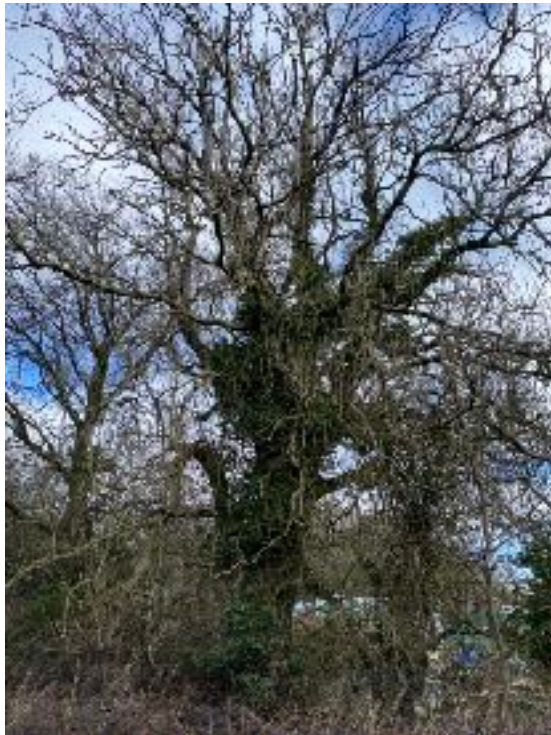
Tree T7 a large mature multi stemmed Ash tree was scored moderate for Potential roost features. The lower trunk has thick interwoven Ivy stems and higher up a very dense covering of bushy Ivy which could hide PRFs not visible from the ground. One west facing large broken bough at approximately 5m height was still attached and reached the ground, near its base a large crack and lifted bark was visible which could potentially provide a roost site for at least one Bat. There is one other north facing broken branch but this did not contain any PRF visible from the ground. Photos of T7 are provided in Appendix 2.

| Tree No. | Species | PRF Height | PRF Aspect | PRF Type | Notes from site Visit |
|---|---|---|---|---|---|
| T7 | Ash | 5m | West<br><br>Full surround | Broken dead limb still attached.<br><br>Dense covering of Ivy | Large multi limbed Ash tree. Broken limb still attached, large crack and lifted bark. Ivy dense and bushy with thick interwoven stems<br>Moderate PRF |

T7 Large multi limbed Ash tree. Viewing east

- Moderate bat roost trees must be felled during the winter when bats are least likely to be present.
- All moderate bat roost trees must be felled in sections and lowered to the ground using ropes. The sections will then be inspected for the presence of bats using an endoscope by a licenced bat ecologist.

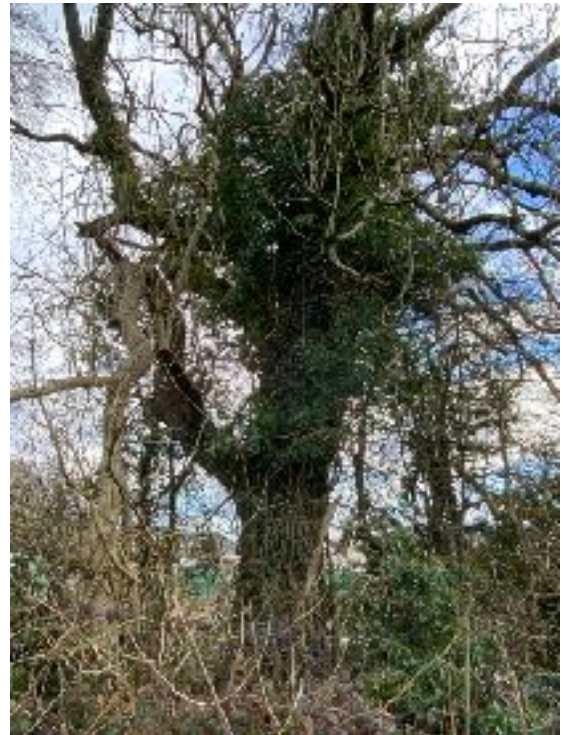
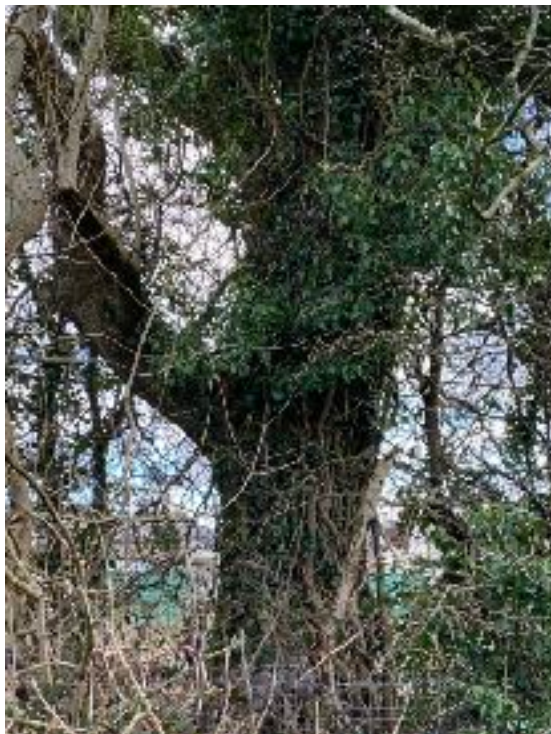
T7 Ivy dense and bushy with thick interwoven stems. Viewing east

T7 Ivy dense and bushy with thick interwoven stems. Viewing East

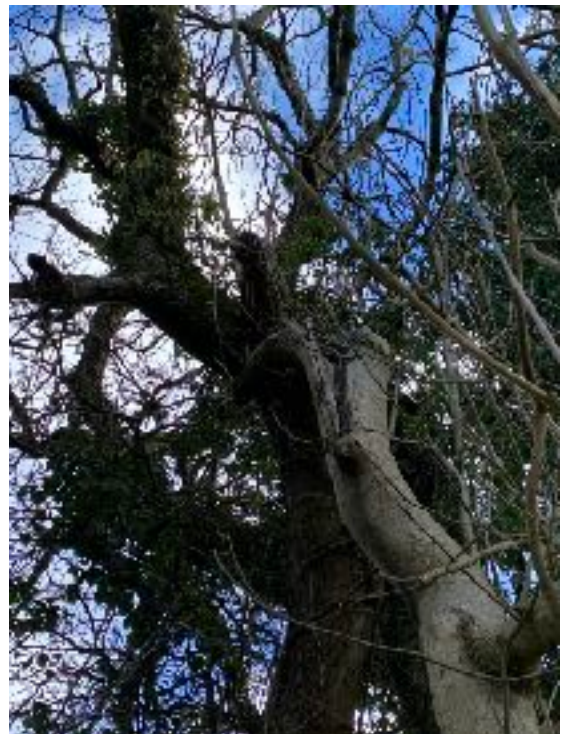
T7 West facing broken limb still attached with large crack and lifted bark.

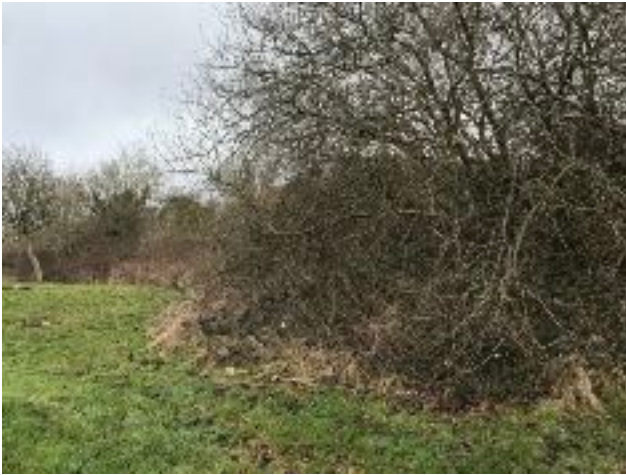
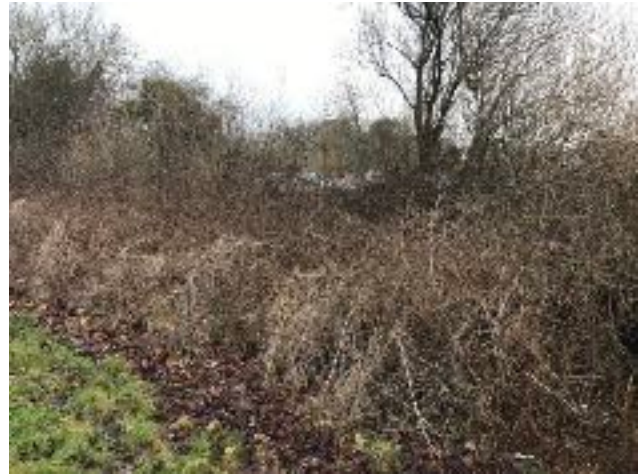
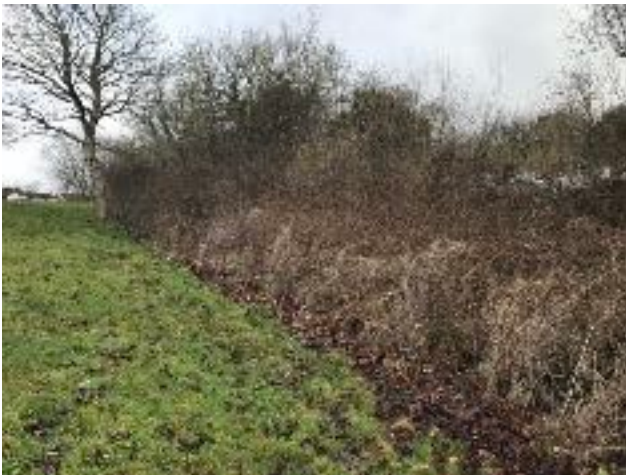
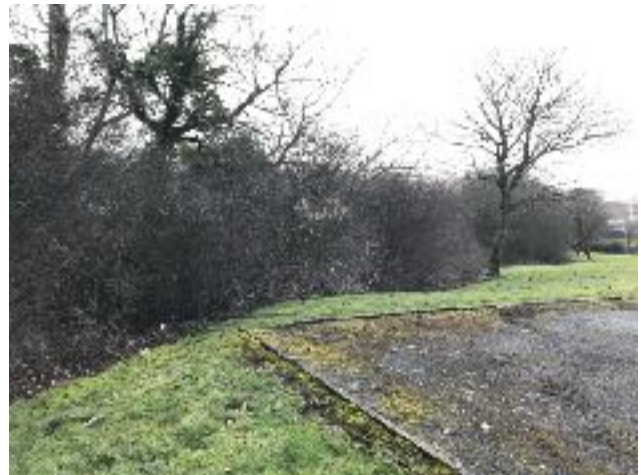
| G10 | Blackthorn, Hazel, Wild Cherry, Goat Willow, Crack Willow and Ash Group | - | Full surround | Bushy ivy cover on Wild Cherry Trees | Two Wild Cherry trees near north end of tree group at approx 800537C754 with bushy ivy on main trunks. Low PRF. Other trees in group quite young with no ivy or dead wood. |

G10 Blackthorn, Hazel, Wild Cherry, Goat Willow, Crack Willow and Ash group. Viewing north

**Trees and tree groups** - T11, G10, G20, G47 and G57 were found to have low potential for roosting use by bats. These trees will be removed preferably in September/October to avoid maternity and hibernation seasons, under a precautionary soft fell methodology. This is where tree limbs are cut and left grounded overnight to allow any bats to make their way out.

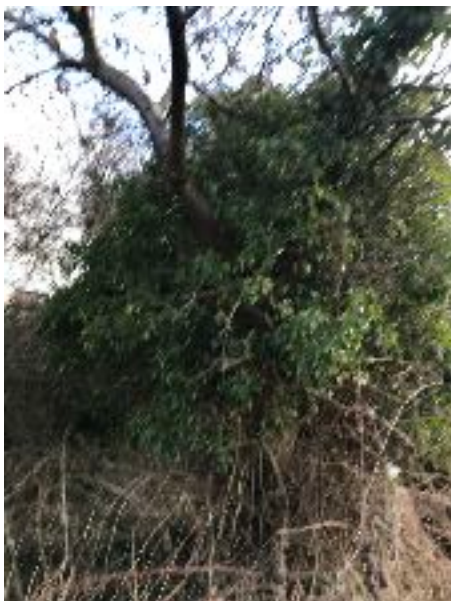
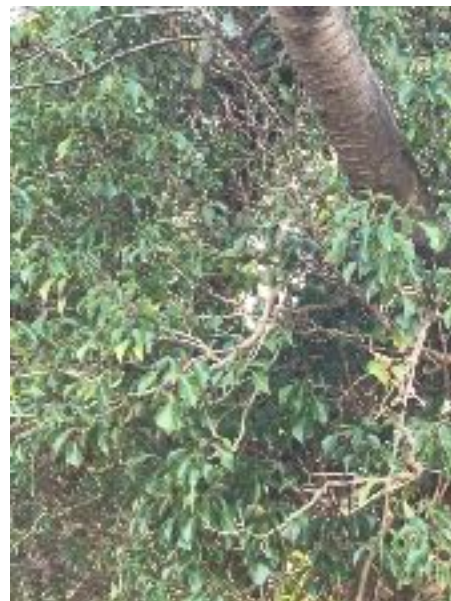
G10 two Wild Cherry trees near north end of tree group at approx SO05370754 with bushy Ivy on main trunks. Viewing east

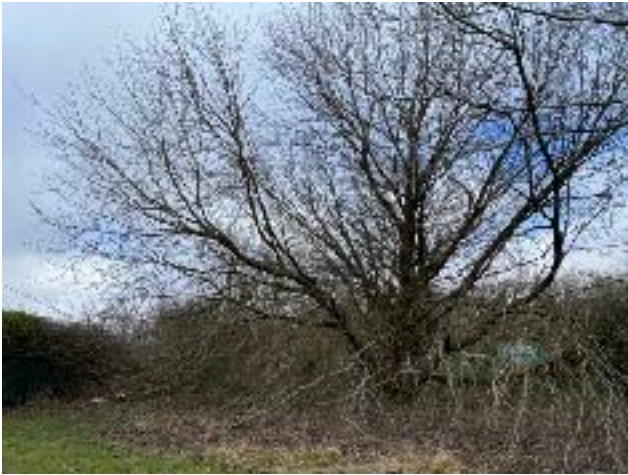
| T11 | Silver Maple | 7m | East | Long split in limb where bark is regrowing around old wound. | Large spreading Silver Maple. Split in bark on east facing branch and blind knot hole. |

T11 Large spreading Silver Maple. Viewing north

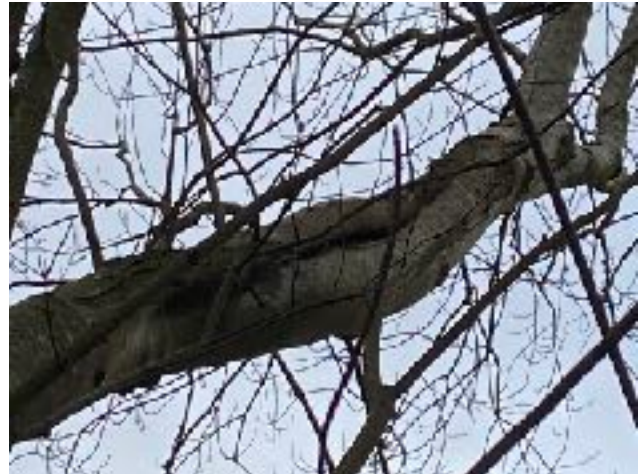
T11 Slit in bark on east facing branch

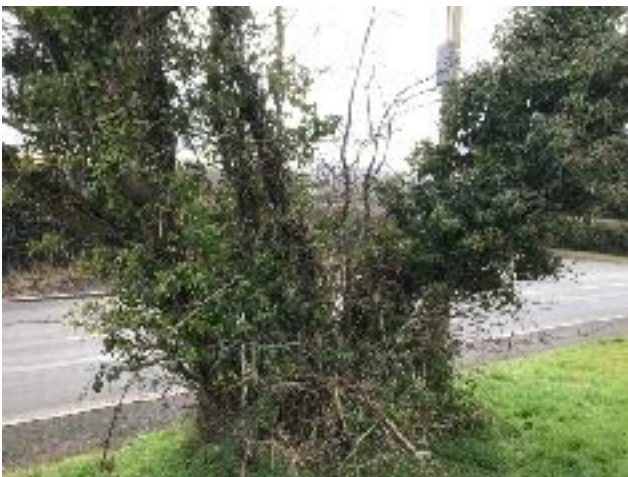
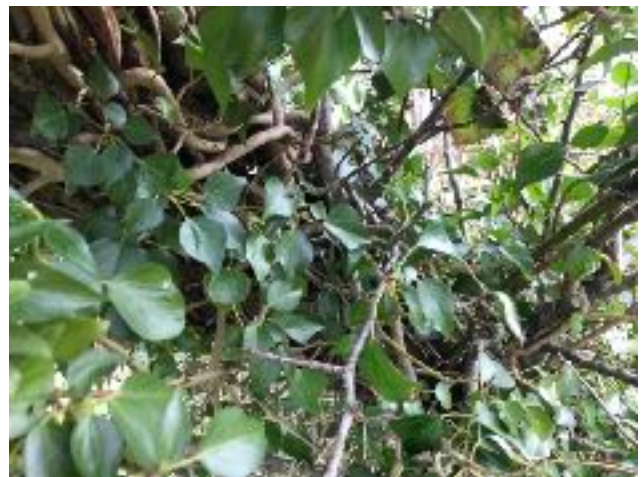
| G20 | Hawthorn Group | - | Full surround | Dense ivy cover | Northern most Hawthorn in group with dense ivy cover with interwoven stems. Other Hawthorns no PRF |

G20 Northernmost Hawthorn in group with dense ivy cover with interwoven stems. Viewing east

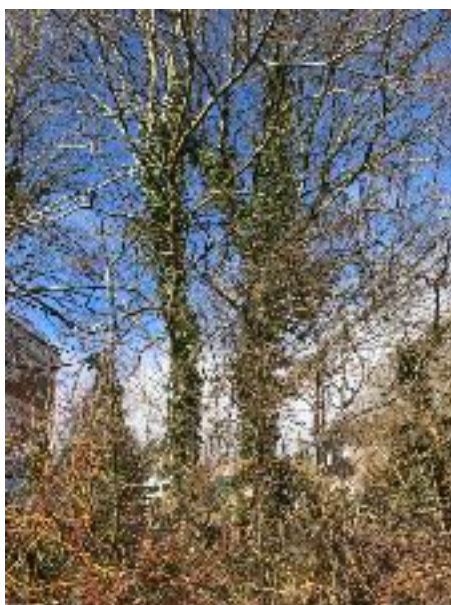
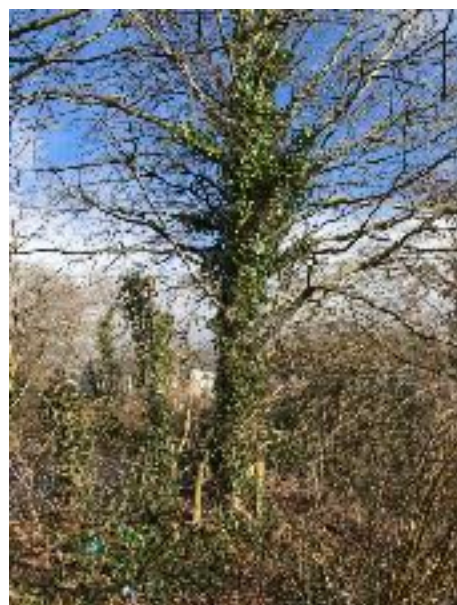
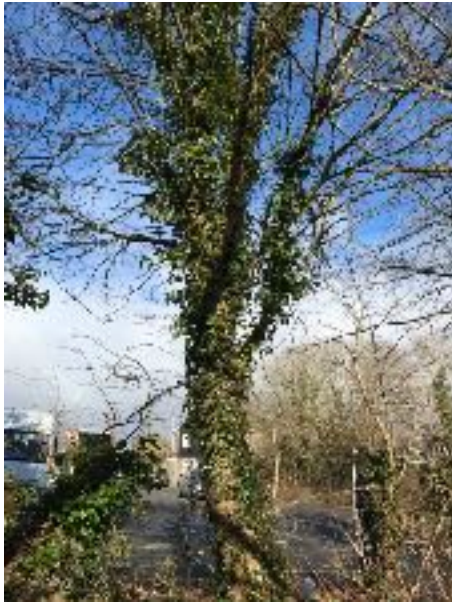
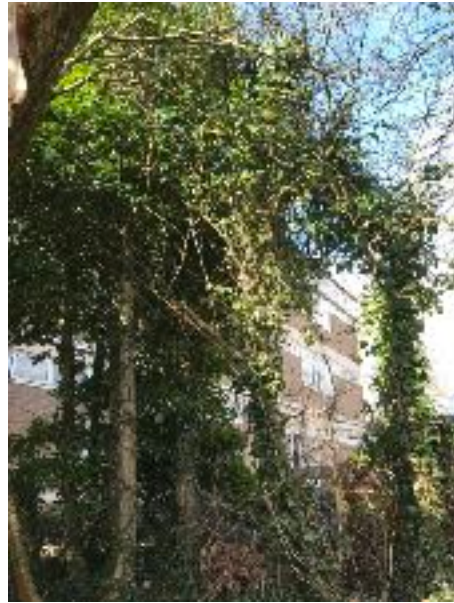
| G47 | Field Maple, Goat Willow and Common Lime Group | - | Full surround | Bushy Ivy cover on trunks | Medium sized tree group, sparse bushy Ivy cover. Low PRF |

G47 Field Maple, Goat Willow and Common Lime Group. With sparse bushy ivy cover. Viewing north

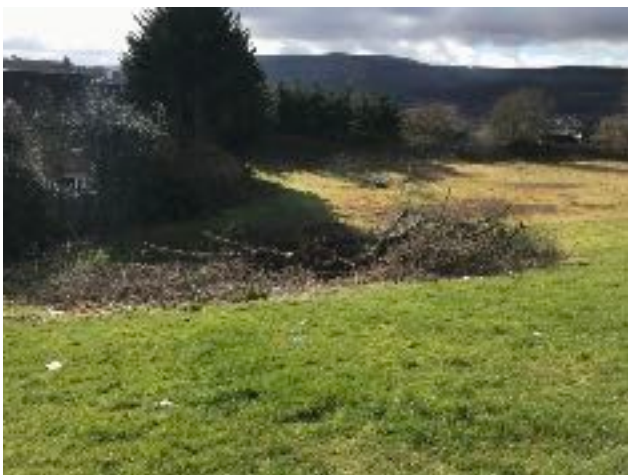
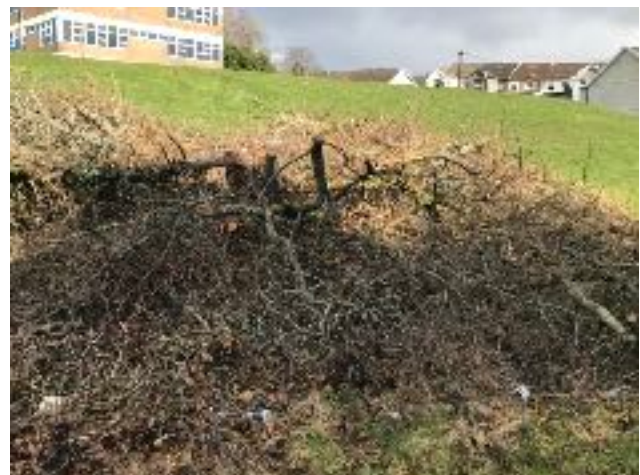
G50 Goat Willow Group. All ready felled. Viewing south

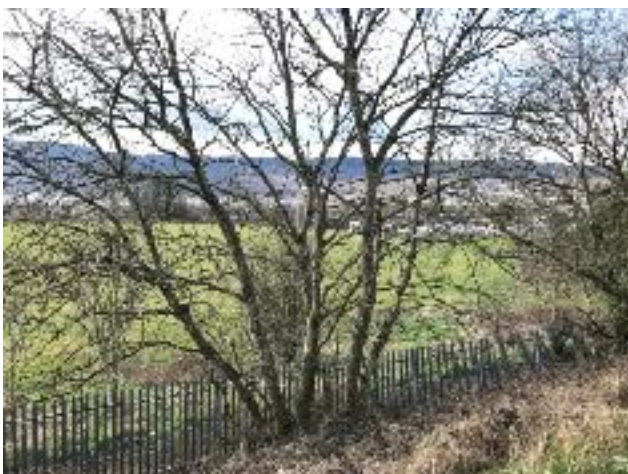
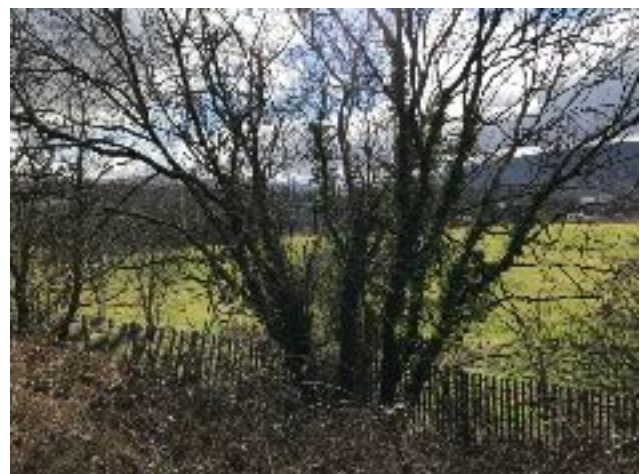
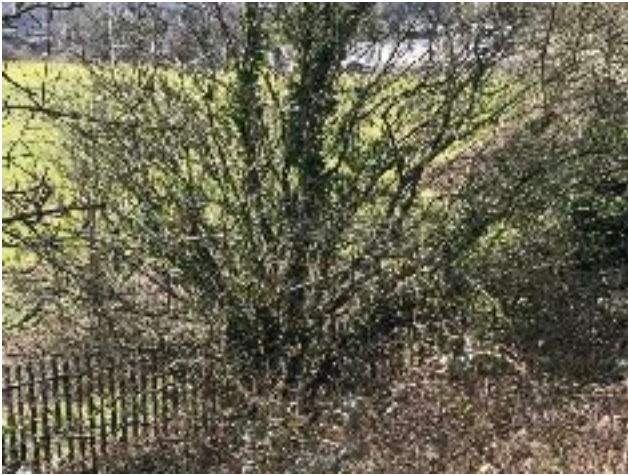
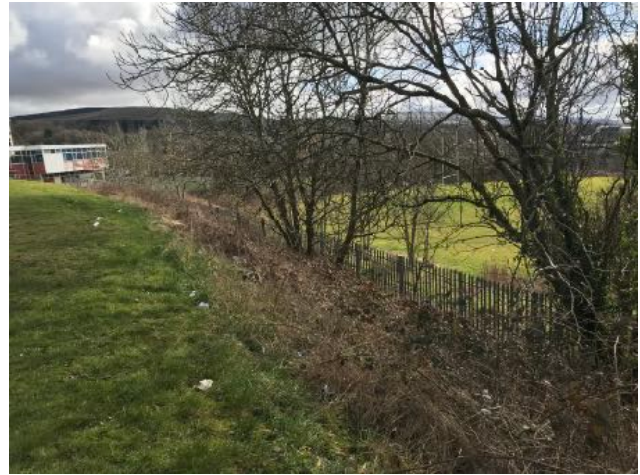
| G57 | ASH Group | - | Full Surround | Bushy Ivy cover on Ash trunks | Medium sized Ash group, sparse bushy Ivy cover. Low PRF |

G57 Medium sized Ash group, sparse bushy Ivy cover. Viewing south
