*Report No. BC/MB/03.17.02.*

# **Mining Risk Assessment: Land at Gelligaer Road, Trelewis**

**Ms J Creese**

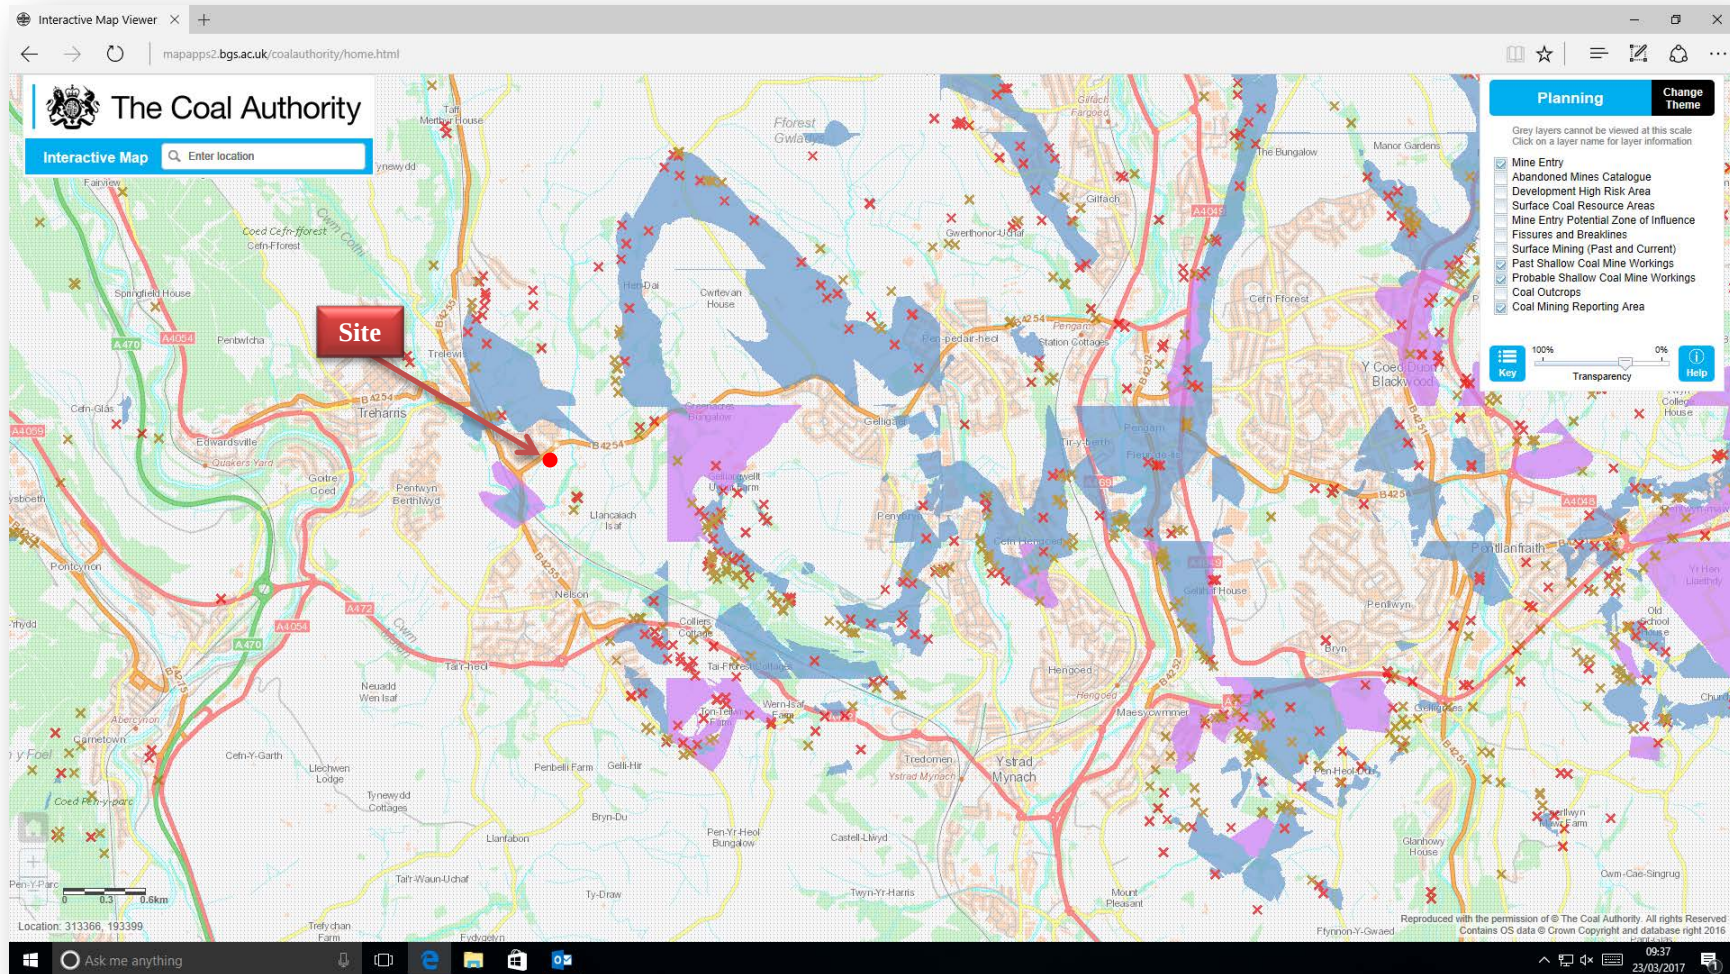
**Figure 3**  
**The Coal Authority's Interactive Map.**  
 Accessed 23<sup>rd</sup> March 2017

The general area has experienced extensive underground operations for coal dating back at least to the very early part of the twentieth century. The workings were prosecuted from a number of adits driven into the valley sides at or near the outcrops of coal seams or ironstone veins, or else from shafts sunk near the valley floor. Several coal seams have been extensively mined beneath the Site, the last in 1991; many of the old workings are of an age and/or are at depths that will have no impact upon the structural integrity of the proposed dwelling(s). The shallowest lying coal seam worked beneath the area of the Site is the Mynyddislwyn Seam, which is approximately 1.5m thick, and which is at relatively shallow depths beneath the Site. The Seam was worked from the Llancaiach Colliery, which ceased working in the early 1990s. The workings from the Colliery extend beneath the Site (see Figure 3 and *Geology Plan*, drawing no. BC/MB/03.17.02.02).

The mine plan for the Llancaiach Colliery identifies that the northern shaft is 65 yards deep, 59m (see *Extract From Abandonment Plan of Llancaiach Colliery: Mynyddislwyn Seam, drawing no. BC/MB/03.17.02.04*). The Site is approximately 650m north of the shafts. The main drivages that extended northwards from the shafts towards the Site were, amongst other things, drainage roadways and would have been driven to rise at water-ease, 1 inch in the yard. The workings beneath the Site are calculated to be at a depth of approximately 41m. The Coal Authority's interactive map identified that there are no recorded shallow mine workings beneath the Site (blue shading) and no potential shallow mine workings (shaded purple).
