**Land At Winch Fawr Road**

**Coal Mining Risk Assessment**

October 2020

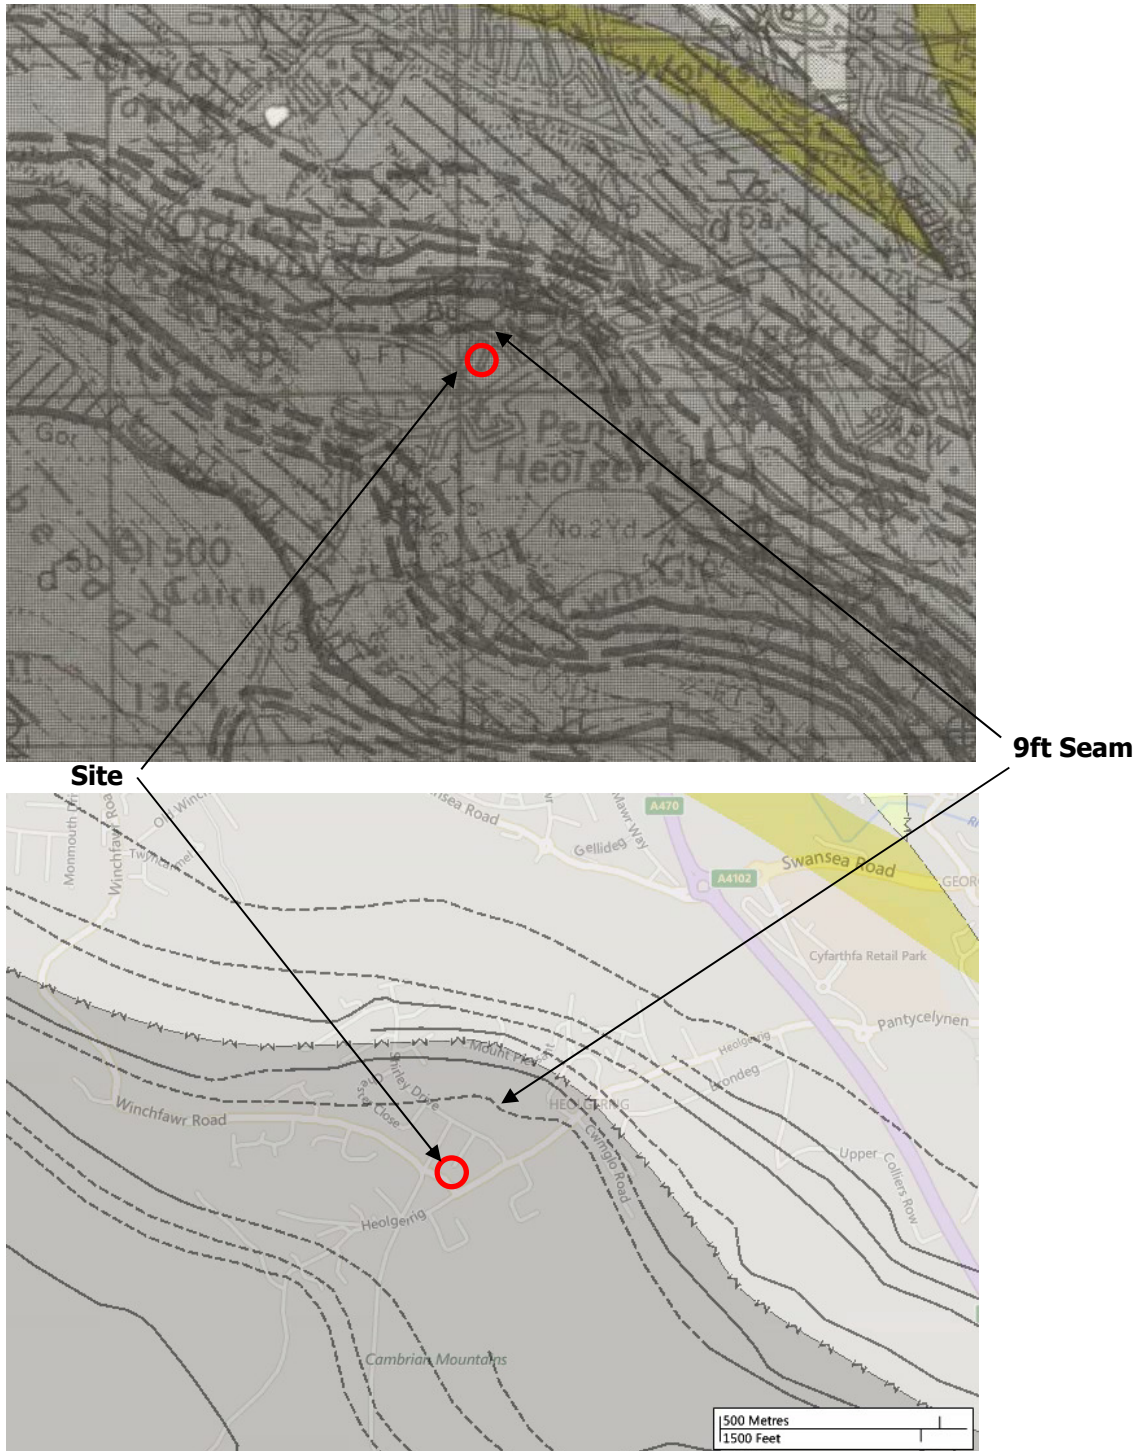
**Plates 2 & 3: BGS online mapping**

These show the site to be underlain by Glacial Till superficial deposits and solid geology of the South Wales Middle Coal Measures. A coal seam, the Nine Foot, is conjectured to outcrop 165m north of the site, dipping approx. 8 degrees in a generally south to south easterly direction. The site sits approximately +10m aOD topographically from where the seam outcrops.
