*Report No. BC/MB/06.20.05/2.*

# **Coal Mining Risk Assessment, Land at Pencoedcae Farm, Merthyr Tydfil.**

## **Mining Risk Assessment: Land at Pencoedcae Farm, Merthyr Tydfil.**

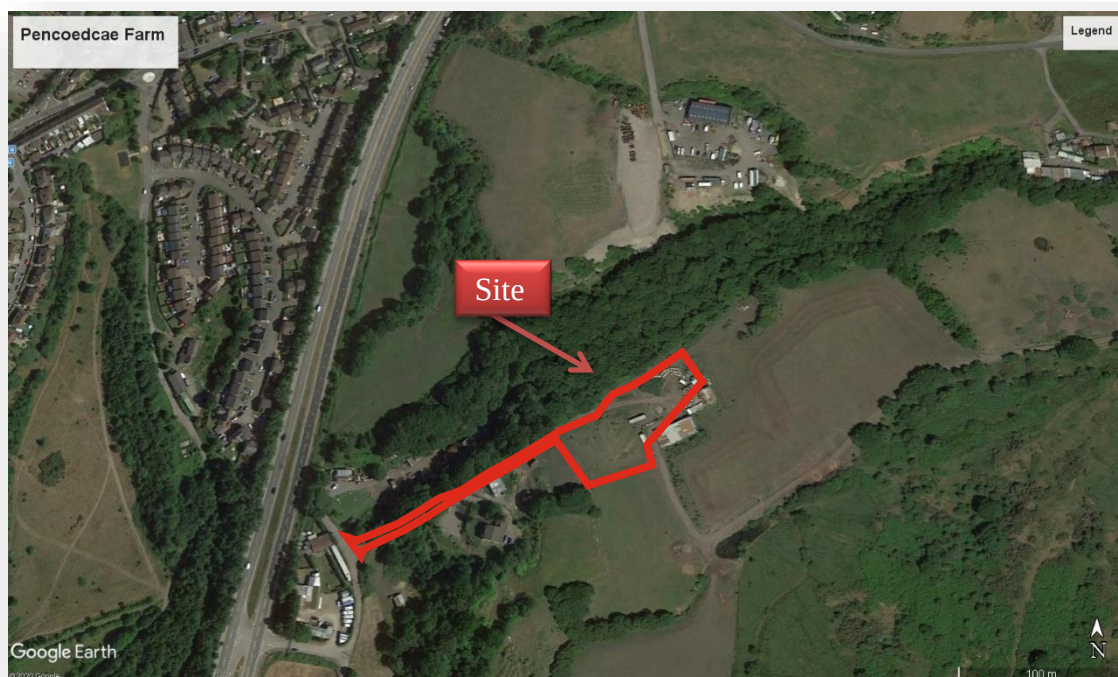
**Figure 1**  
**Aerial View of Site**

The parcel of land that is the subject of this report ('the Site') is located 1.5km south-east of the centre of Merthyr Tydfil in the Mountain Hare region of the town (see *General Location Plan, drawing no. BC/MB/06.20.05.01*). The Site is located within a semi-rural setting on the westerly facing slopes of the Taff Valley where average ground slopes are 1 in 12. "The Site" is within an agricultural enclosure and is irregular in shape, occupying an area of approximately 0.45 hectares. (see *Detailed Location Plan, drawing no. BC/MB/06.20.05.03*). The location of the proposed barn is at an approximate elevation of 257m aod.

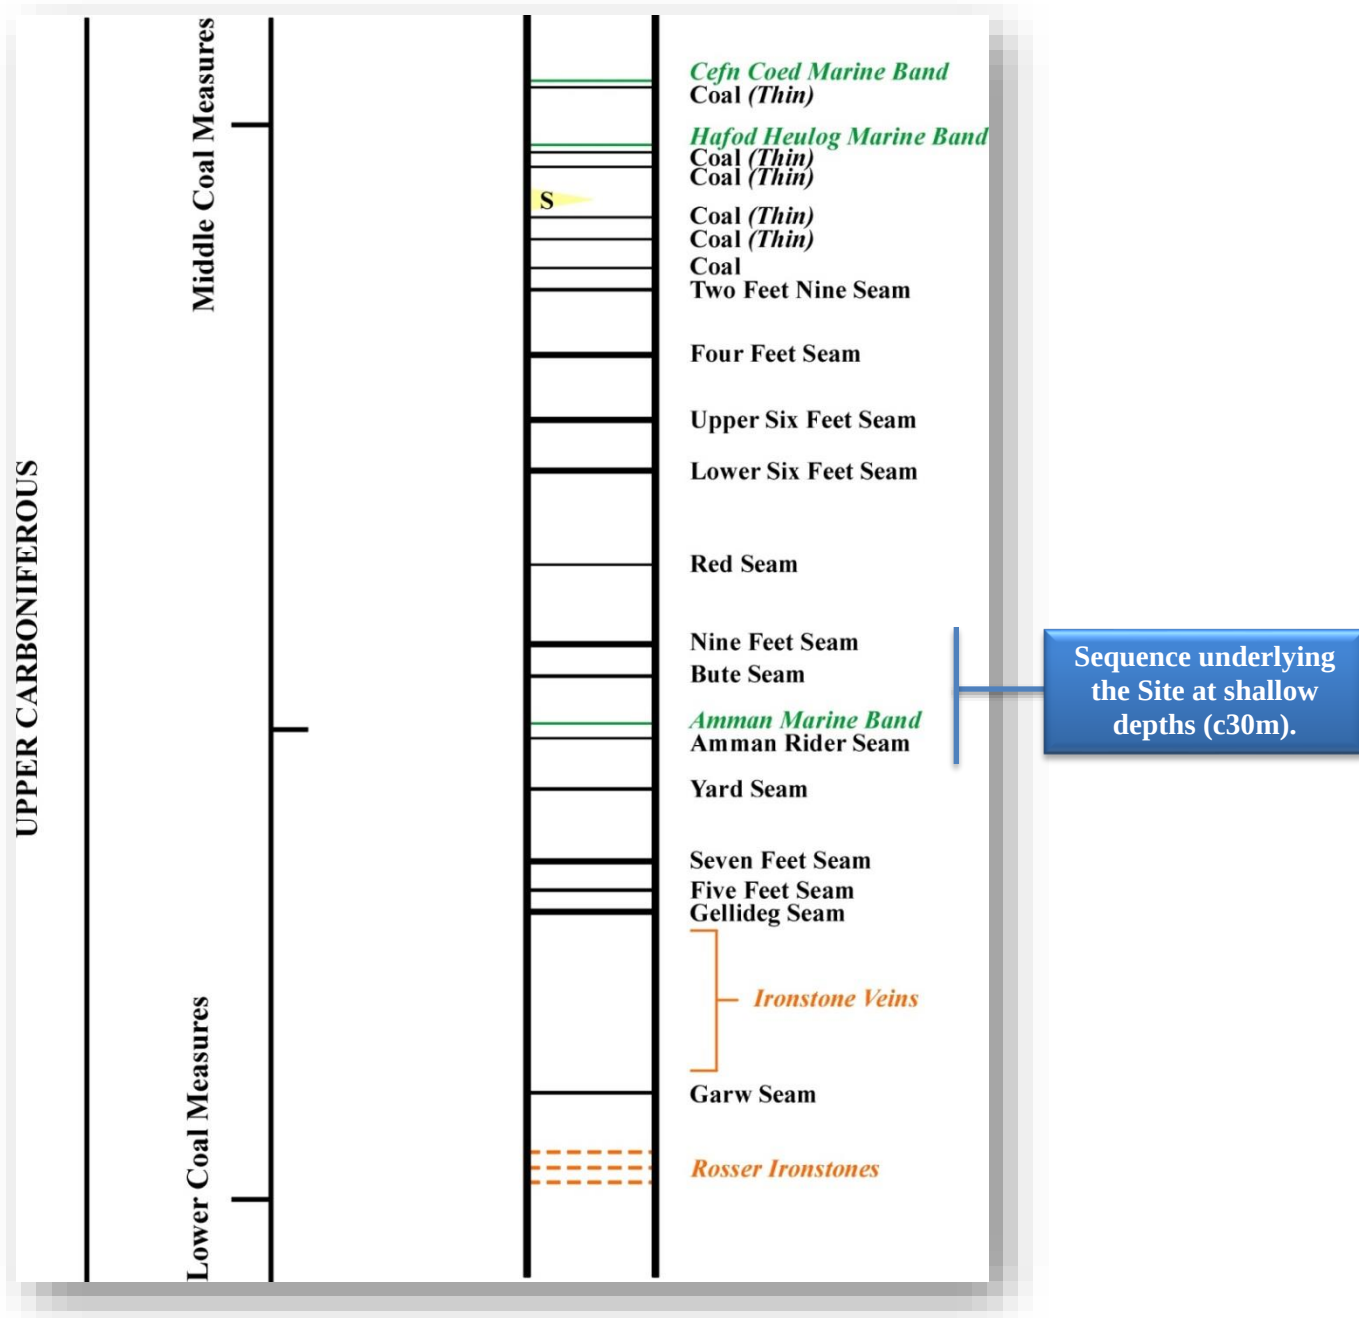
**Figure 1**  
**Part of the Stratigraphic Column.**

The Site is situated towards the northern margin of the South Wales Coalfield and is underlain at shallow depths with strata assigned to the Middle Coal Measures, a sub-division of the Upper Carboniferous Period. The published geological sheet for the area at a 1:10,560 scale, SO 00 NE, shows the inferred position of the outcrops of the Nine Feet and Bute Seams to pass through the Site in the immediate vicinity of the proposed barn. The inferred position of the outcrop of the Amman Marine Band and the immediately underlying Yard Seam are shown to be present approximately 120m north-west of the proposed barn, passing at the entrance to the access road that serves the farm (see *Geology Plan, drawing no. BC/MB/06.20.05.02*); the Amman Marine Band marks the division between the Middle and Lower Coal Measures (see *Figure 2, Part of the Stratigraphic Column*).

The inferred outcrops of the Seven Feet and Gellideg Seams are shown to be present further to the west. All the outcrops follow a sinuous trace along the hillside following a roughly north-easterly trend. The regional dip of the strata in the Pencoedcae area is 1 in 12 in a south-easterly direction so that the Nine Feet and Bute Seams may underlie the proposed building at very shallow depths and the Yard Seam at fairly shallow but deeper depth. The Seven Feet and Gellideg Seams underlie the Site at greater depths.

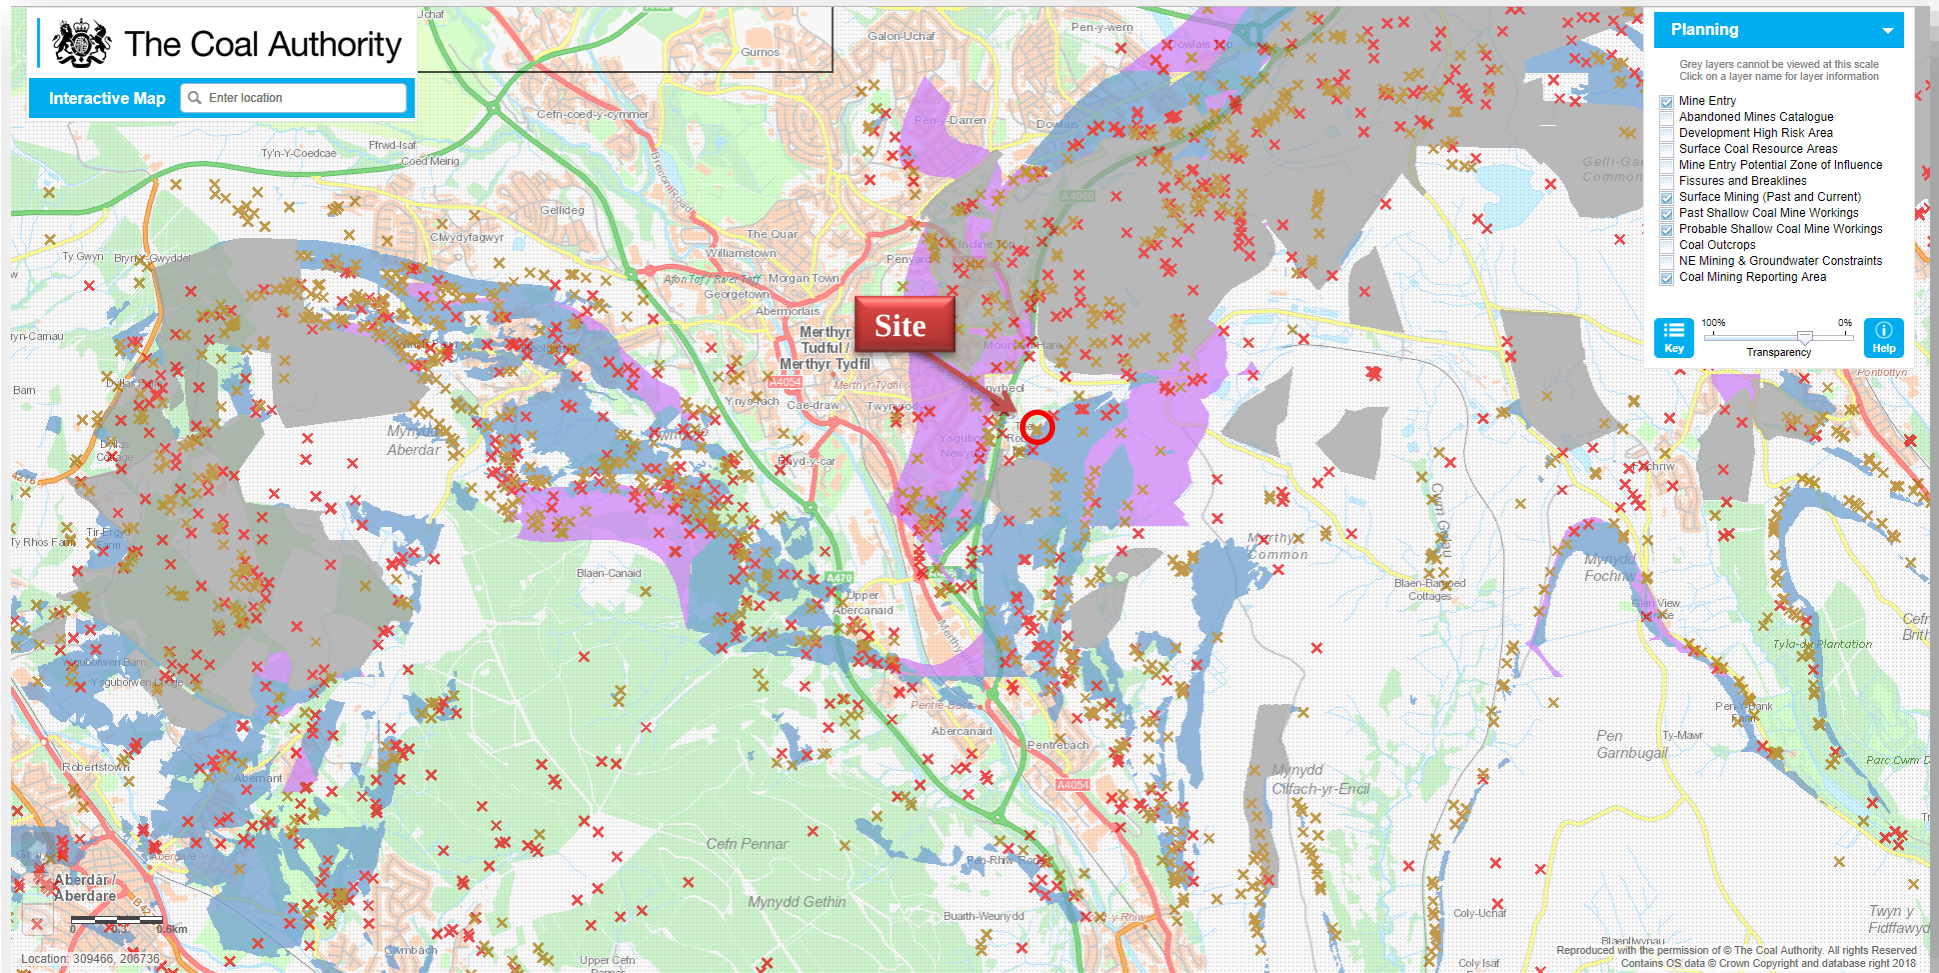
**Figure 3**  
**Print-out of The Coal Authority's Interactive Map**  
**(Accessed 18<sup>th</sup> October 2022)**

Our searches found records of two disused mine entries within the confines of the Site or within 20m of it. The two features are adits, Pencoedcae Level immediately to the south of the Site and a disused ironstone level immediately to the east of the Site. The Coal Authority has no record of what steps, if any, have been taken to stabilise either of the adits.

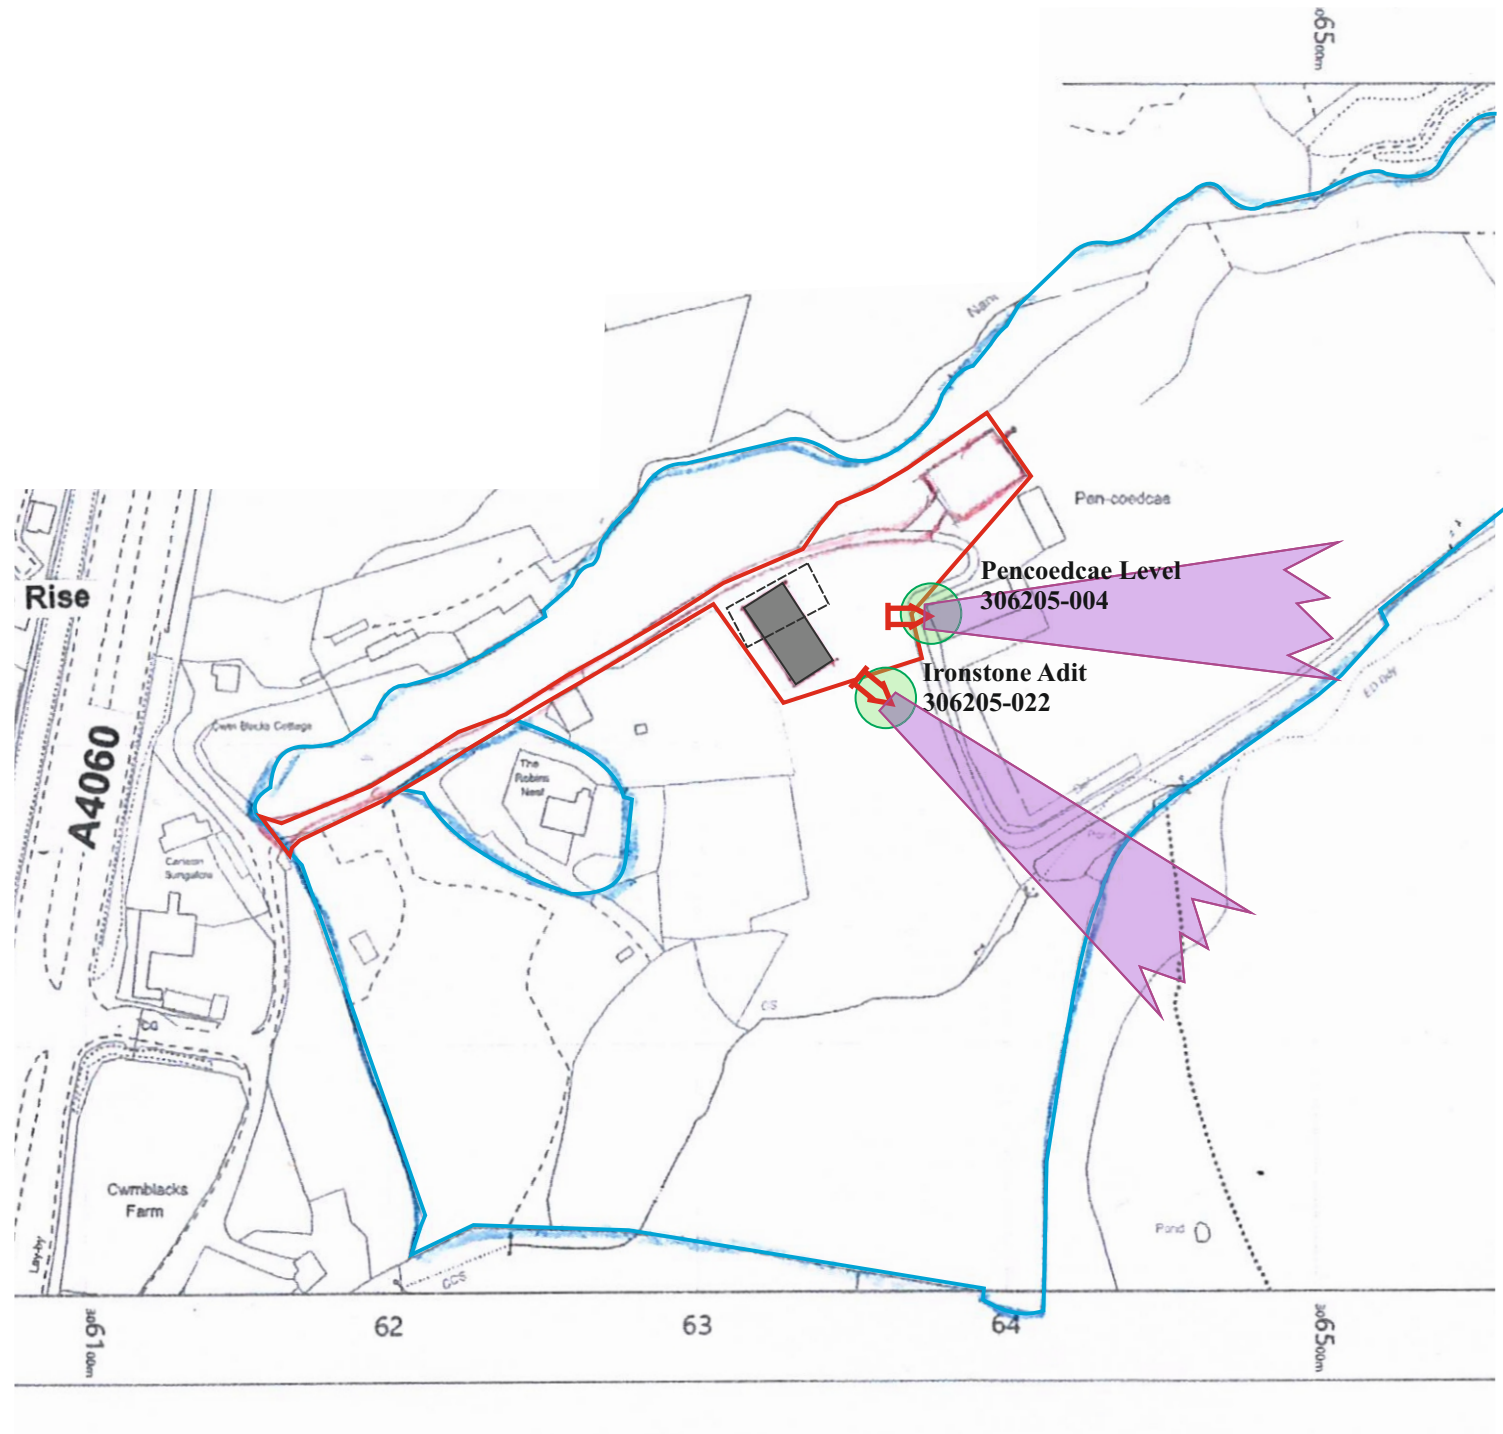
Drawing No: BC/MB/06.20.05.04.

Our searches found records of two disused adits within the confines of the Site or 20m of it. Both adits lie outside the bounds of the study area. The locations shown for the two adits are imprecise, consequently a cautionary zone with a 10m diameter has been constructed around each of the two adits' locations (see *Mining Risk Plan, drawing no. BC/MB/06.20.05.04*). It would be unusual for a mining feature to be more than 10m from its shown position in a Coal Authority report. It can be seen that the cautionary zones do not approach the proposed building's location, which is another 8m beyond the cautionary zone, i.e. 18m from the shown position of the ironstone adit and an even greater distance from the Pencoedcae Level. The risk of the proposed building being influenced by the

A hypothetical collapse/exclusion zone has been calculated for the adits, the zones follow the underground drivages away from the Site and the proposed building.

mouth of either adit is very low. Yet more confidence that the building is remote from the mouths of the adits could be achieved by rotating the building as shown on the Mining Risk Plan.
