# Cyfarthfa Castle

*Urgent Repair Works – Roofs, Facades and Rainwater Goods*

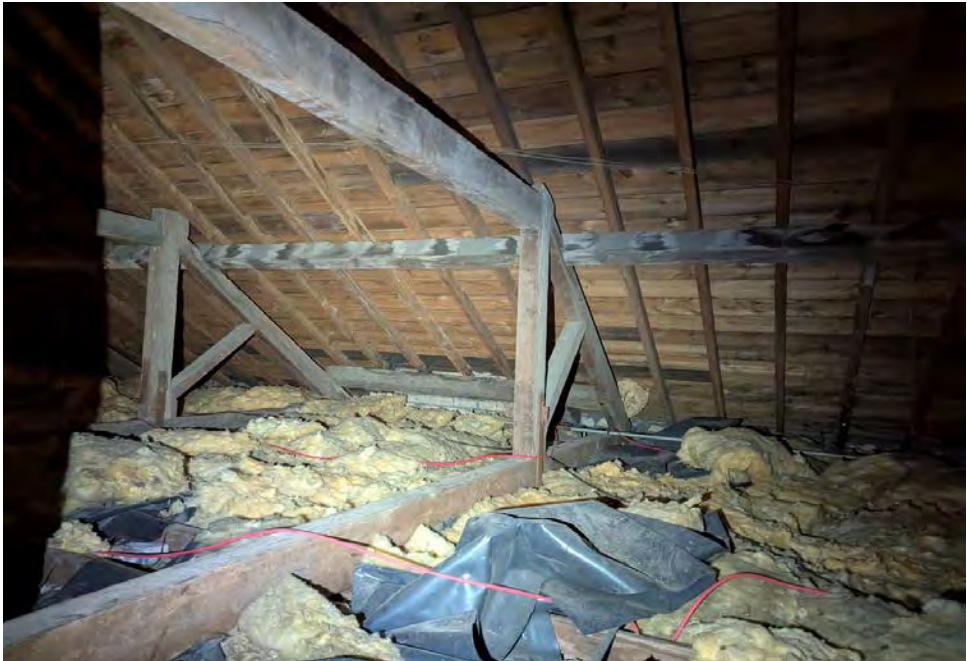
*Image of roof space below R.7 where access walkway is proposed to enable safe access to roof space for maintenance and inspection.*

To facilitate the ongoing maintenance and inspection of the attic spaces beneath the pitched roofs, the installation of new maintenance walkways is proposed. These walkways will provide safe and secure access for maintenance personnel, enabling regular inspection of the roof structure while protecting the historic trusses from accidental overloading or damage.

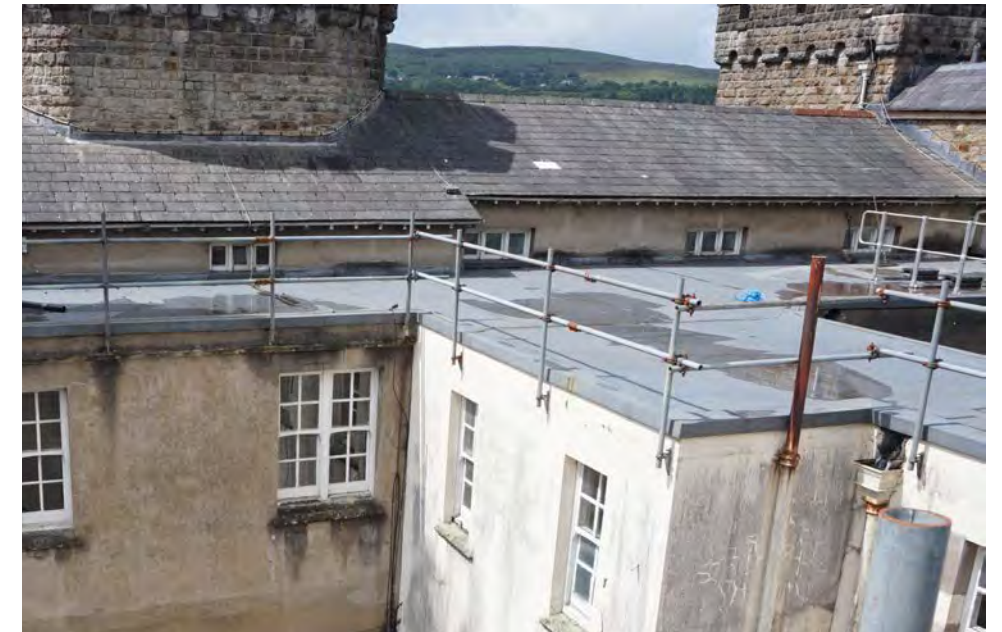
Image showing 4 of 5 no. windows to be replaced with new windows with raised cill. Proposed windows will feature glazing bars to mirror existing casement proportions and actuators to allow windows to be opened easily and ventilate internal spaces. Existing poor quality face-fixed guarding will be removed and replaced with freestanding guardrail.

- **Replacement of clerestory windows:** The clerestory windows along the southern edge of the roof will be replaced and their cills raised to accommodate the increased roof build-up. The new windows will match the style and detailing of the existing units, including glazing bars, and will be fitted with actuators to provide natural ventilation to the internal spaces below.

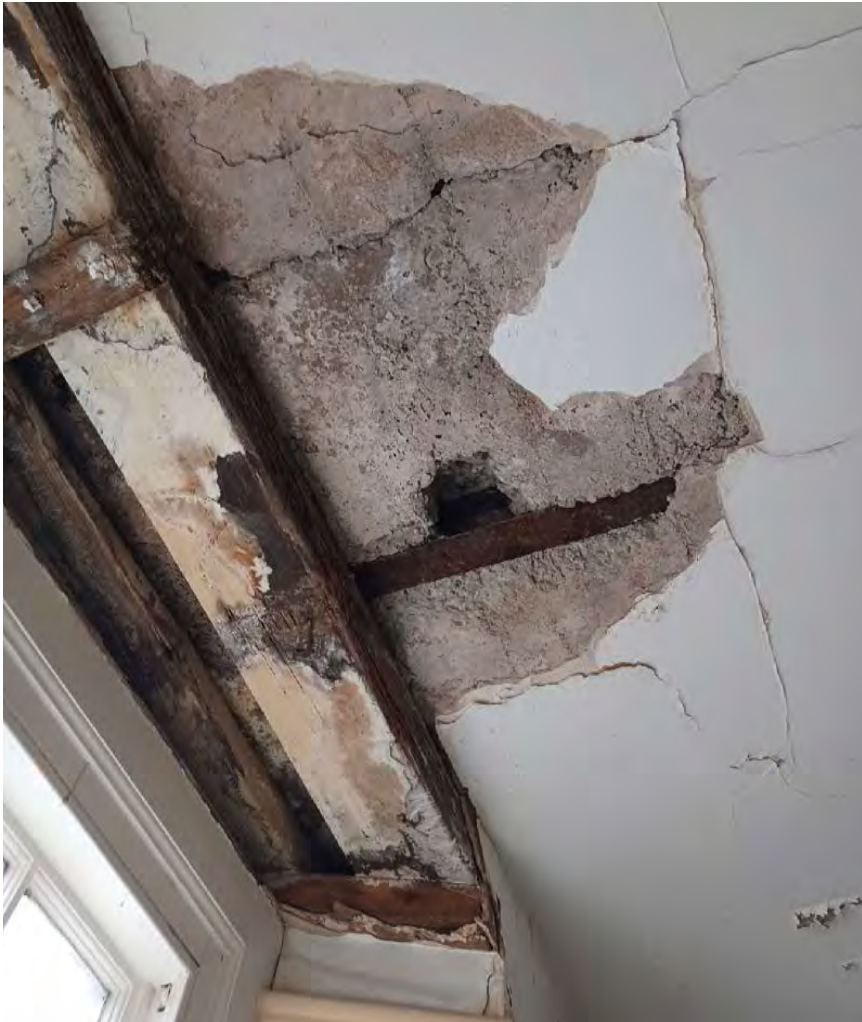
The existing filler joist flat roof structure has been compromised due to historic water ingress and subsequent corrosion of steelwork. In order to ensure the roof will be safe for future access and capable of supporting plant equipment, it is proposed to install new steel beams beneath the existing structural deck. There will be a new gypsum dropped ceiling to conceal the steelwork within the first floor spaces.

Image from opening up works showing corroded condition of existing steelwork. New steels have been designed to keep depth to a minimum and ensure interventions sit above the window reveals.

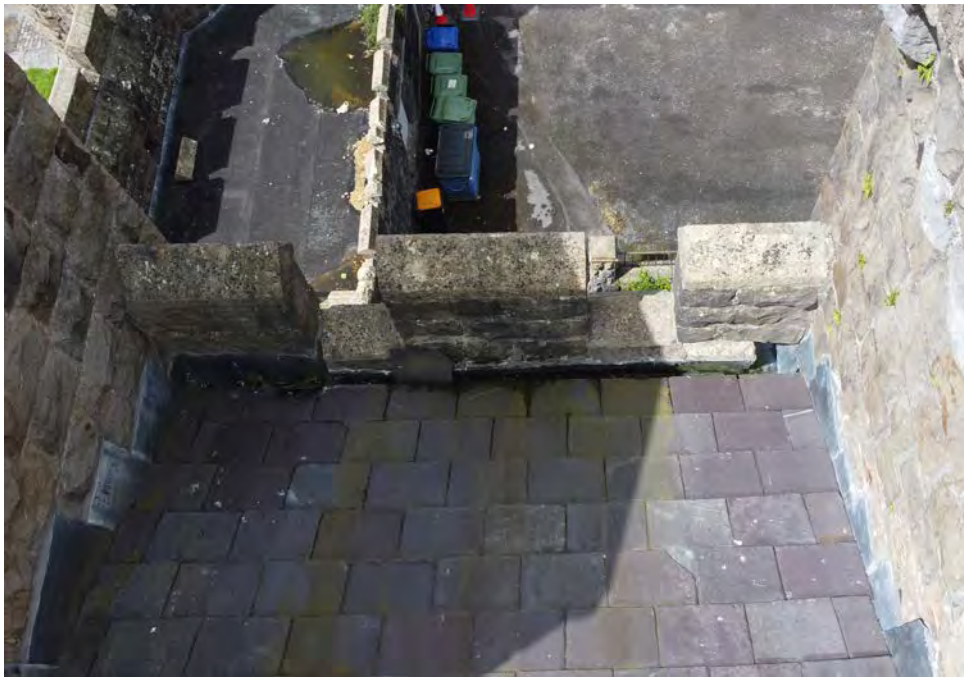
Parapet to increase in height to facilitate installation of DPC course below coping stone at a minimum of 150mm above gutter.

The parapet to Roof R.22 will be raised to achieve a 150 mm upstand from the new lead gutter to the DPC course below the coping stone, creating a robust waterproofing detail and preventing rainwater from running down the façade and causing staining or deterioration. The parapet will be carefully dismantled, numbered, photographed, and rebuilt to ensure its appearance is not altered. Any required new stone will be sourced to match existing.

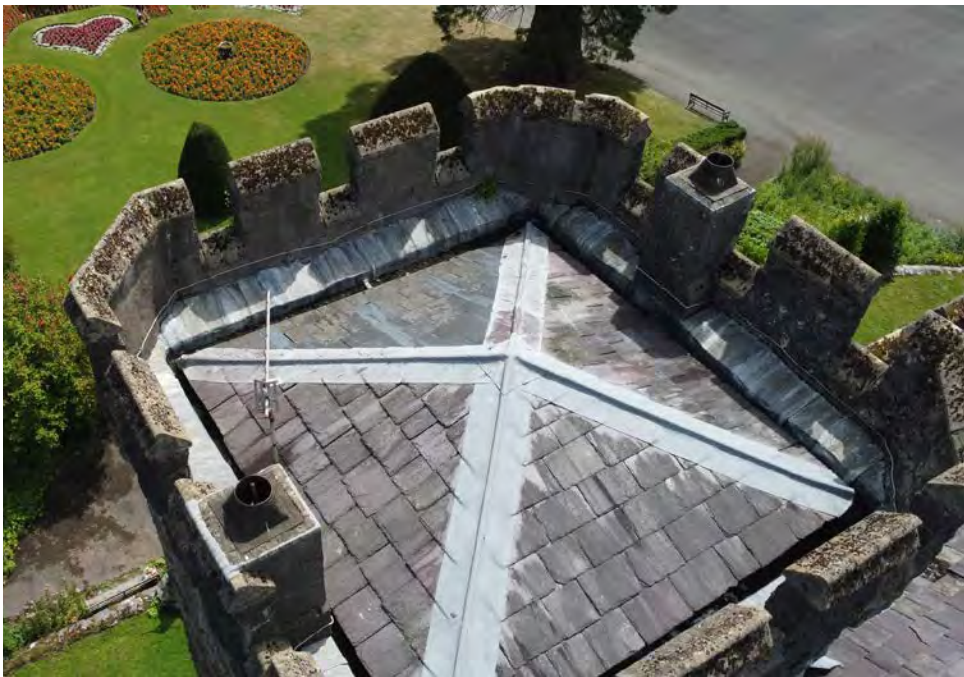
Roof pitch to be increased from rafters and slate roof above rebuilt.

The pitch of Roof R.9 will be increased from 20° to 25° to improve weathering performance and enhance the roof’s ability to shed water, reducing the risk of long-term water ingress. This will be achieved by introducing furring to the top of the principle rafters before the slate roof buildup is placed. This alteration may result in a slight increase in the area of roof visible between the crenellations, although this is considered a very minor visual change with negligible impact on the overall appearance of the building.

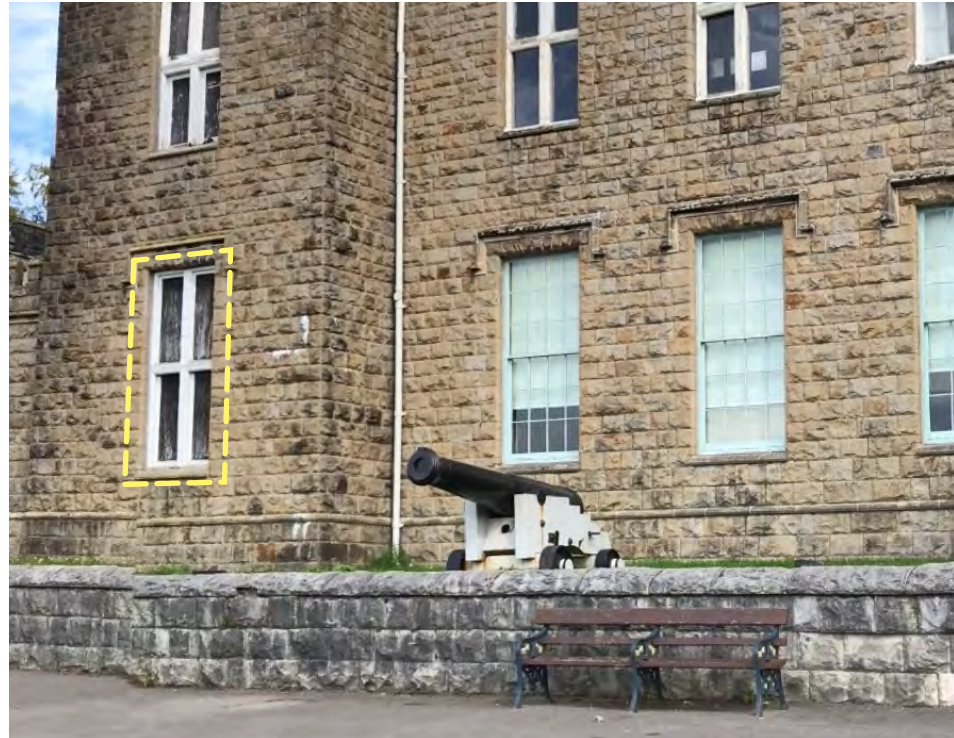
*Existing boarded up window to caretaker's house (marked on image) is to be replaced with sash window to match adjacent ground floor windows.*

The existing blind window to the ground floor of the caretakers house is to be replaced with a sash window, to match with the existing ground floor windows on the principle elevation. This will restore visual consistency to the façade. The restoration of this window will also improve thermal condition and water tightness and improve the internal condition of the room.

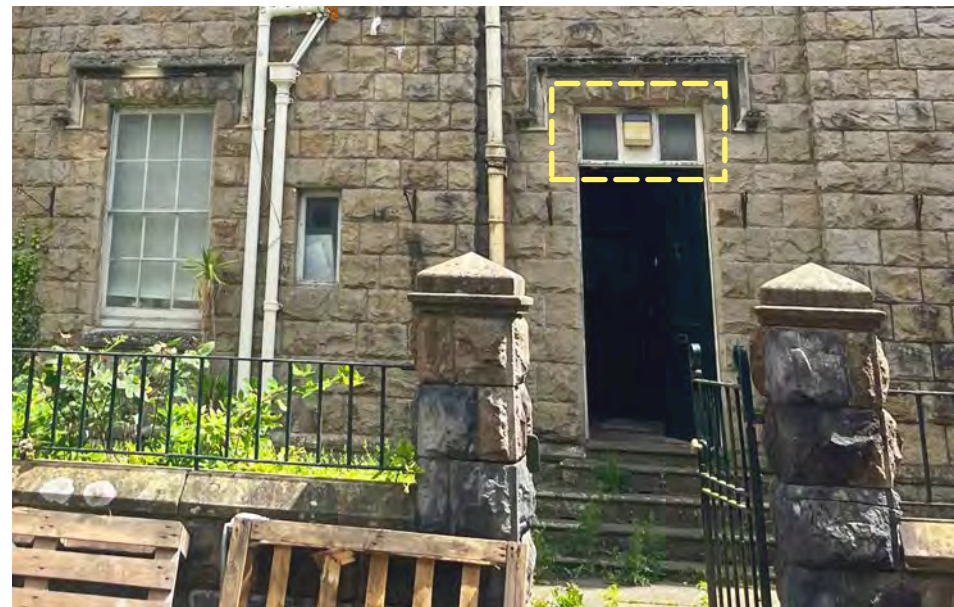
*Example fo location where glass has historically been replaced with an infill and is to be reinstated.*

Several windows on the courtyard elevations have been altered historically, with the introduction of vents and blank infill panels. Where these elements are now redundant, the infill panels will be removed and replaced with glazing, and the original window frames will be repaired. This work will reinstate the original appearance of the windows.

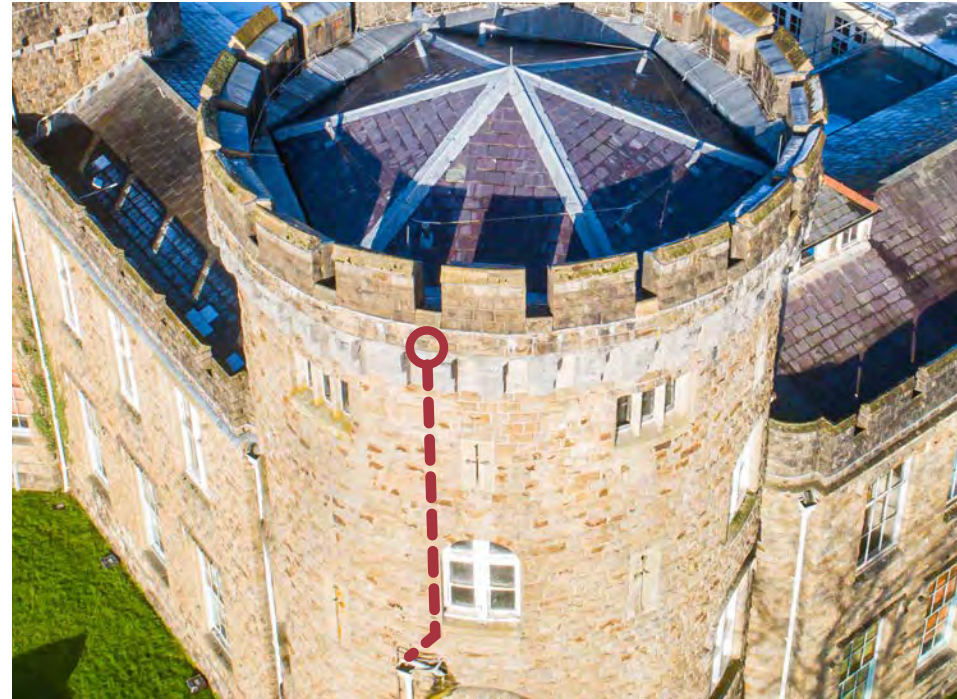
New rainwater pipe **RWDP 11A** to be installed from roof level and connect to the existing pipe from first floor level as indicated with red dashed line. Existing penetration through wall to be infilled. New chute will be required at roof level in location indicated by circle.

- **RWDP 11A (SE Tower):** Re-routing the existing internal downpipe to an external location, eliminating the need for a penetration through the wall. This provides a more robust and accessible drainage solution that reduces the risk of internal water ingress.
- **RWDP 28A:** Re-routing of rainwater away from Roof R1.12, which is difficult to access, thereby reducing future maintenance requirements and improving system reliability.
- **RWDP 43, 44, 45, 46, 49, 50:** These roof areas currently lack dedicated downpipes, resulting in uncontrolled water run-off. The installation of new downpipes will improve rainwater management, direct flows away from the façades and increase drainage capacity.

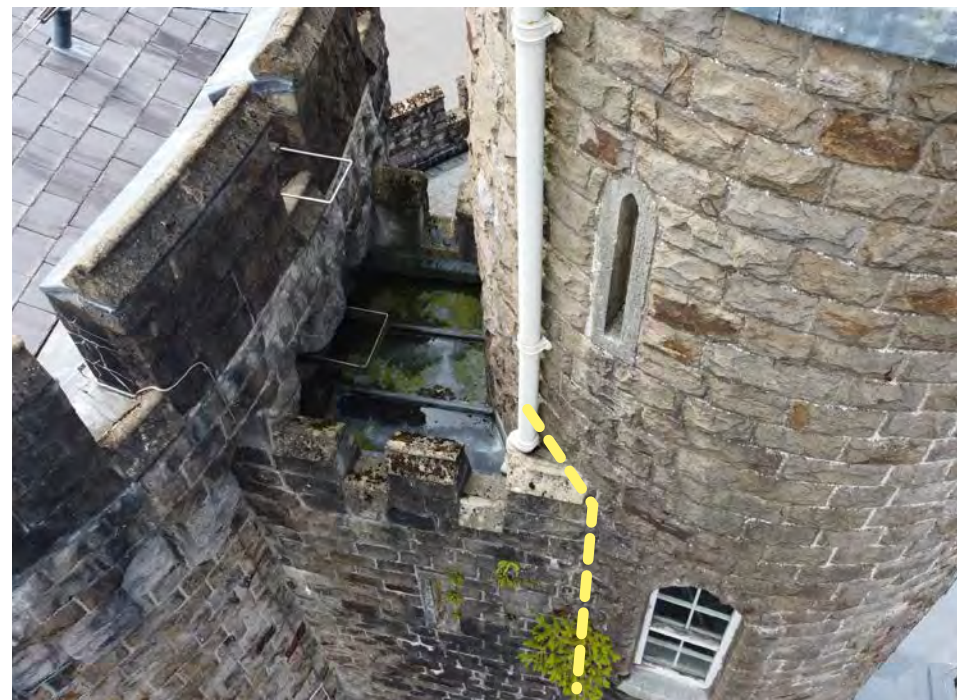
New rainwater pipe **RWDP 28A** to connect to RWP28 from upper roof level and redirect water onto R.7 as indicated with yellow dashed line..

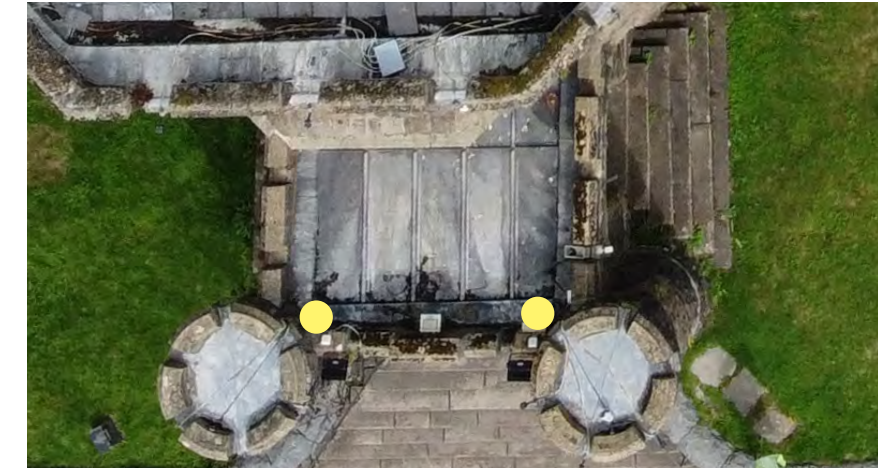
New RWPs 44 & 45 to direct water flow off towers thus preventing run off onto facade causing staining.

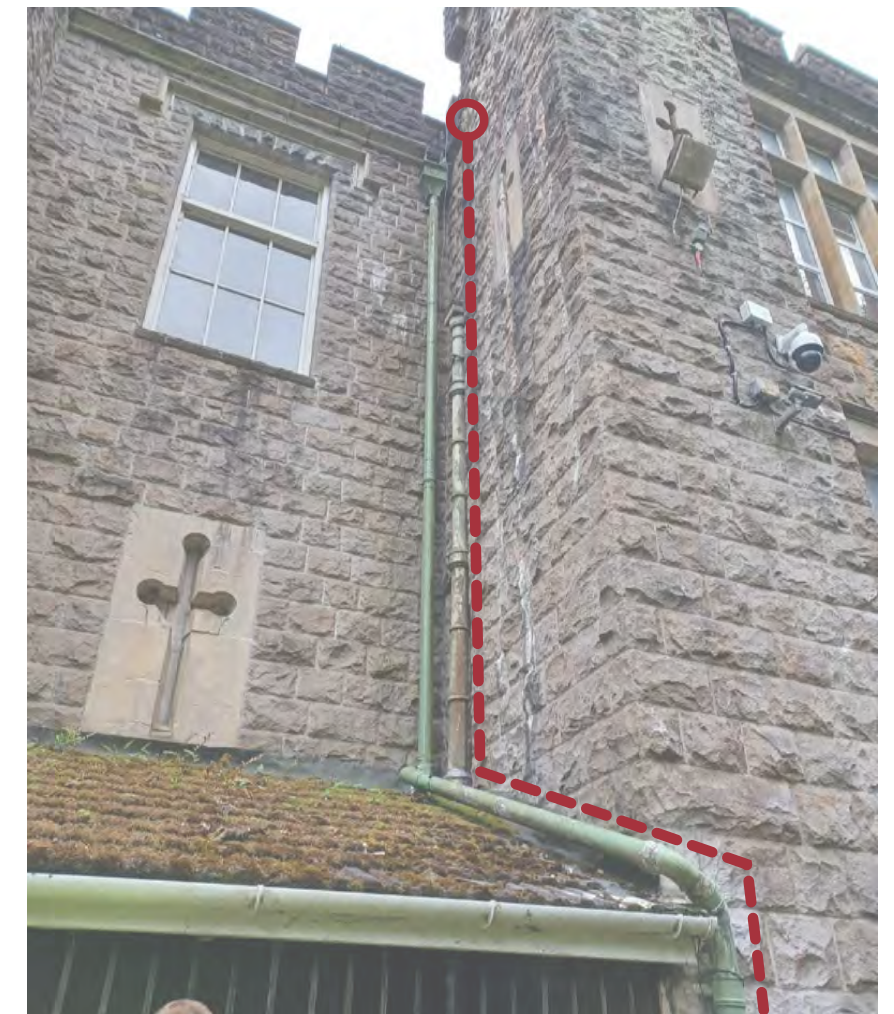
RWP 43: New chute, hopper and downpipe to manage water flow off flat roof area thus preventing water spilling over facade.
