*Report No. BC/MB/12.19.02*

# **Mining Risk Assessment: Land at Crophorne Stables, Trelewis.**

**AW Properties Ltd.**

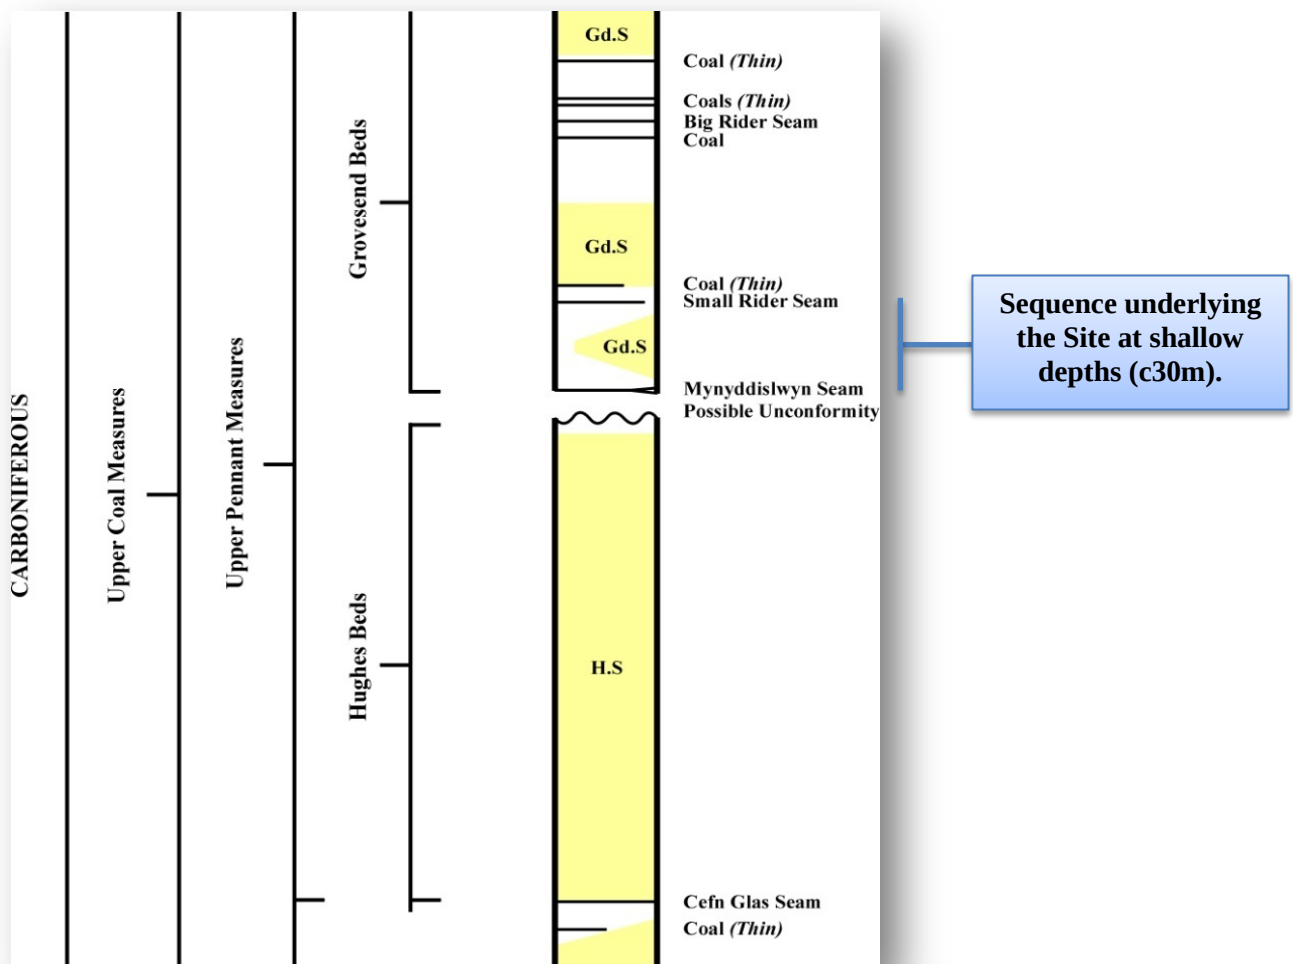
**Figure 2**  
**Part of the Stratigraphic Column.**

The inferred position of the outcrop of the Mynyddislwyn Seam is shown to be present approximately 150m west of the Site; the Mynyddislwyn Seam marks the division between the Grovesend Beds and the underlying Hughes Beds. The inferred outcrop follows a V-shaped trace where it crosses the floor of the valley between two large faults. Trelewis lies near the axis of a large synclinal fold (U-shaped) where the strata dips are very shallow and towards the southeast, resulting in the position where the Mynyddislwyn Seam underlies the Site, probably at shallow depths.

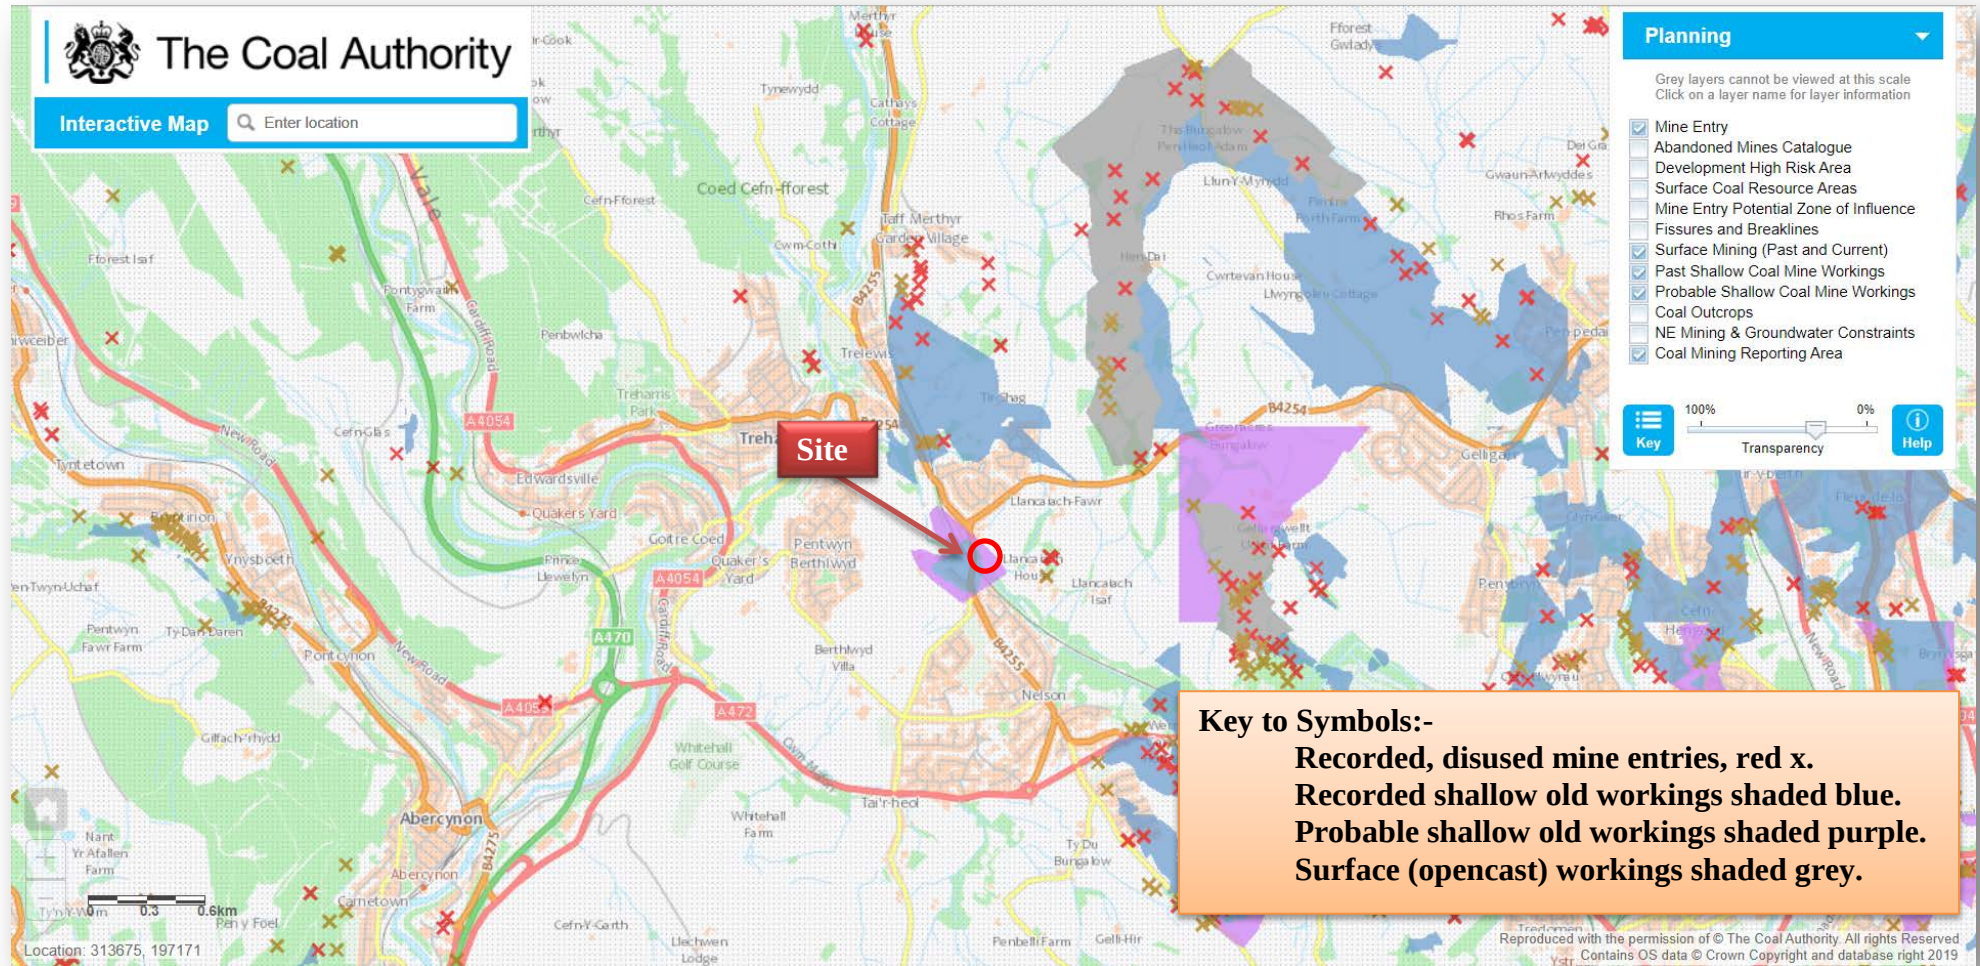
**Figure 3**  
**Print-out of The Coal Authority's Interactive Map**  
 (Accessed 10<sup>th</sup> December 2019)

Shallow, unrecorded old workings have been found to be present in the Seam on the west, upthrow side of the fault; the workings were encountered during the construction of the five houses at The Paddocks, immediately beyond the B4255, to the north-west of the Site. Drilling and Grouting operations on the southernmost of the five plots, Plot 5, encountered old workings in the Seam at an approximate depth of 20m with approximately 9m of superficial deposits. The Coal Authority's interactive map identifies shallow and probable (shallow, unrecorded old workings) beneath and in the area immediately surrounding the Site.

The locality has experienced extensive mining operations for coal with fairly extensive old workings in the Mynyddislwyn Seam and The Coal Authority's interactive map identified shallow and probable workings across the Site and the surrounding area. Whilst shallow old workings were encountered during the development of The Paddocks, exploratory drilling for a dwelling immediately north of the Site encountered superficial deposits of between 8m and 13m, but no coal to a depth of 30m. The latter drilling indicates that the Seam is too deep to pose a risk of any old workings that might be present collapsing to the surface.

A programme of exploration boreholes should be drilled on the Site in order to examine in greater detail the risk from faulting and from shallow mine workings; the boreholes should be monitored for the presence of mine gases. The boreholes should be designed and supervised by a Chartered Geologist and will require a permit from The Coal Authority.

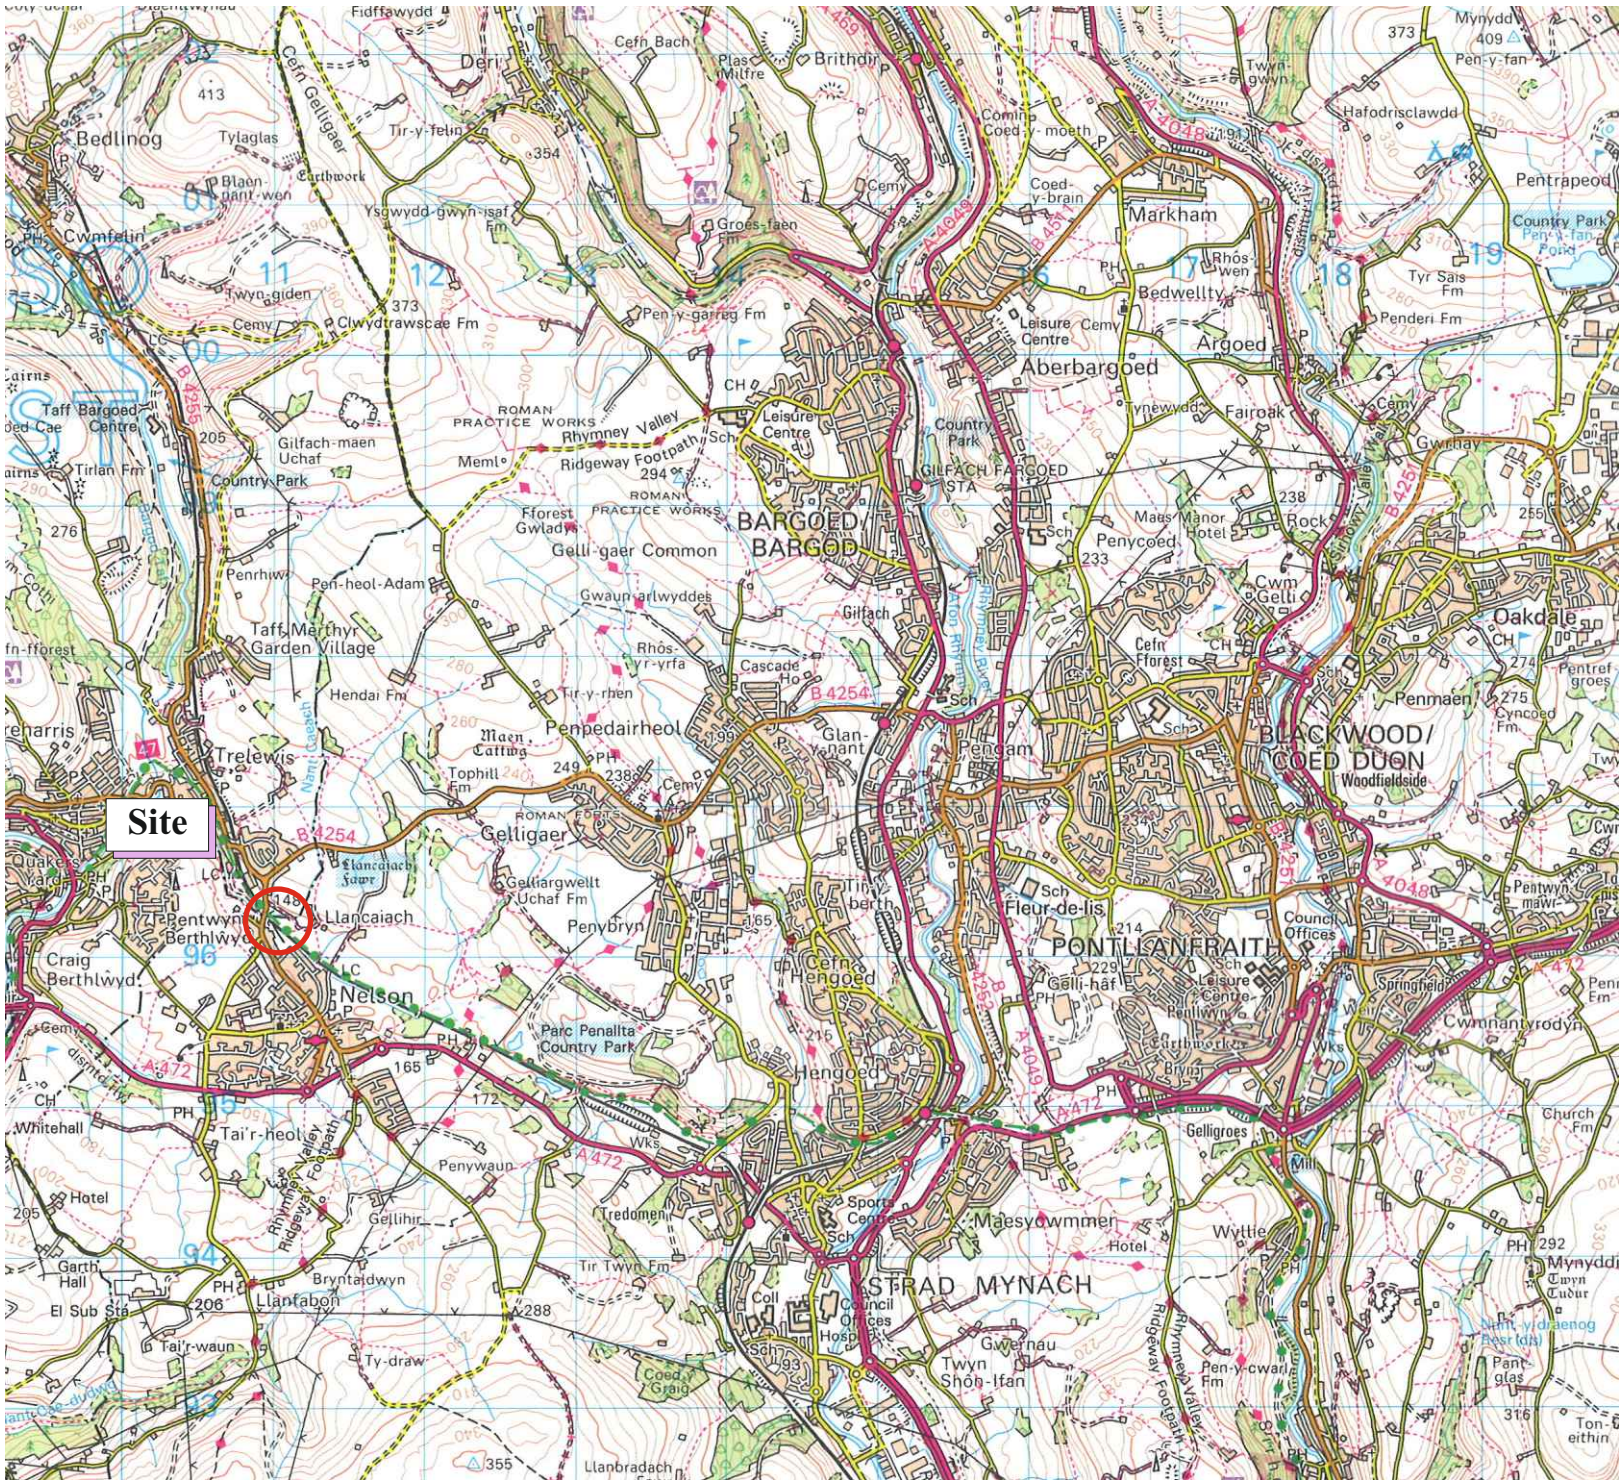
Geology Plan.

The published geological sheet for the area at a 1:10,560 scale, ST 19 NW, shows the Site to be underlain at shallow depths by strata assigned to the Grovesend Beds, the topmost subdivision of the Upper Coal Measures (see *Geology Plan, drawing no. BC/MB/12.19.02.02*).

The published geological sheet shows the Site to be underlain with deposits of glacial till, Sand and Gravels, and that the Site is not affected by landslip conditions.
