**Heritage Impact Assessment**

**Proposed Replacement Windows**

5 Chapel Row, Georgetown, Merthyr Tydfil, Cf48 1BN

October 2023

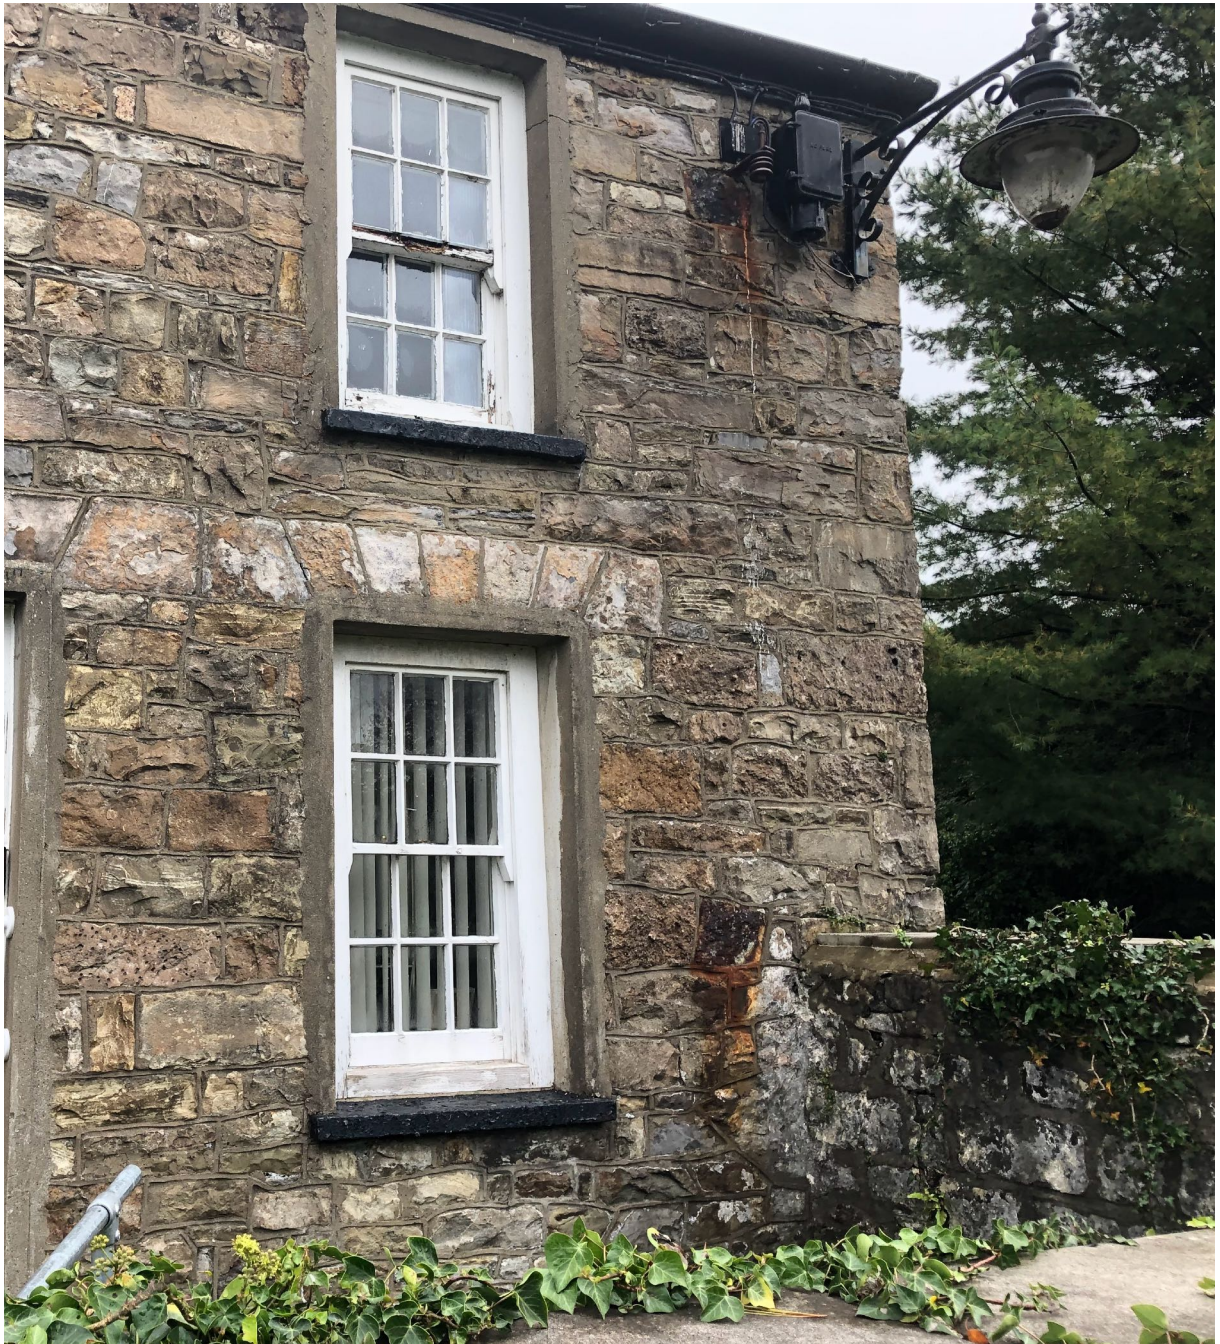
The existing windows are all single glazed sliding sash of decorated softwood and there are three windows that are in a poor condition, especially the first-floor bedroom window – (photo 4)

Photo 4 – Windows – First floor window in poor condition

This proposal includes replacing the timber windows (identified in the accompanying drawings) on a 'Like for Like' basis. Windows that are showing minor signs of rot will be repaired (as existing) The front and rear doors and frames are also to be replaced due to rot at the base of the frames again on a like for like basis. In line with the above guidance, it is considered the development conserves the contribution the building makes to the character of this area of Merthyr Tydfil.

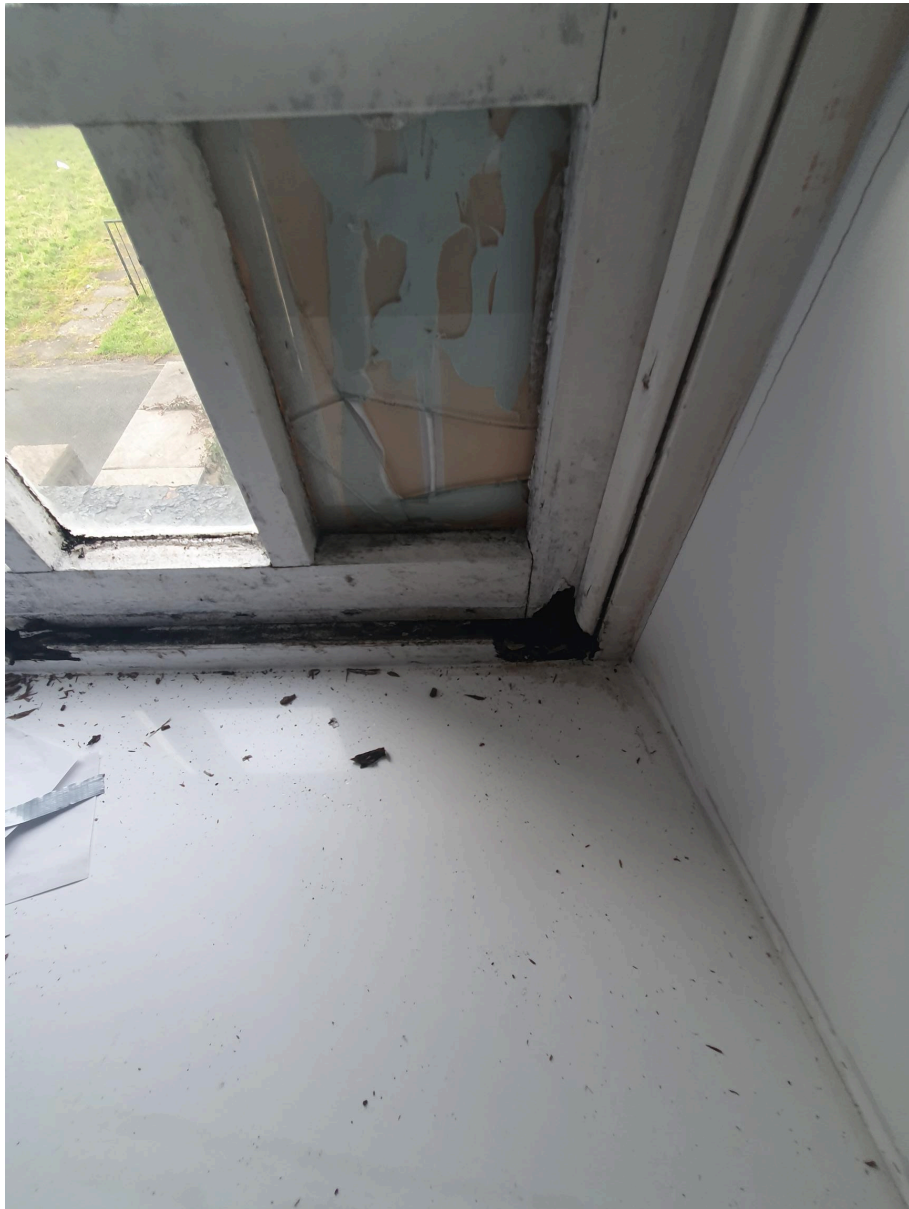
The following photographs show the windows and doors that require replacement.

Photo 5 – First floor bedroom window

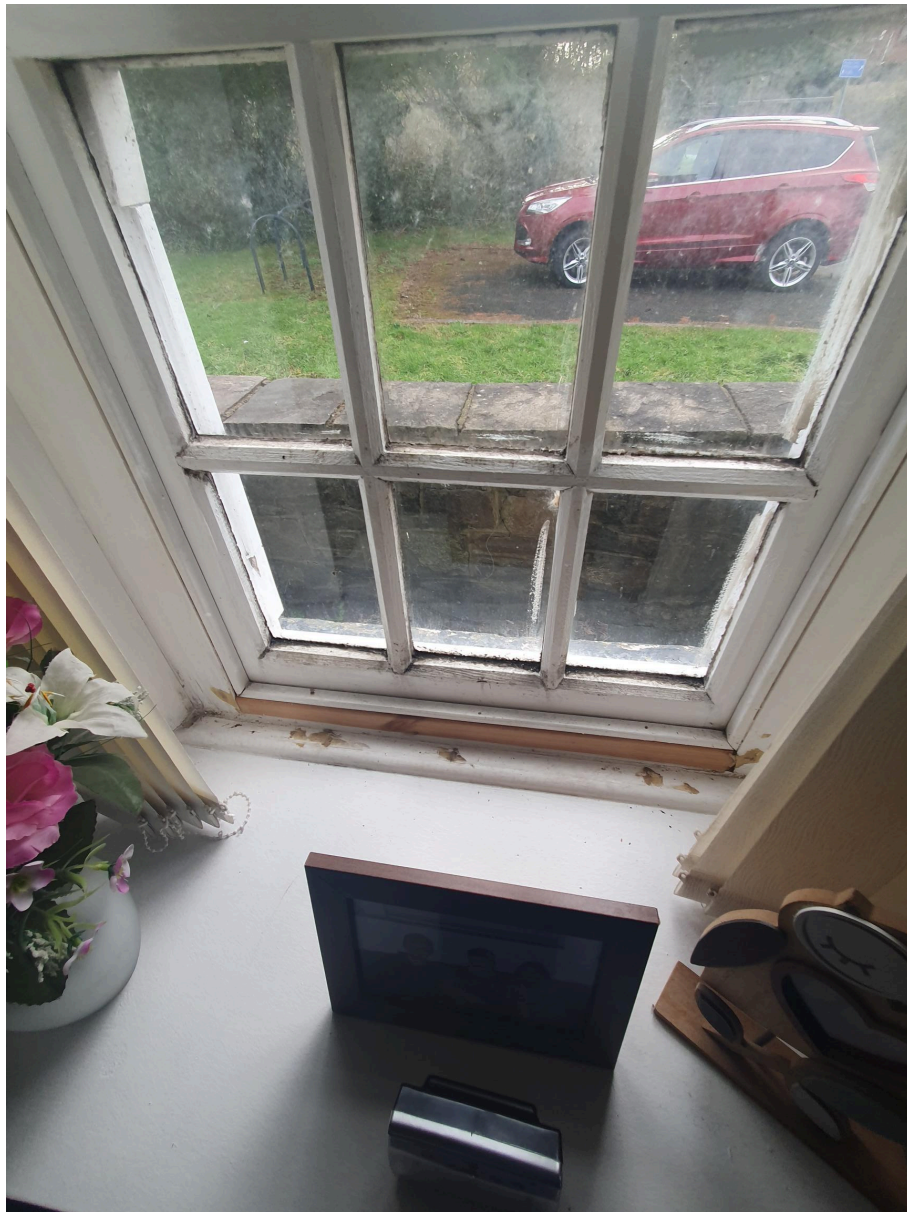
Photo 6 – Ground floor side window

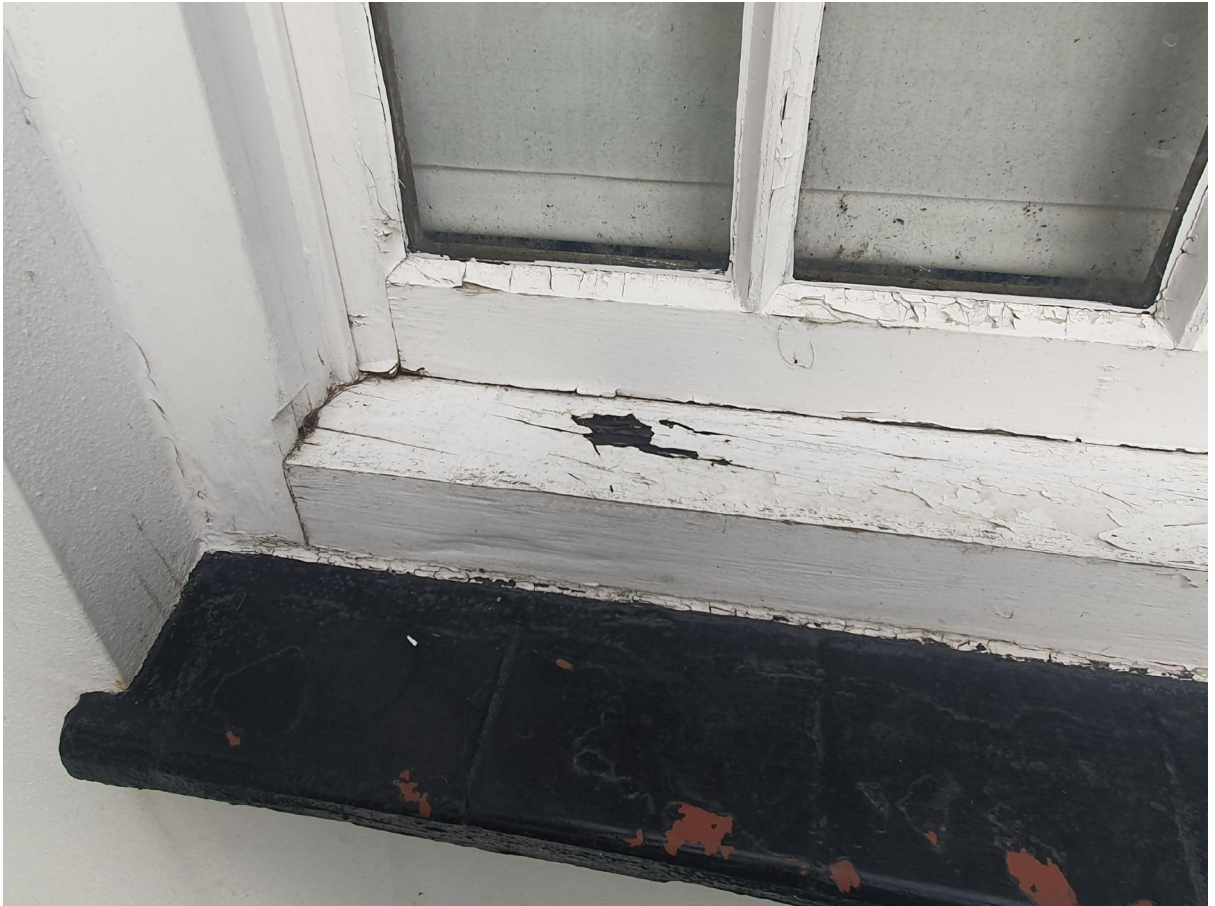
Photo 7 – Rear ground floor window

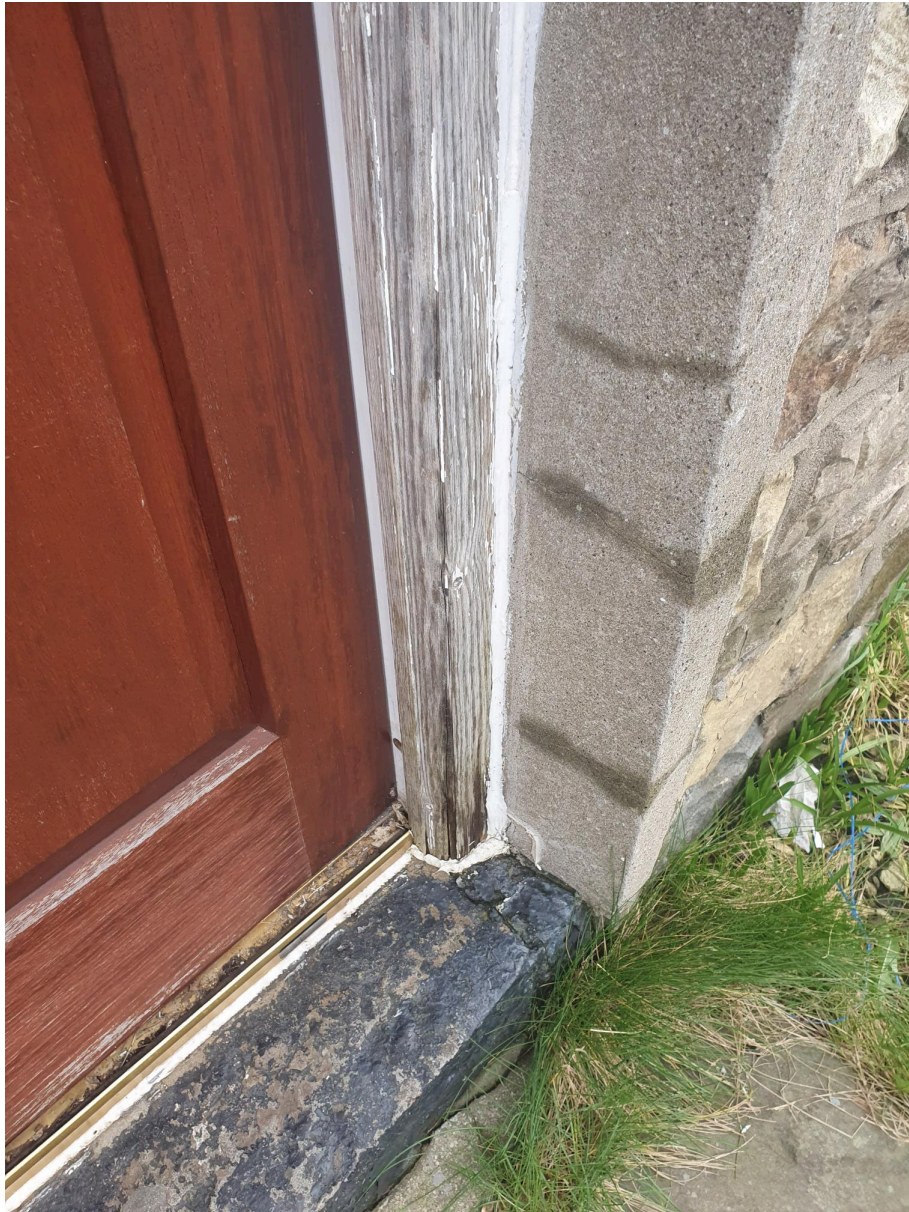
Photo 8 – Front door frame rotten at base

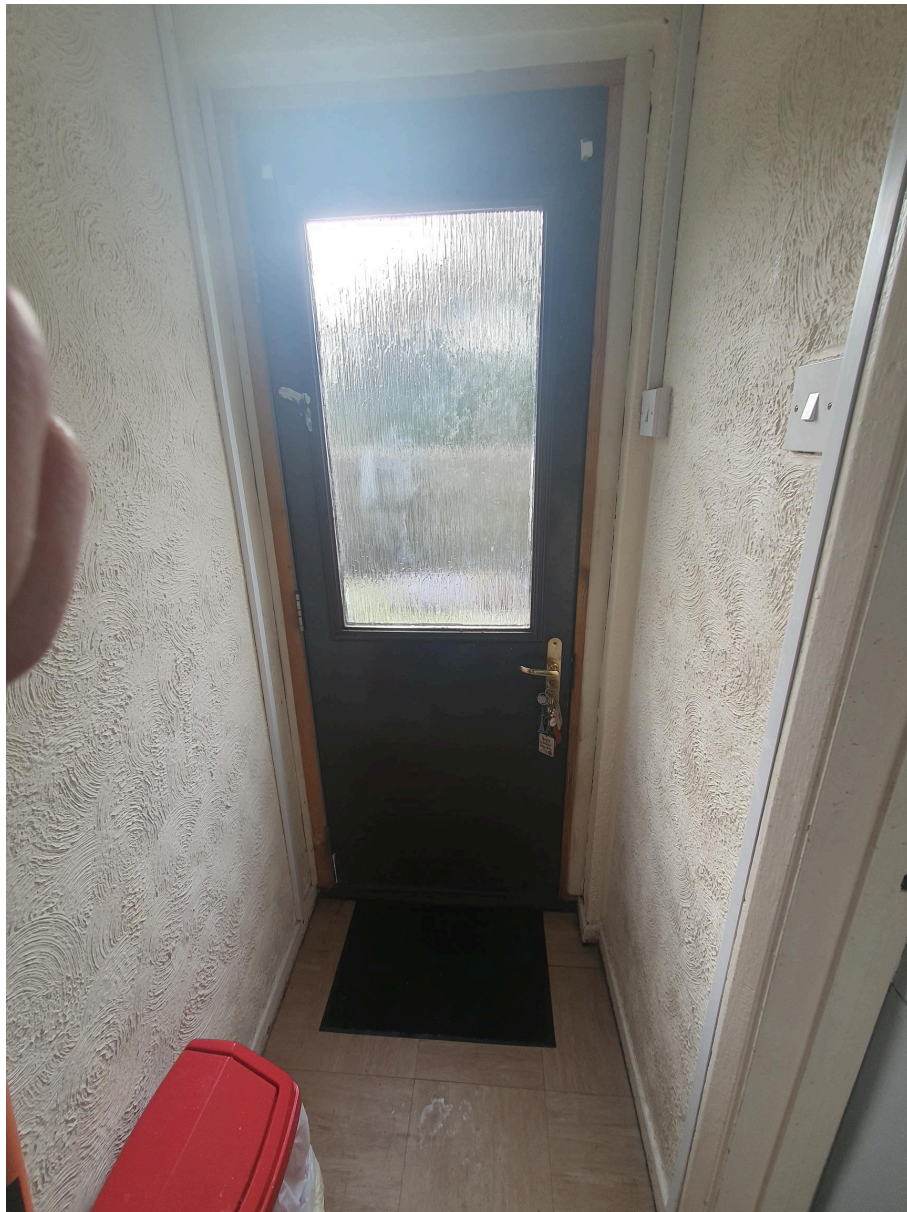
Photo 9 – Rear door
