**Bryniau Road, Pant,  
Merthyr Tydfil.  
Holbrook Homes**

**Flood Consequences Assessment and Drainage Strategy Report**

**November 2019**

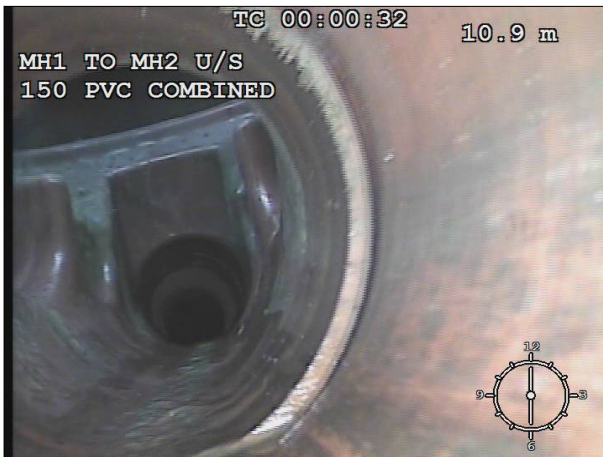
Place:  
**MERTHYR TYDFIL**Road:  
**BRYNIAU ROAD**Date:  
**25/10/2019**section number:  
**2**PLR:  
**MH2 X**

- Medium open joint at 11.1M.

Photo: 18\_5a, 00:00:00  
11.1m, Open joint medium

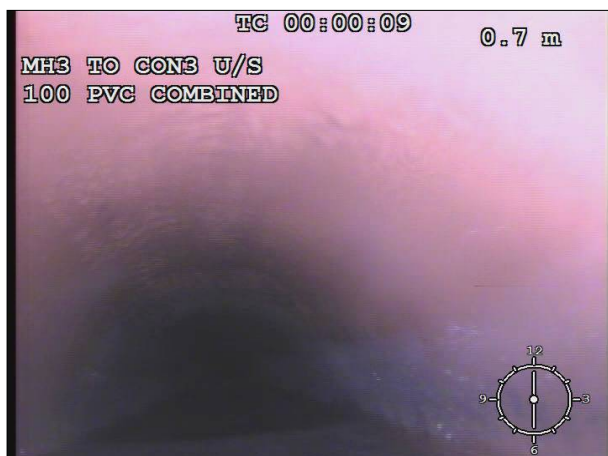
Photo: 45\_4a, 00:00:00  
0.7m, Water level, 50 % height/diameter

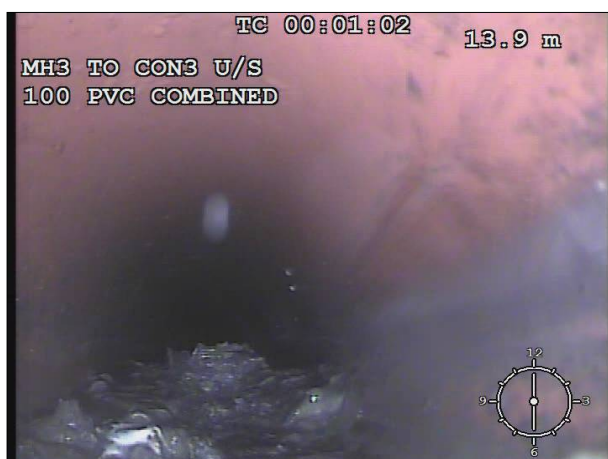
Photo: 49\_8a, 00:00:00  
13.9m, Debris, 40 % cross-sectional area loss

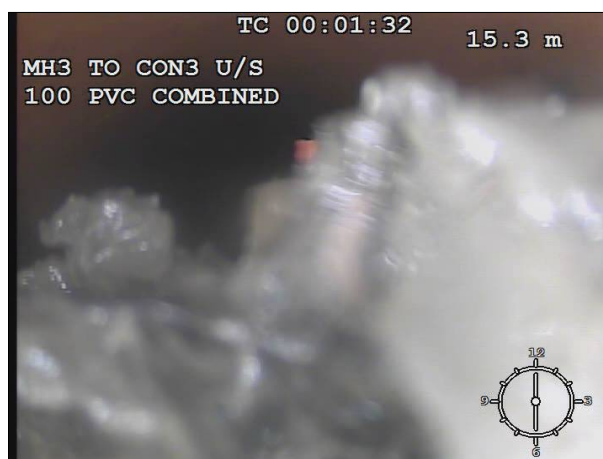
Photo: 50\_9a, 00:00:00  
15.3m, Survey abandoned, Remark: Unable to CCTV past debris

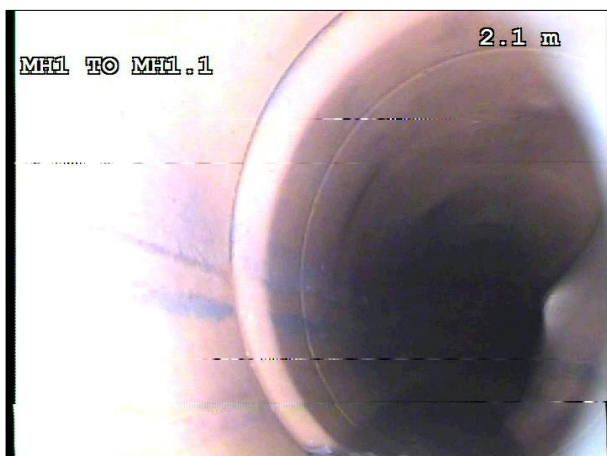
Photo: 56\_4a, 00:00:00  
2.4m, Open joint medium

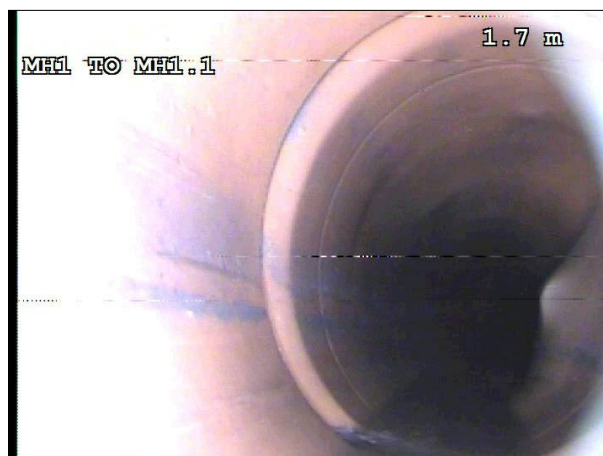
Photo: 10\_5a, 00:00:00  
2.5m, Sewer Deformed, 20 %, Remark: Stone Impact, from 02 to 04 o'clock

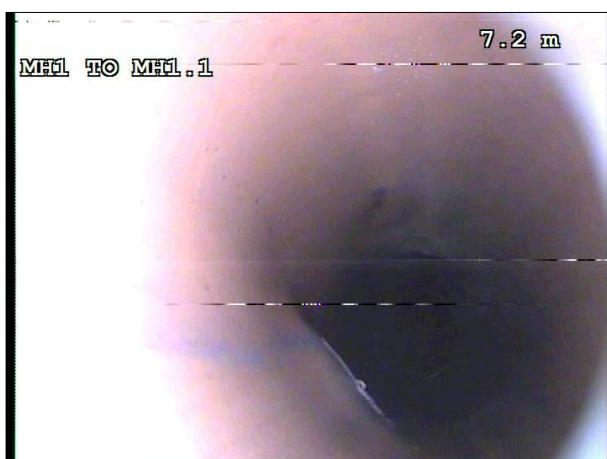
Photo: 57\_6a, 00:00:00  
7.4m, Sewer Deformed, 10 %, Remark: Stone Impact, from 06 to 08 o'clock

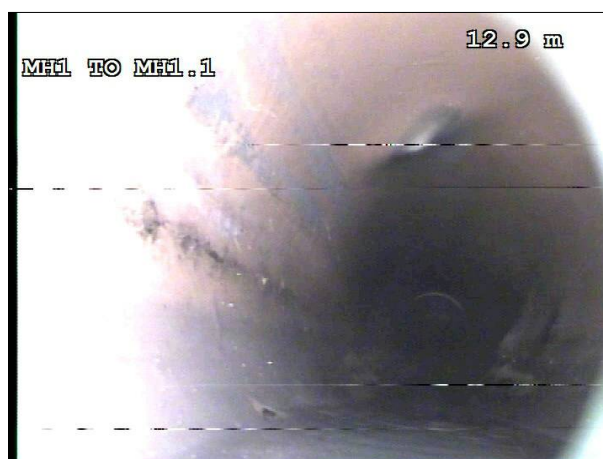
Photo: 58\_7a, 00:00:00  
13.2m, Sewer Deformed, 10 %, Remark: Stone Impact, from 11 to 01 o'clock

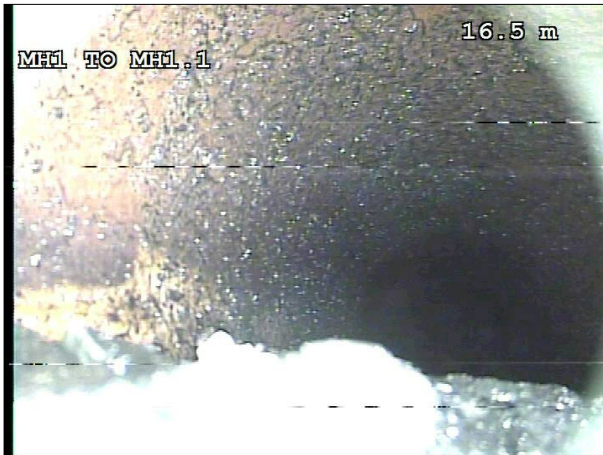
Photo: 59\_8a, 00:00:00  
16.5m, Debris, 20 % cross-sectional area loss

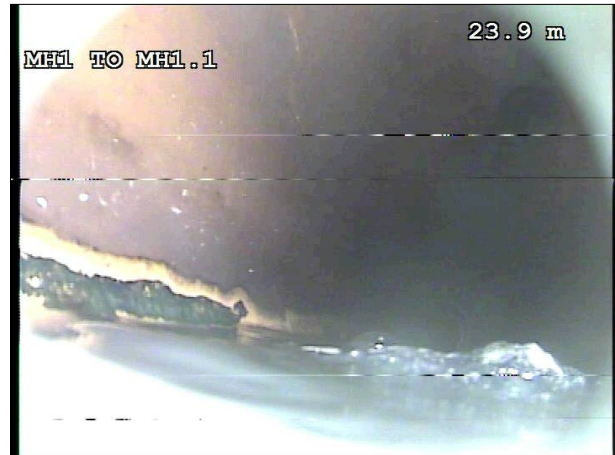
Photo: 60\_9a, 00:00:00  
23.9m, Water level, 20 % height/diameter
