## Pandy Farm, Merthyr Tydfil

### Bat Report

Report Ref: 1703 / 02e

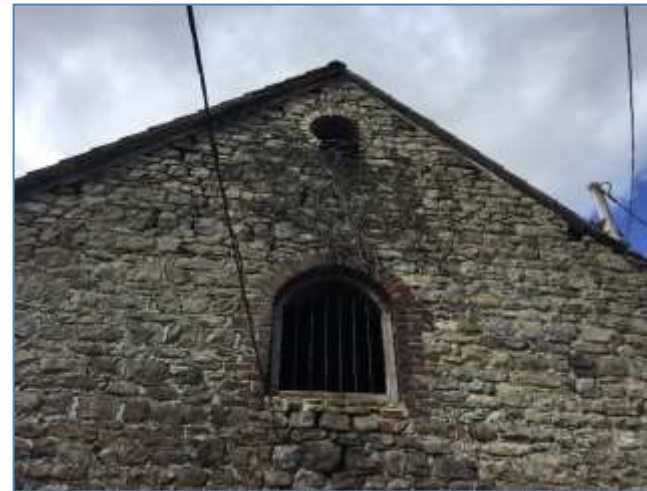
Photograph 4. Building B, eastern section. The eastern elevation with gappy verges.

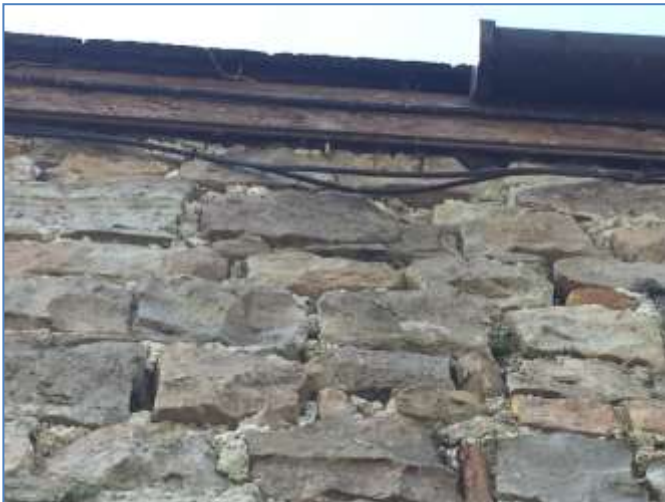
Photograph 7. Building B, eastern section. Gaps beneath fascia boards on the northern elevation.

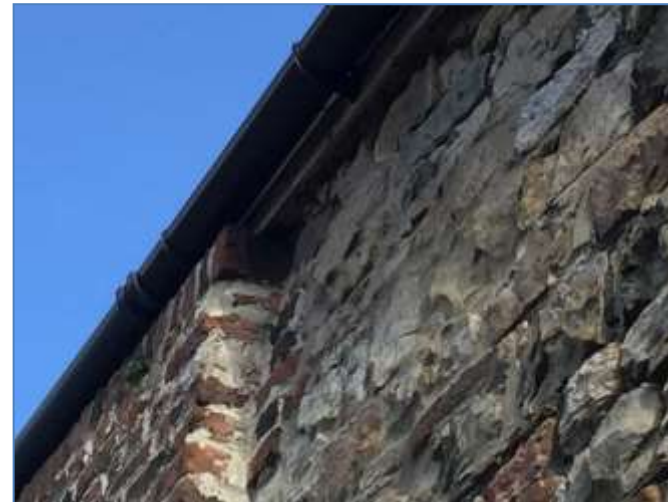
Photograph 8. Building B, eastern section. Further gaps beneath fascia boards.

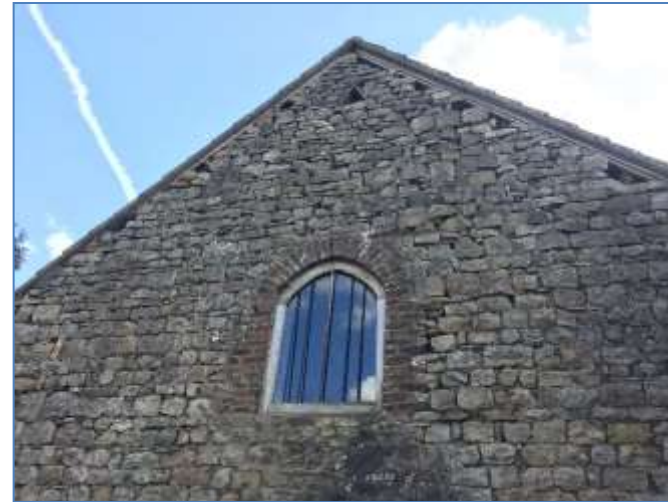
Photograph 10. Building B, western section. Gappy verges on the western elevation.

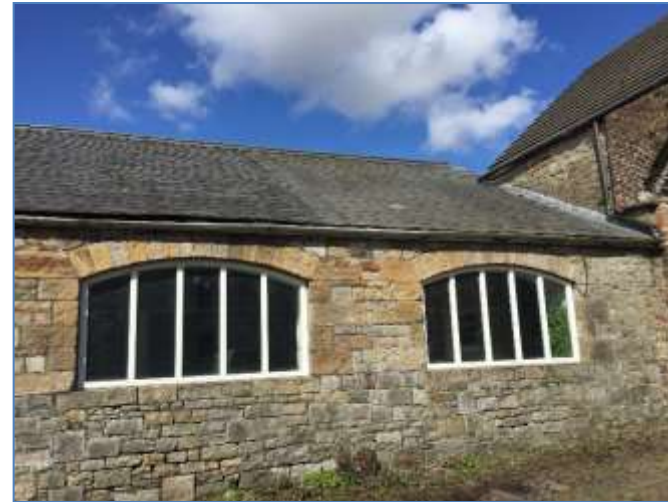
Photograph 14. Building C, northern half of the eastern elevation, with missing ridge tiles and bowing of roof visible.

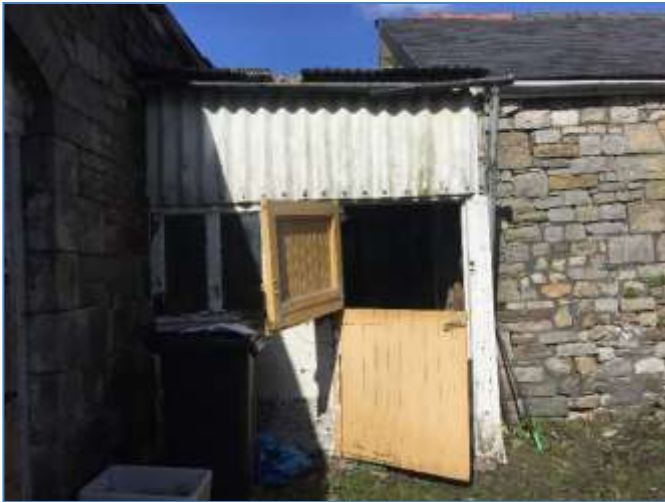
Photograph 17. Building D. The damaged storeroom entrance on the eastern elevation.

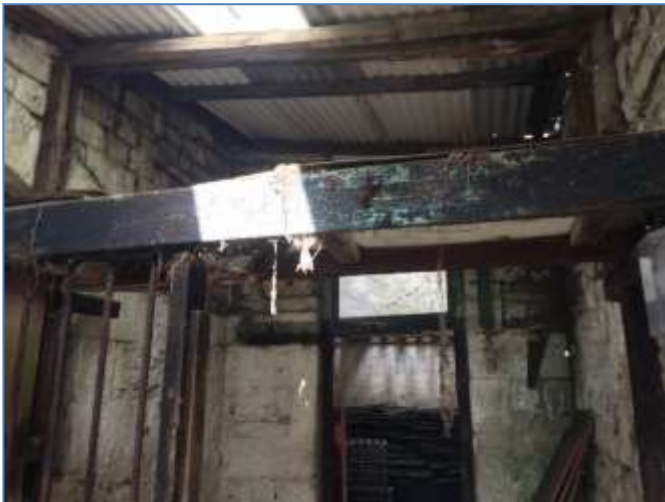
- 3.8 Building D forms the south western corner of the main courtyard. It comprises a northern section that is in a very poor state of repair and a workshop in the southern section.
- 3.9 The entire section is single storey, although the workshop forms the main part and is in considerably better condition. The northern part comprises two small store rooms of rough stone construction that are in poor condition. There are notable deep crevices within the walls, which are very damp. The roof comprises corrugated metal and fibreboard and is significantly damaged, with some sections missing entirely.

Photograph 19. Building D. The store rooms in a very poor state of repair.

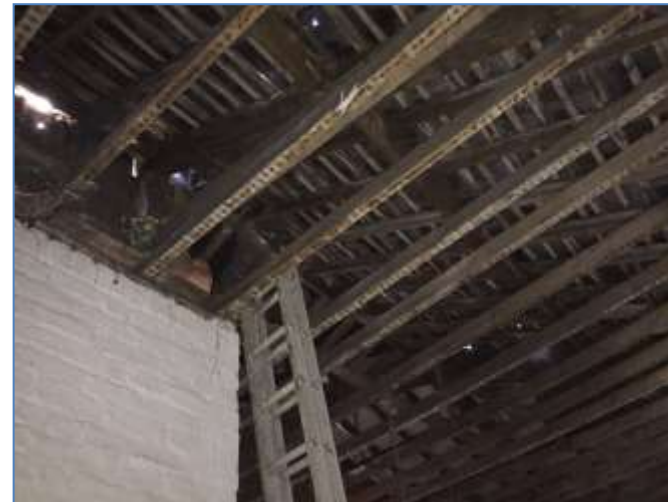
- 3.12 Internally, the workshop is open to the roof, which has a collar beam construction, and is cluttered near the apex. There is bitumen felt present in part and this is in very poor condition, being absent in places and badly torn. The timber double doors on the western elevation are not tightly fitted, and small gaps are present around them.

Photograph 20. Building D. The roof structure of the workshop, which has some sections of bitumen felt.

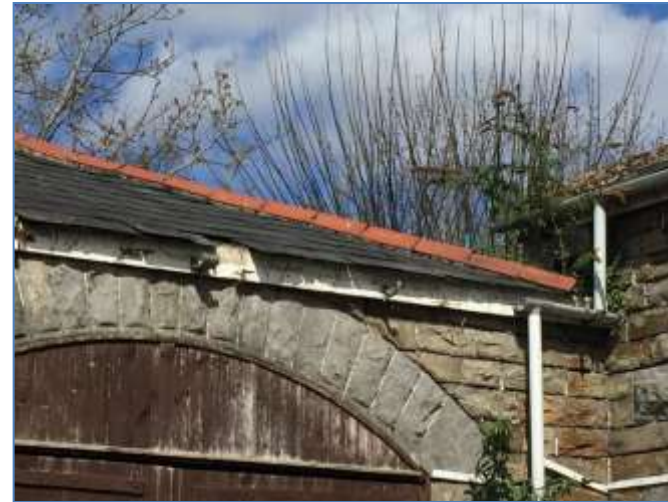
- 3.18 The roof slates are in poor condition with several raised and missing slates, particularly on the bottom course.
- 3.19 The timber fascias are all present, but choked with vegetation beneath. It is possible that gaps are present into the roof void amongst the vegetation.

Photograph 22. Building E. Missing tiles from the lower courses.

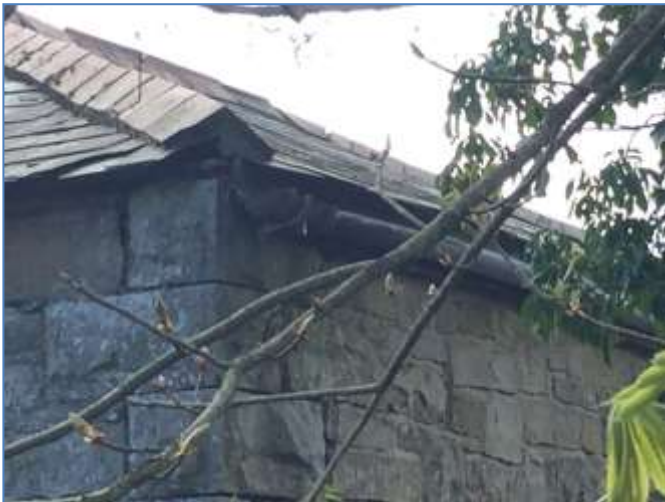
- 3.17 The pitched roof is hipped and almost square with nearly equal sized roofs on all aspects. The main north-south ridge is clad with clay tiles, one of which has been replaced with a concrete tile. The majority of tiles, whilst being uneven to appear to be sealed with concrete, as do the hips on the eastern elevation. The hips on the western elevation were only partly visible and appear to be uneven. There is missing mortar beneath the bottom tile on the north western hip.

Photograph 23. Building E. The Missing mortar from the hip.

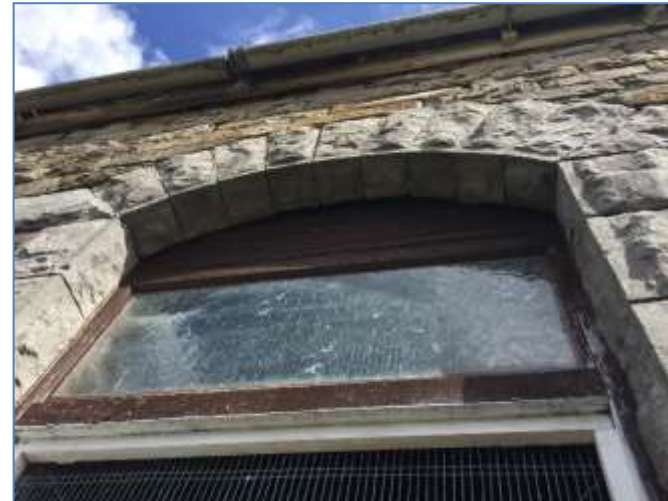
- 3.25 The southern elevation is of cut stone construction, which is in excellent condition. Similar to Building E, there are cut stone arches around all doors and windows, which are well fitted in the main. A gap is present between one of the stone window arches and timber cladding above the window. The eastern and western elevations are both of rough stone construction and in moderate condition. There are no visible gaps on the eastern elevation but large gaps at the wall tops on the west. A single window is present on both elevations, with the one on the west being gappy. The northern wall is the joining wall with Building H.

Photograph 28. Building F. Gaps present below window arches.

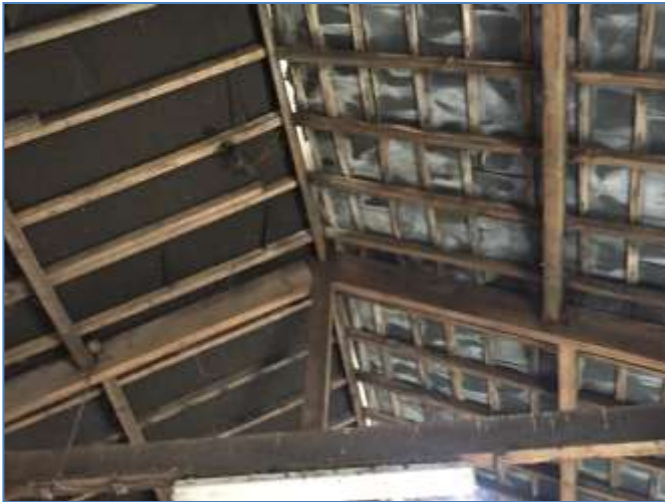
Photograph 29. Building F. The unlined slate tiles on the southern pitch and bitumen felt on the north.

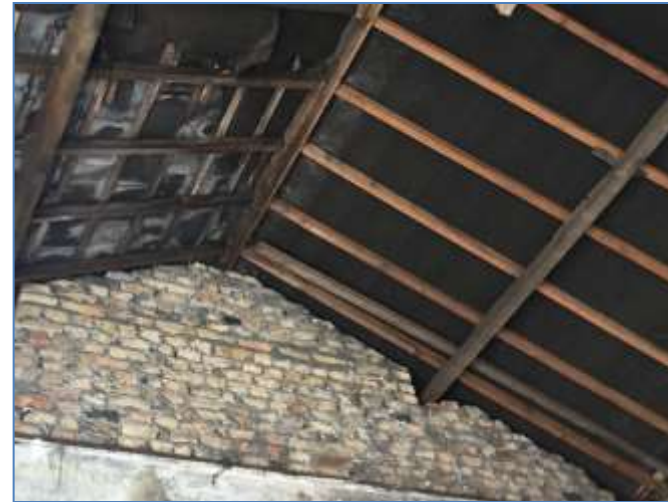
Photograph 30. Building F. Gappy internal wall tops allowing access between sections.

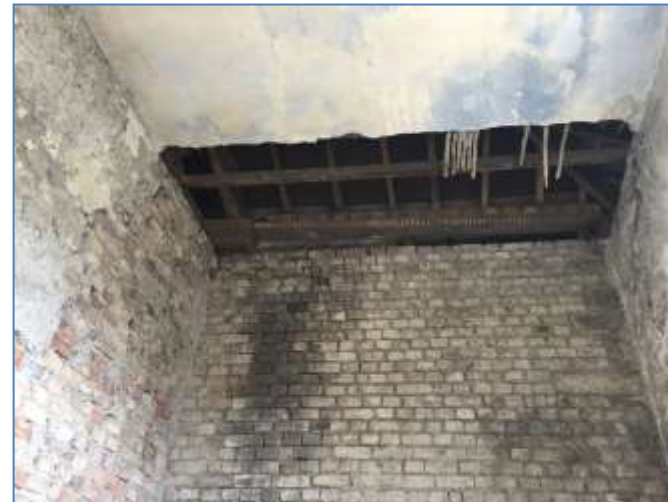
Photograph 32. Building F. A damaged ceiling showing loft space on the eastern end.

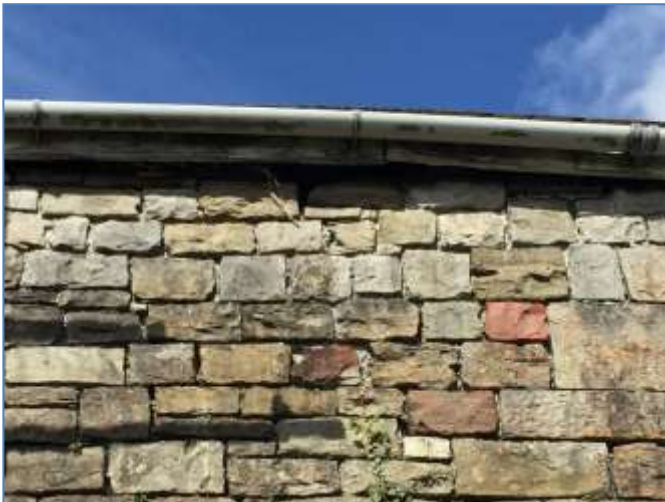
- 3.32 The roof is clad with small concrete tiles, with a concrete ridge and appears to be in good condition. There are timber fascias on the eastern and western elevations, with large gaps present beneath all.

Photograph 35. Building G. Significant gaps beneath fascias on the eastern elevation.

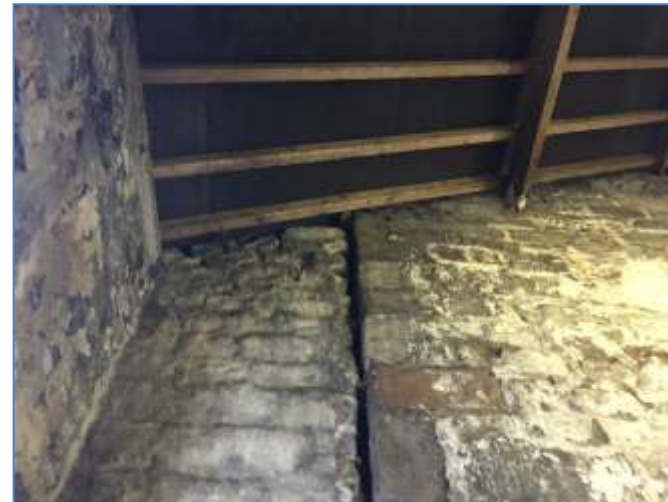
- 5.2 There was no increase in the number bat droppings recorded in Building G, first noted in April 2022, by October 2022. The DNA analysis confirmed the droppings as brown long-eared bat. The small number does not reflect a significant roost and is likely to be a single brown long-eared bat on a couple of occasions. It is clear that the roost is not used regularly and therefore the individual is not reliant on the internal space.

Photograph 36. Building G. A large internal crevice and the bitumen felt in good condition in close proximity to where bat droppings were recorded.

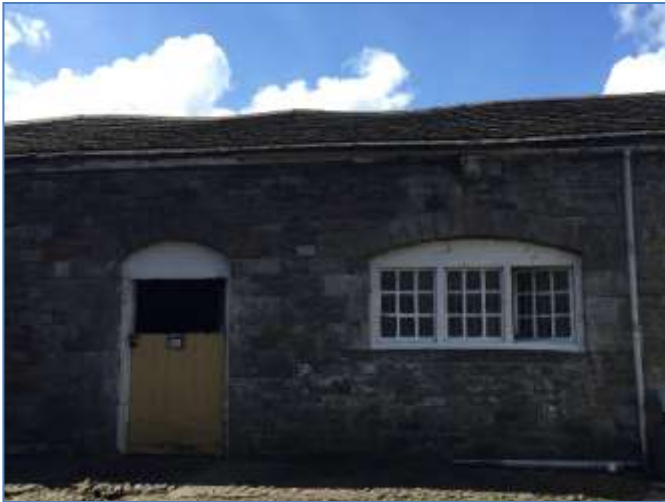
- 3.39 The simple pitched roof is clad with small concrete tiles on the northern pitch. This is in poor condition and numerous tiles have slipped on the bottom courses. The southern pitch is corrugated fibreboard with corrugated plastic light panels. This is intact and, together with the ground floor windows on the north, renders the internal space very light. It is not possible to view the exterior of the southern pitch nor the valley where the roof joins Building F.

Photograph 37. Building H. The northern elevation showing bowing of the roof and an open stable door.

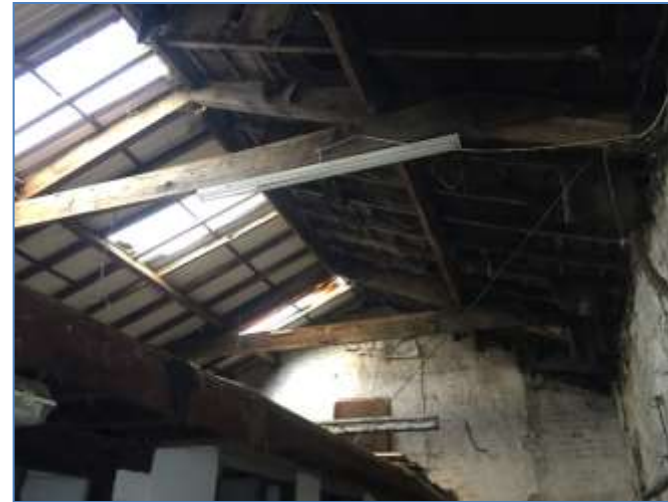
- 3.41 The roof is a simple collar beam construction, very similar to Building C. There is bitumen felt beneath which is in very poor condition, shredded, with large sections hanging.

Photograph 38. Building H. The internal space showing northern pitch of roof in very poor condition.

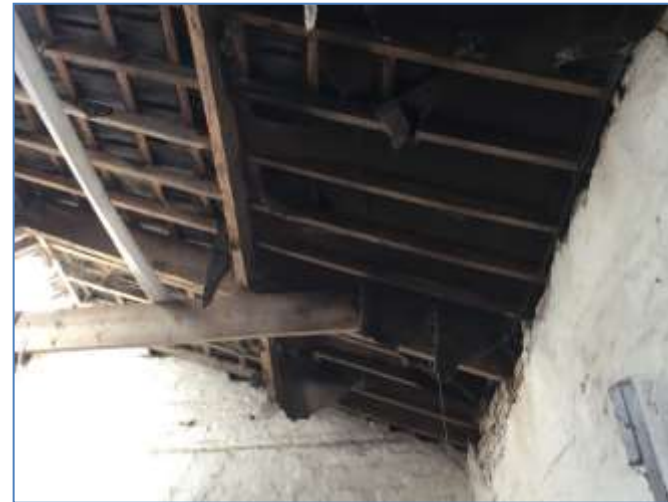
Photograph 40. Building H. Gappy brickwork visible at the wall tops.
