*Report No. BC/MB/03.17.02.*

# **Mining Risk Assessment: Land at Gelligaer Road, Trelewis**

**Ms J Creese**

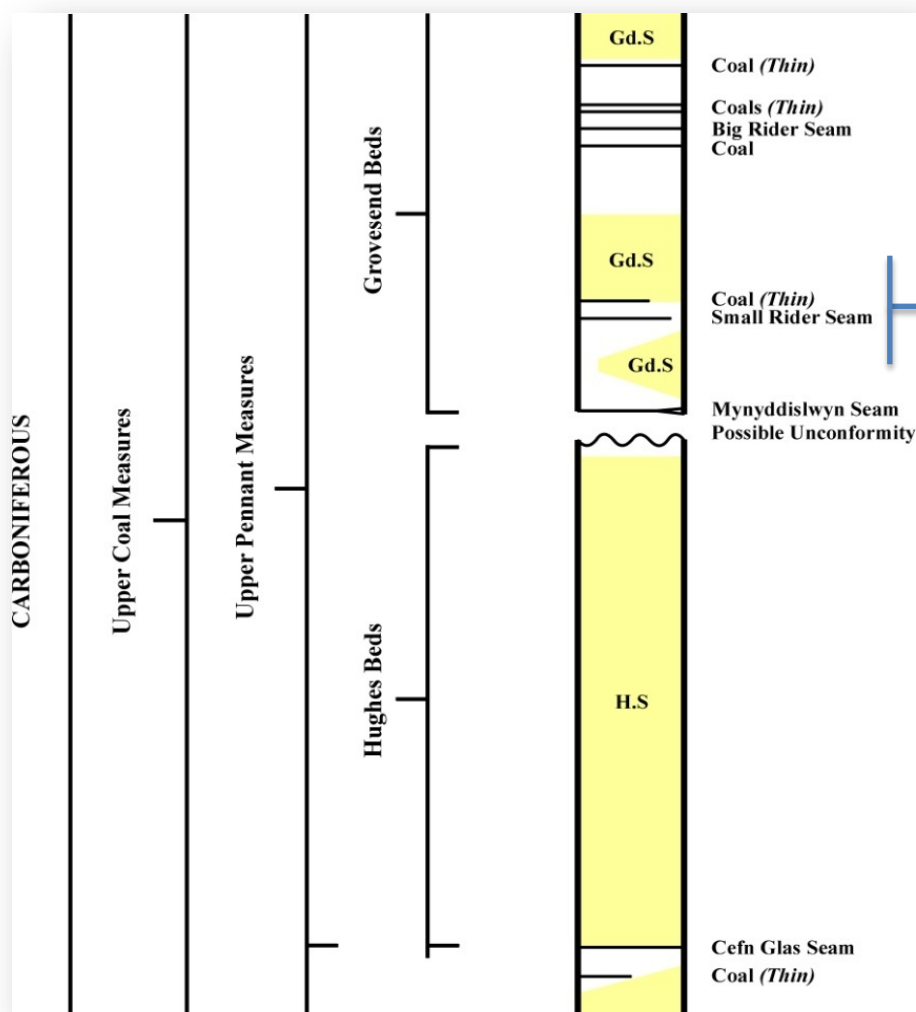
**Figure 2**  
**Indicative Stratigraphic Column.**  
**Scale: Not to Scale.**

position of the outcrop of the Mynyddislwyn Seam to be present approximately 900m north-west of the Site (see *Geology Plan, drawing no. BC/MB/03.17.02.02*); the Mynyddislwyn Seam marks the division between the Grovesend Beds and the underlying Hughes Beds. The inferred outcrop follows a V-shaped trace where it crosses the floor of the valley between two large faults. Trelewis lies near the axis of a large synclinal fold (U-shaped) where the strata dips are very shallow and towards the south-east, resulting in the position where the Mynyddislwyn Seam underlies the Site at relatively shallow depths. Other than the Mynyddislwyn Seam, there is no other coal seam underlying the Site at shallow depths that could have supported underground mining operations.

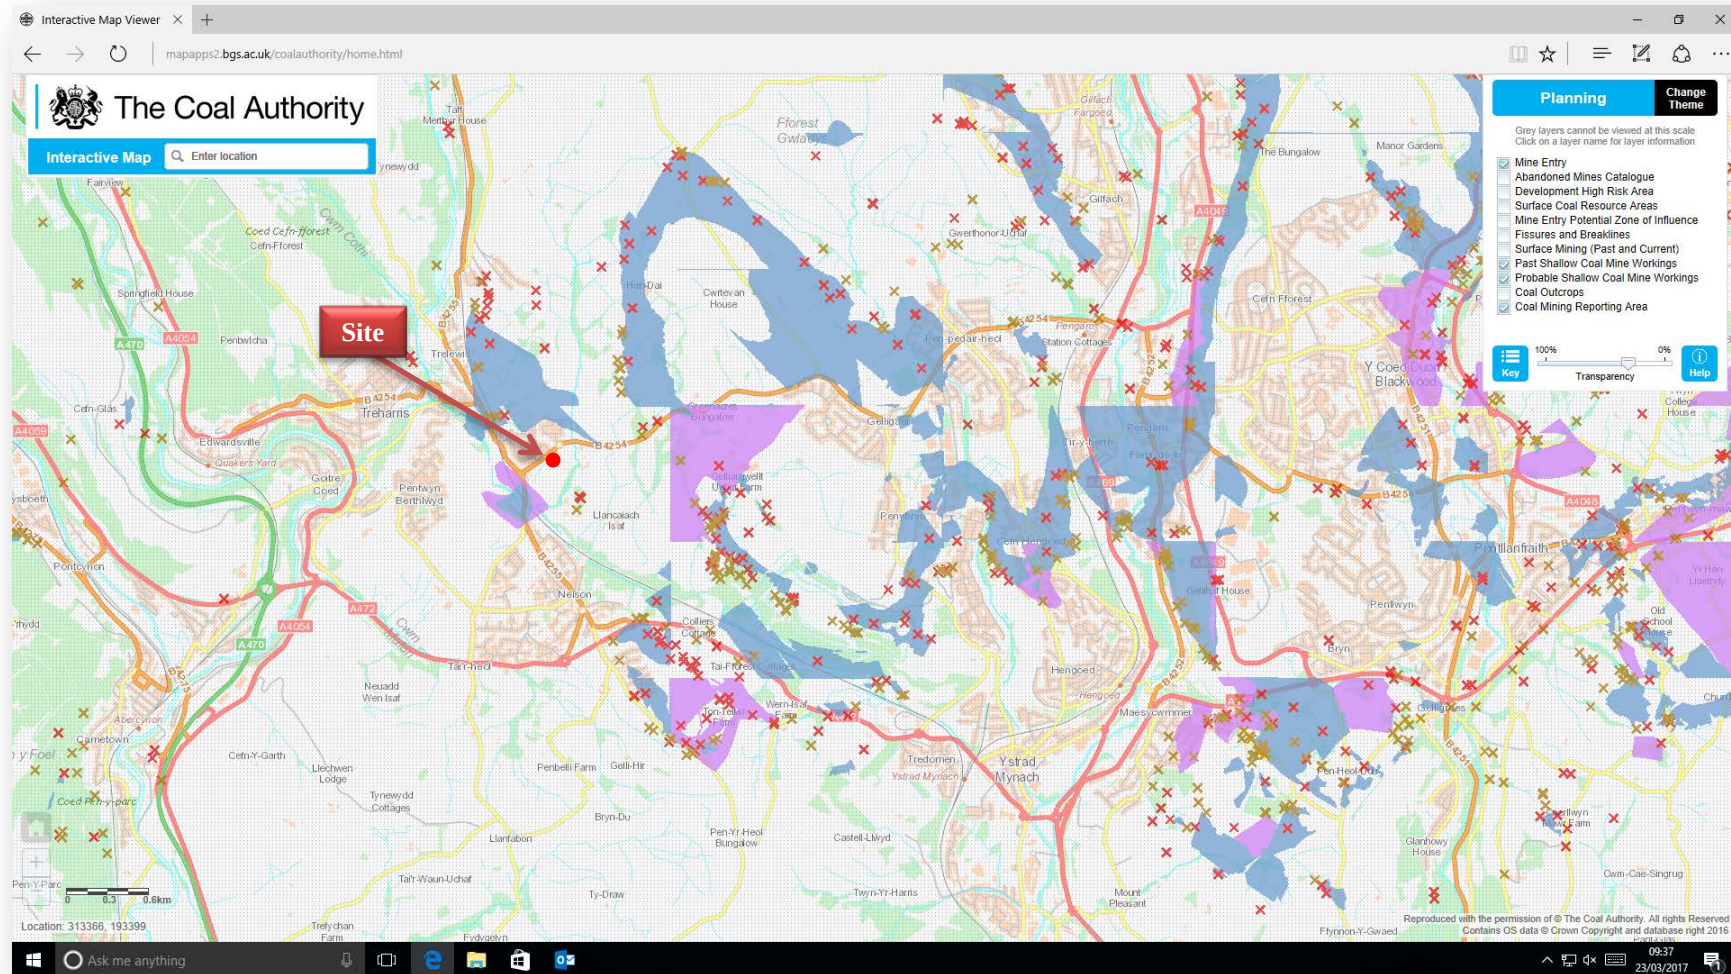
**Figure 3**  
**The Coal Authority's Interactive Map.**  
 Accessed 23<sup>rd</sup> March 2017

The general area has experienced extensive underground operations for coal dating back at least to the very early part of the twentieth century. The workings were prosecuted from a number of adits driven into the valley sides at or near the outcrops of coal seams or ironstone veins, or else from shafts sunk near the valley floor. Several coal seams have been extensively mined beneath the Site, the last in 1991; many of the old workings are of an age and/or are at depths that will have no impact upon the structural integrity of the proposed dwelling(s). The shallowest lying coal seam worked beneath the area of the Site is the Mynyddislwyn Seam, which is approximately 1.5m thick, and which is at relatively shallow depths beneath the Site. The Seam was worked from the Llancaiach Colliery, which ceased working in the early 1990s. The workings from the Colliery extend beneath the Site (see Figure 3 and *Geology Plan, drawing no. BC/MB/03.17.02.02*).

The mine plan for the Llancaiach Colliery identifies that the northern shaft is 65 yards deep, 59m (see *Extract From Abandonment Plan of Llancaiach Colliery: Mynyddislwyn Seam, drawing no. BC/MB/03.17.02.04*). The Site is approximately 650m north of the shafts. The main drivages that extended northwards from the shafts towards the Site were, amongst other things, drainage roadways and would have been driven to rise at water-ease, 1 inch in the yard. The workings beneath the Site are calculated to be at a depth of approximately 41m. The Coal Authority's interactive map identified that there are no recorded shallow mine workings beneath the Site (blue shading) and no potential shallow mine workings (shaded purple).

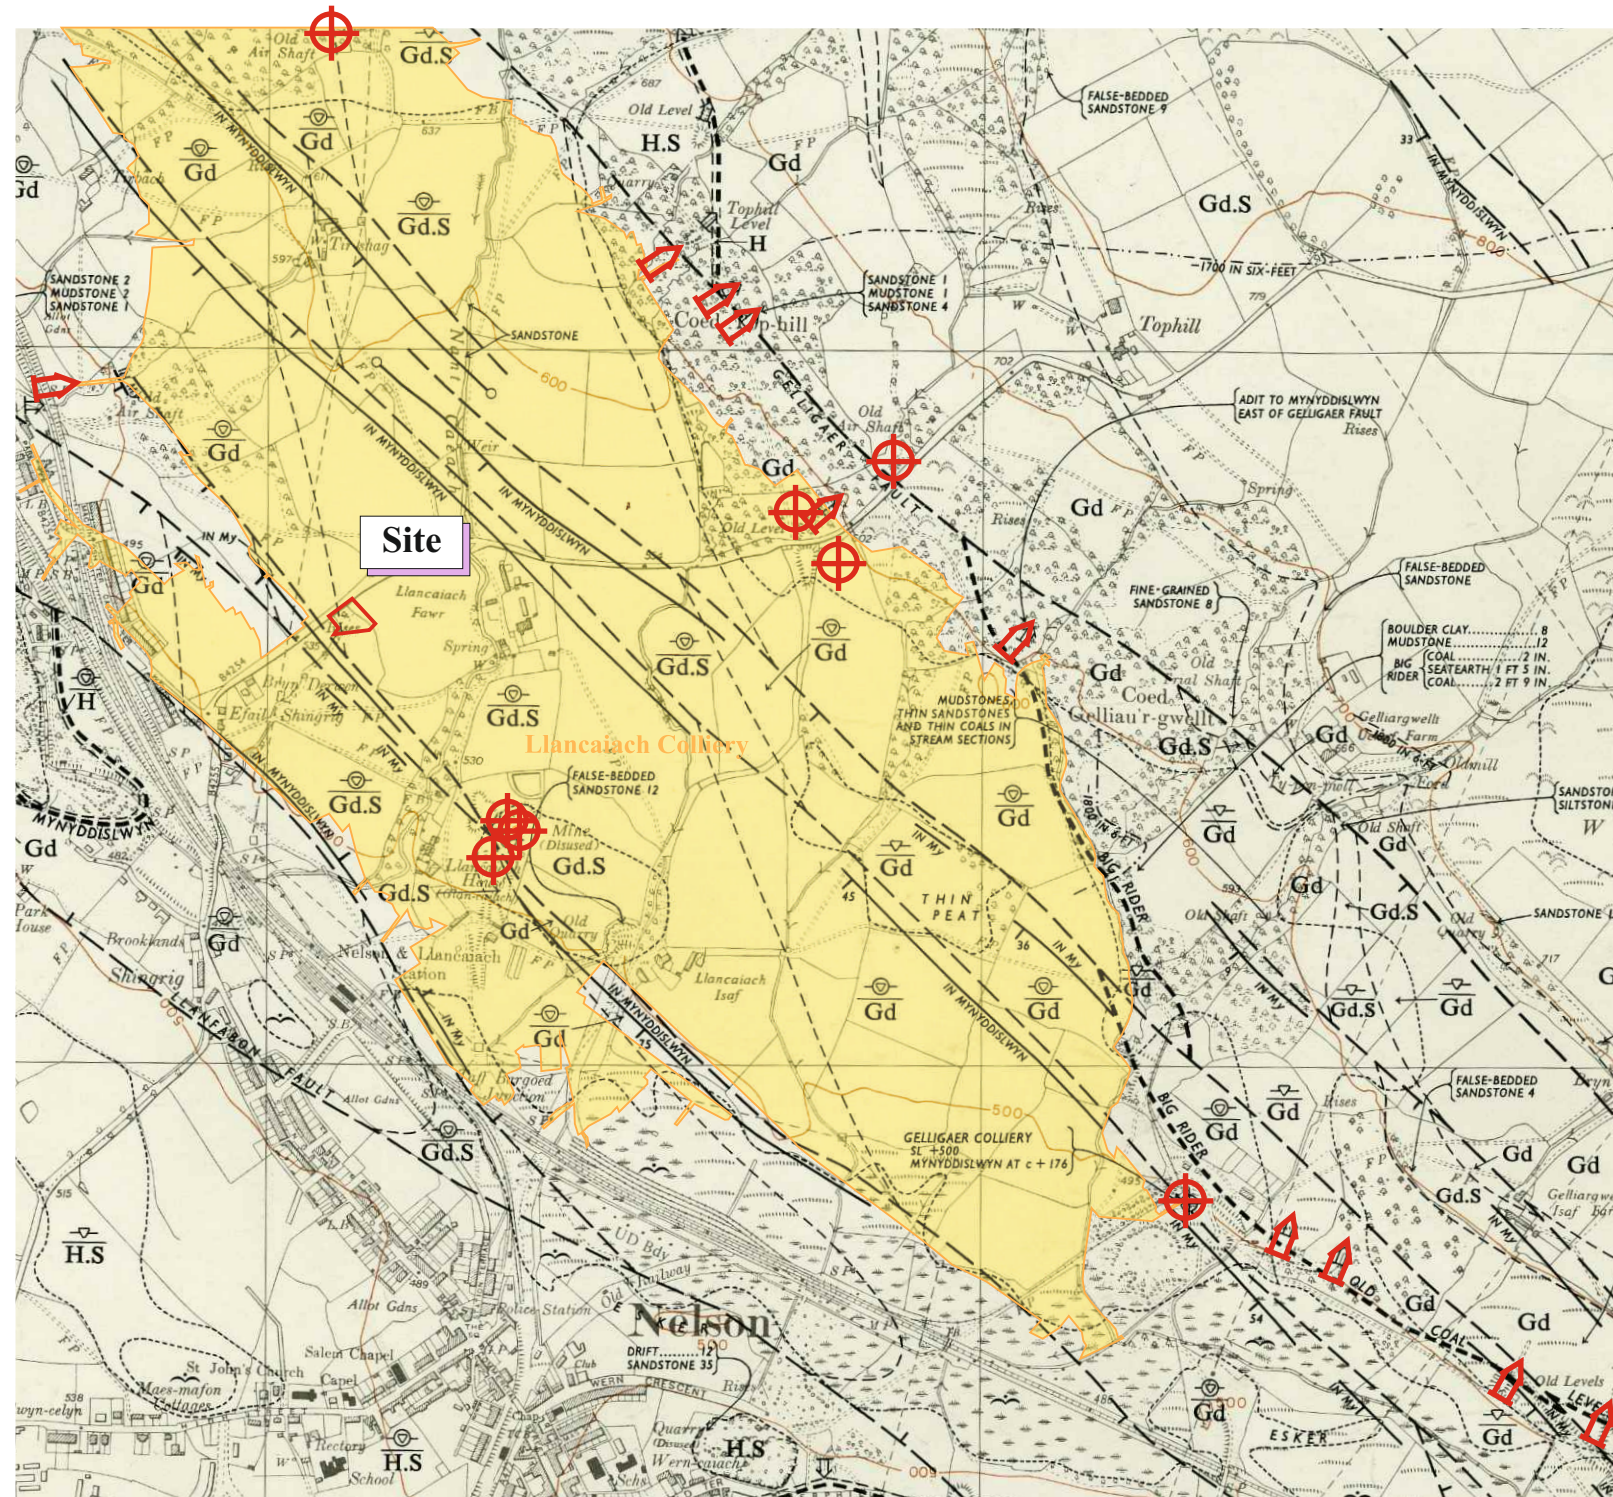
**Drawing No: BC/MB/03.17.02.02.**

The coal measures of the South Wales Coalfield have been affected by large normal faults, frequently referred to as ‘cross faults’. In the Trelewis area these faults have a sinuous trace at the surface and an average trend towards the north-west. Published geological information indicates that the Site lies within the Llanfabon Trough, a down-faulted block between the Llanfabon Fault to the south-west and the Gelligaer Fault to the north-east. Both faults are complex and comprised of a series of splay faults that make up each of the two faults. There are further fairly large faults in the Llancaiach Trough between the two main faults. The nearest fault to the Site is one such fault, which is shown to be present immediately to the west of the Site. The fault plane dips south-westwards, away from the Site.

To ensure that the fault is to the west of the Site and does not pass through it, it is recommended that a series of exploratory boreholes are drilled on the Site.

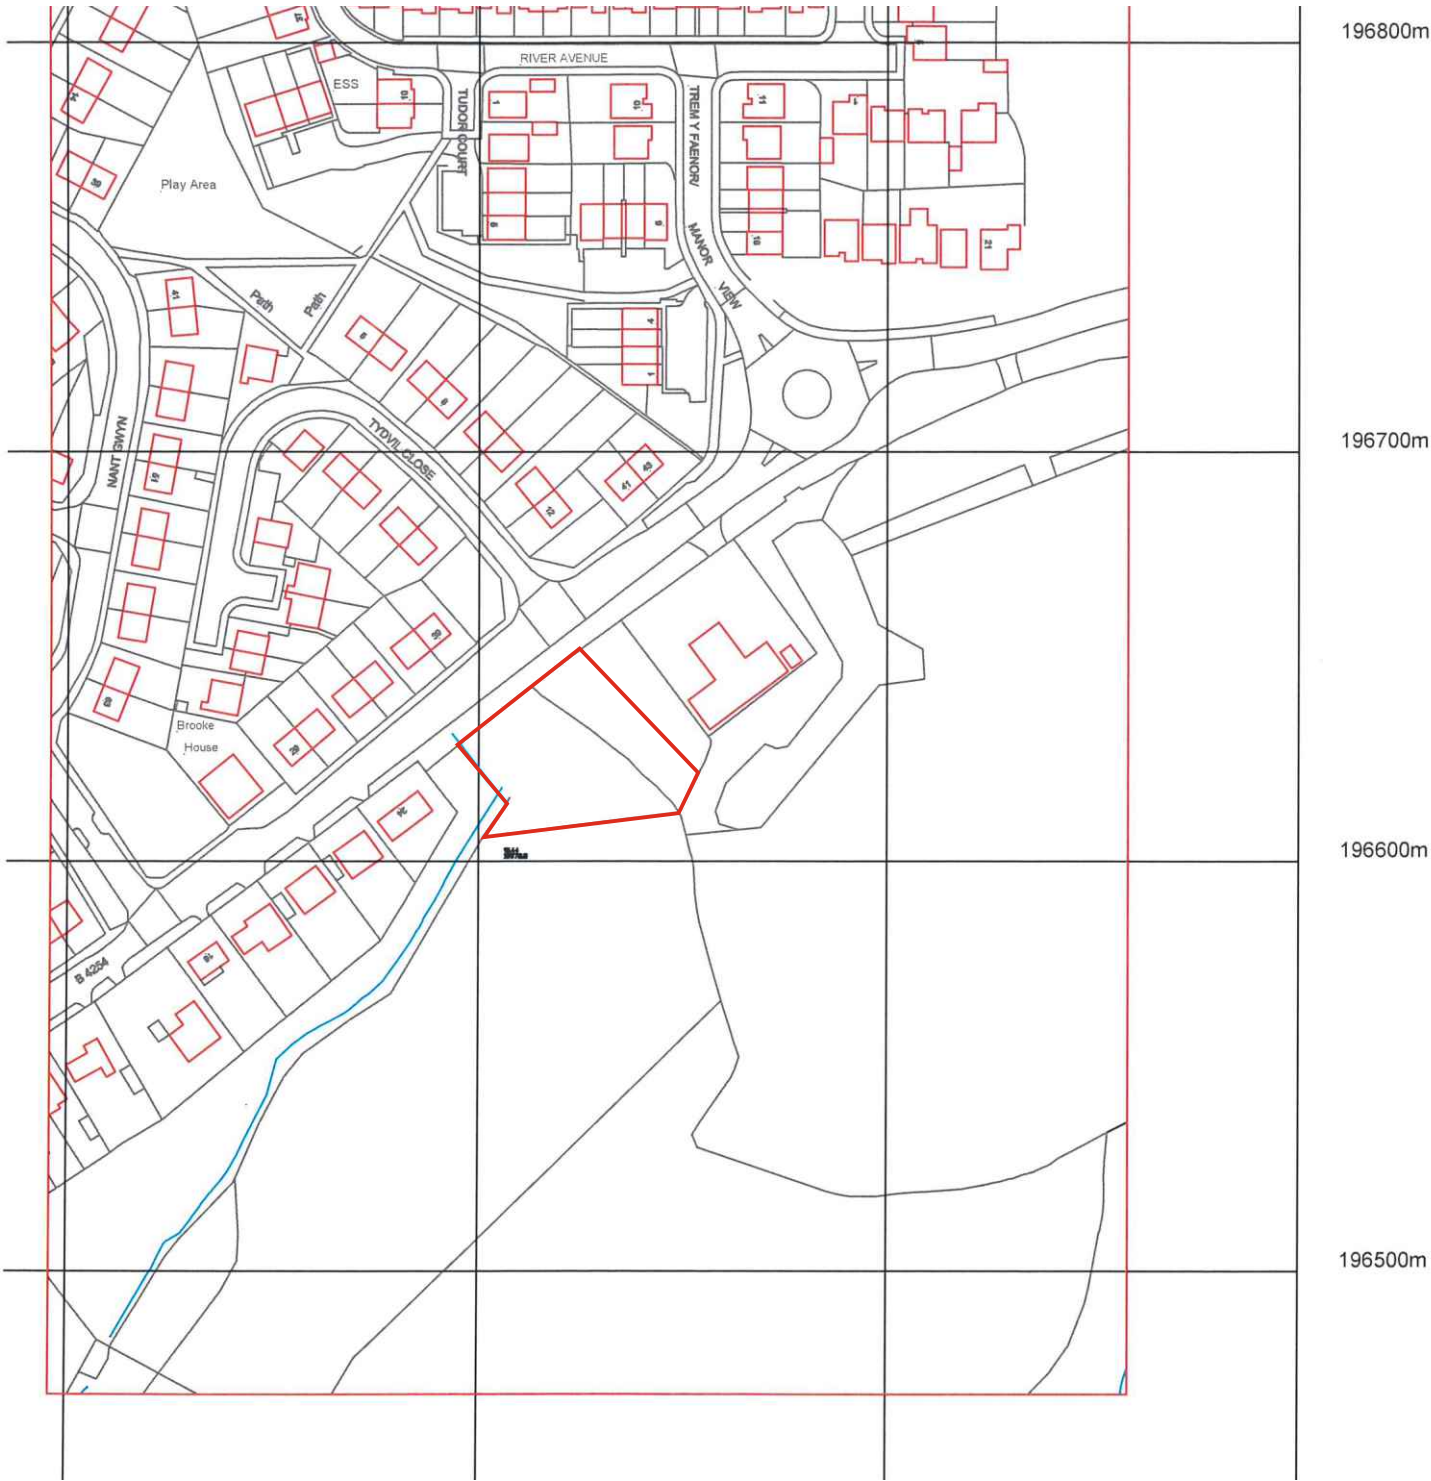
*Extract From Abandonment  
Plan of Llancaiach Colliery:  
Mynyddislwyn Seam.*

affect the structural integrity of the proposed dwelling(s). The Mynyddislwyn Seam has been extensively mined in the locality and the old workings are at an estimated depth of 41m beneath the Site, which is too deep to pose a risk of surface subsidence. The exploratory boreholes recommended to examine the position with regards to faulting should also be used to examine the position with regards to the Mynyddislwyn Seam.

A limited programme of exploratory boreholes is recommended in order to establish the position with regard to the large fault and to confirm the position with regard to old workings in the Mynyddislwyn Seam. The boreholes should be monitored for mine gases.
