**Land At Winch Fawr Road**

**Coal Mining Risk Assessment**

December 2020

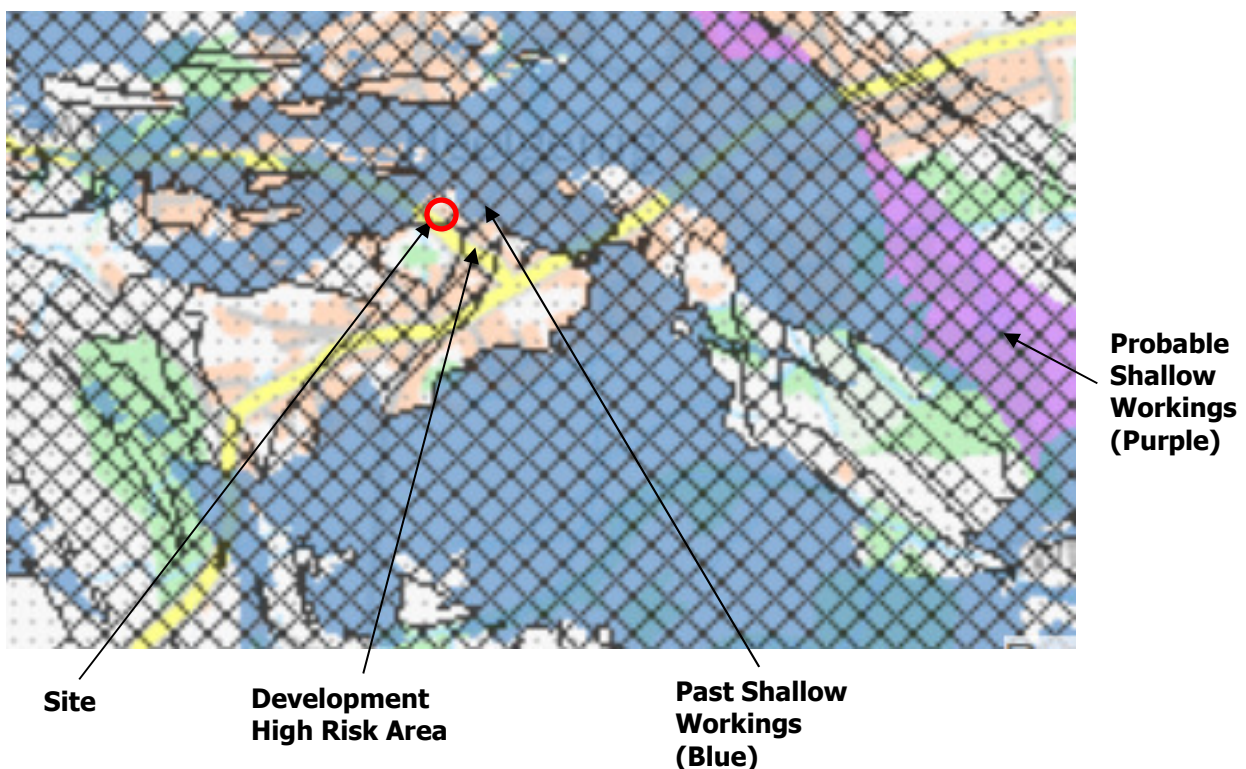
**Plate 1: CA interactive online mapping – development high risk area**

- The site falls within a 'Development High Risk Area', (See Plate 1 below).
- The property outside an area of past shallow coal mining workings.
- The property outside an area of probable shallow coal mining workings

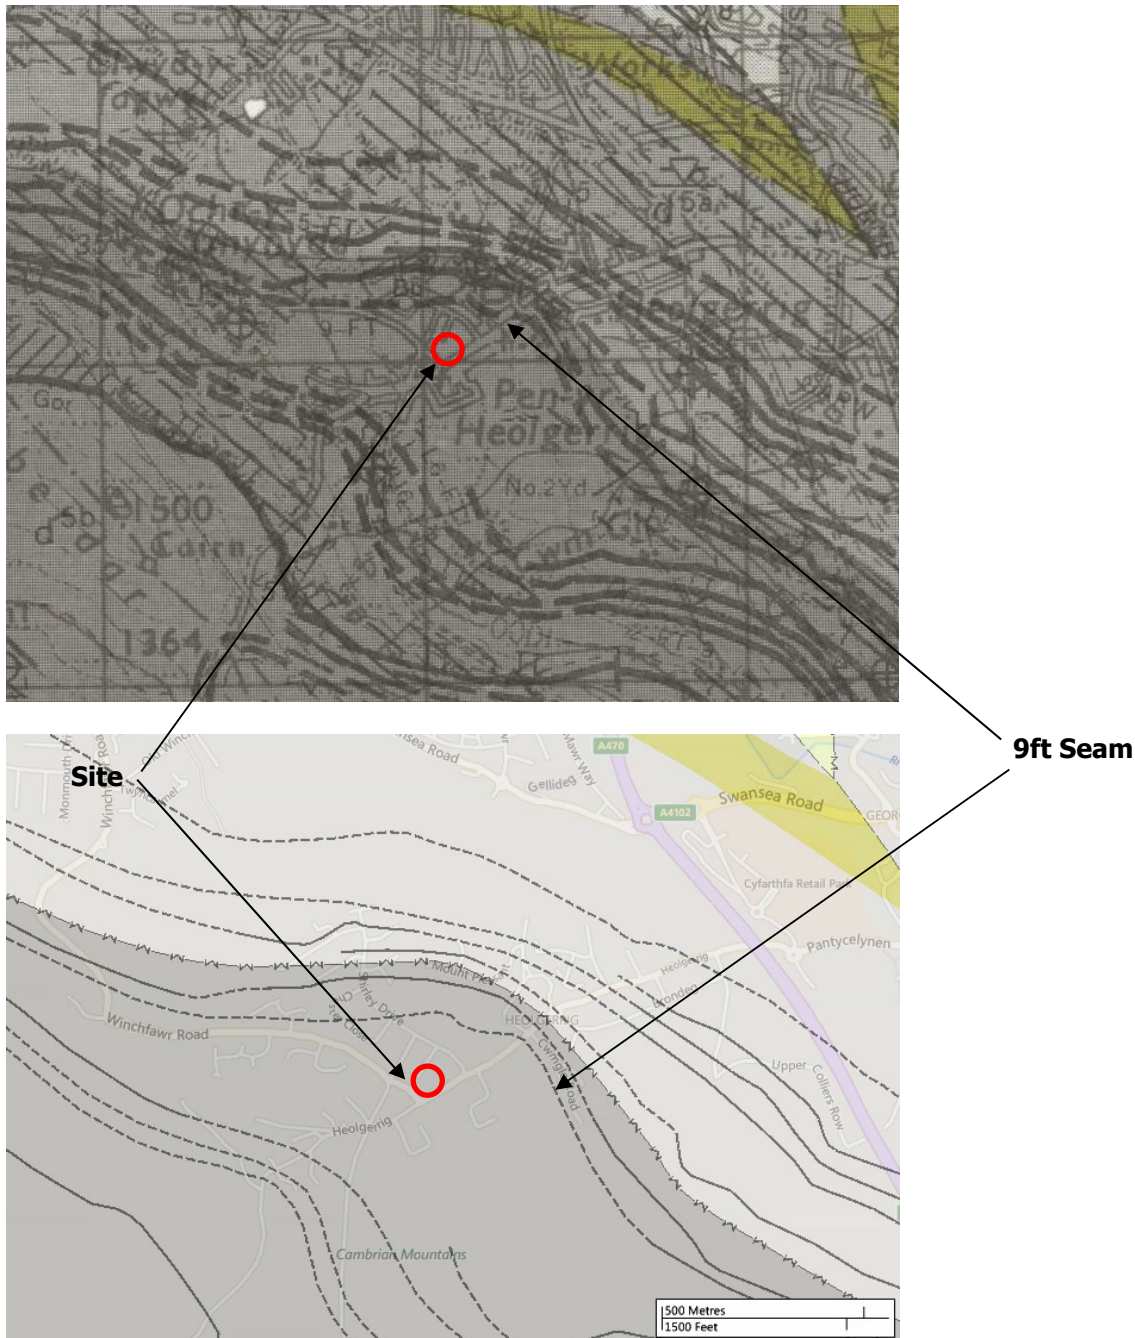
**Plates 2 & 3: BGS online mapping**

These show the site to be underlain by Glacial Till superficial deposits and solid geology of the South Wales Middle Coal Measures. A coal seam, the Nine Foot, is conjectured to outcrop 165m north of the site, dipping approx. 8 degrees in a generally south to south easterly direction. The site sits approximately +10m aOD topographically from where the seam outcrops.

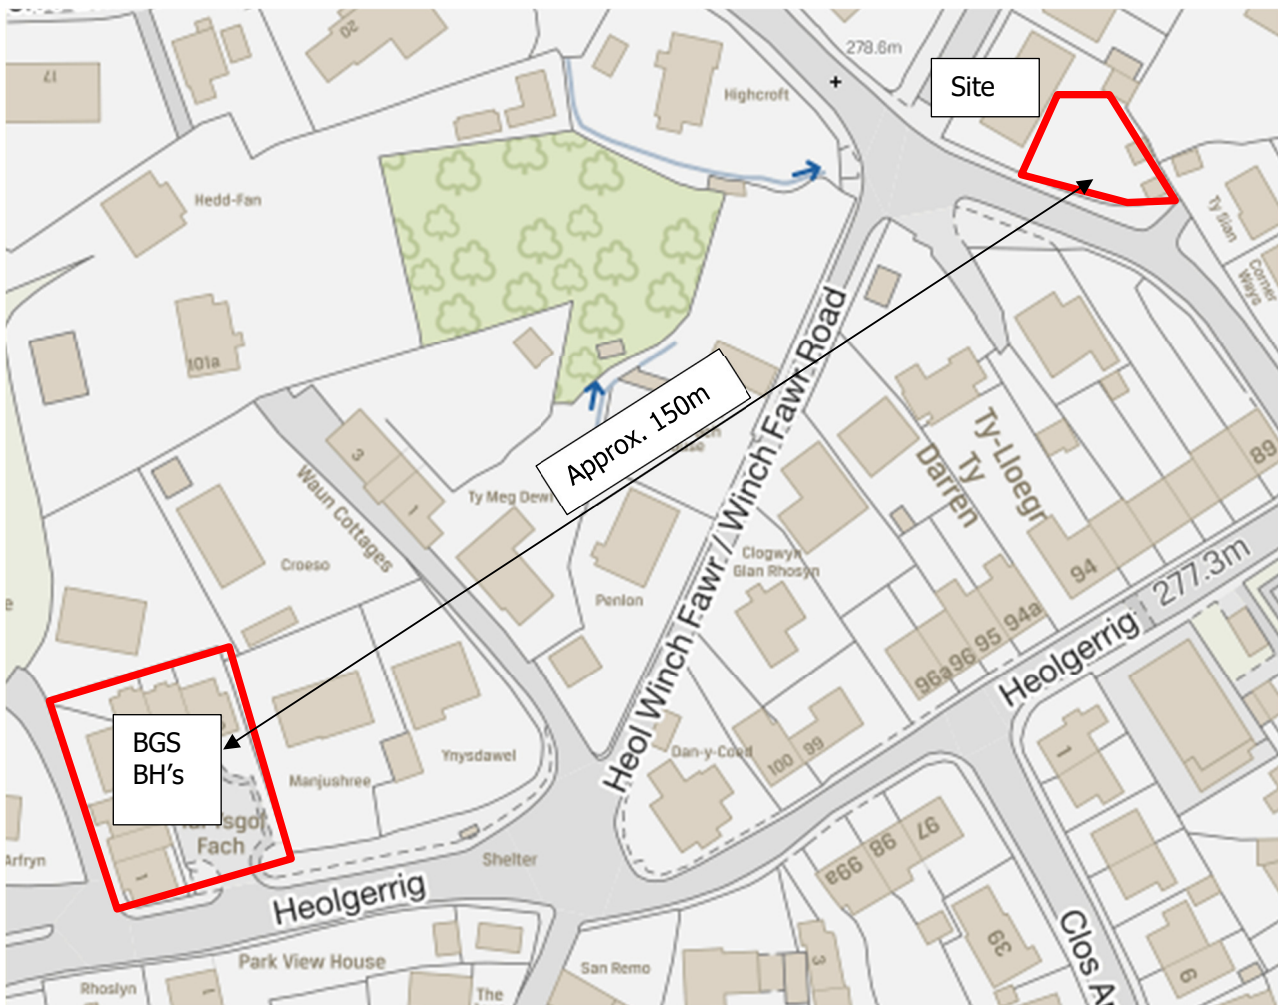
Two borehole records were obtained from the BGS Geoindex Online Mapping service, the two boreholes were located approximately 150m south west of the site and topographically 3m lower aOD (285m aOD). The findings of the two BH's were as follows:

- The Red Vein was encountered at depths between 13.20m (R3) and 18.60m (R2) and was 500mm thick in both boreholes and unworked.
