**Heritage Impact Statement.**

**Project & Site Address:** Proposed Remodelling of Chapel Hall at High Street Baptist Chapel, Lower High Street, Merthyr Tydfil.

## **Addendum Report on West Gable – Historic Merthyr Townscape Wall**

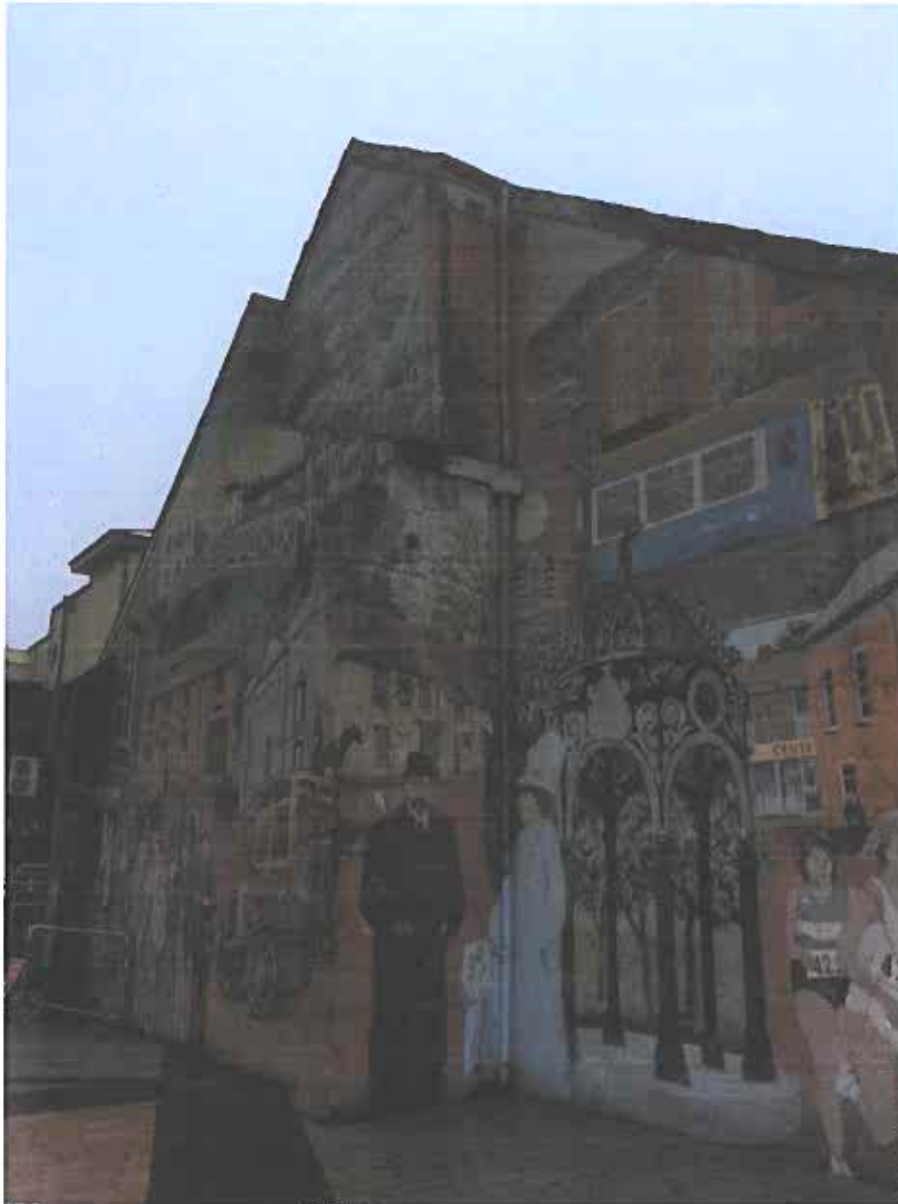
**Townscape Mural on West Gable Wall.**

The west gable wall is partly composed by the hall wall and an array of pierced gable end walls left in situ following the demolition of industrial terraced housing carried out during the local authority slum clearance programme in the 1950's and 60's.

The walls were left standing to negate insurance claims for the ingress of damp against the local authority from the owners of the building left standing. The wall was 'gable ended' by the construction of a rendered blockwork outer skin. This resulted in a dense block wall built in a strong sand & cement mortar being joined to aged masonry stone walls built in black lime mortar that had become friable having lost the cementitious qualities required to maintain the walls structural integrity and stop the ingress of moisture. The beds of black lime mortar which often deteriorate to beds of dust thus become pathways which readily track water through the wall into the building.

The wall has two piers and four roof planes capped in slate or tiles with poor inadequate lead abutment flashings, themselves the potential source of water entry at the roof to wall junctions. The walls are rendered in a strong sand and cement render which has become badly cracked, crazed, and hollow as it parts away from the weaker background surfaces of the stone, black mortar, and blockwork walls. The defects allow water to be tracked back into the hall showing as damp patches in the rear internal wall and wet staining the ends of the T&G floor boarding at the wall to floor junction.

These remnant walls of previously demolished houses did not and still do not present an aesthetically pleasing built form, and certainly detract from the setting of the listed building. To improve the malaise, the walls were painted (possibly by local school children) with the Merthyr Townscape Mural which has itself since become a part of the townscape of Merthyr.

The artwork is dirty and much faded and would within a short period of time require cleaning and repainting.

Due to the poor structural condition of the wall and the crazed render which provides the canvas for the mural - the mural needs to be repaired and or repainted and or be demolished rebuilt and repainted.

Unfortunately, the level of repair required to the render would obliterate a large portion of the mural which is badly faded and itself in need of renovation. The logical decision is thus to demolish, built a waterproof, insulated and aesthetically pleasing cavity wall and repaint the mural on the flat surface created.

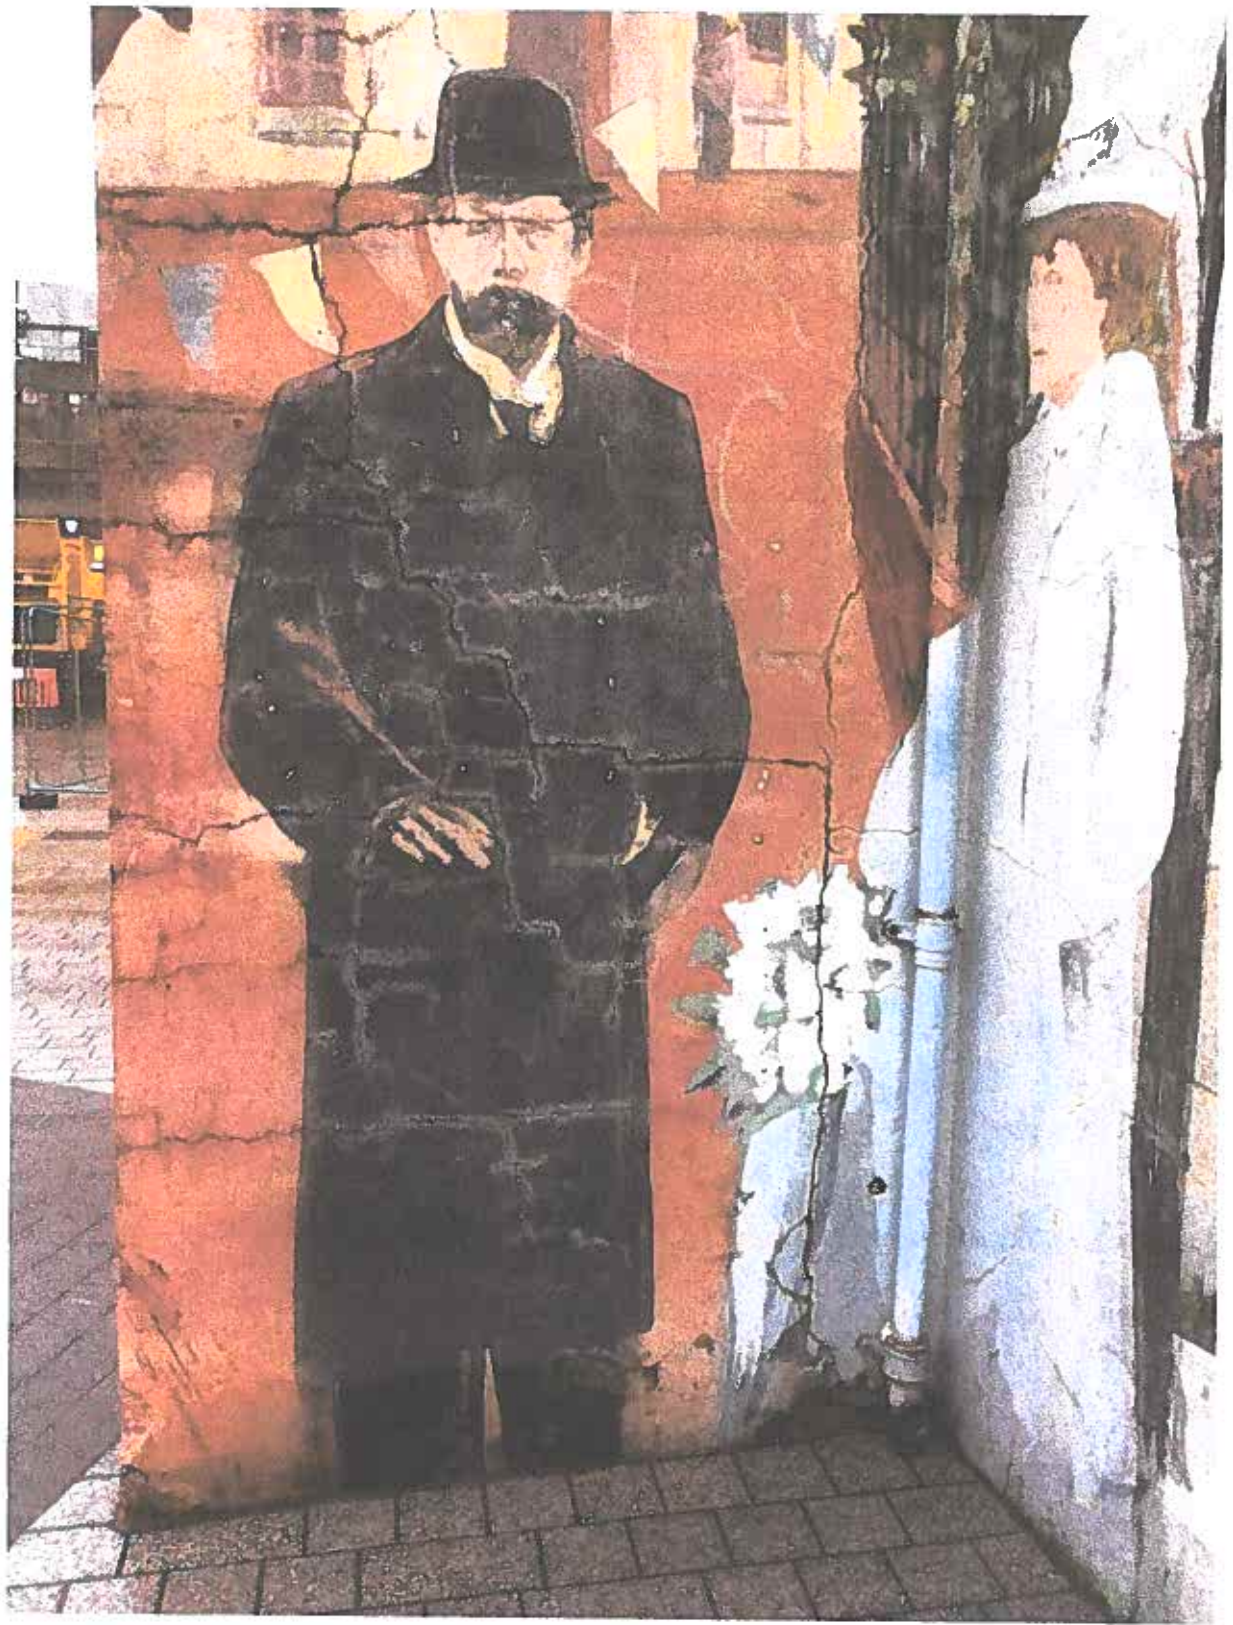
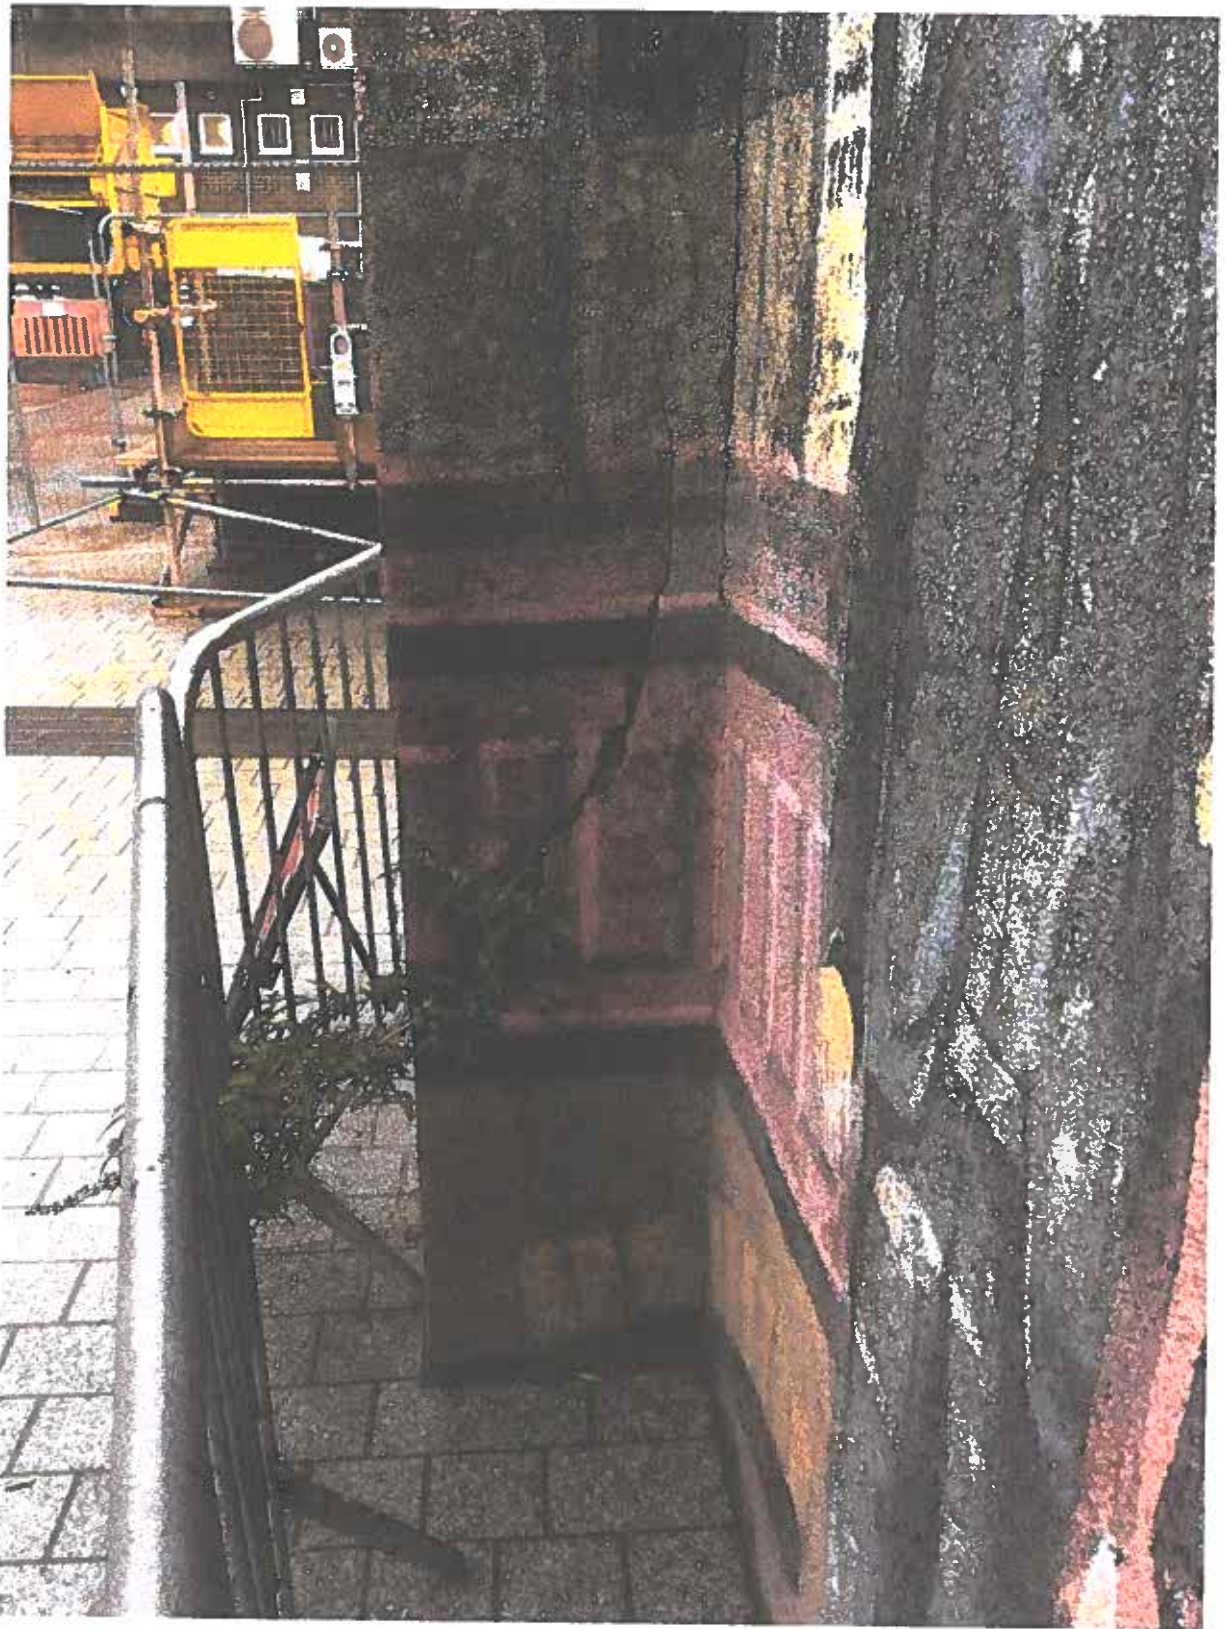
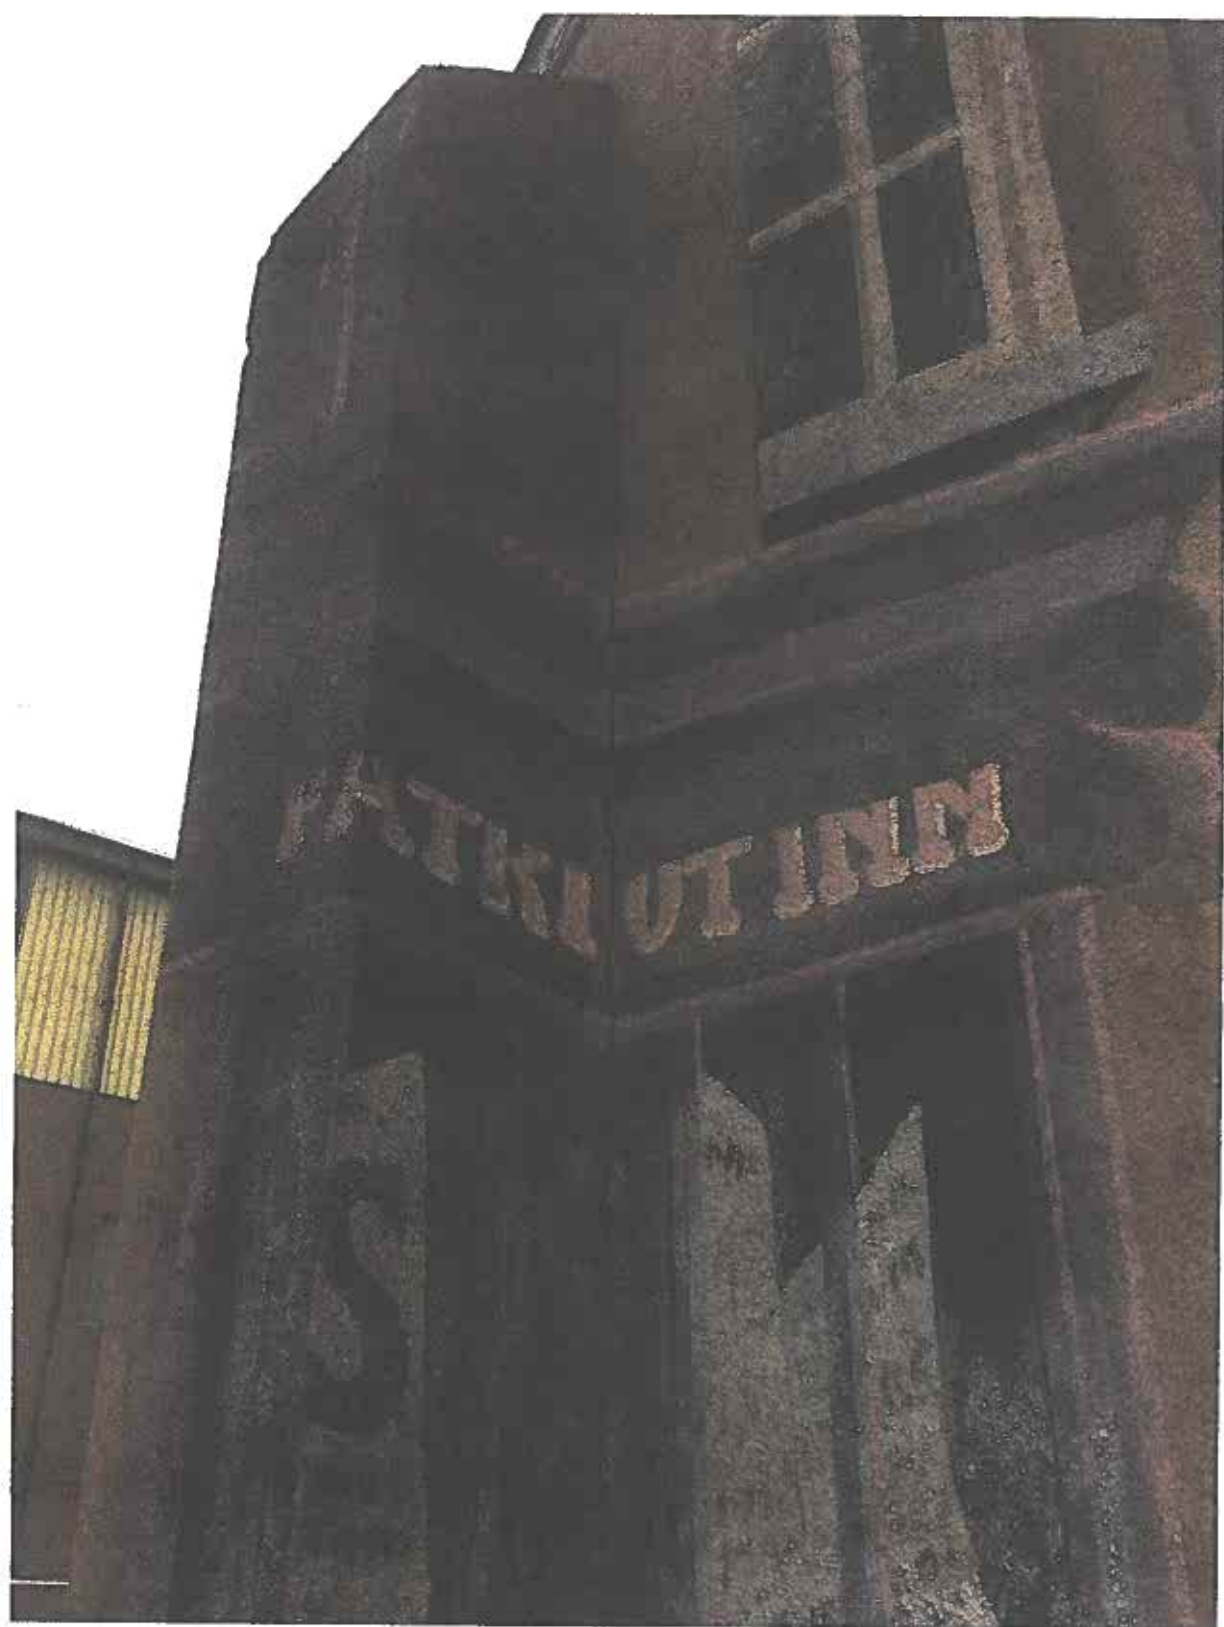
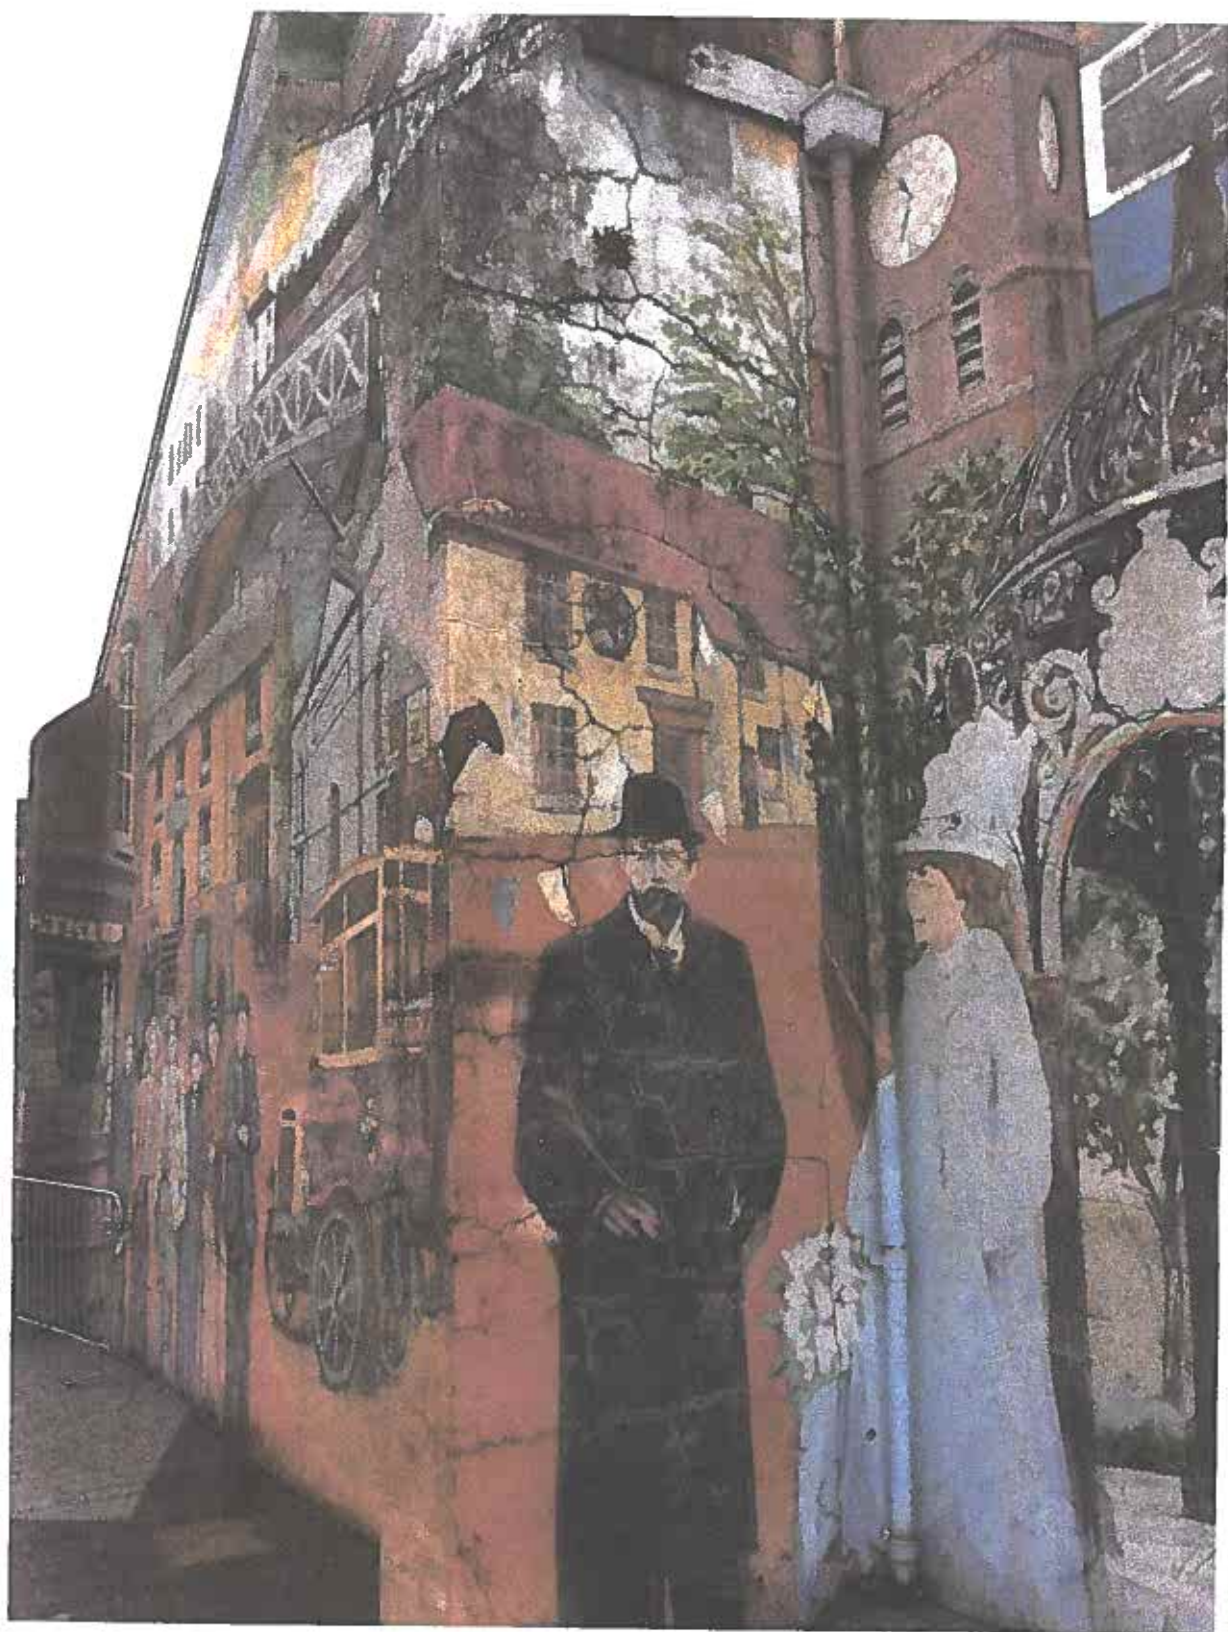
Photographs of the Mural showing extent of cracked and splayed render.
