*Report No. BC/MB/06.20.05.*

# **Coal Mining Risk Assessment, Land at Pencoedcae Farm, Merthyr Tydfil.**

## **Mining Risk Assessment: Land at Pencoedcae Farm, Merthyr Tydfil.**

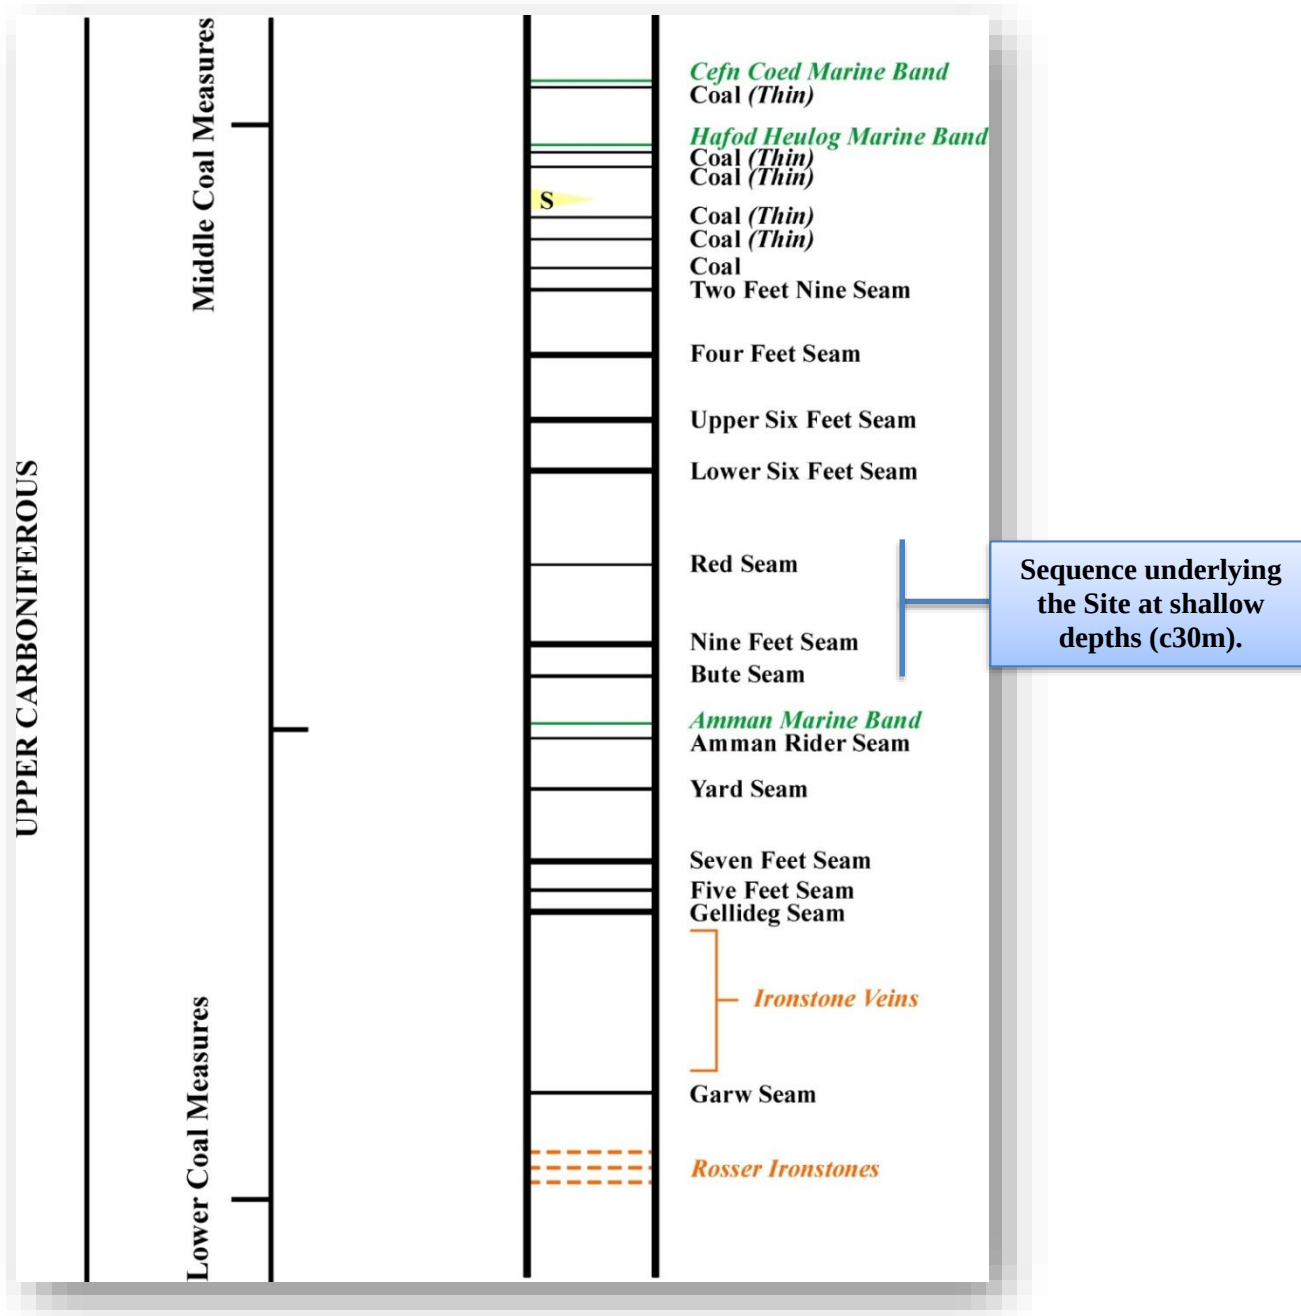
**Figure 1**  
**Part of the Stratigraphic Column.**

The Site is situated towards the northern margin of the South Wales Coalfield and is underlain at shallow depths with strata assigned to the Middle Coal Measures, a sub-division of the Upper Carboniferous Period. The published geological sheet for the area at a 1:10,560 scale, SO 00 NE, shows the inferred position of the outcrops of the Nine Feet and Bute Seams to be present immediately to the west of the farmhouse and downslope from it. The inferred position of the outcrop of the Amman Marine Band and the immediately underlying Yard Seam are shown to be present approximately 150m north-west of the Farmhouse, passing at the end of the access road that serves the farm (see *Geology Plan, drawing no. BC/MB/06.20.05.02*); the Amman Marine Band marks the division between the Middle and Lower Coal Measures (see *Figure 2, Part of the Stratigraphic Column*).

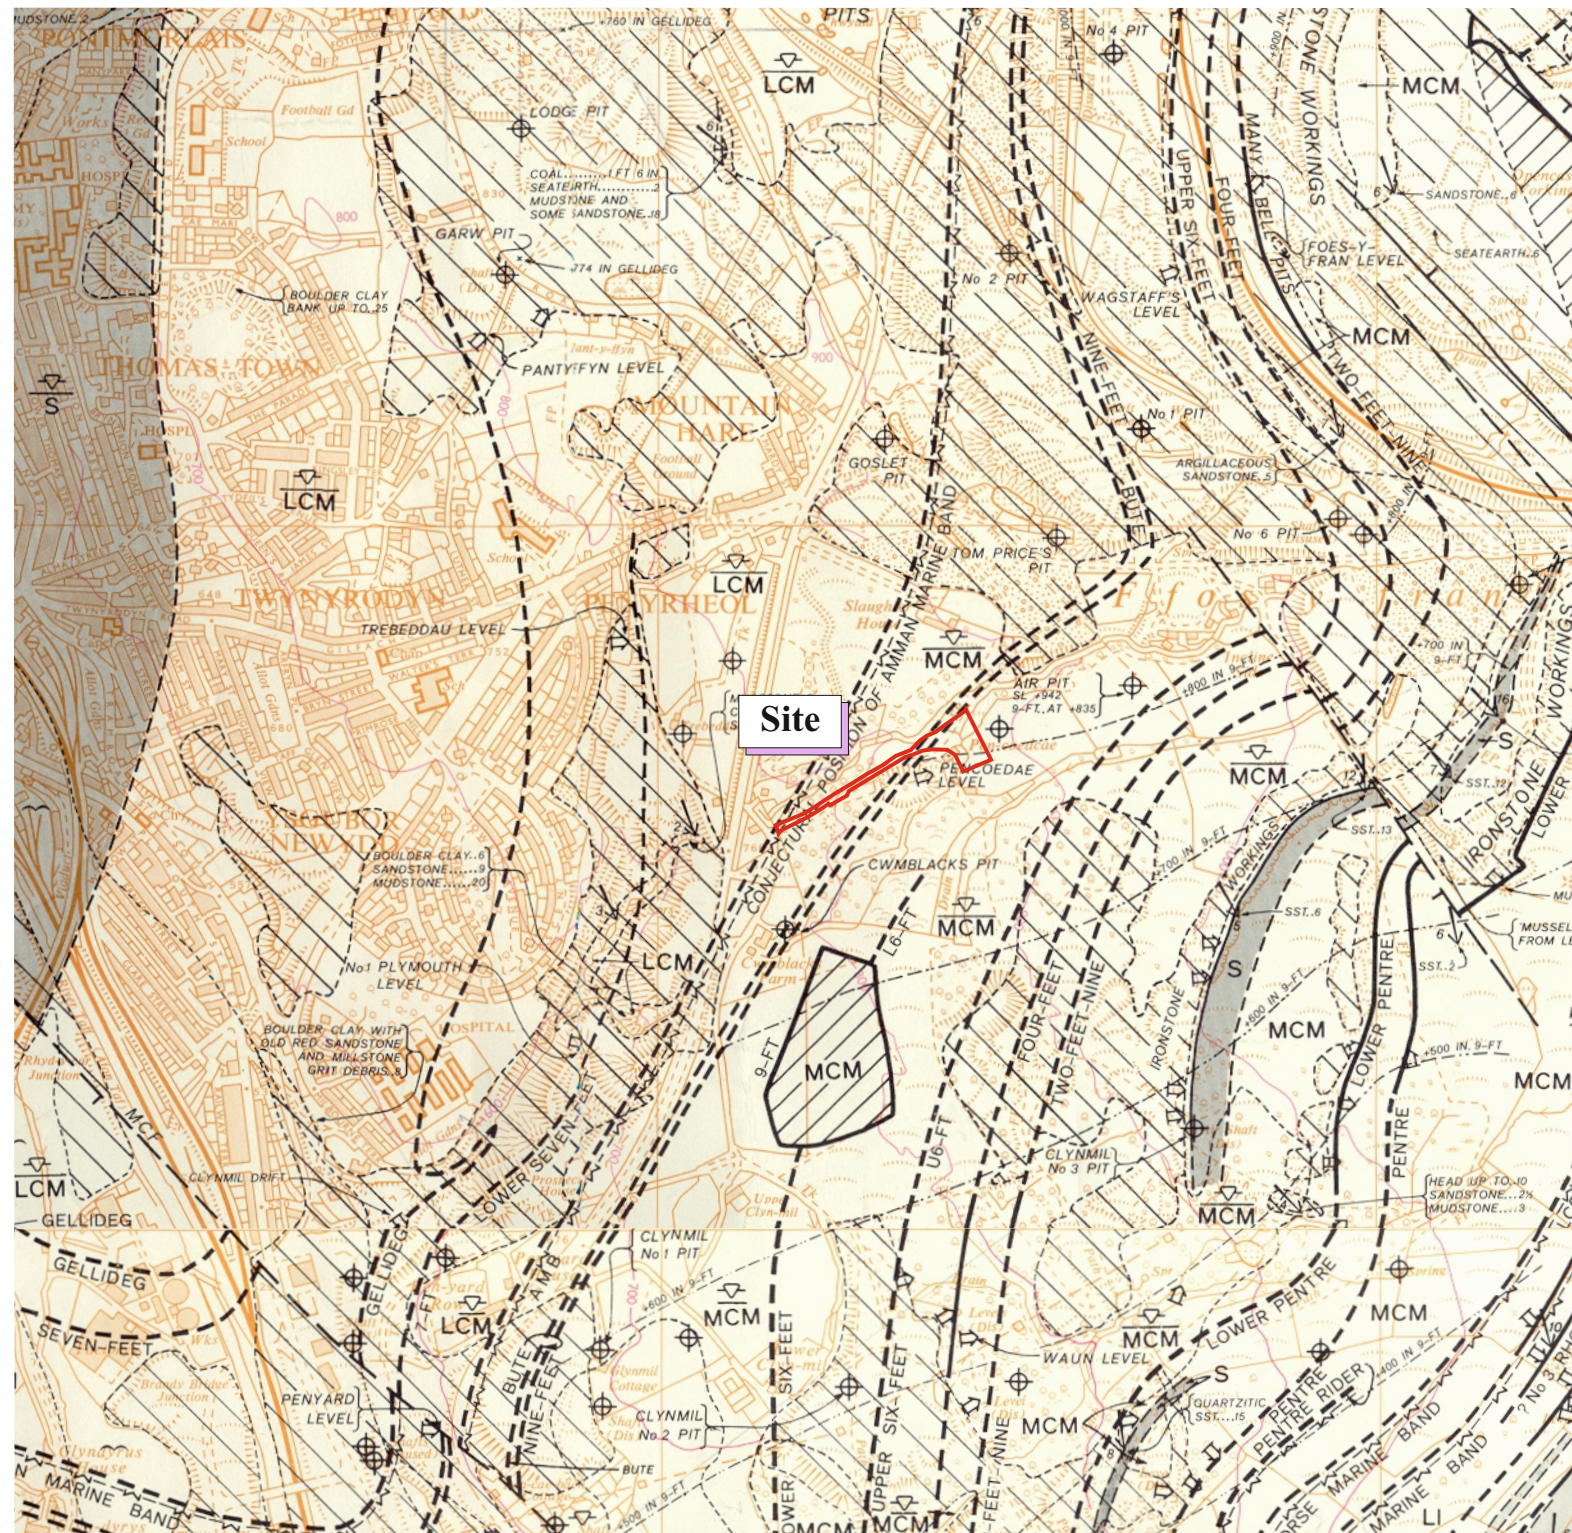
**Drawing No: BC/MB/06.20.05.02.**

The inferred outcrops of the Seven Feet and Gellideg Seams are shown to be present further to the west. All the outcrops follow a sinuous trace along the hillside following a roughly north-easterly trend. The regional dip of the strata in the Pencoedcae area is 1 in 12 in a south-easterly direction so that the Nine Feet and Bute Seams may underlie the farmhouse at very shallow depths and the Yard Seam at fairly shallow, but deeper depths. The Seven Feet and Gellideg Seams underlie the Site at greater depths.

number of adits driven into the valley sides at or near the outcrops of coal seams or ironstone veins, or else from shafts sunk near the valley floor. The Site is within influencing distance of three seams of coal at depths of between 'shallow' and 90m and last mined in 1922. In addition, the Site has been undermined in two ironstone veins at depths in excess of 100m and last mined in the 1850s. The published geological sheet shows the 800 feet (244m) contour on the Nine Feet Seam to pass through the Site.

The locality has experienced extensive mining operations for both coal and ironstone. Mining records show the Site to be within influencing distance of old workings in three coal seams and two ironstone veins, at least one coal seam of which is at shallow depths and may pose a risk to the proposed development. The published geology sheet for the area shows the 800 feet (244m) basal contour of the Nine Feet Seam to pass through the Site and close to the farmhouse; this would mean the base of the Seam is approximately 19m deep beneath the

farmhouse. The fact that the geology sheet shows the contour means that there are mining records of the Seam having been mined there. Given the thickness of the Nine Feet Seam and the presence of Boulder Clay on the Site there is a significant risk that old workings in the Seam may collapse to the surface. The remaining coal seams and the ironstone veins are of an age/and or are at depths whereby they will not affect the structural integrity of the proposed redevelopment of the Site. It is recommended that the nature and depth of suspected shallow old workings underlying the Site should be further assessed in more detail by means of exploratory boreholes. The exploration programme should be designed and supervised by a Chartered Geologist and will require a permit from The Coal Authority.

It is recommended that exploratory boreholes are drilled on the Site to examine in greater detail the shallow old workings thought to be present and any risk that they may pose to the redeveloped dwelling. The boreholes should be monitored for the presence of mine gases. If the shallow old workings are found to present a risk, then they should be stabilised by means of a drilling and grouting programme.

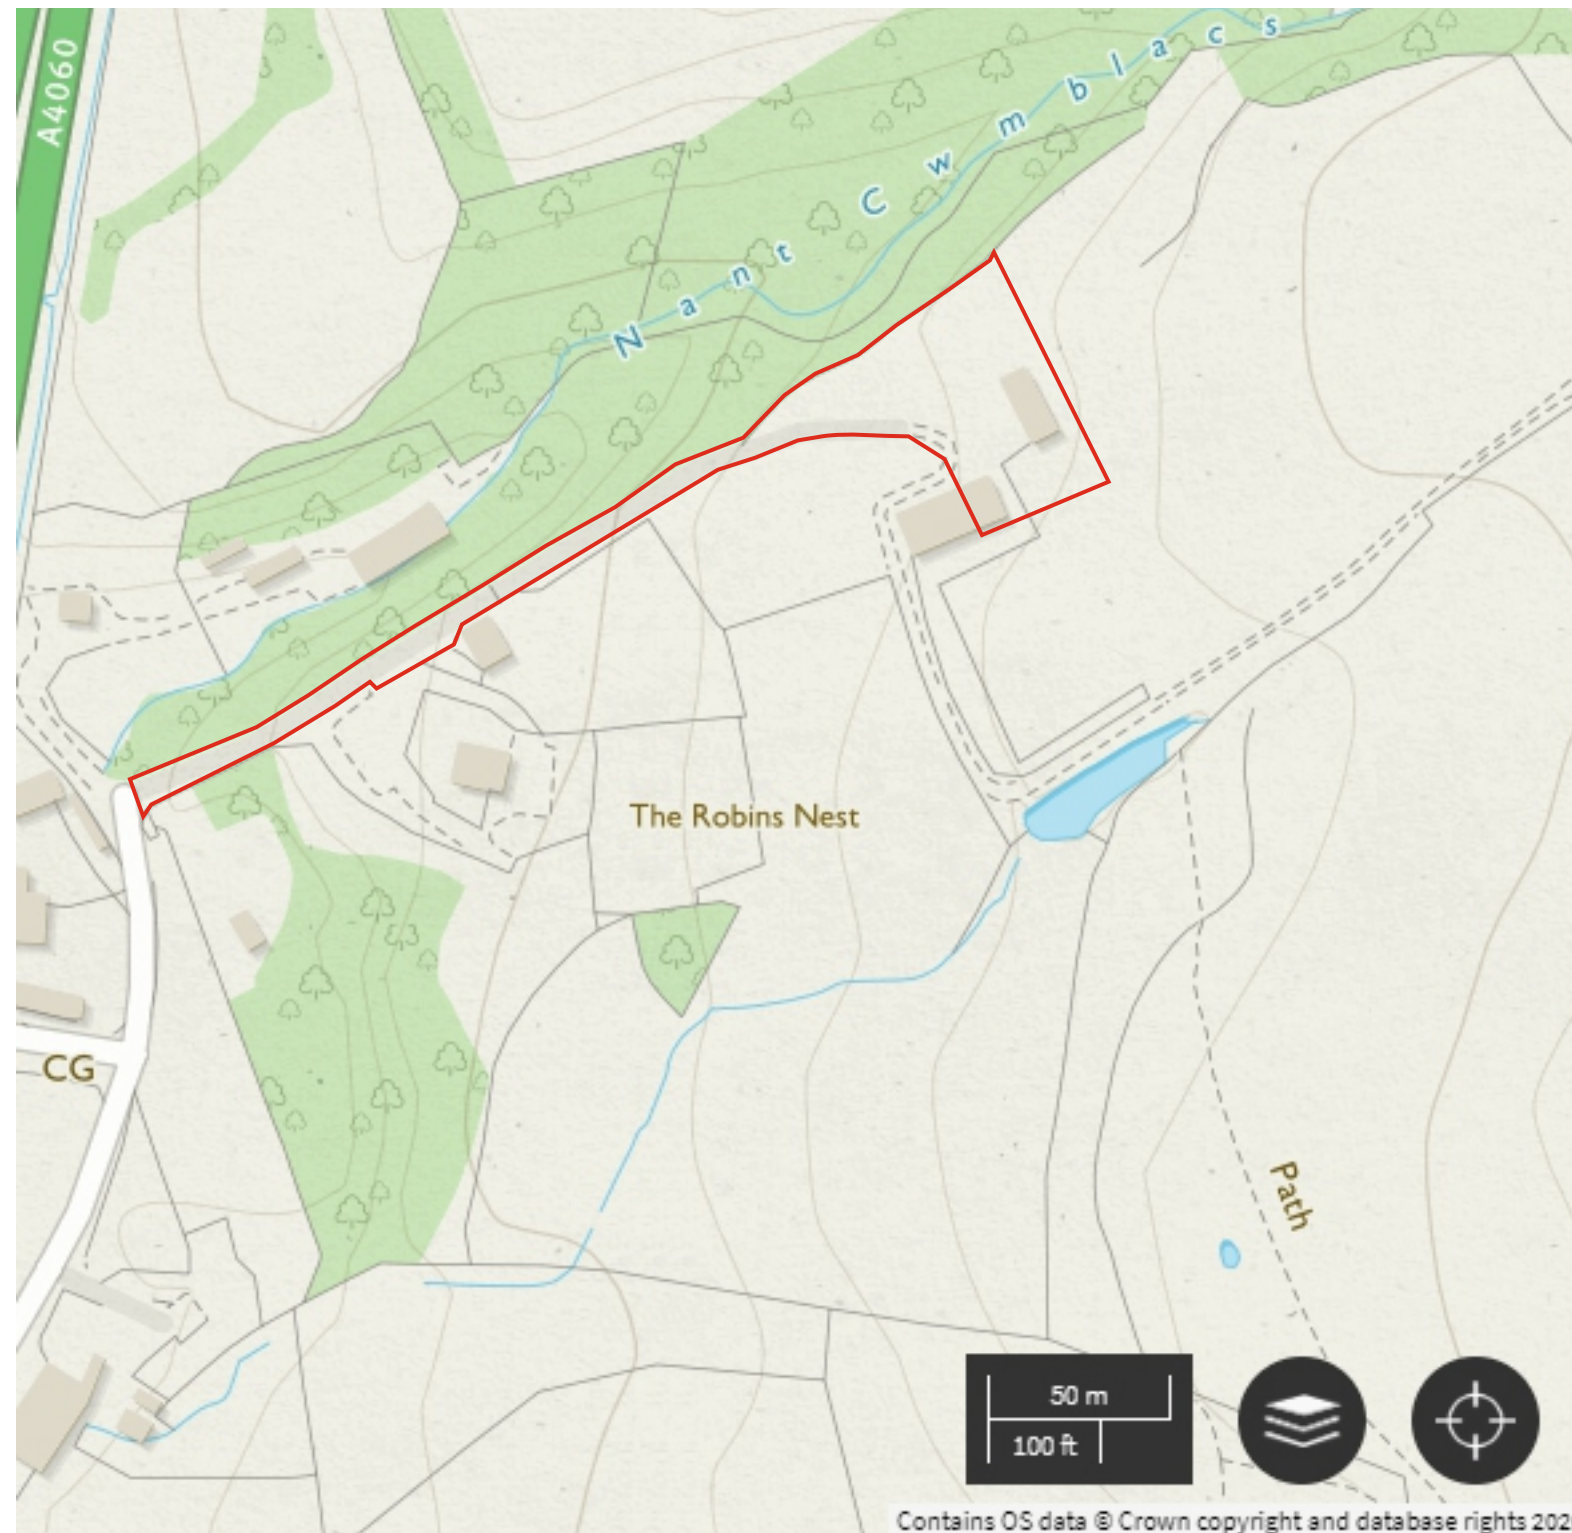
Drawing No: BC/MB/06.20.05.03.

Our searches found no recorded, disused shaft or adit within the confines of the Site or 20m of it. However, the published geological sheet shows the Pencoedcae Level, a disused adit, to be present approximately 60m south-west of the farmhouse and downslope from it. The adit potentially presents a risk of collapsing and affecting the proposed redevelopment. It is recommended that the adit is further investigated by means of a specific search of mining records and/or by physical inspection.

There is a potential risk from a collapse of the Pencoedcae Level. The risk of an unrecorded, disused mine entry being present within the Site is low but cannot be entirely dismissed.

Further study should be made of the Pencoedcae Level, including a plan search and walkover survey. The risk of an unrecorded, disused mine entry being present within the confines of the Site is low but cannot be entirely discounted. If any unusual features are encountered during excavation works, the works must be stopped immediately, and advice sought from a Chartered Geologist or from The Coal Authority.
