# BAT SURVEY REPORT

HOOVER SITE,  
MERTHYR TYDFIL

| <b>Project: Hoover Site, Merthyr Tydfil</b> | | |
| <b>Title</b> | Bat Survey Report | |

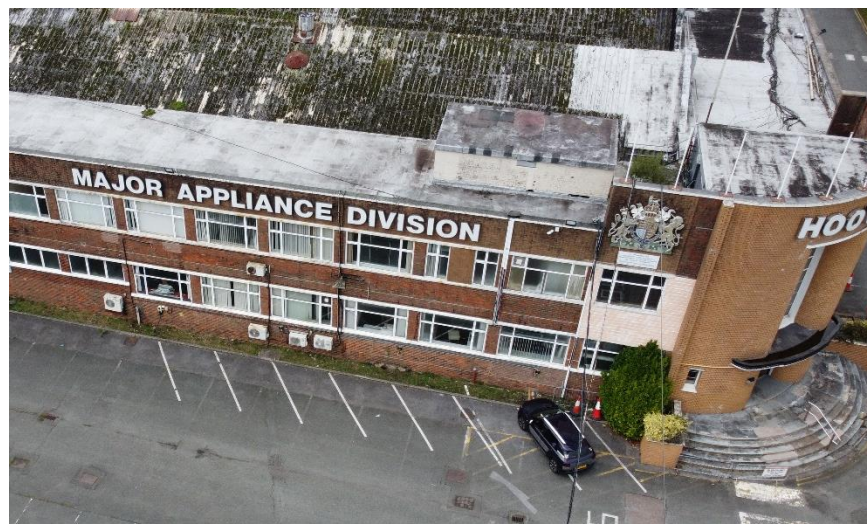
- 3.4 Building 1, is an art deco style brick fronted, flat roofed, office building that backs onto a corrugated steel warehouse with transparent plastic and glass panels. Though it's the same building, for the purpose of this report we're referring to the office section as 1a, and the warehouse section as 1b.

*Photo 1:* Overview of building 1.

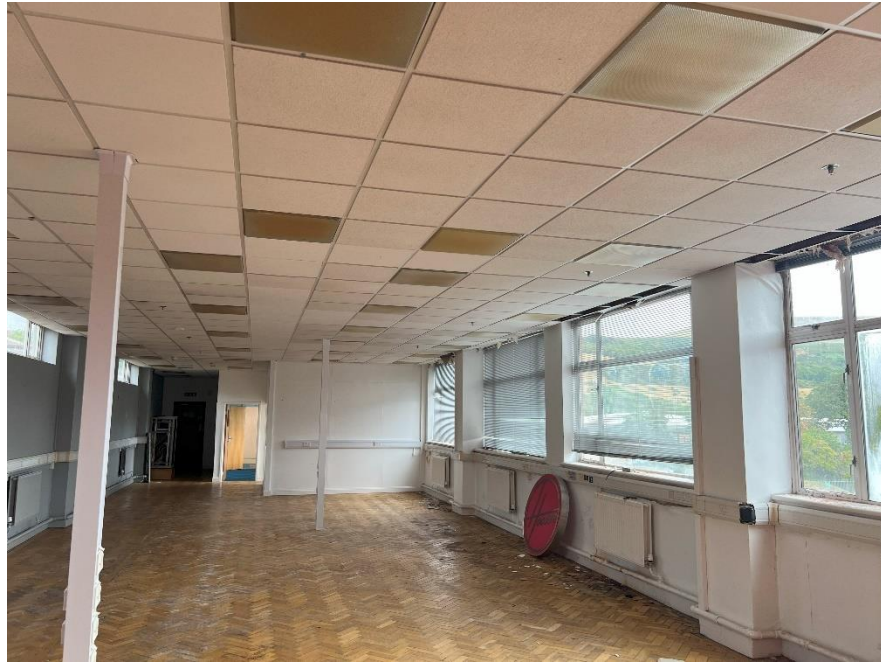
Internally the offices of building 1a are in poor condition with damp throughout. There is a suspended ceiling that offers negligible opportunities for crevice dwelling bats. The building has been empty for some time and a thick layer of dust is visible showing the building hasn't been cleaned. No evidence of bats was found within the office.

*Photo 2:* Example of the typical office space within building 1a.

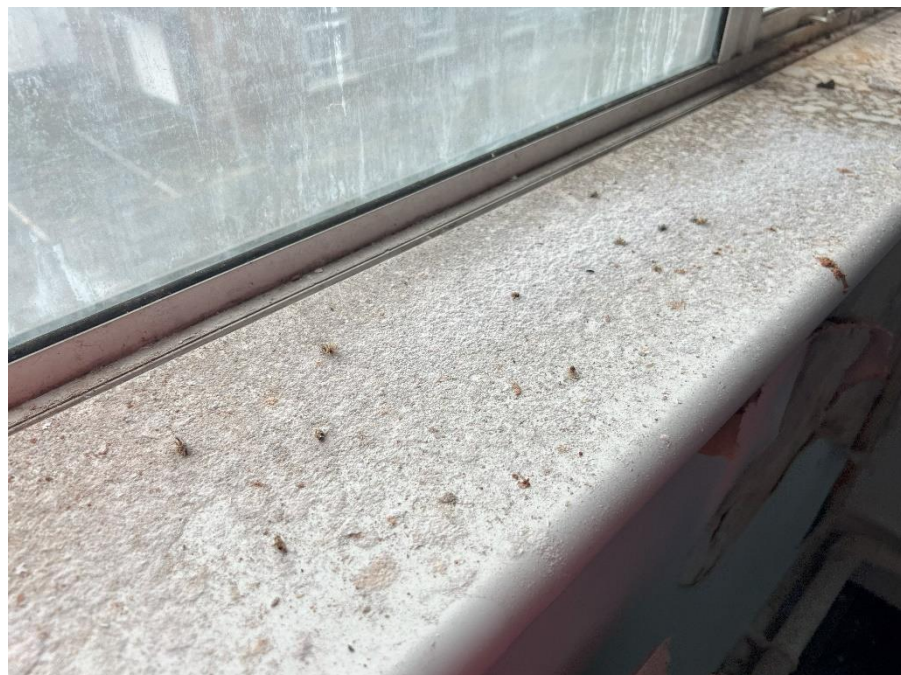
*Photo 3:* Uncleaned window sills with no bat evidence.

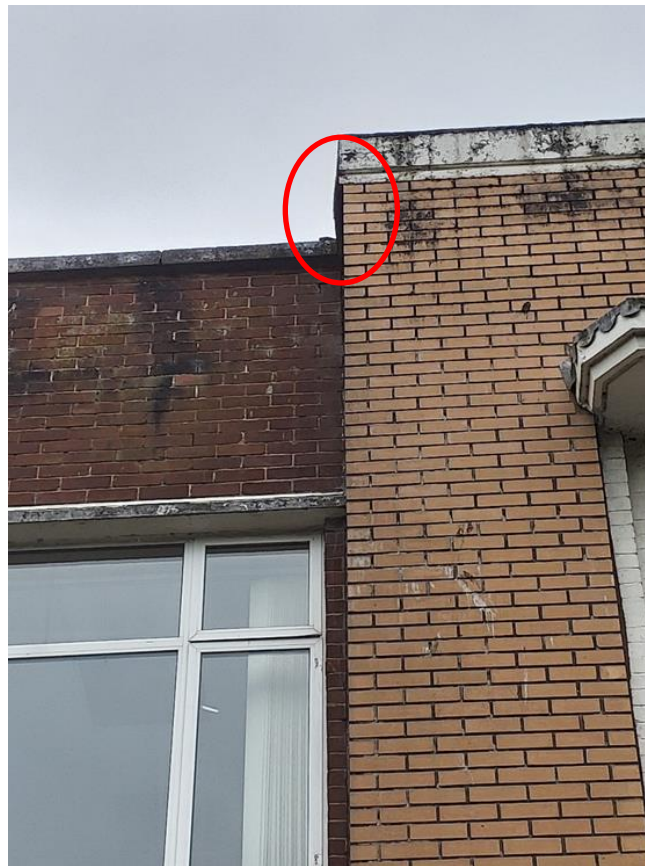
Externally the brickwork for building 1a is in relatively good condition. There were multiple areas where the roofing material had lifted to create gaps that could be utilised by crevice dwelling bats. Some small gaps were present within the brick work but likely not large enough to provide potential for roosting bats. The building is part of an area well used at night, as result it is heavily flood lit reducing its suitability for bats. Considering the size of the building and the number of possible PRFs, the building has been classified as having moderate bat potential.

*Photo 4: Lifting in roof felt*

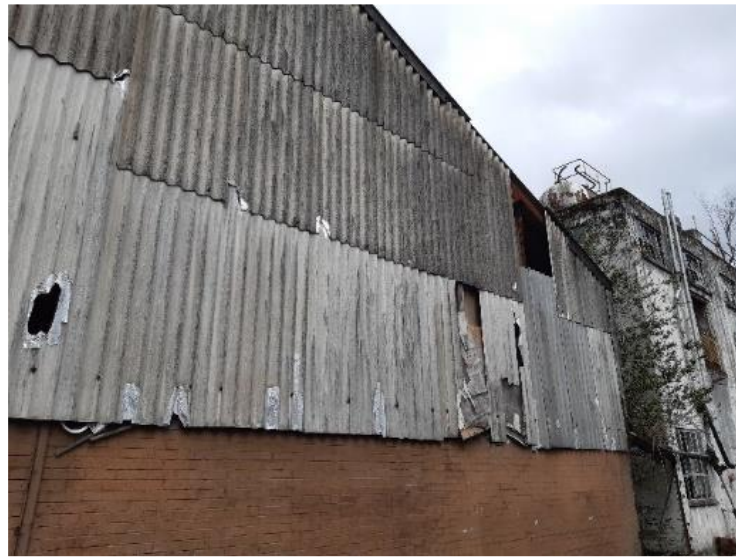
Building 1b's exterior cladding has multiple gaps and damaged or missing panels throughout. There are also small brick and breezeblock storage building on the western aspect. These building are in a poor state of repair with damaged roof, broken windows and access throughout. The building is part of an area well used at night, as result it is heavily flood lit reducing its suitability for bats. The buildings are also lit internally at night.

*Photo 5:* Example of damaged boarding

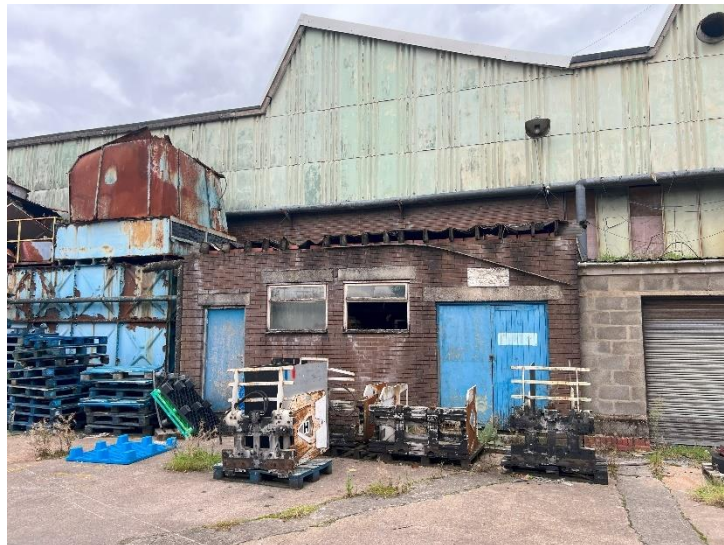
*Photo 6:* Example of the brick structures adjacent to the building and further examples of the steel boarding.

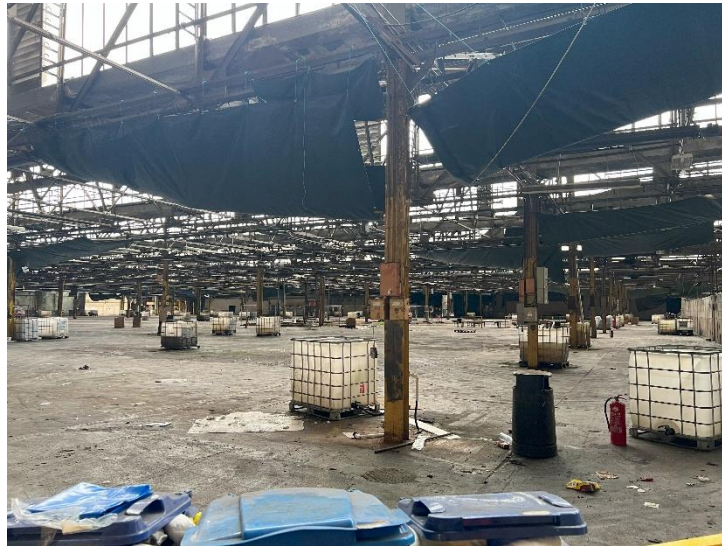
Internally building 1b; the warehouse is large, open, light with water ingress throughout. The internal microclimate of the building would vary greatly, and many of the structures are damp. The brick buildings are simple storage sheds and have negligible internal roosting opportunities for crevice-dwelling bats, they also have water and light ingress and would have an unstable internal microclimate. No evidence of bats was found within any of the structures. Despite internal and external artificial lighting, the building is classified as having moderate bat potential due to its size and number of possible PRFs.

*Photo 7:* Overview of the buildings internal structure.

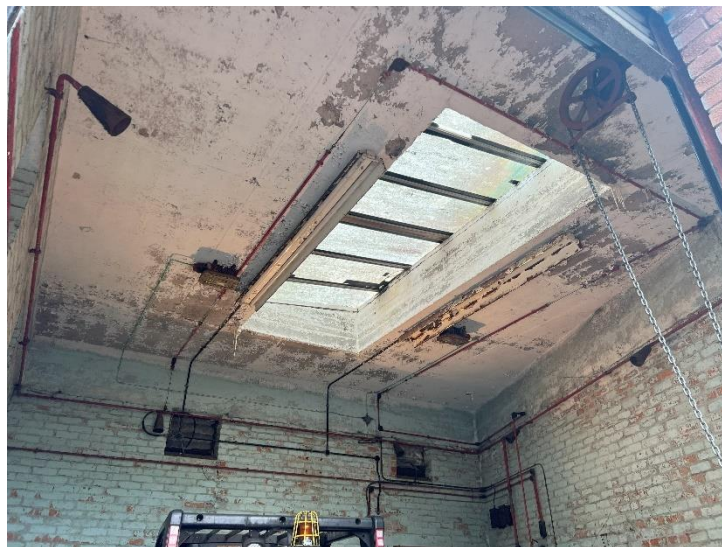
*Photo 8:* An example of the internal structure of one of the small storage rooms adjacent to the main building.

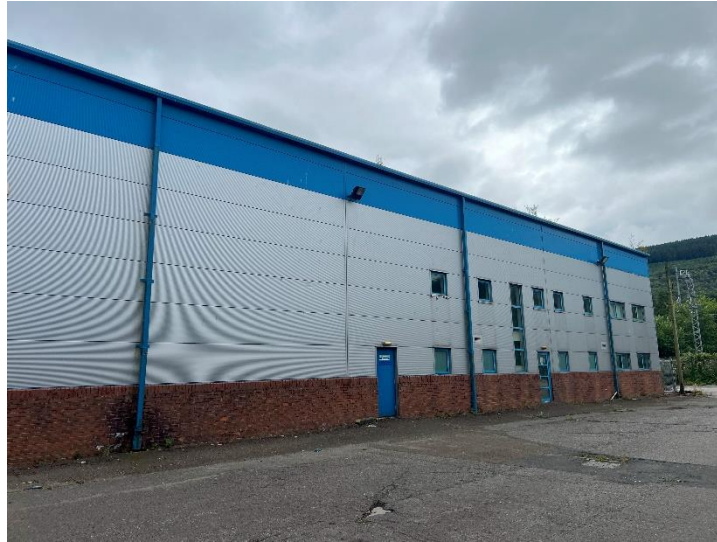
Building 2 is a modern steel warehouse. The building is in good order with no visible access points or crevices. Internally there were no visible PRFs for crevice-dwelling bats, and no evidence of bats was found within the building. The building is part of a well-used area that is heavily flood lit at night, reducing its suitability for bats. Considering the size of the building its possible some PRFs may be present but not

visible; as a result it's been classified as having low bat potential.

*Photo 9:* overview of the external structure of building 2

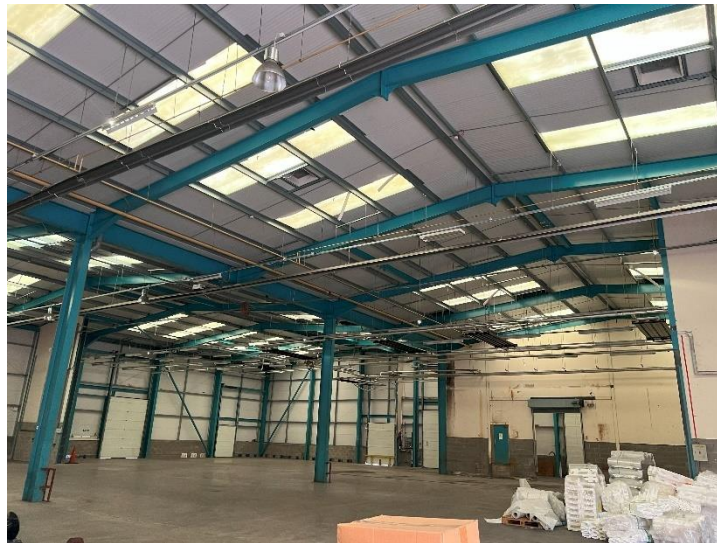
*Photo 10:* Overview of the internal structure of building 2.

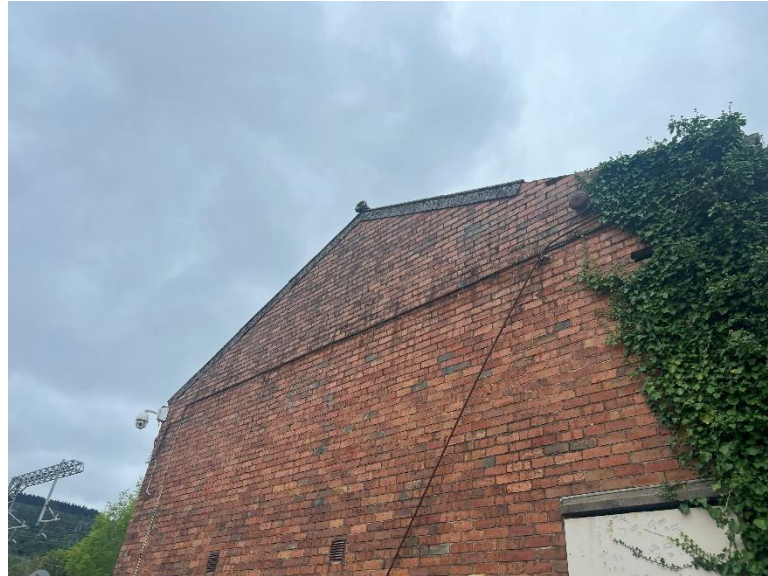
Building 3 is a brick and corrugated asbestos workshop. The building has been permanently sealed due to asbestos contamination, as a result an internal inspection wasn't undertaken. There is significant damage to the roof and some of the windows are broke allowing access into the building. There are windows all along the roof and along the top of the walls. Consequently, the building receives ample natural light during the

day, and the damaged roof may allow moisture to enter. It's unlikely the building has a stable internal microclimate. Considering the available access to the building and the inability to conduct an internal assessment, the building is classified as having moderate bat potential.

*Photo 11:* Damage to the barge boards allowing possible access for bats

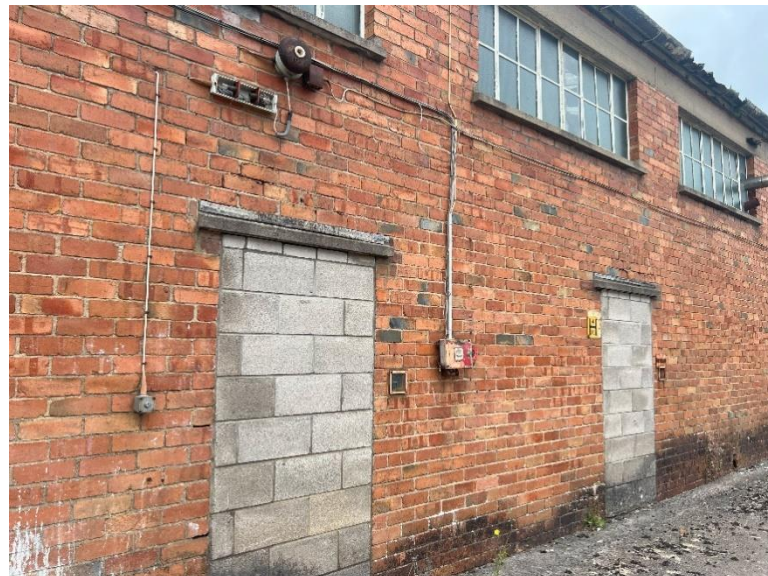
*Photo 12:* Shows how the building g has been closed for H&S reasons. The windows show the light levels from the roof lighting.

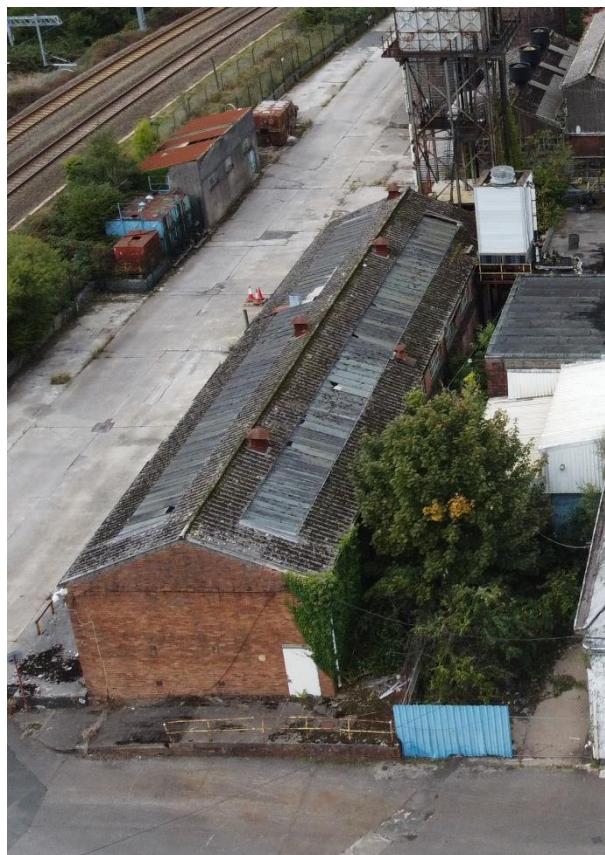
*Photo 13: overview of building 3.*

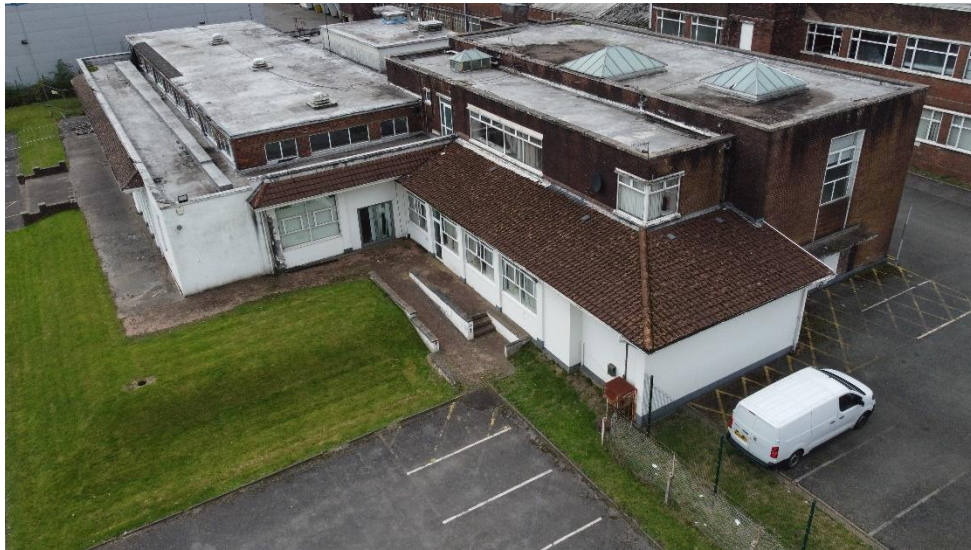
Building 4 is a two storey, flat roofed office building. The southern and eastern elevations of the building feature small sections of lean-to pitched roofing above the ground floor. The lead flashing where the roof meets the exterior wall offers the potential for crevice dwelling bats. The roofs appear in good order with no visible signs of damage. There was no access available into the loft space of the small, pitched roofs. There is a crack in the wall on the western aspect of the building. The crack has negligible potential for roosting bats. Internally the offices are in moderate condition with evidence of damp. There is a suspended ceiling that offers negligible opportunities for crevice dwelling bats. The building has been empty for some time and a thick layer of dust is visible showing the building hasn't been cleaned. No evidence of bats was found within the offices. As a thorough internal inspection of the loft spaces couldn't be undertaken, as a precaution the building has been classified as having high bat potential.

*Photo 14: Overview of building 4*

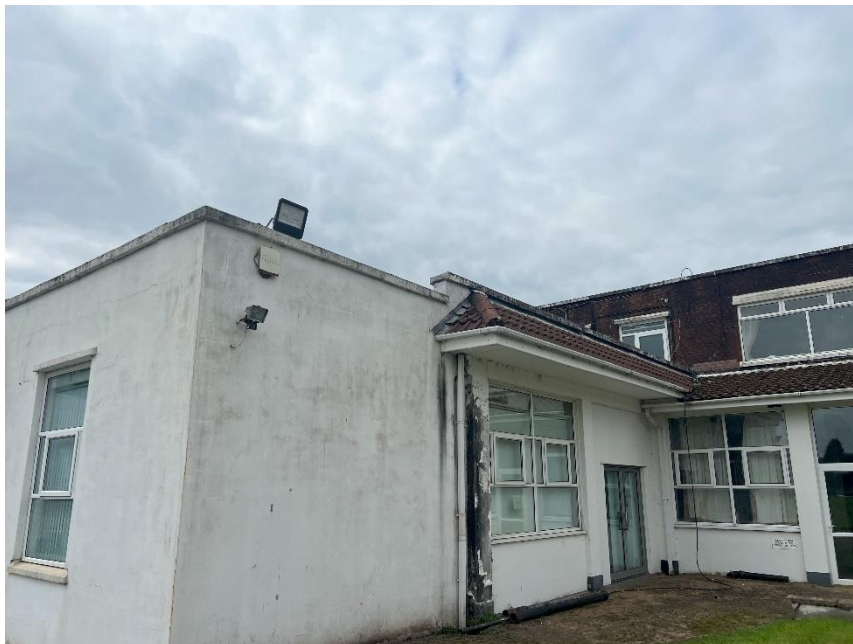
*Photo 15: The flat roof is generally in good order with negligible PRFs, the small, pitched roof has lead flashing all around offering roosting opportunities.*

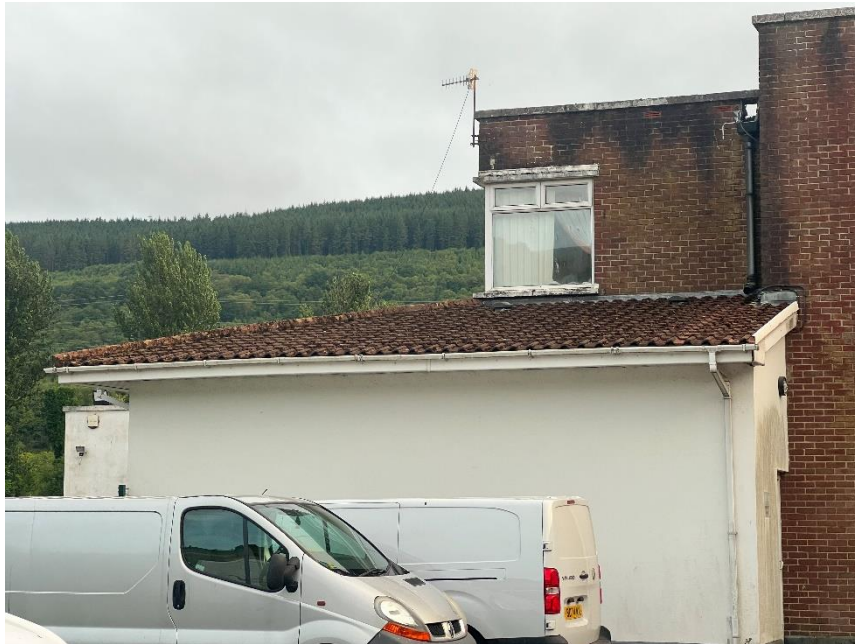
*Photo 16:* Minor damage to the small roof.

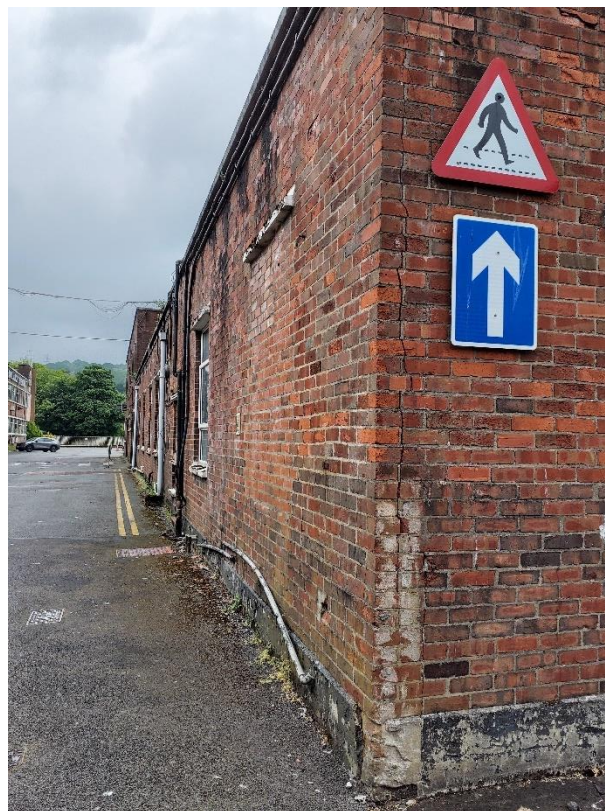
*Photo 17:* A crack in the wall, and inspection with an endoscope shows the crack has negligible potential for bats. An inspection was also made behind any signage; no evidence of bats was found.

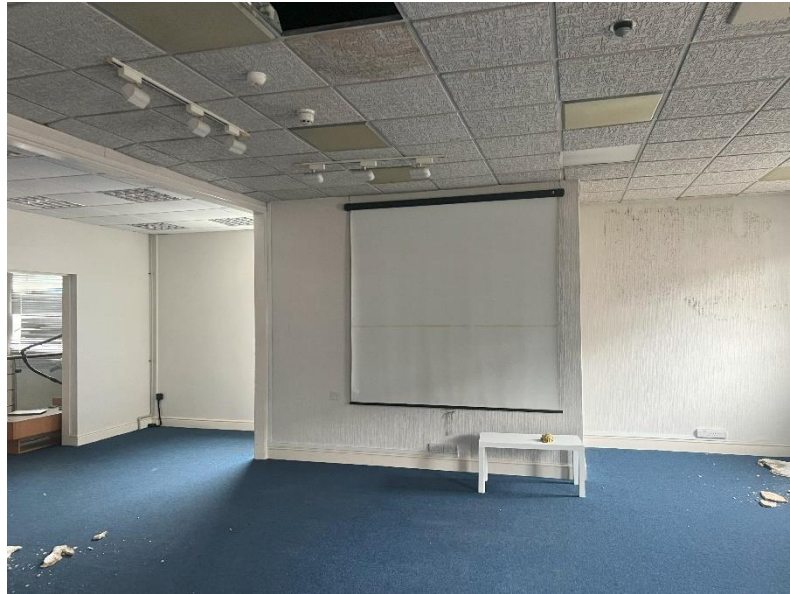
*Photo 18:* Overview of the internal structure of the building, there is evidence of damp in the walls.

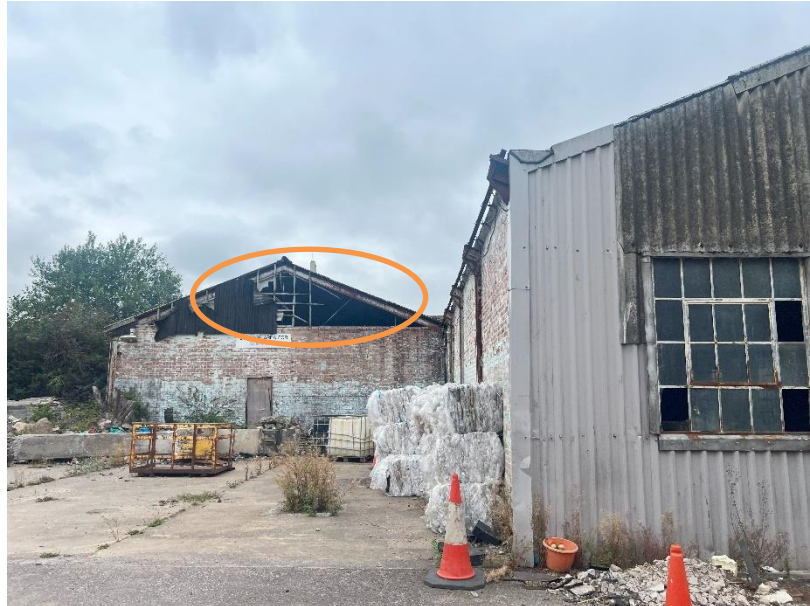
Building 5 is a brick and corrugated metal building adjacent to the western site boundary. The building has been significantly damaged with large open gables, and damaged windows throughout. The building has asbestos contamination, and an internal inspection wasn't possible. The internal microclimate of the building would vary greatly, and the brickwork is likely damp. The building is part of an area well used at night, as result it is heavily flood lit reducing its suitability for bats. There are areas of the building that couldn't be seen externally and its possible this section may be dark at night and have more stable microclimate, as a precaution this building has been classified as having high bat potential.

*Photo 19:* overview of building 5, the large open gable has been highlighted, and some broken windows are clearly visible.

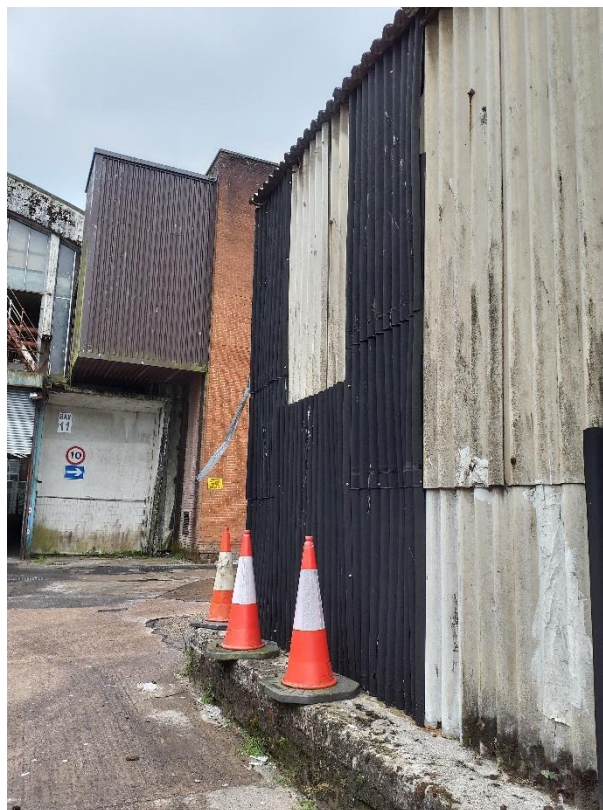
*Photo 20:* Example of the patched repair to building. There are gaps around many of the panels.

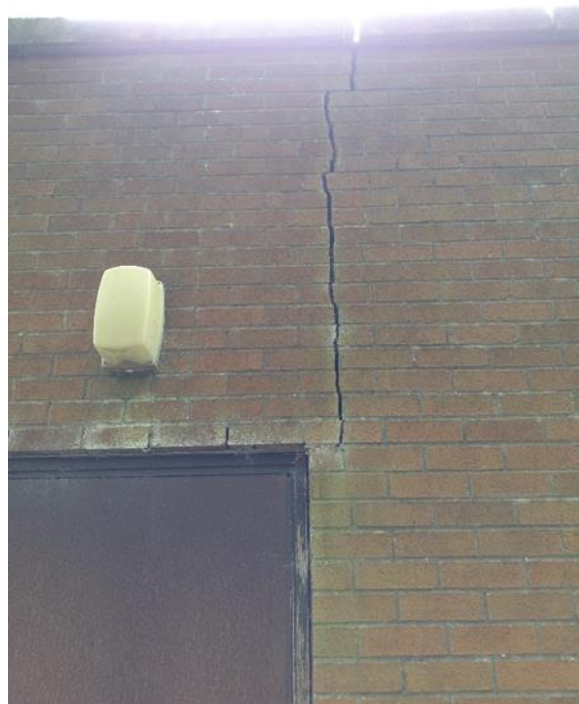
- 3.13 The old water pumping station building 6 was a brick building with a felt roof. The building had cracks within the brickwork which may provide potential for roosting bats. The crack did not allow access into the building. A thorough examination of the crack was made using an endoscope and a thermal imaging camera.

- 3.14 The crack didn't extend further than is visible, there were negligible opportunities for crevice dwelling bats, and no evidence of bats was found. The crack is open from the top so it would allow water into the space further limiting any roosting opportunities. After a thorough inspection the crack is considered to offer negligible opportunities for bats.

*Photo 21:* The crack in the exterior brickwork, open at the top.

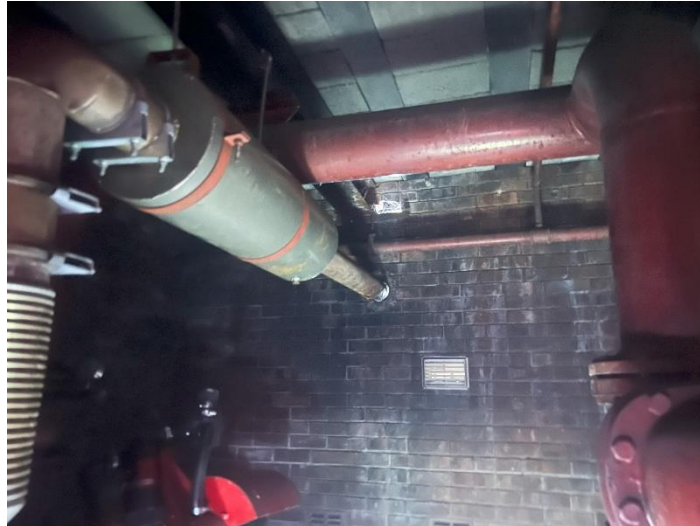
- 3.15 Internally there are negligible opportunities for crevice dwelling bats, no evidence of bats was found. An external ventilation brick has an internal cover limiting potential access opportunities. Internally the walls have a light, oily, slickness from years of use, making the internal environment unsuitable for bats. Considering the results of the endoscope examination, the building has been classified as having negligible potential for roosting bats.

*Photo: 22.* The black internal bricks in contrast to the brown external bricks above are the result of a light coating of oil, making the internal environment of this building unsuitable for bats.

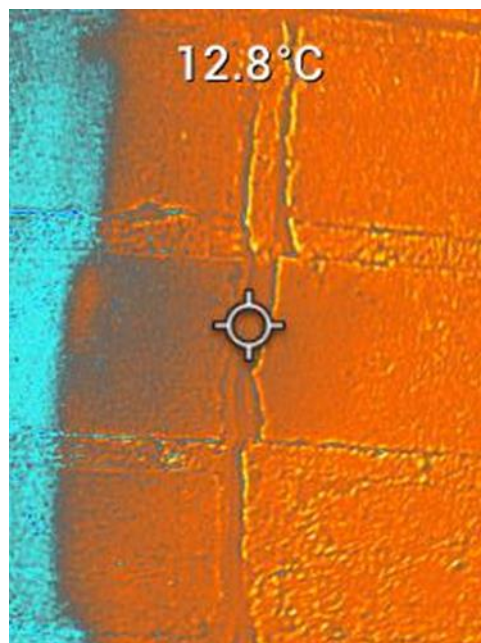
*Photo: 23.* A thermal imaging photo from the onsite inspection.

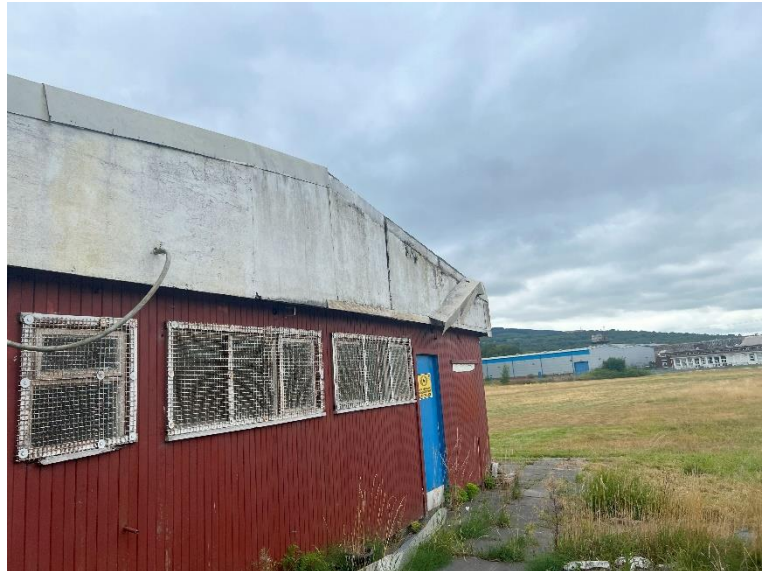
Building 7 is a cricket pavilion to the south of the site. The building is positioned out of the industrial estate adjacent to areas of unilluminated trees and grassland. The building is comprised of wooden boards and a possibly plastic roof. The wood was rotten in many areas creating gaps

and lifted boards. Internally the ceiling is vaulted, with space between the vaulted ceiling and the roof being full of fibreglass insulation, meaning roosting opportunities through the majority of the roof are negligible. There is significant damage to soffit boxes throughout the entire building. Some of the external cladding is damaged offering roosting opportunities behind exterior cladding. The building remains unlit at night and it's possible that space behind the exterior cladding would offer a stable roosting location for a small number of bats. Due to the vaulted ceiling a thorough investigation into spaces beneath the roof couldn't be undertaken; because of this and due to the fact the building is unlit and surrounded suitable habitat, as a precaution this building has been classified as having high bat potential.

*Photo 24:* Shows a lift along the roofing material, offering transitional roosting opportunities for small numbers of bats.

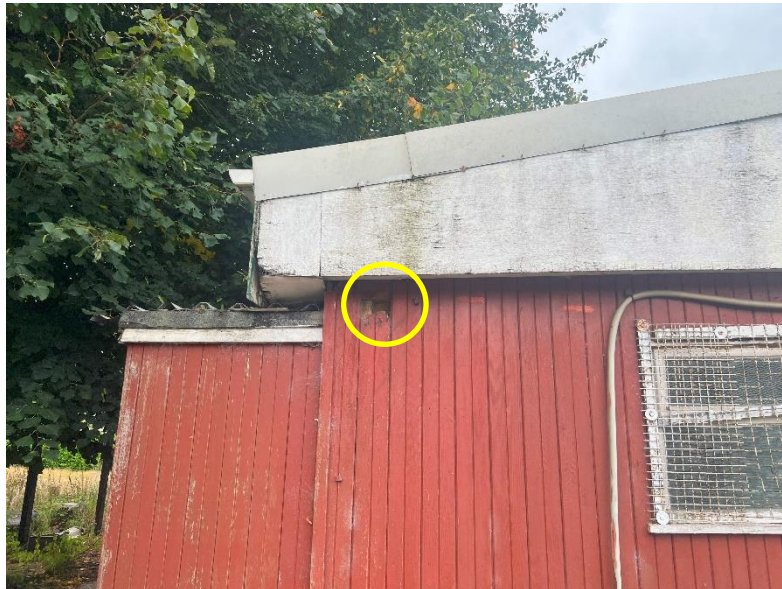
*Photo 25:* Shows a hole in the exterior cladding that could allow bats too access possible roosting locations.

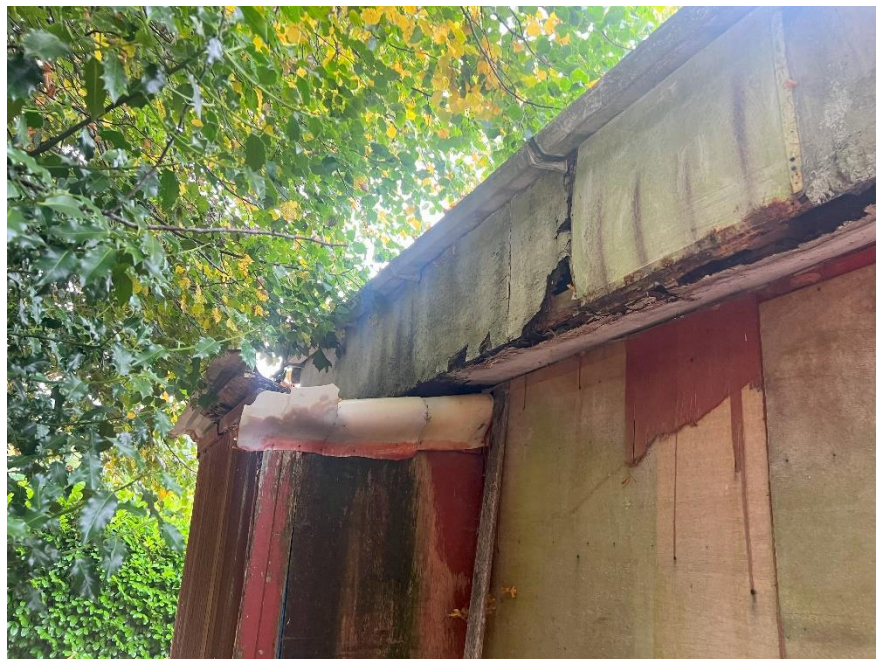
*Photo 26:* There is extensive damage to soffit boxes. Access is available for bats however it's likely the internal space is damp with little long term roosting potential.

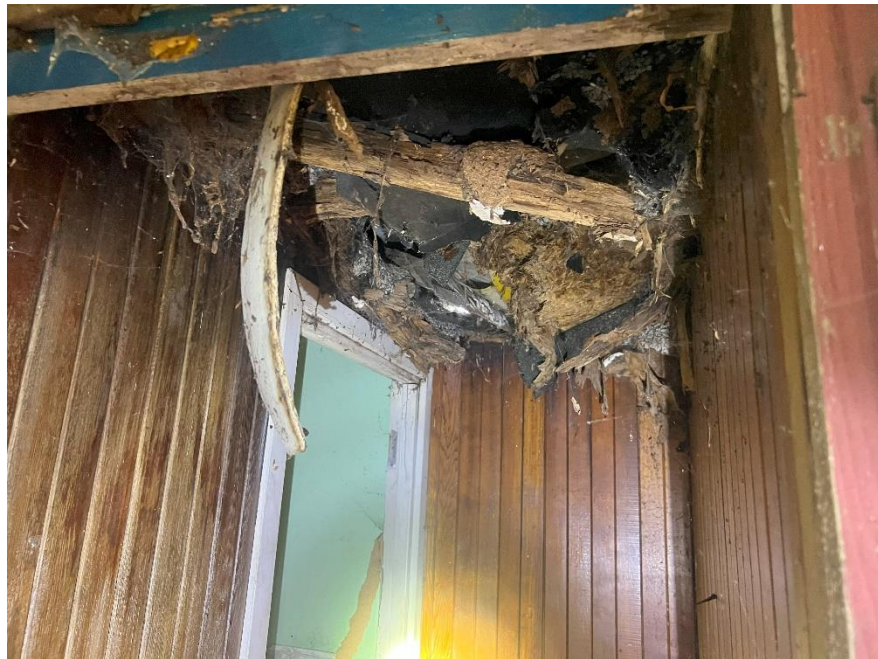
*Photo 27:* Example of the rot and damp within the roof.

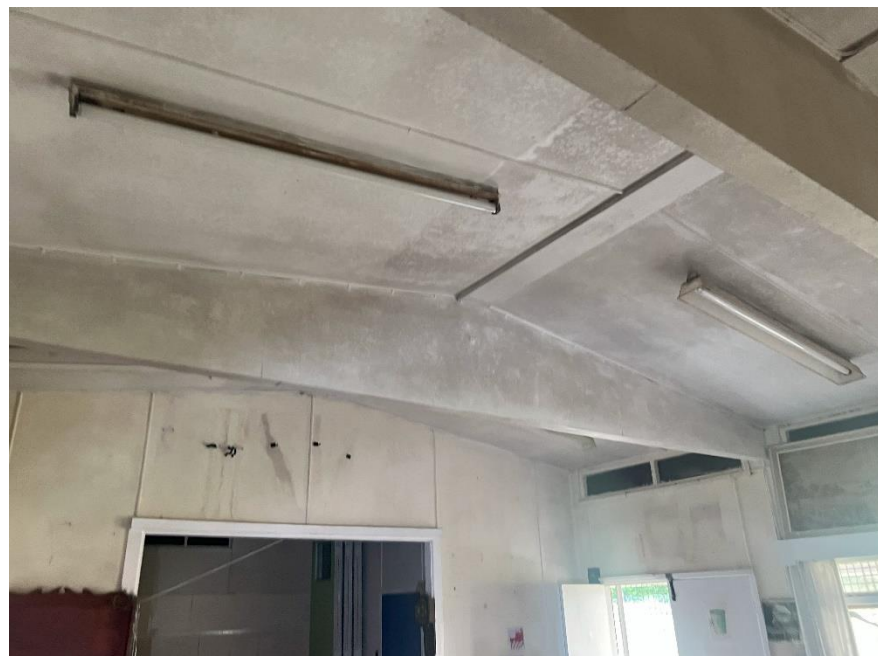
*Photo 28:* The ceiling vaulted, the insulation between the ceiling and the roof reduces the buildings suitability for bats.

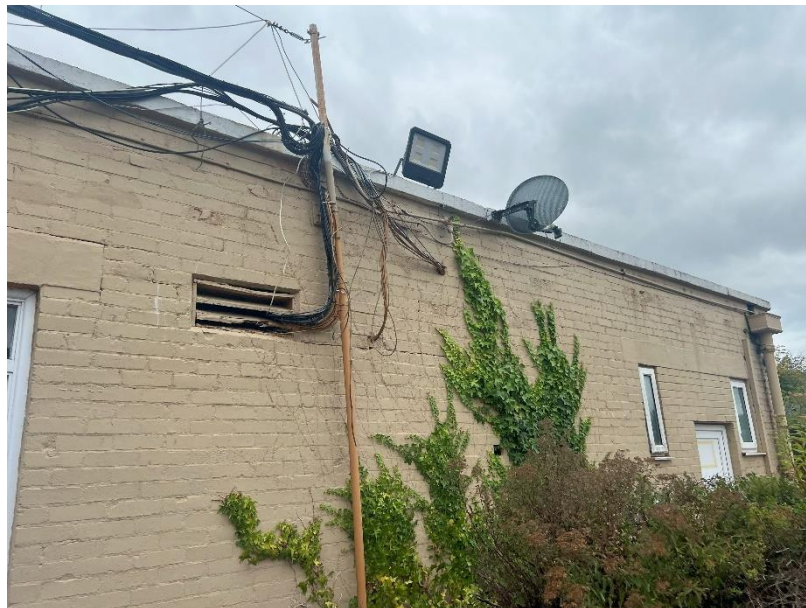
building is part of an area well used at night, as result it is heavily flood lit reducing its suitability for bats. On the western aspect of the building there is a ventilation block that allows cables to pass into a storage area. This ventilation block would allow bats to access the storage shed; however the internal structure offers few suitable roosting opportunities for bats and there is signs of damp throughout. No evidence of bats was found. Considering the possible access into the storage area, the building has been classified as having low potential for bats.

*Photo 29:* ventilation block on the western aspect of building 8

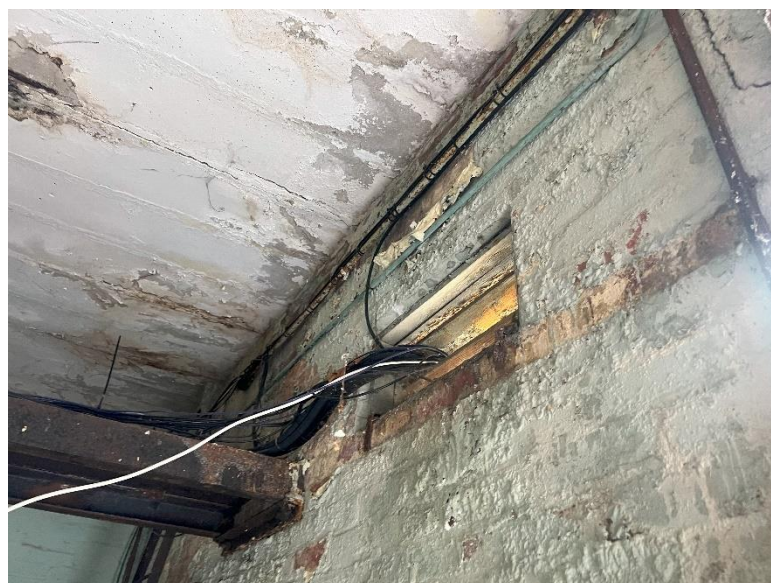
*Photo 30:* internal structure of building 8

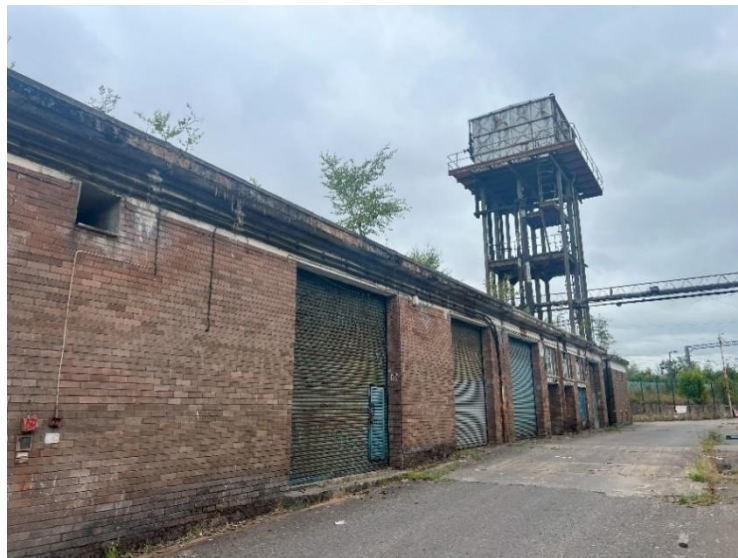
Building 9 is a series of single storey, flat roofed garage and storage buildings with a water tower. The buildings have large openings where ventilation blocks once were. Though access was available into the building, internally there were no visible PRFs for crevice-dwelling bats, and no evidence of bats was found within the building. The building is part of a well-used area that is heavily flood lit at night, reducing its suitability for bats. Though the building is artificially lit externally, considering the access points, the building has been classified as having moderate bat potential.

*Photo 31:* Overview of structure, missing ventilation bricks are clearly visible allowing unobstructed access into the building.

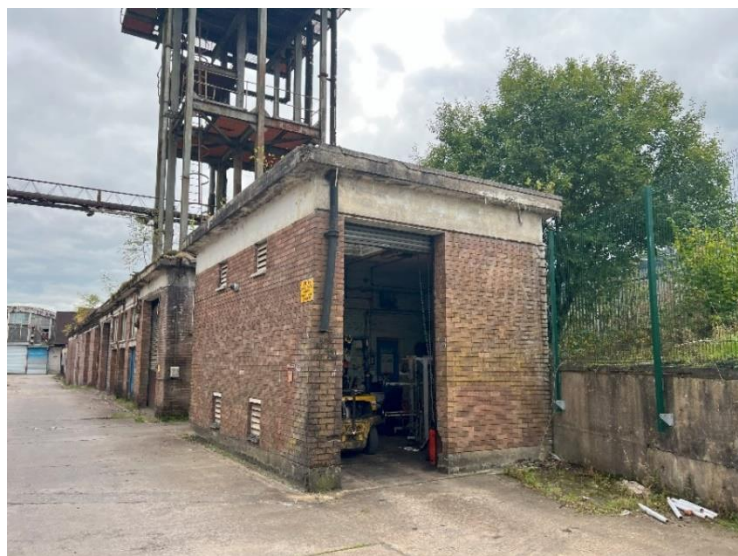
*Photo 32:* view from northern aspect, ventilation blocks are clearly visible.

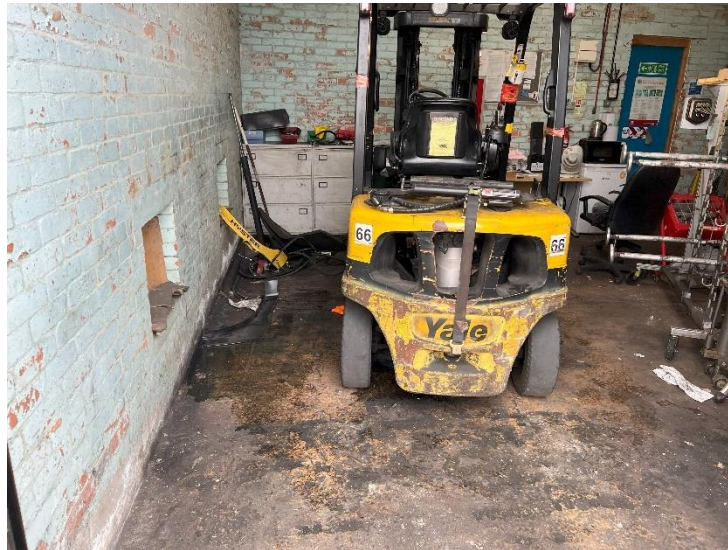
*Photo 33:* Internally the buildings are brick walled with no visible PRFs, the walls are damp, and no evidence of bats was found.

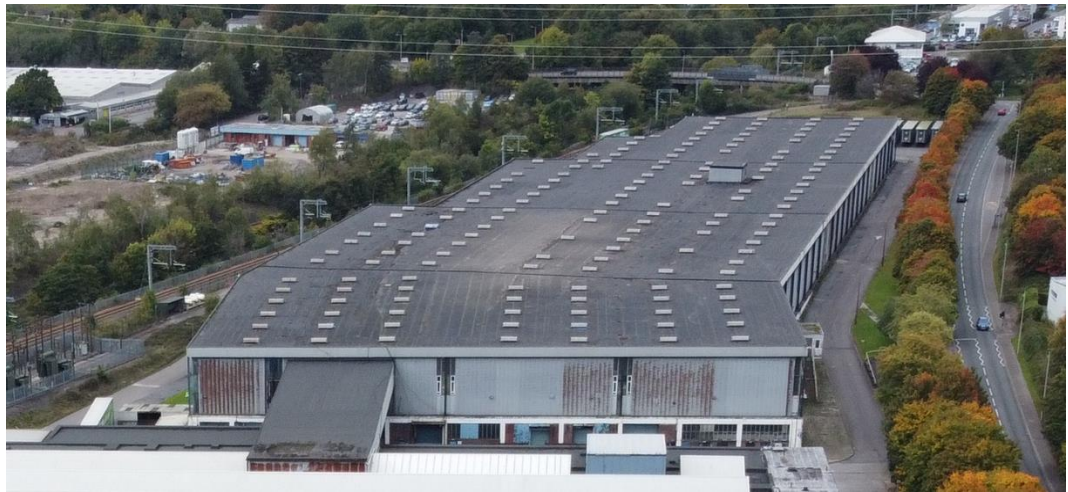
- 3.20 Building 11 is a large warehouse constructed of brick and breezeblock with metal panelling. The roof is corrugated steel with skylights. Internally some of the brick windows that have been bricked up and broken creating a space for bats to roost. A tough inspection with an endoscope revealed no evidence of bats. There are void in the metal cladding that offer potential roosting opportunities for bats.
- 3.21 The building are currently in use, with internal lighting on 24hrs a day and strong floodlights at night. No evidence of bats was found within any of the structures. Considering the size of the building and the number of possible PRFs, the building has been classified as having moderate bat potential.

*Photo 34: Overview of building 11.*

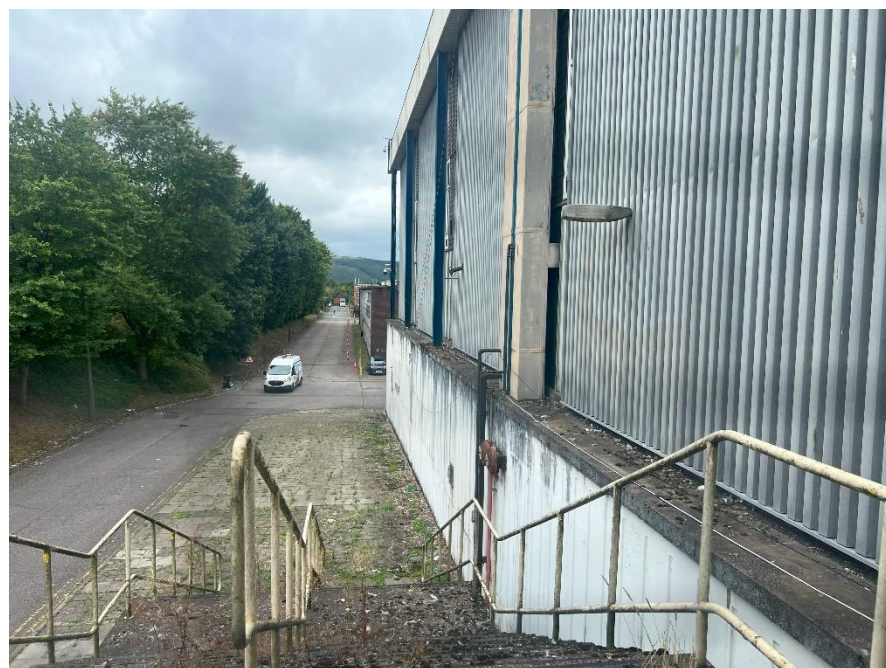
*Photo 35: The external panelling is not flush to the wall and access is available throughout.*

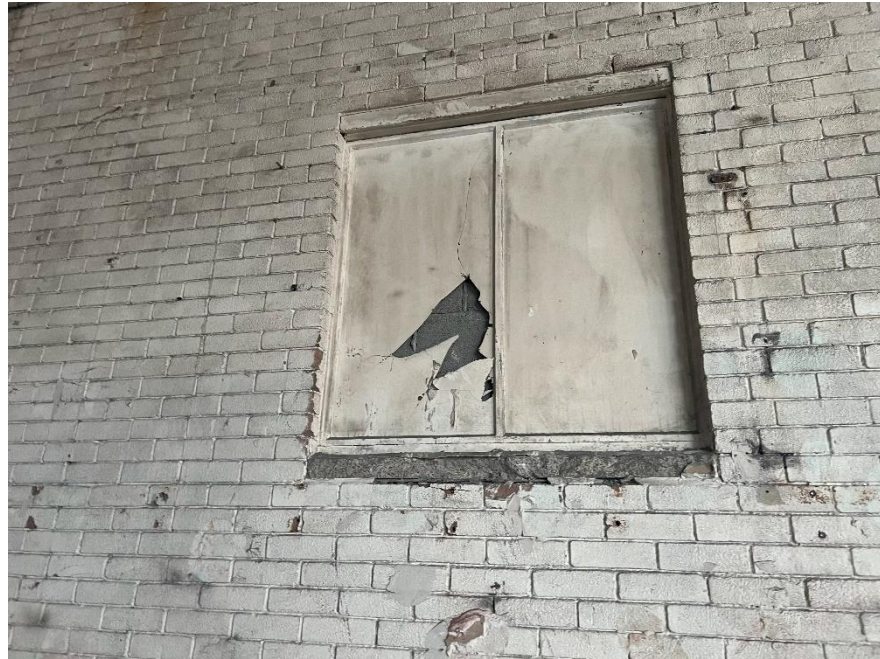
*Photo 36: broken window PRFs with building.*

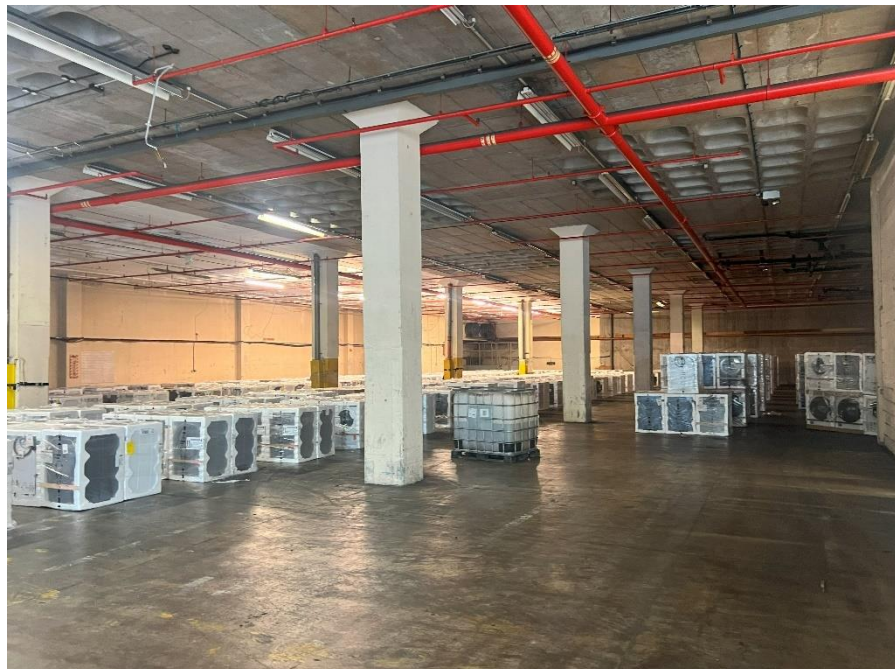
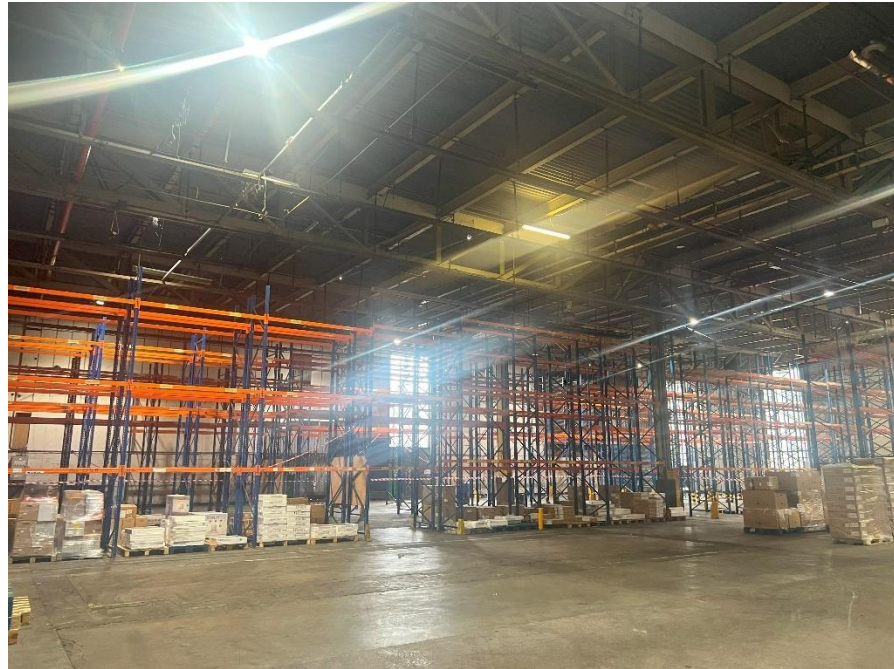
*Photo 37 and 38: Warehouse is active with internal lighting 24hrs a day.*
