**92 SHIRLEY DRIVE, HEOLGERRIG, MERTHYR TYDFIL**

**BAT SURVEY  
ISSUE 1, VERSION A**

**Bat Survey Report**

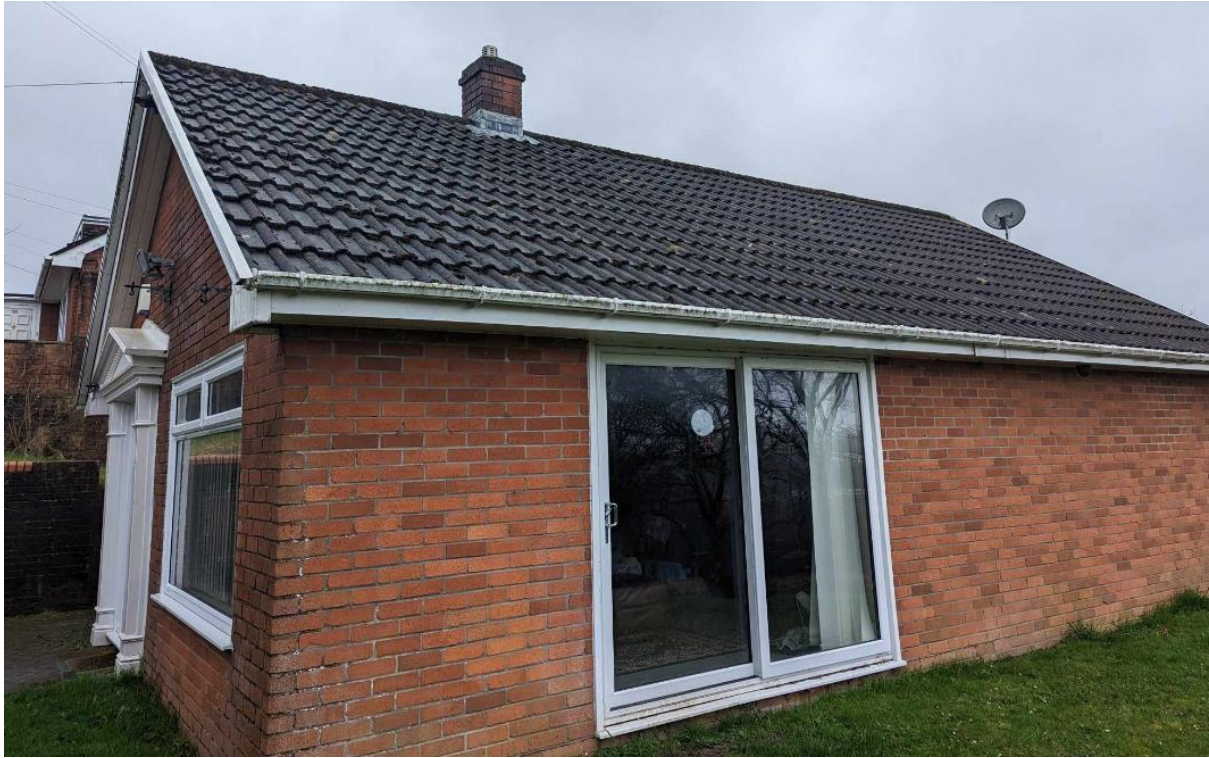
Please see appended plates for photographs of the property exterior. Other than these areas, the building appears to be relatively sealed. No gaps were noted around the lead flashing of the chimney nor beneath tiles on the main building.

Plate 1- photograph of tightly sealed roof

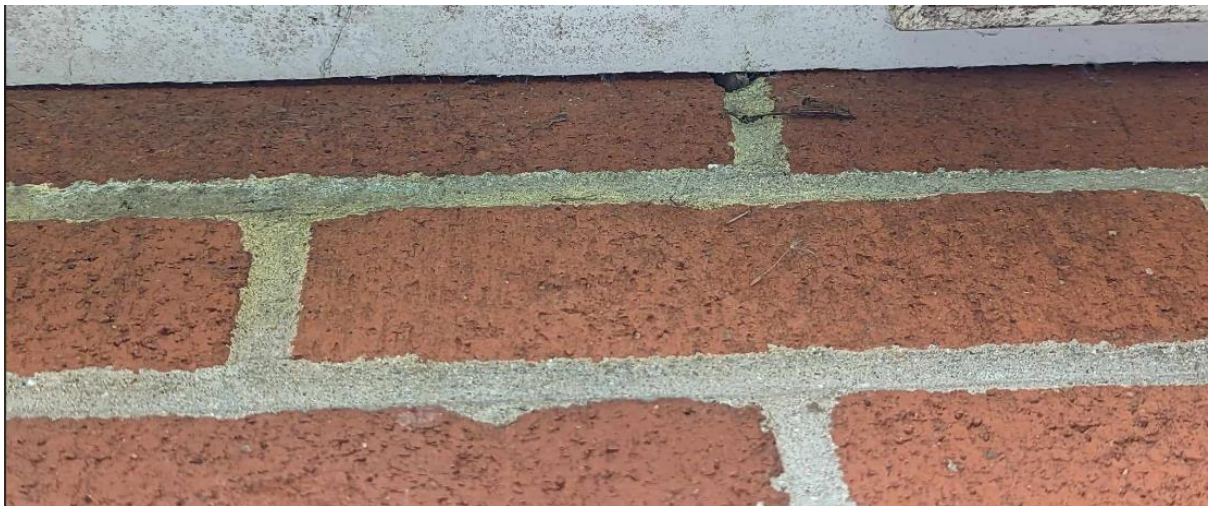
- Gaps beneath uPVC barge boards and fascias

Please note, the gap beneath fascias and barge boards are very small and it is considered unlikely that bats can actually enter at these locations.

Plate 2- example of this gaps at eaves level

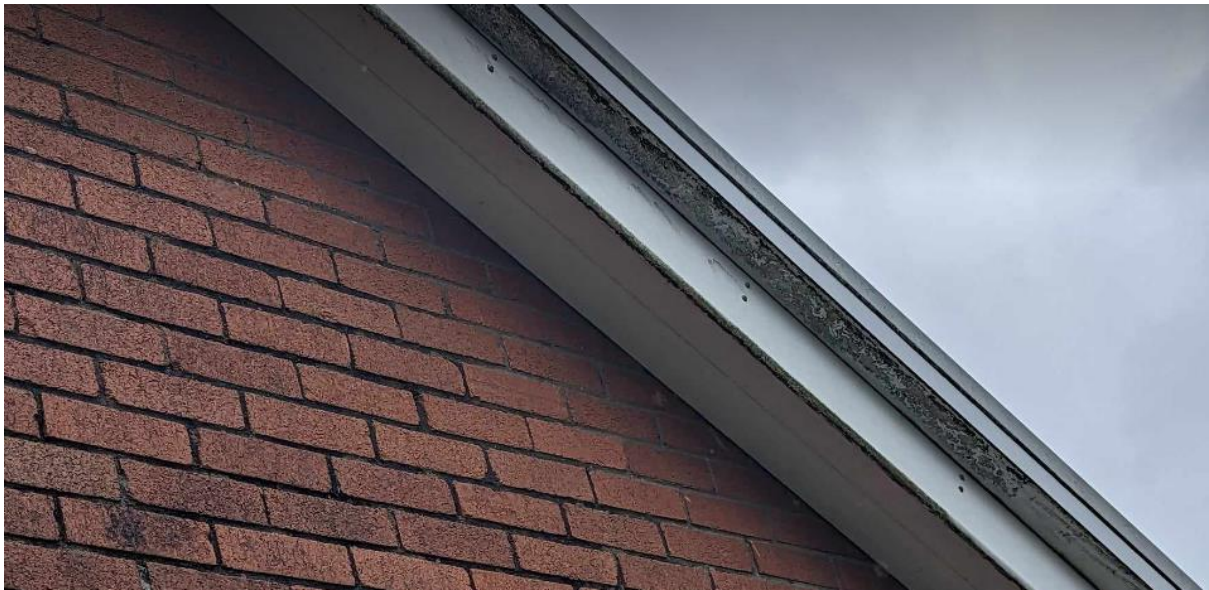
**Plate 3- example of thin gaps beneath barge board**

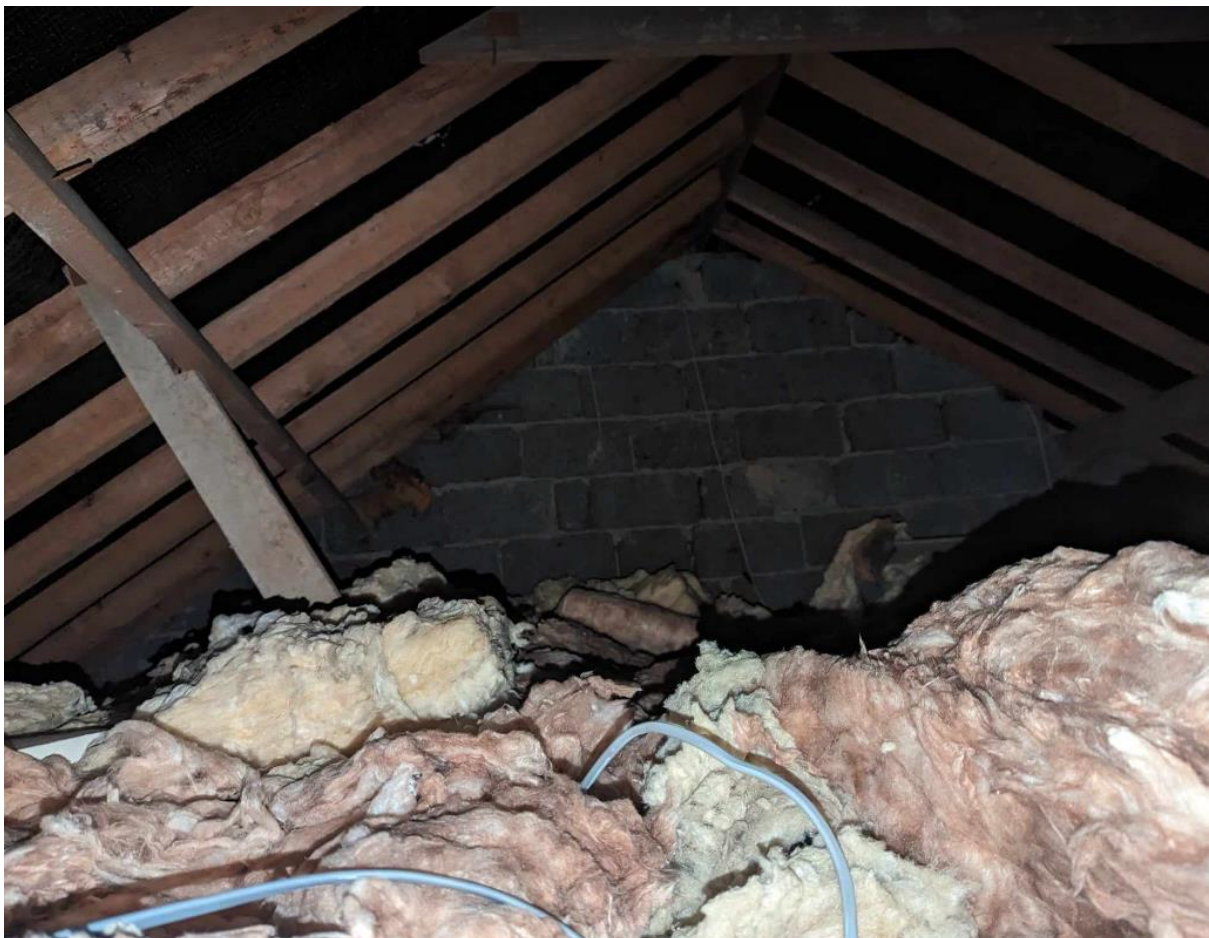
There is a small roof void above the property with an approximate height of 1.5m from joist to ridge. The void is a typical rafter and perlin construction with a bitumen felt roof. A section of bitumen appears to have been replaced by a plastic membrane. The loft is insulated at joist level with fiberglass insulation. The loft has a light present, appears to be relatively clean and tightly sealed with no obvious light ingress. No bats or evidence of bats was observed.

**Plate 4- photograph of roof void**

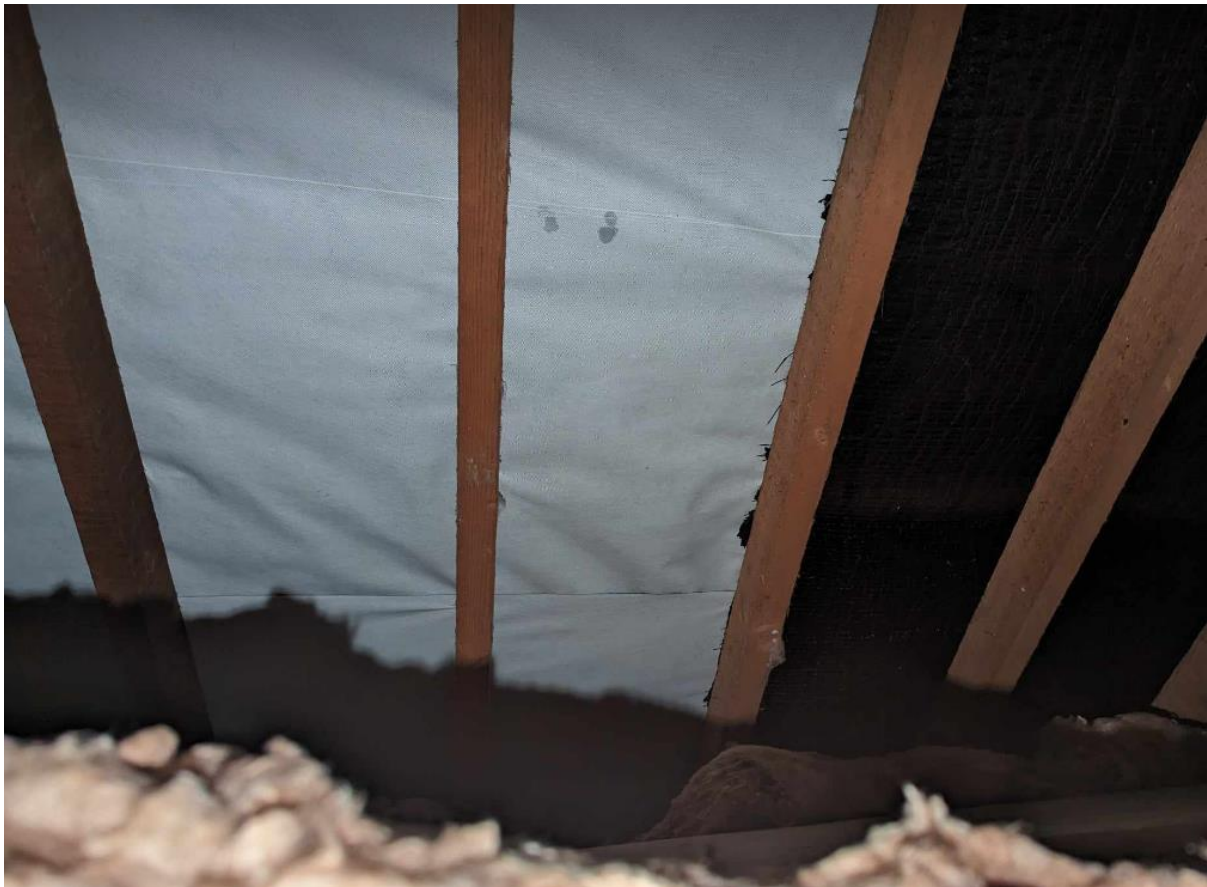
**Plate 6-plastic membrane**

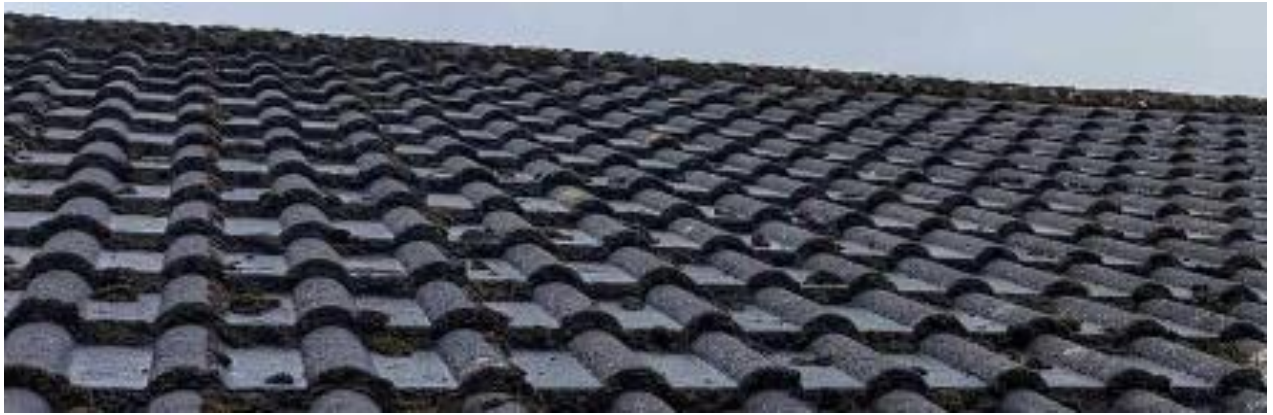
**Plate 7- photograph of tightly fitting tiles**

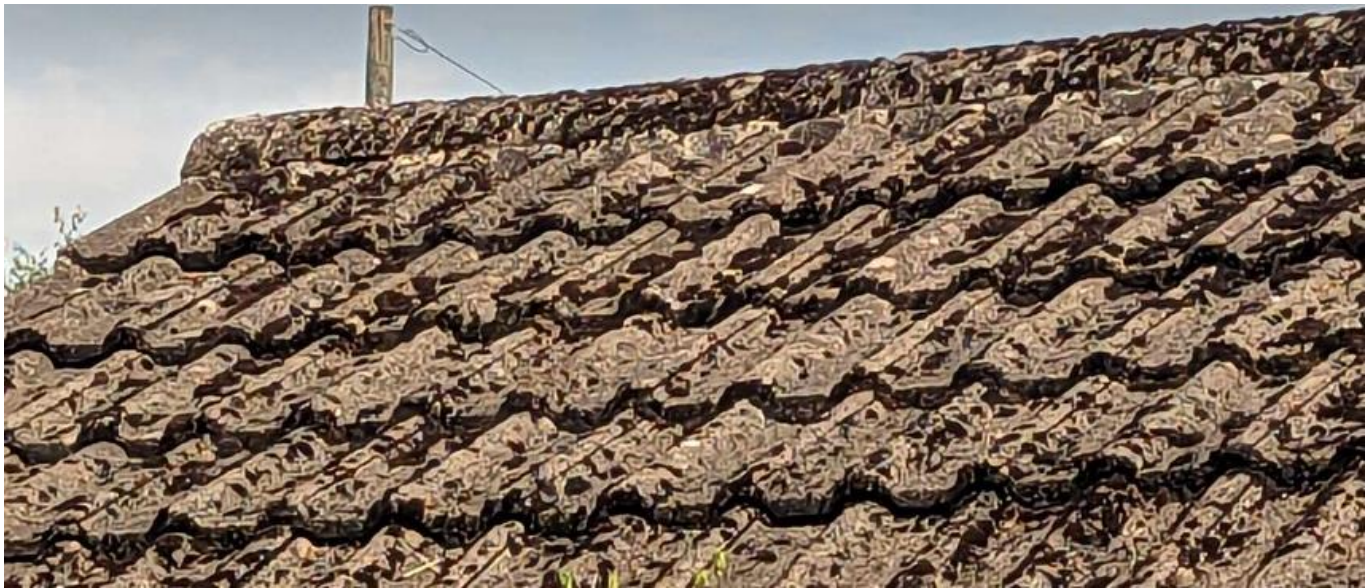
The onsite garage appears to have very few points of ingress for roosting bats. The roof appears to be well cemented with tile overhangs blocked with moss. The windows and doors are kept closed. The fascias are bevelled so that they fit flush with the wall. The ridge tiles are tightly cemented.

**Plate 8- photograph of tight fitting tiles on garage**

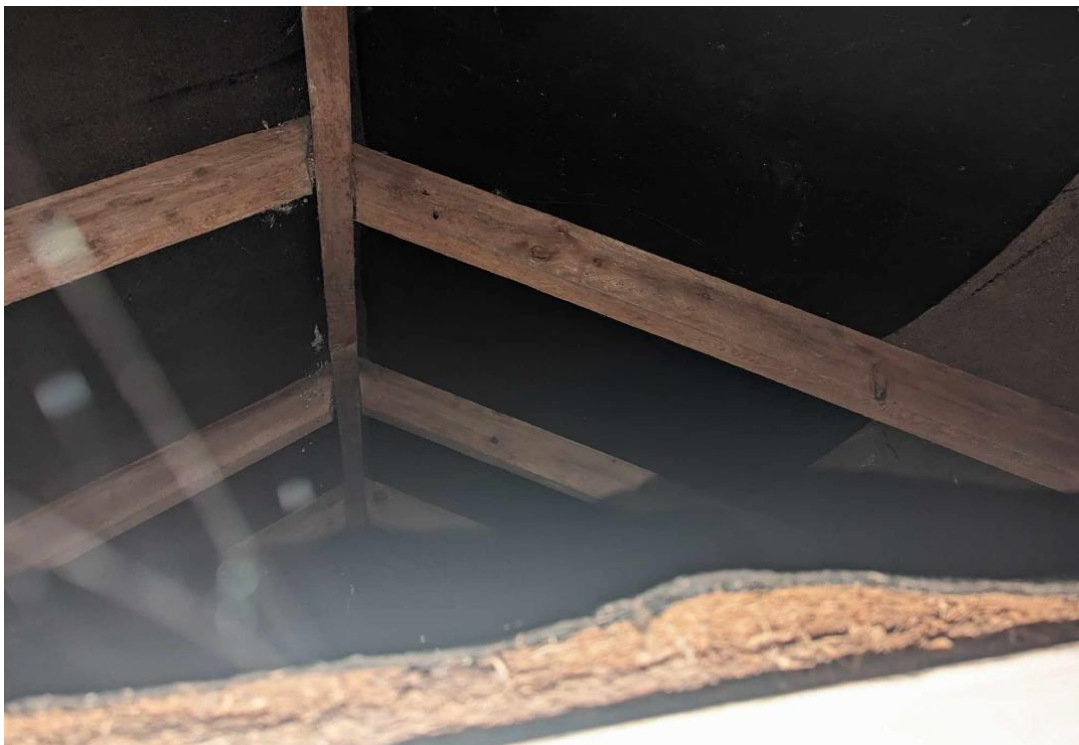
There is a very small void present above the garage. The void is lined with bitumen felt and is not safe to walk on but can be viewed from the entrance hatch. No bats or evidence of bats was found in this location and no obvious light ingress' or points of ingress were noted.

**Plate 10- photograph of roof void above garage**

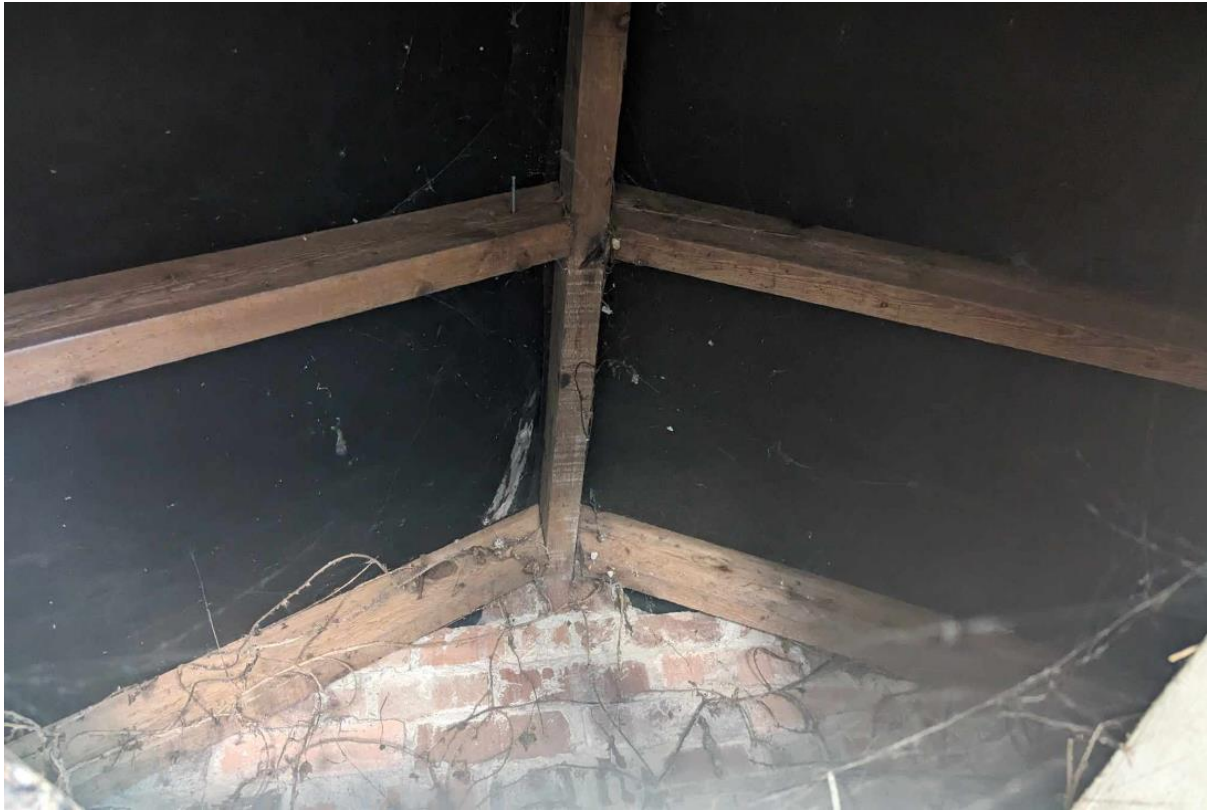
**Plate 11- photograph of rood void above garage**

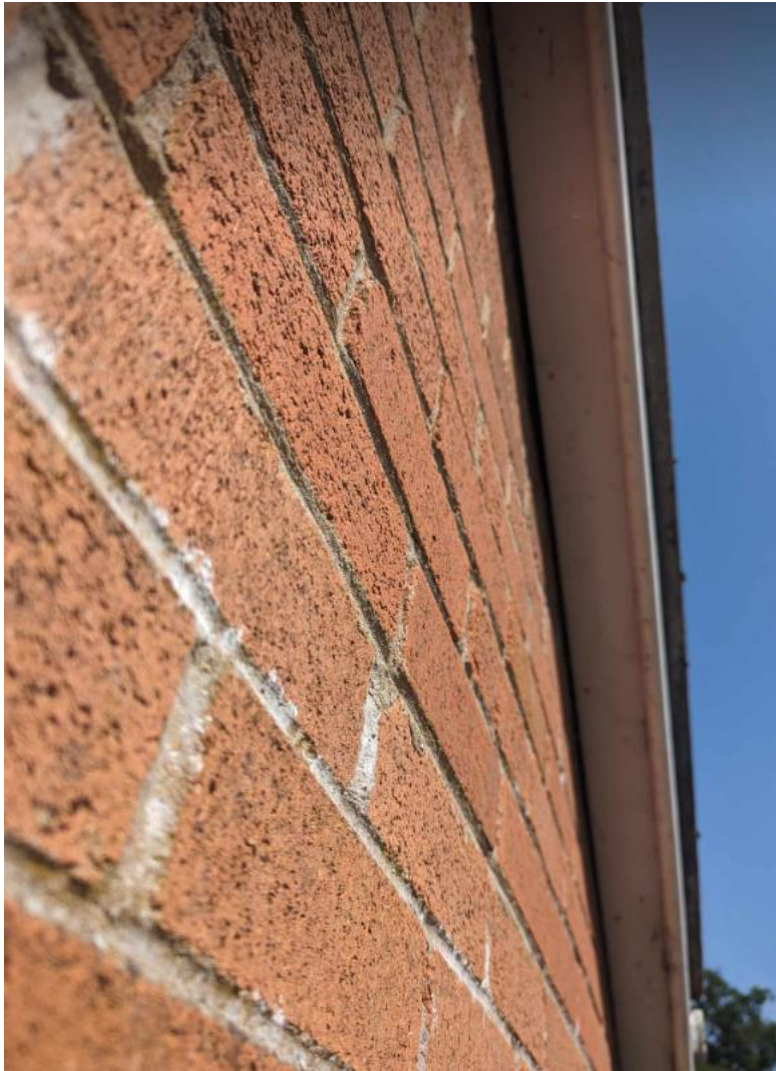
**Plate 13- photograph of small gaps beneath garage fascias**

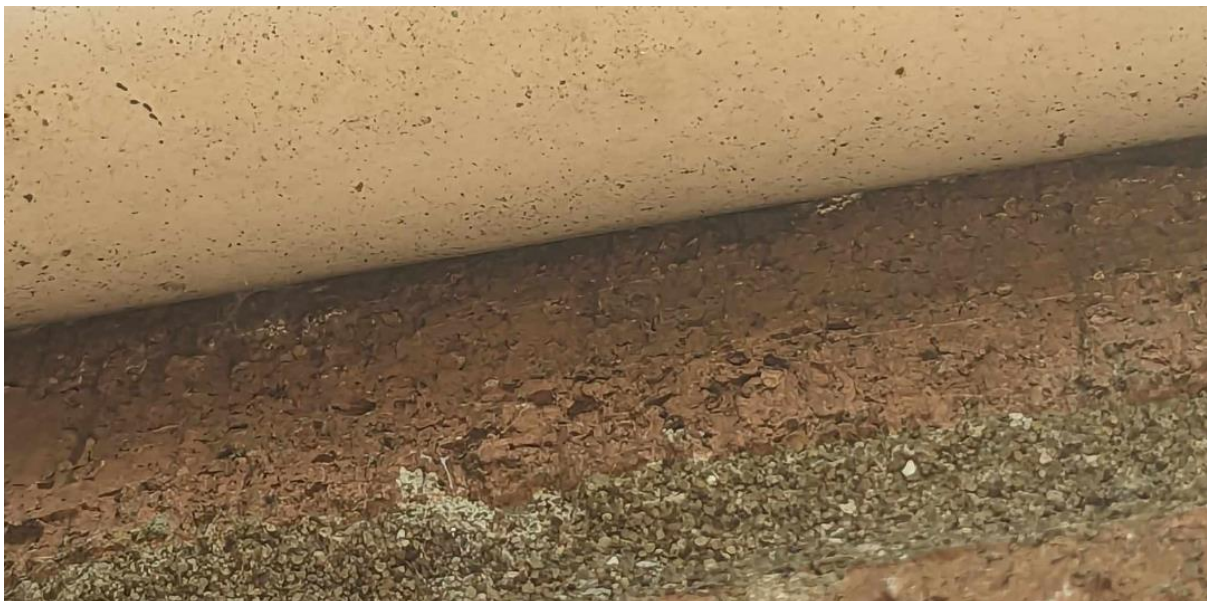
**Plate 14- Close up of gap between wall and uPVC of garage (showing very little access space)**
