# LISTED BUILDING HERITAGE IMPACT ASSESSMENT

BARN / STORAGE SHEDS  
BERTHLWYD FARM  
PENTWYN ROAD  
QUAKERS YARD

K. J. Lloyd AA Dip. RIBA Chartered Architect

OCTOBER 2023

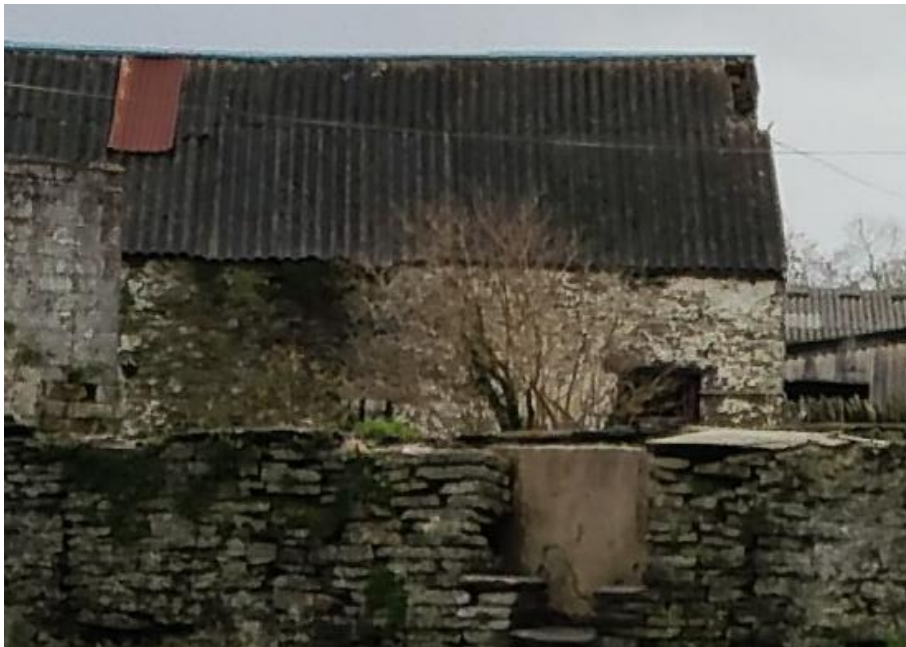
The roof covering was corrugated asbestos and in a poor state of repair. The supporting structure had failed in some areas and needed replacement.

The external walls were generally structurally sound but suffering from water ingress at the head in certain areas due to the failure of the roof covering. Gutters had failed some time ago so water from the roof was generally discharging on to the stonework.

This is the only photograph that has been found illustration the state of the building prior to any work being carried out. The general decayed state is obvious to see

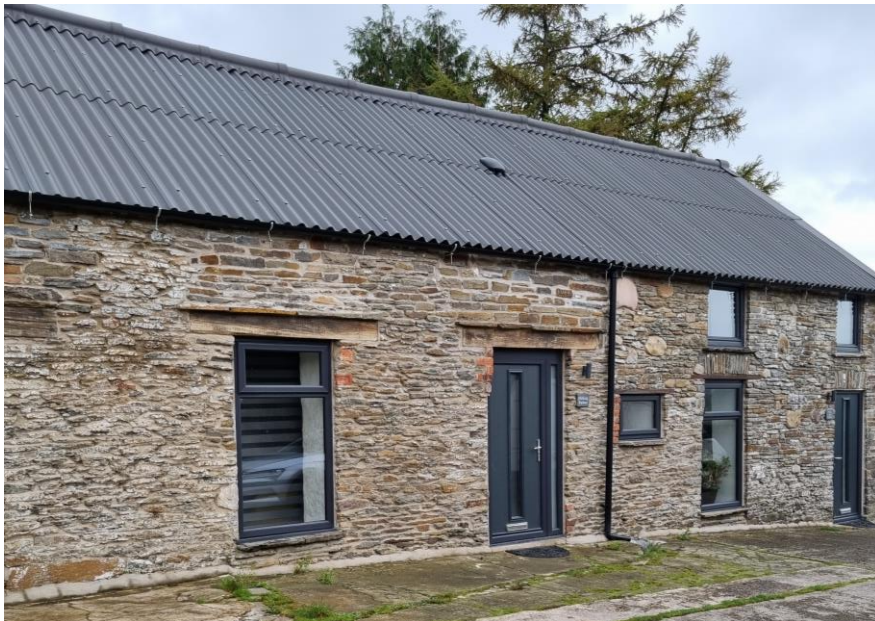
The external walls had been covered with a limewash over the stonework. Due to the water penetration this had become worn away and provided no protection against any weather. The walls have been cleaned down and repoint.

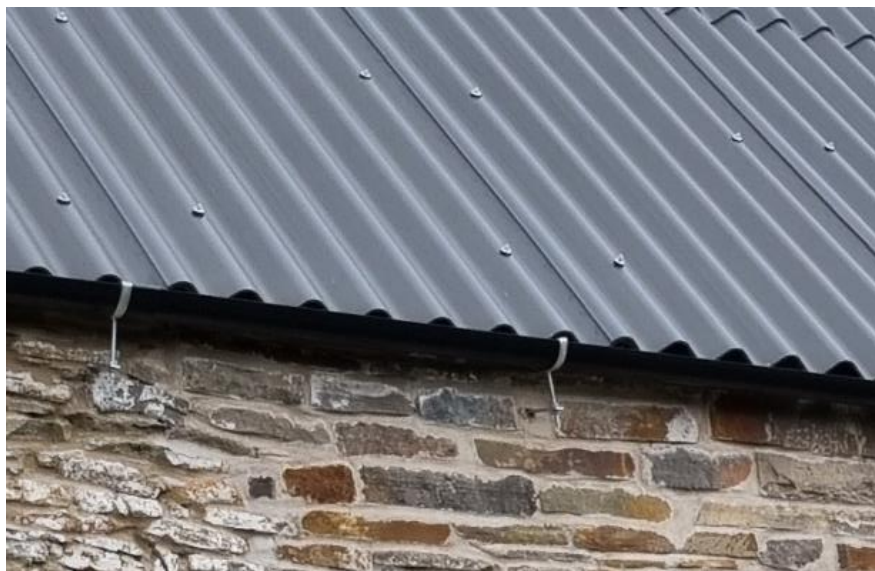
Areas of defective stonework have been removed and re-built.  
The roof has been covered with Black Corrugated roofing sheets

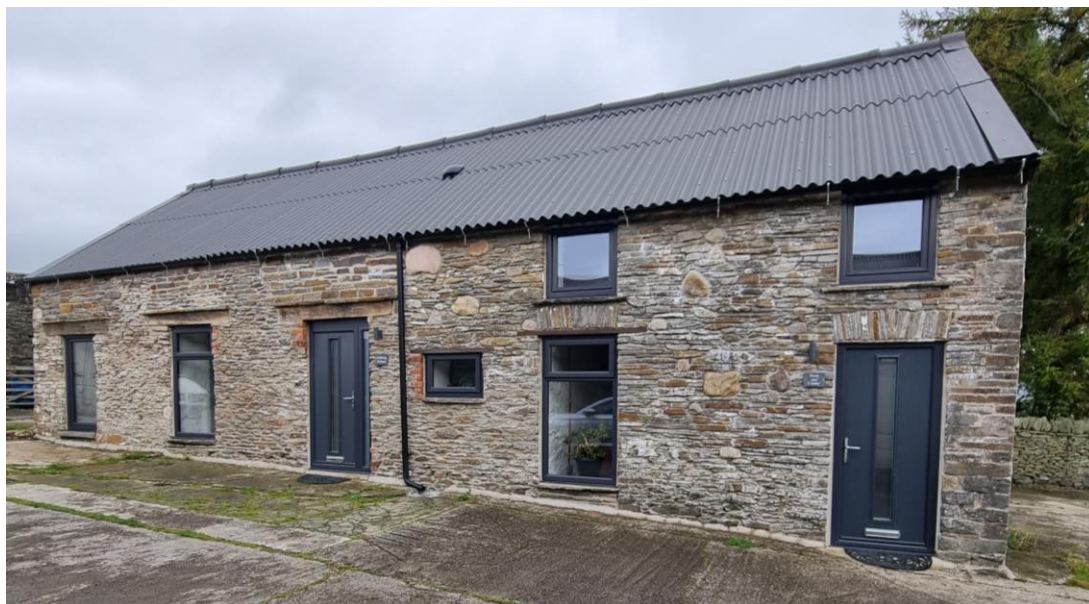
Black gutters have been secure to the stonework using galvanised metal brackets

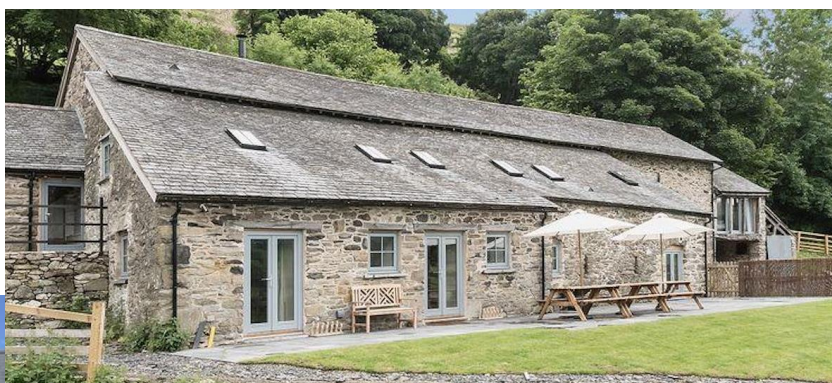
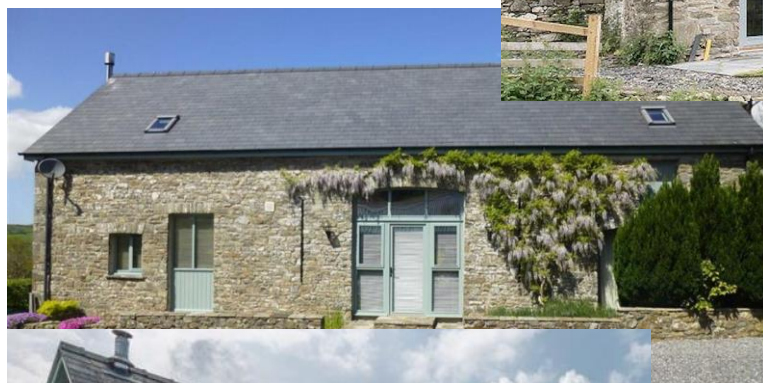
External windows and doors have been installed in Anthracite coloured UPVC. It is proposed to remove these and replace in hardwood painted with a sympathetic colour form the Farrow and Ball range

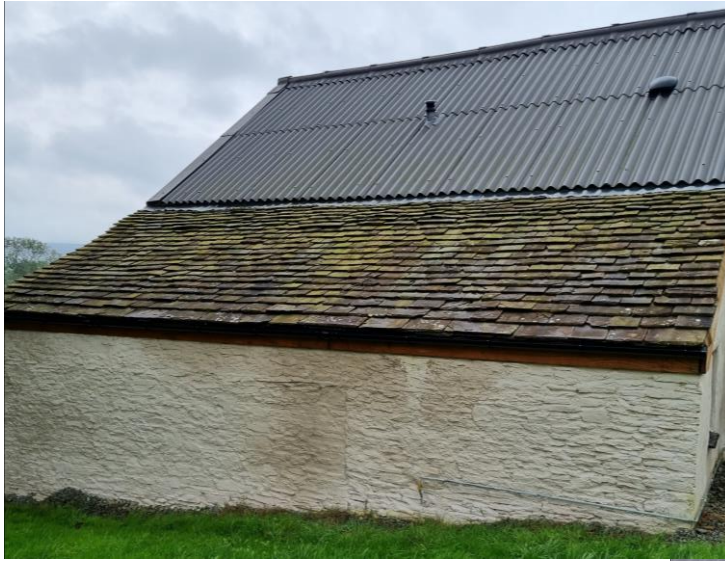
Stonework to the rear has been pointed and finished in masonry paint. It isn't proposed to undertake any further work to these areas

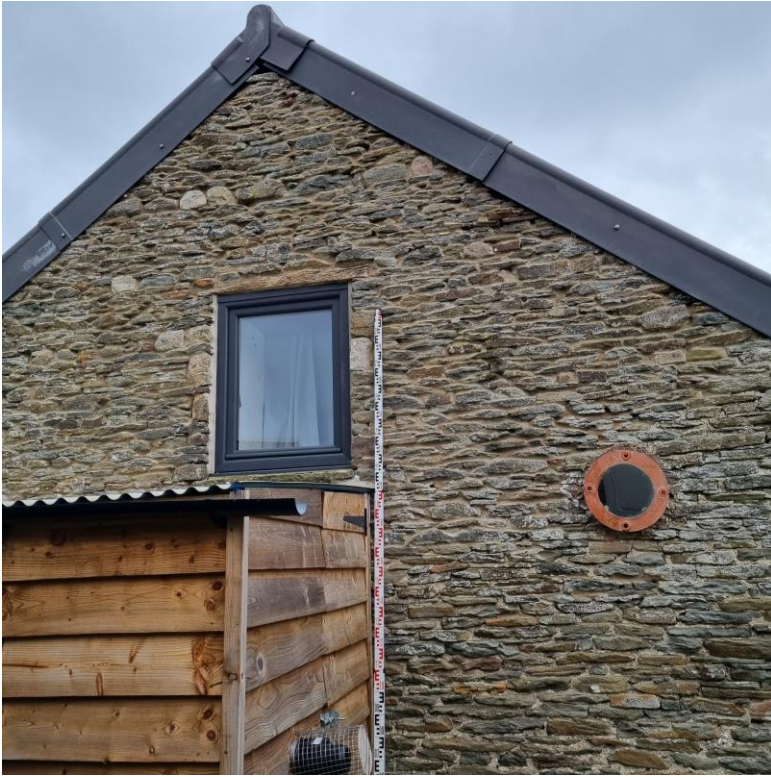
Stonework to this north facing gable has weather well and merely needed cleaning and re-pointing. The window will be replaced

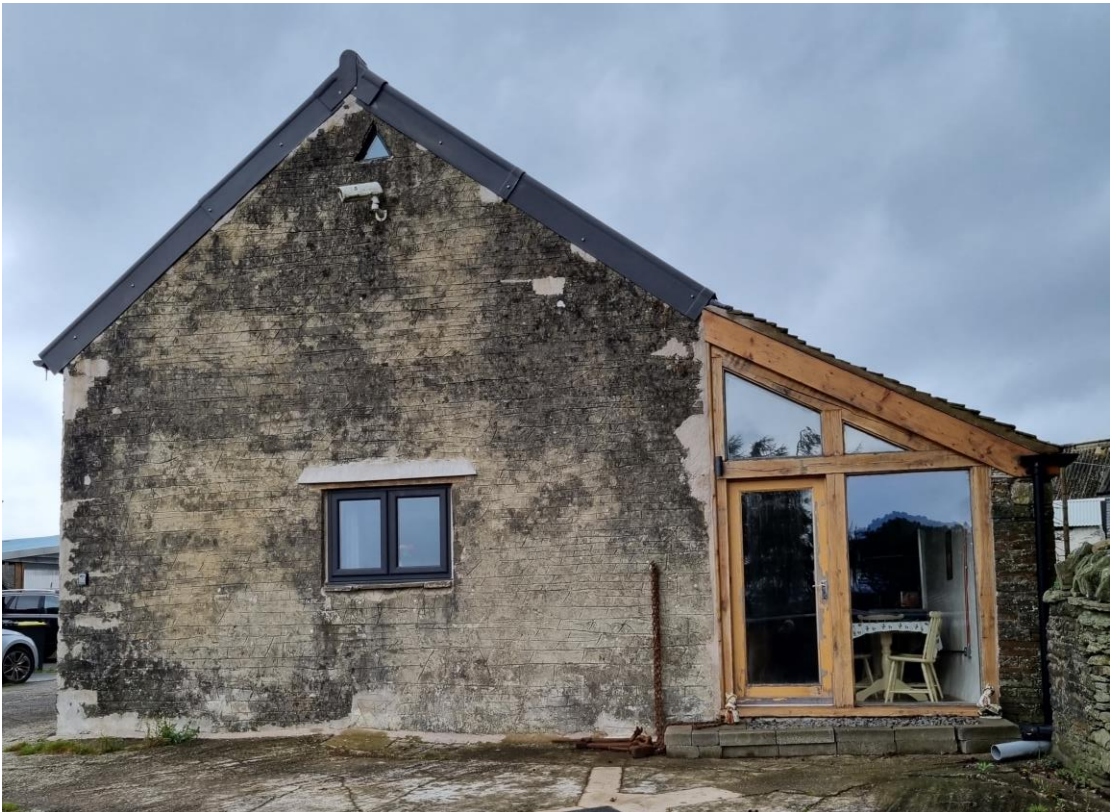
This South facing gable has seen the greatest impact from the weather due to the elevated and exposed location of the building. The render is currently structurally sound with no evidence of de-lamination from the building. The proposal would be to clean down and paint as removal would expose the stonework long-term to water penetration. The window will be replaced

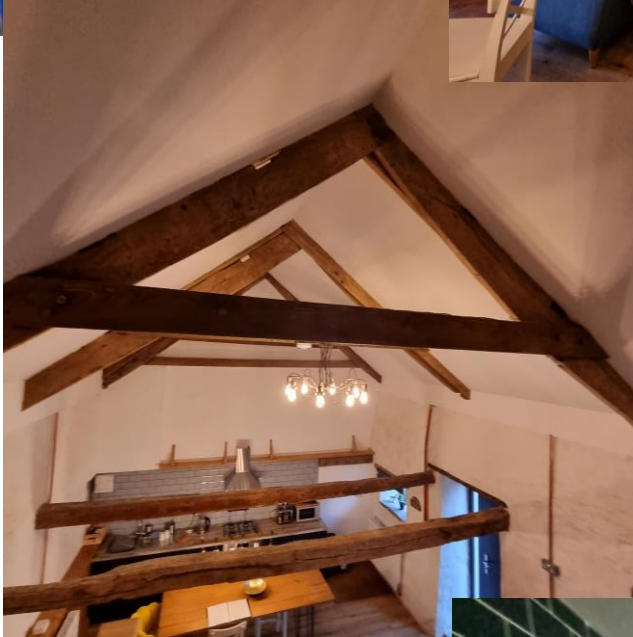
Original timber roof trusses were retained and improved structurally where required

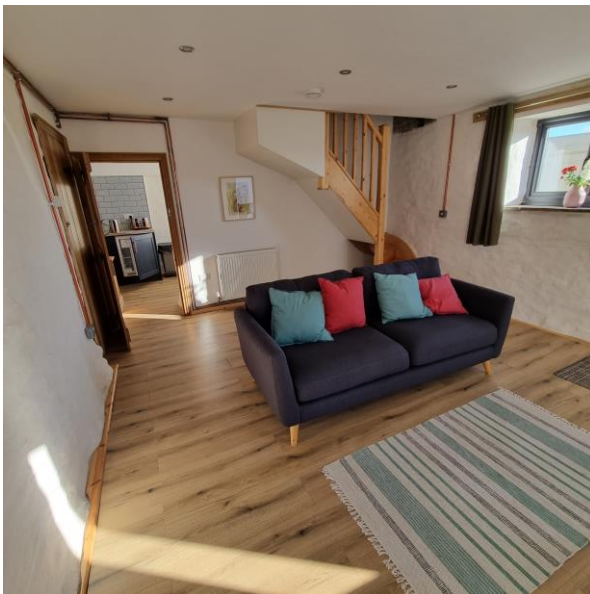
The ground floor was covered in concrete some time ago and there is no record of what is beneath. It could have been paving slab or cobbled as it was a workshop. This has now been covered with a timber flooring
