# Abercynon Feeder Pipe Bridge Replacement

## Arboricultural Impact Assessment Report for Baker Hicks

| Job Number | 7028 | | |

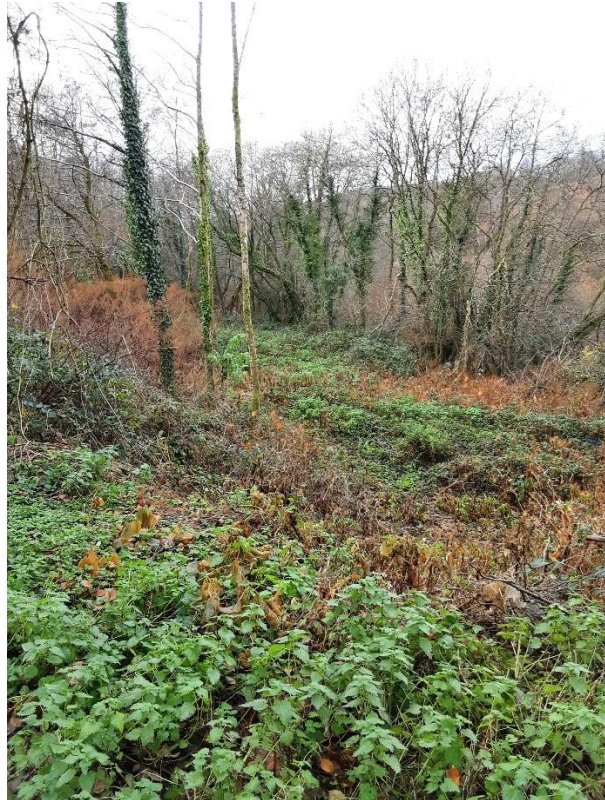
**Photograph 1**

View looking towards G4, with  
T35, T36, T37

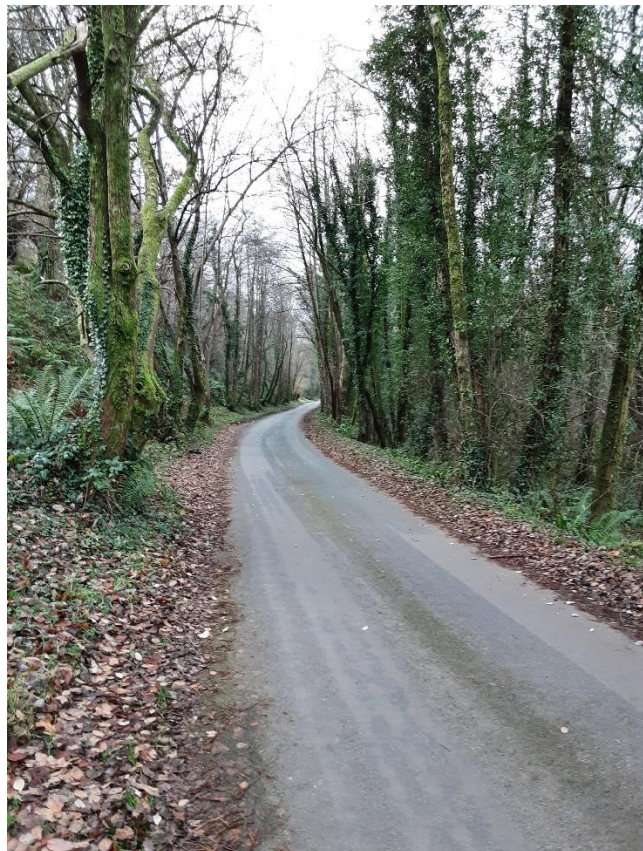
**Photograph 2**

View along road with T19 in  
the left of picture.

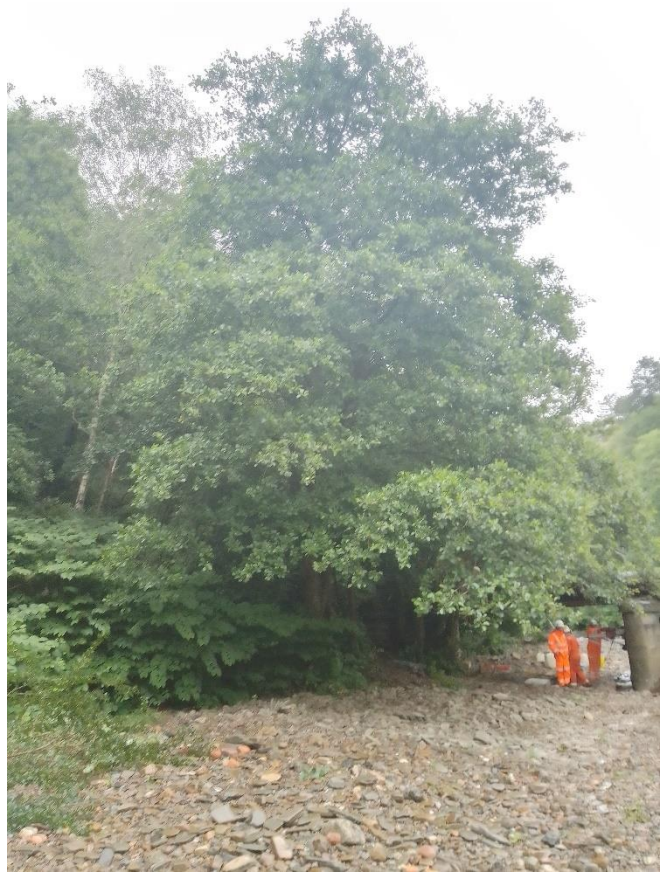
**Photograph 3**

View looking towards T62

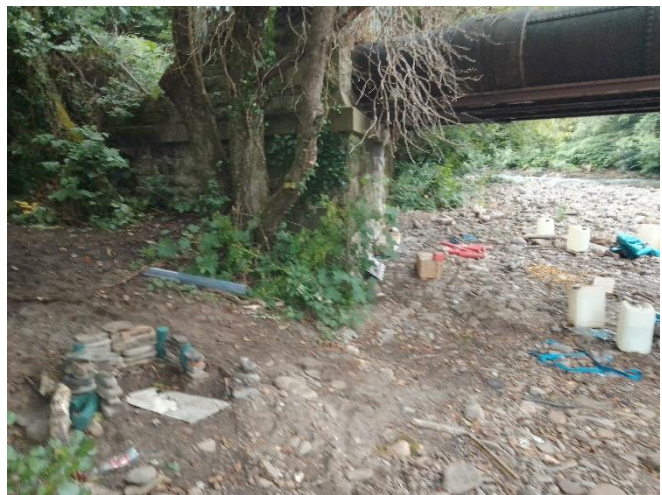
**Photograph 4**

View looking towards T89

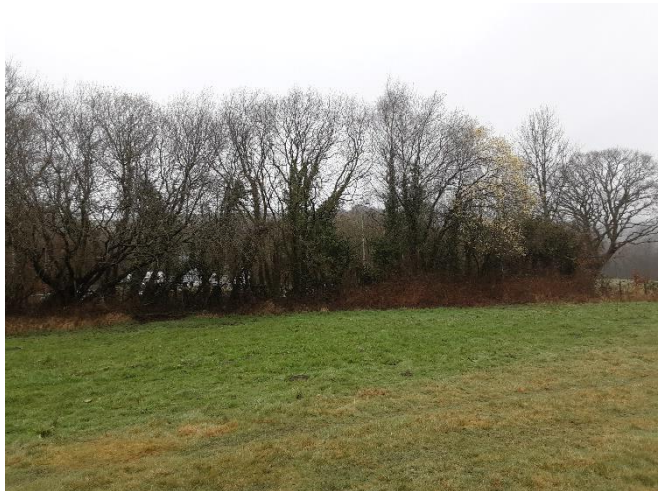
### Photograph 5

View looking towards G8.

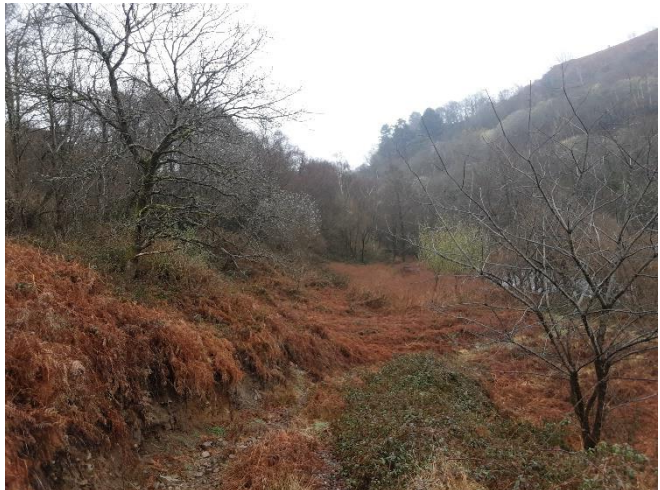
### Photograph 6

- 3.16 On the north bank, an access road has been proposed throughout woodland group W2 and within the RPAs of trees T48, T51, T52, T65, T67, T68, T75 T76, T79, T80, T81, T82, T83, T84, T86, T88 and G7. The existing ground surface at these locations is soft, providing good growing conditions and the trees can be expected to have developed extensive root systems. Any excavations inside RPAs or compaction to the soil will have the potential to cause significant damage to the structural and physiological condition of the trees. An Arboricultural Method Statement will therefore be required to demonstrate that proposals can be properly carried out using specialised no dig methods only. Such works will require close arboricultural supervision in order to help mitigate against damage.

View looking down proposed access rout, T49 left T48 right.

- 4.3 It is recommended that the access road proposed for the north bank is comprised of a no-dig system (Cellweb TRP, tree root bridge or similar), suitable for heavy vehicular construction traffic, topped with a permeable hardstanding in order to protect the existing soil strata from overloading while maintaining gaseous and aqueous exchange capacity. If installed correctly, under direct arboricultural supervision and in accordance with an AMS, impact on the structural or physiological condition of the adjacent trees, and of the soil, will be significantly mitigated.

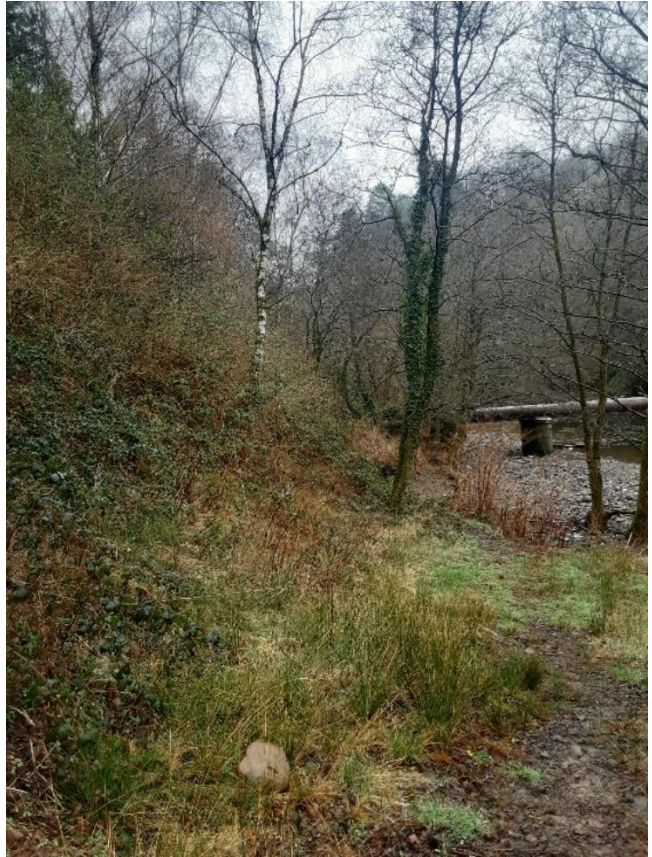
**Photograph 7**

View looking upstream towards  
bridge on north side of river.
