**CHURCH STREET, PENYDARREN, MERTHYR TYDFIL**

**BAT SURVEY**

**SEPTEMBER 2023**

**Bat Survey Report**

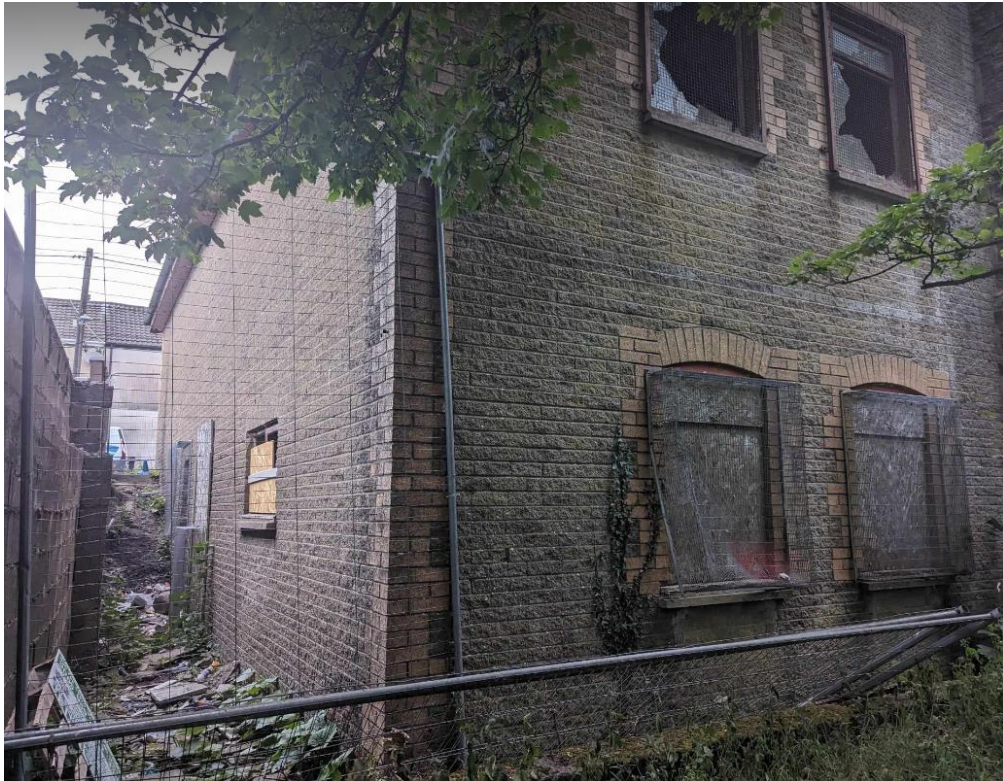
Barge boards and fascias where present are timber and in a poor state of repair. The property has numerous smashed windows and kicked in boarding as a result of vandalism

**Plate 1- Photograph of rear elevation showing boarded up and smashed windows**

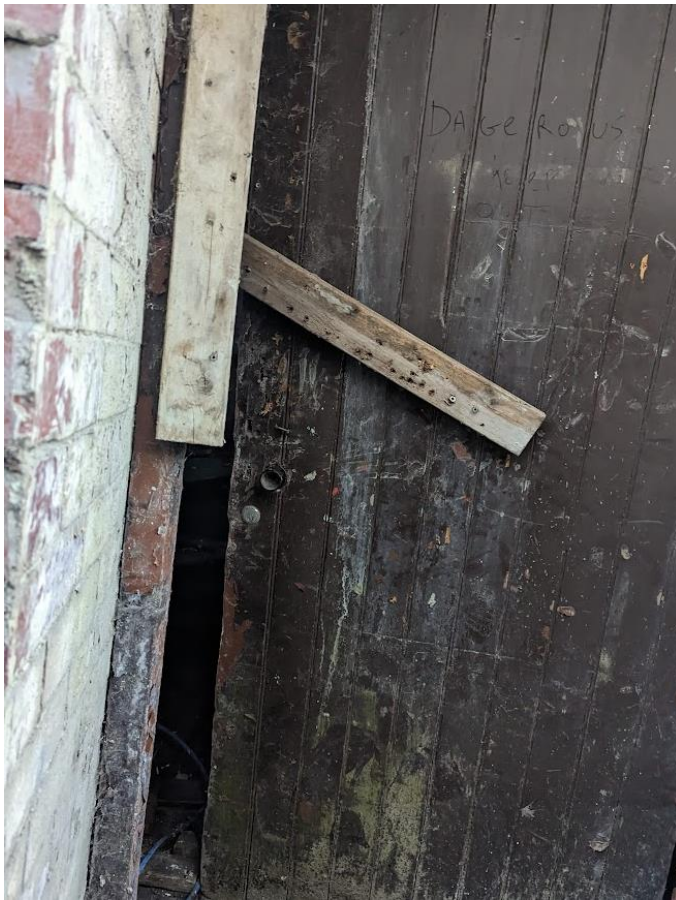
At present the roof is open to the elements and is wet internally with lots of pigeons and pigeon excrement. The floor at the entrance of the building is rotten and not safe to walk on. The pigeon guano on the floor is quite thick in places and very slippery to walk on. The slates of the roof have fallen in over time and are continuing to do so. The basement is not accessible. The floor above the basement is falling in, therefore it is neither safe to walk to the basement nor in the basement. The beams are not structurally safe and there is debris throughout obscuring the floor. The roof and floor structures are not sound and are unsafe for human access. The building is continuing to deteriorate. Given this, the risks associated with entering the building are too high and will not be covered by insurance. As such, full entry into the building was not possible. The interior of the building was able to be inspected from the side door that has been broken into and photographs were taken from this location, however, further entry was not possible.

**Plate 4- photograph of interior with caved in areas**

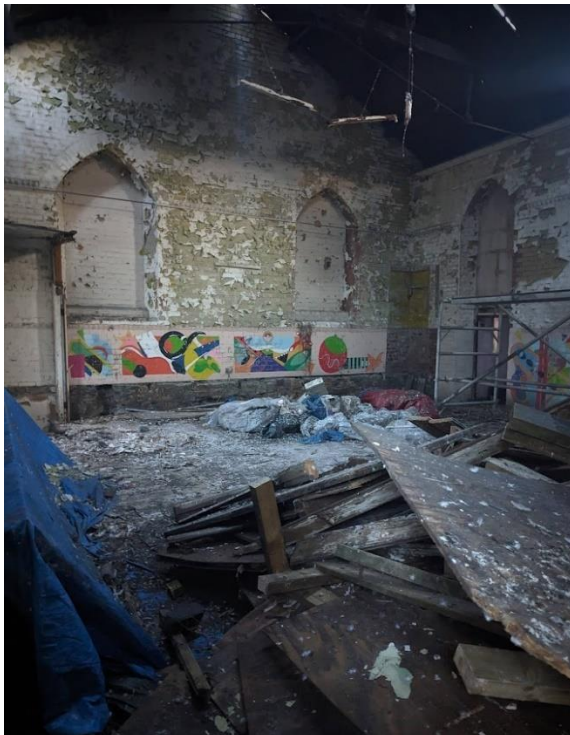
- Holes beneath barge boards
- Open holes in the roof
- Slipped slates
- Smashed windows and open doors

**Plate 5- photograph of slipped and falling slates**

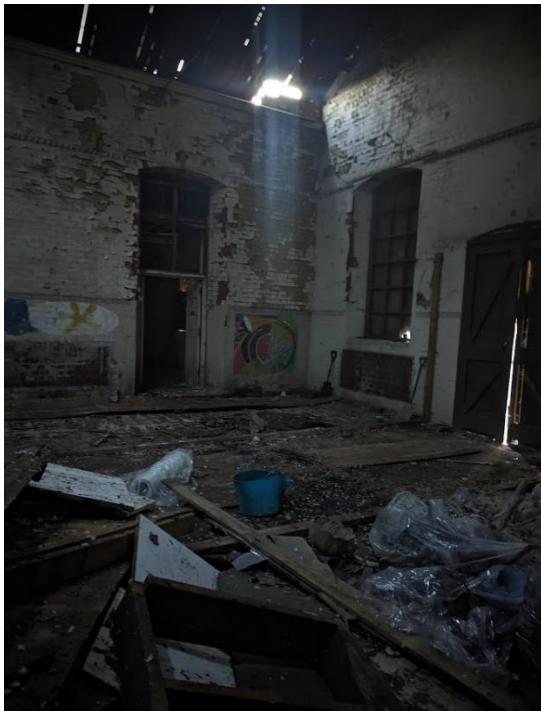
The building has a large number of roosting pigeons. The interior of the building is covered in pigeon guano.

**Plate 6- photograph of pigeon guano**

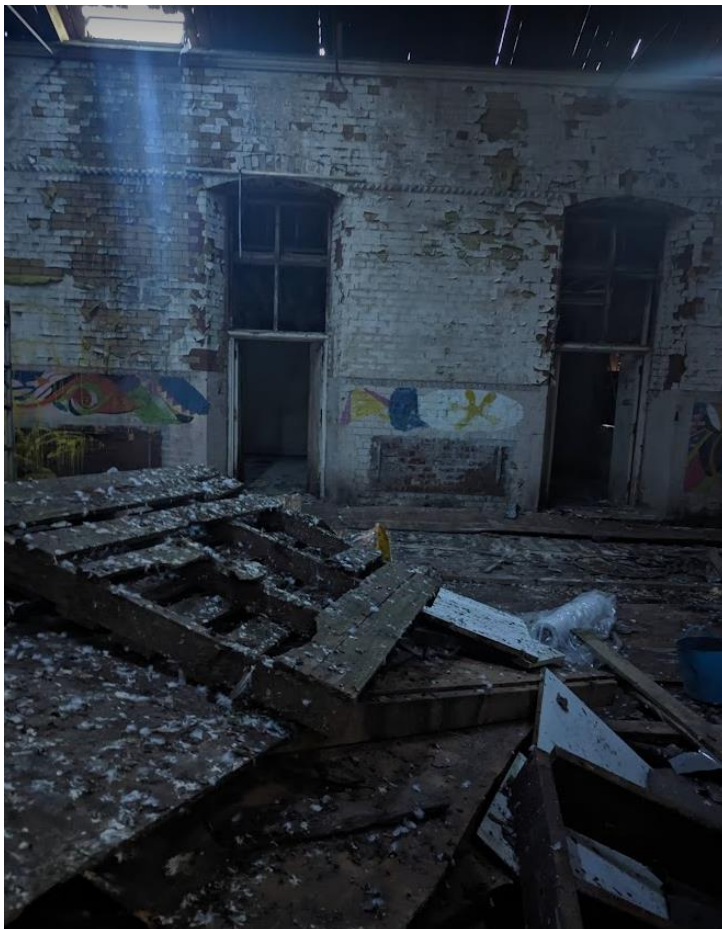
**Plate 7- photograph of splaying roof**
