## **REFURBISHMENT OF GARDEN DECKING / GAZEBO AREA**

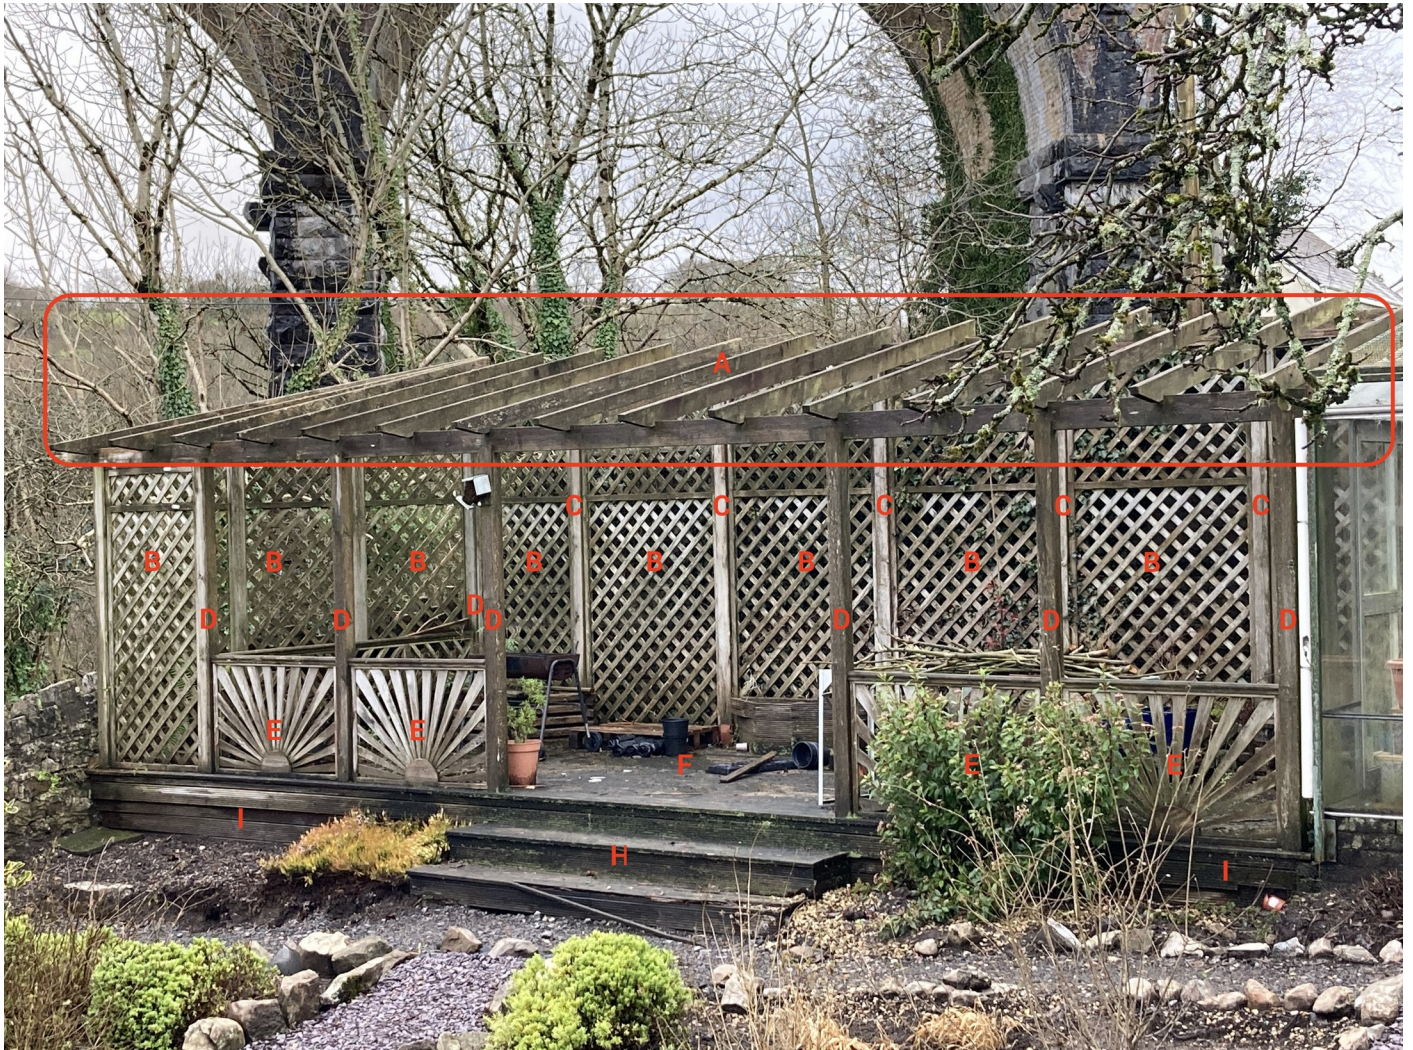
The north-west corner of the garden currently contains a wooden decking area with overhead joists that were previously used to support climbing plants. The area is currently closed to guests as the decking boards have become unsafe for guests to walk on over the last 6 months.

We will remove the overhead joists and all other timbers above the height of the existing front railings, including the latticework panels at the rear. The old decking boards will be removed & replaced. We are not able to check the condition of the supporting wooden timbers until we remove the old decking boards, but any supporting timbers that are no longer fit for purpose will be replaced.

The new design will cover the same floor area (8.5 x 2.95m) as the existing floor, using Enhanced Grip decking boards for guest safety. The concrete wall at the rear of the area, currently hidden behind the latticework panels, will be re-covered with new wooden cladding. The railings on the front & left sides of the structure will be retained.

- A: Overhead joists: Removed completely
- B: Latticework panels at front, side & back: Removed completely with rear wall to be finished in timber cladding
- C: Vertical support joists at rear: Cut down to level of deck
- D: Vertical support joists at front and sides: Cut down to level of existing railings
- E: Decorative panels between deck floor and railings: Removed completely
- F: Decking floor: Replaced with new Enhanced Grip decking boards. Same floor area as existing deck
- G: Decking support framework (not shown): Checked for structural integrity and repaired or replaced where appropriate
- H: Steps: Replaced using new Enhanced Grip decking boards. Same dimensions as existing steps
- I: Fascia boards: Replaced like for like.
