# PHASE 2 CONTAMINATED LAND ASSESSMENT

M.T.C.B.C. PLANNING REF. P/22/0018

DETACHED DWELLING WITH GARAGE

LAND OFF WINCHFAWR ROAD

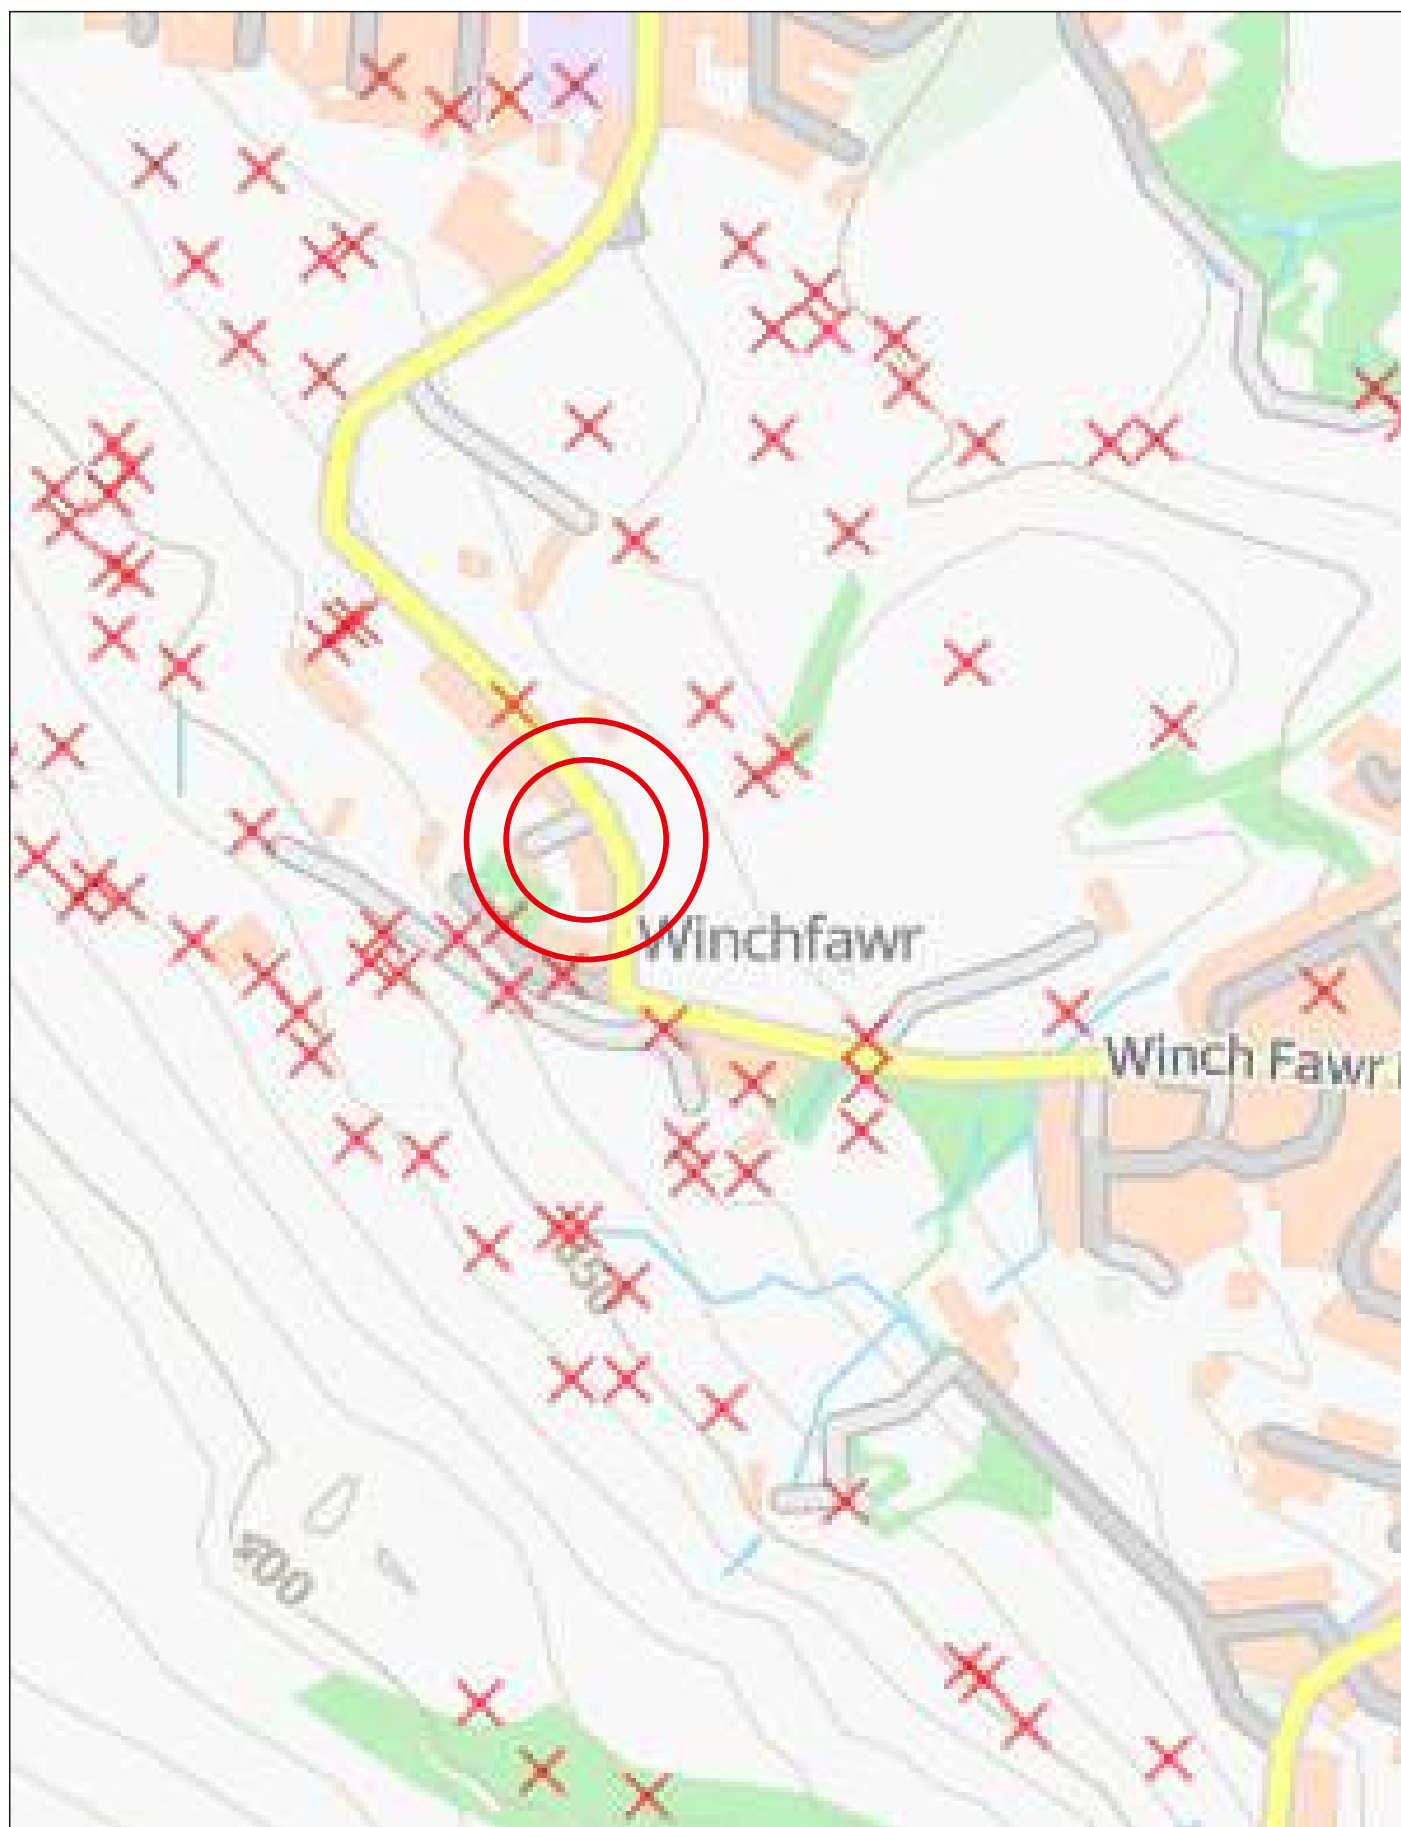
FIGURE 6  
C.A. VIEWER, PLANNING WINDOW. RED CROSSES ARE MINE  
ENTRIES. 50m AND 75m RADII FROM THE SITE ARE SHOWN.

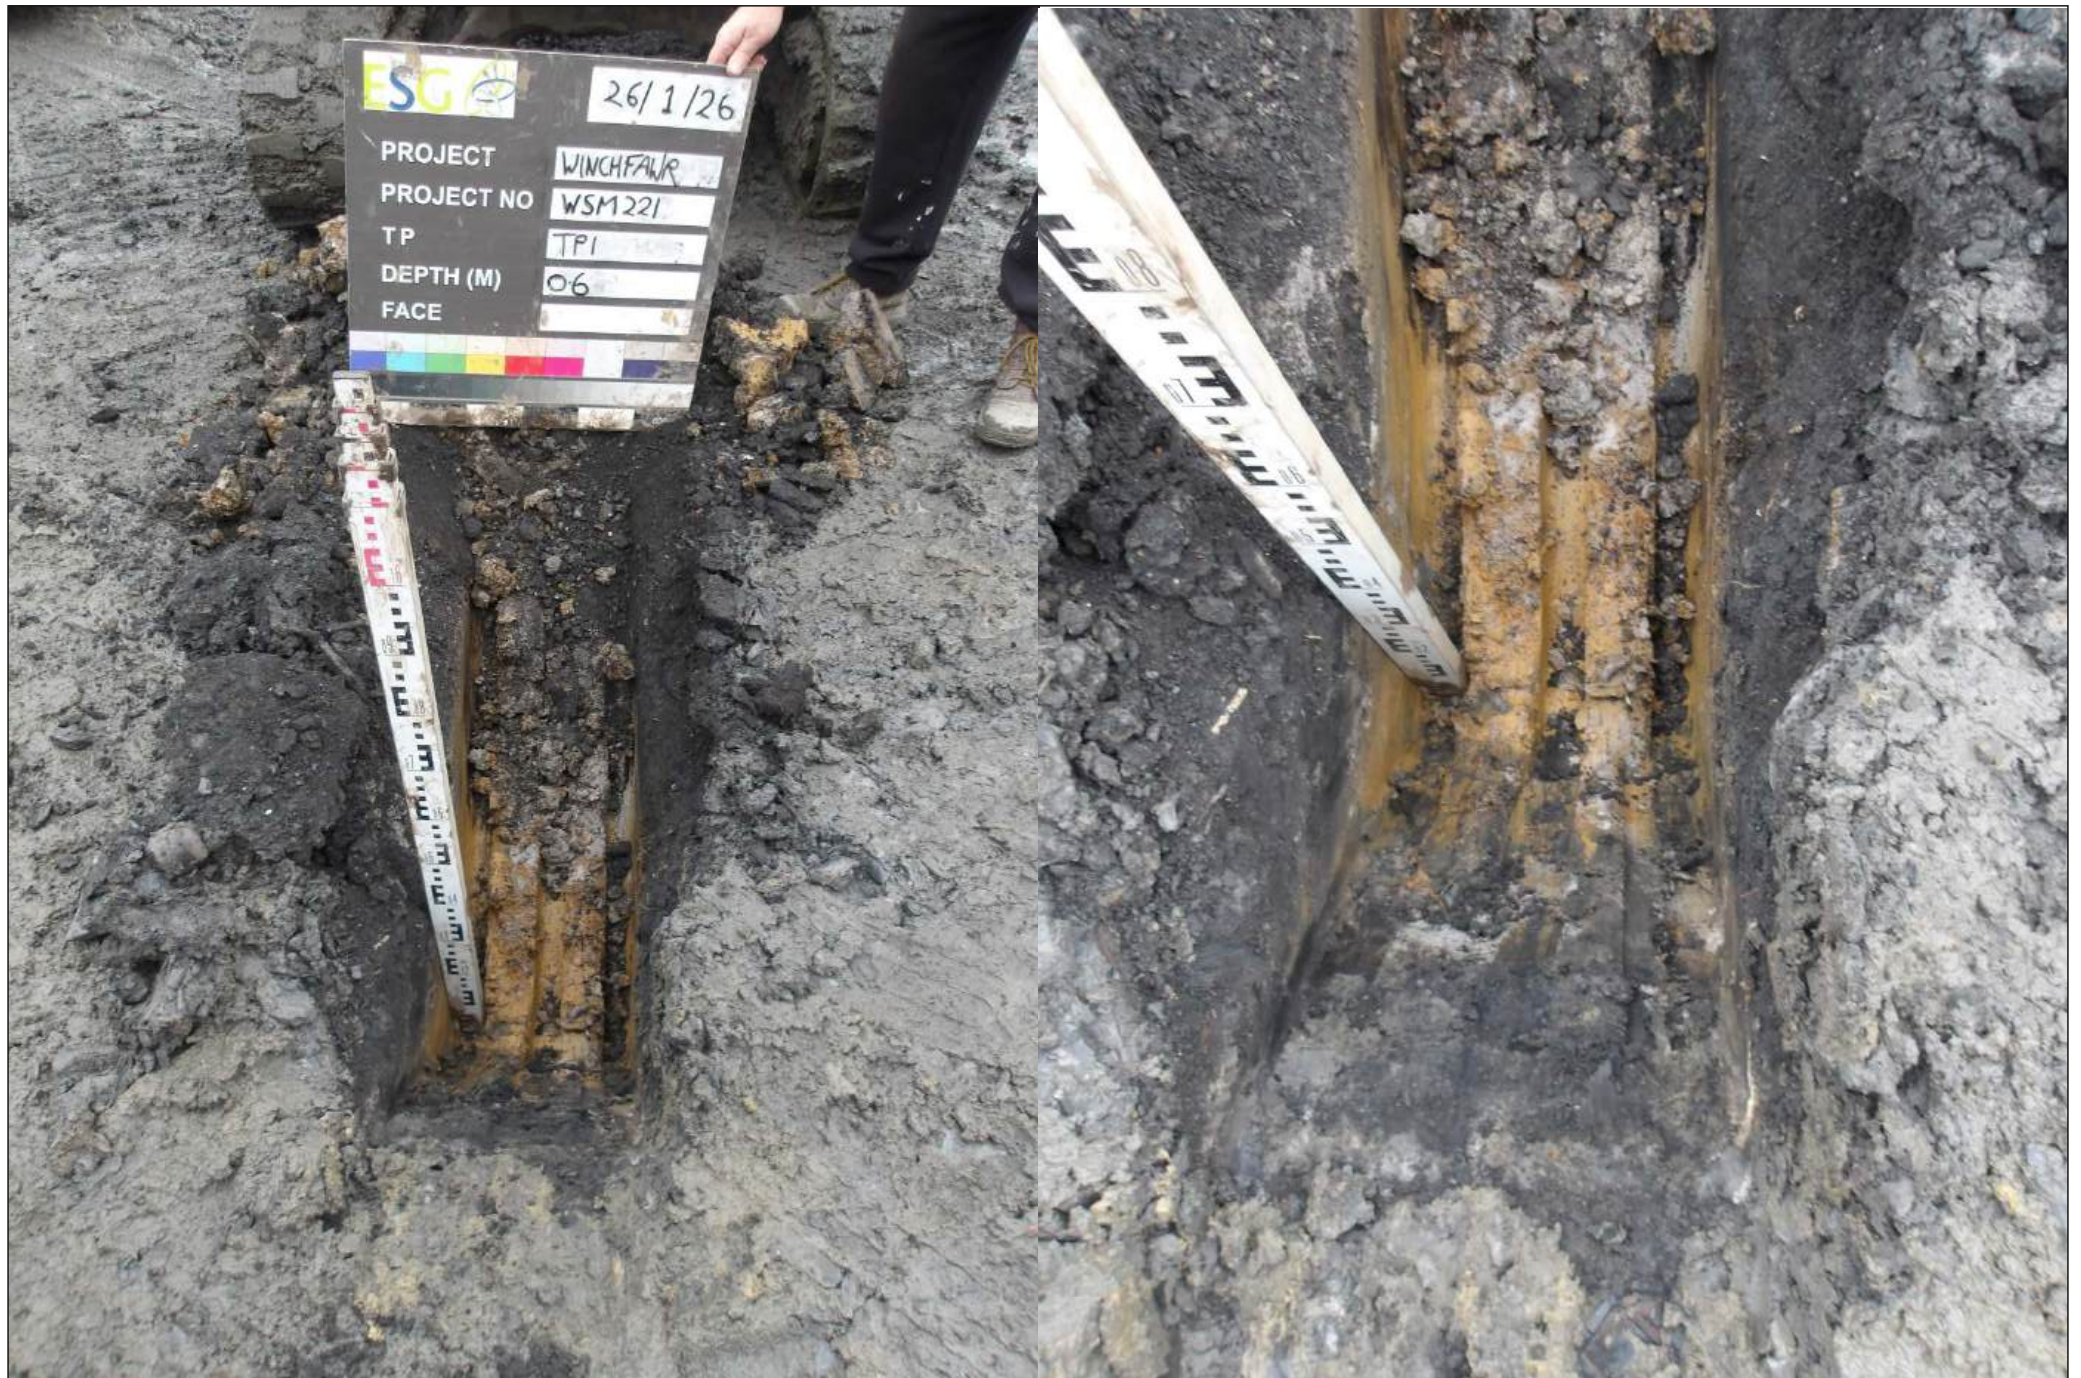
TP 2 22 WINCHFAWR

| Samples and Tests | | Strata | |
|---|---|---|---|
| | | G.L. | MADE GROUND. Loose to medium dense black sandy, slightly clayey GRAVEL. Gravel is angular, fine to coarse of Mudstone and siltstone, sandy component is small oal and ash (COLLIERY SPOIL) |

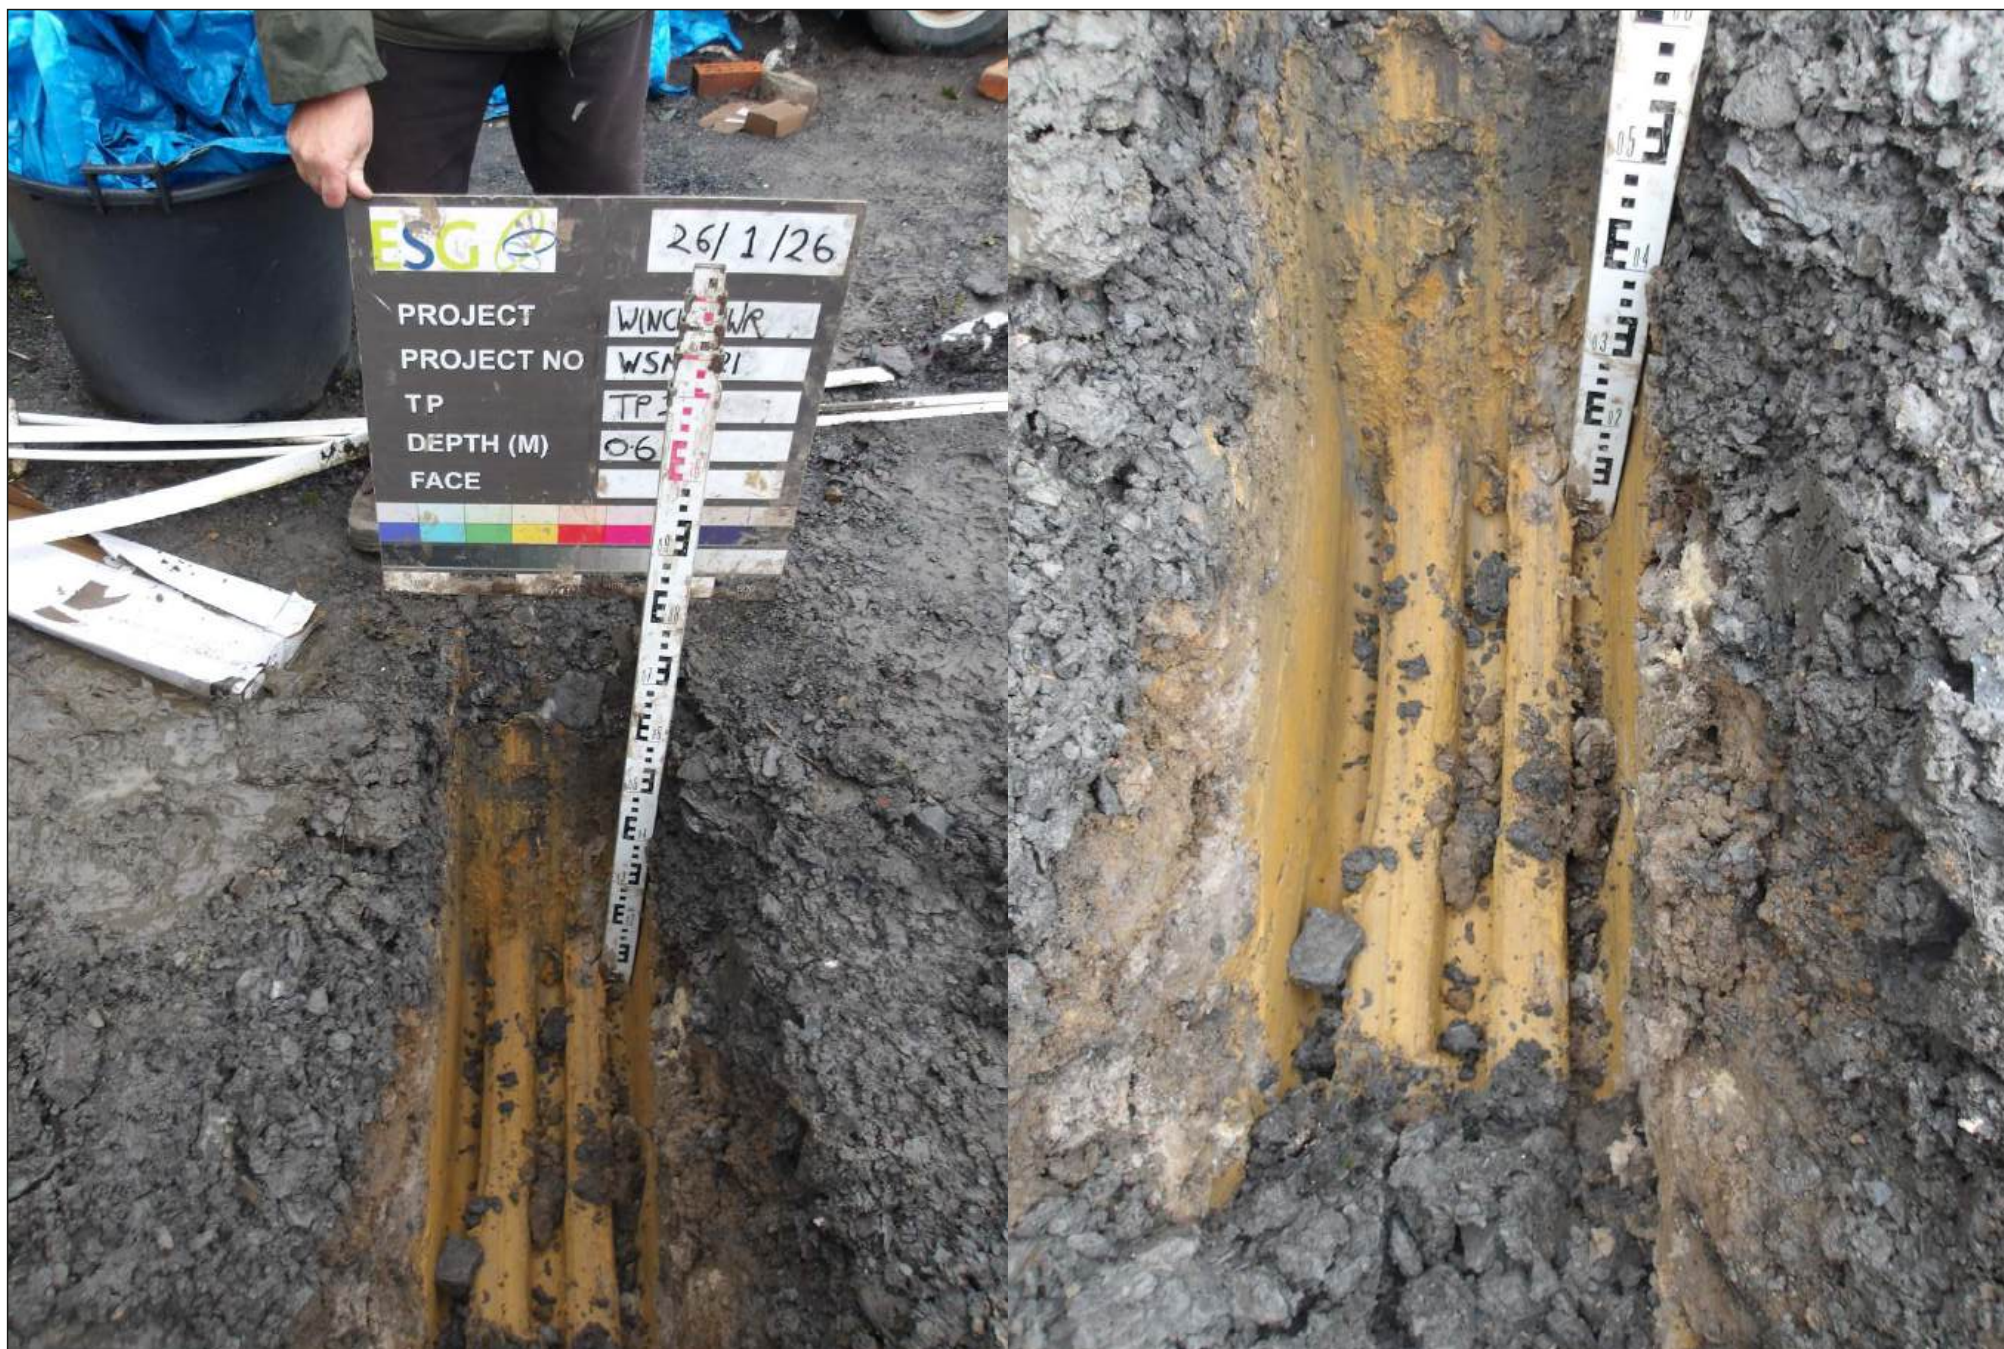
TP 2 22 WINCHFAWR

| Samples and Tests | | Strata | |
|---|---|---|---|
| | | G.L. | MADE GROUND. Loose to medium dense black sandy, slightly clayey GRAVEL. Gravel is angular, fine to coarse of Mudstone and siltstone, sandy component is small oal and ash (COLLIERY SPOIL) |

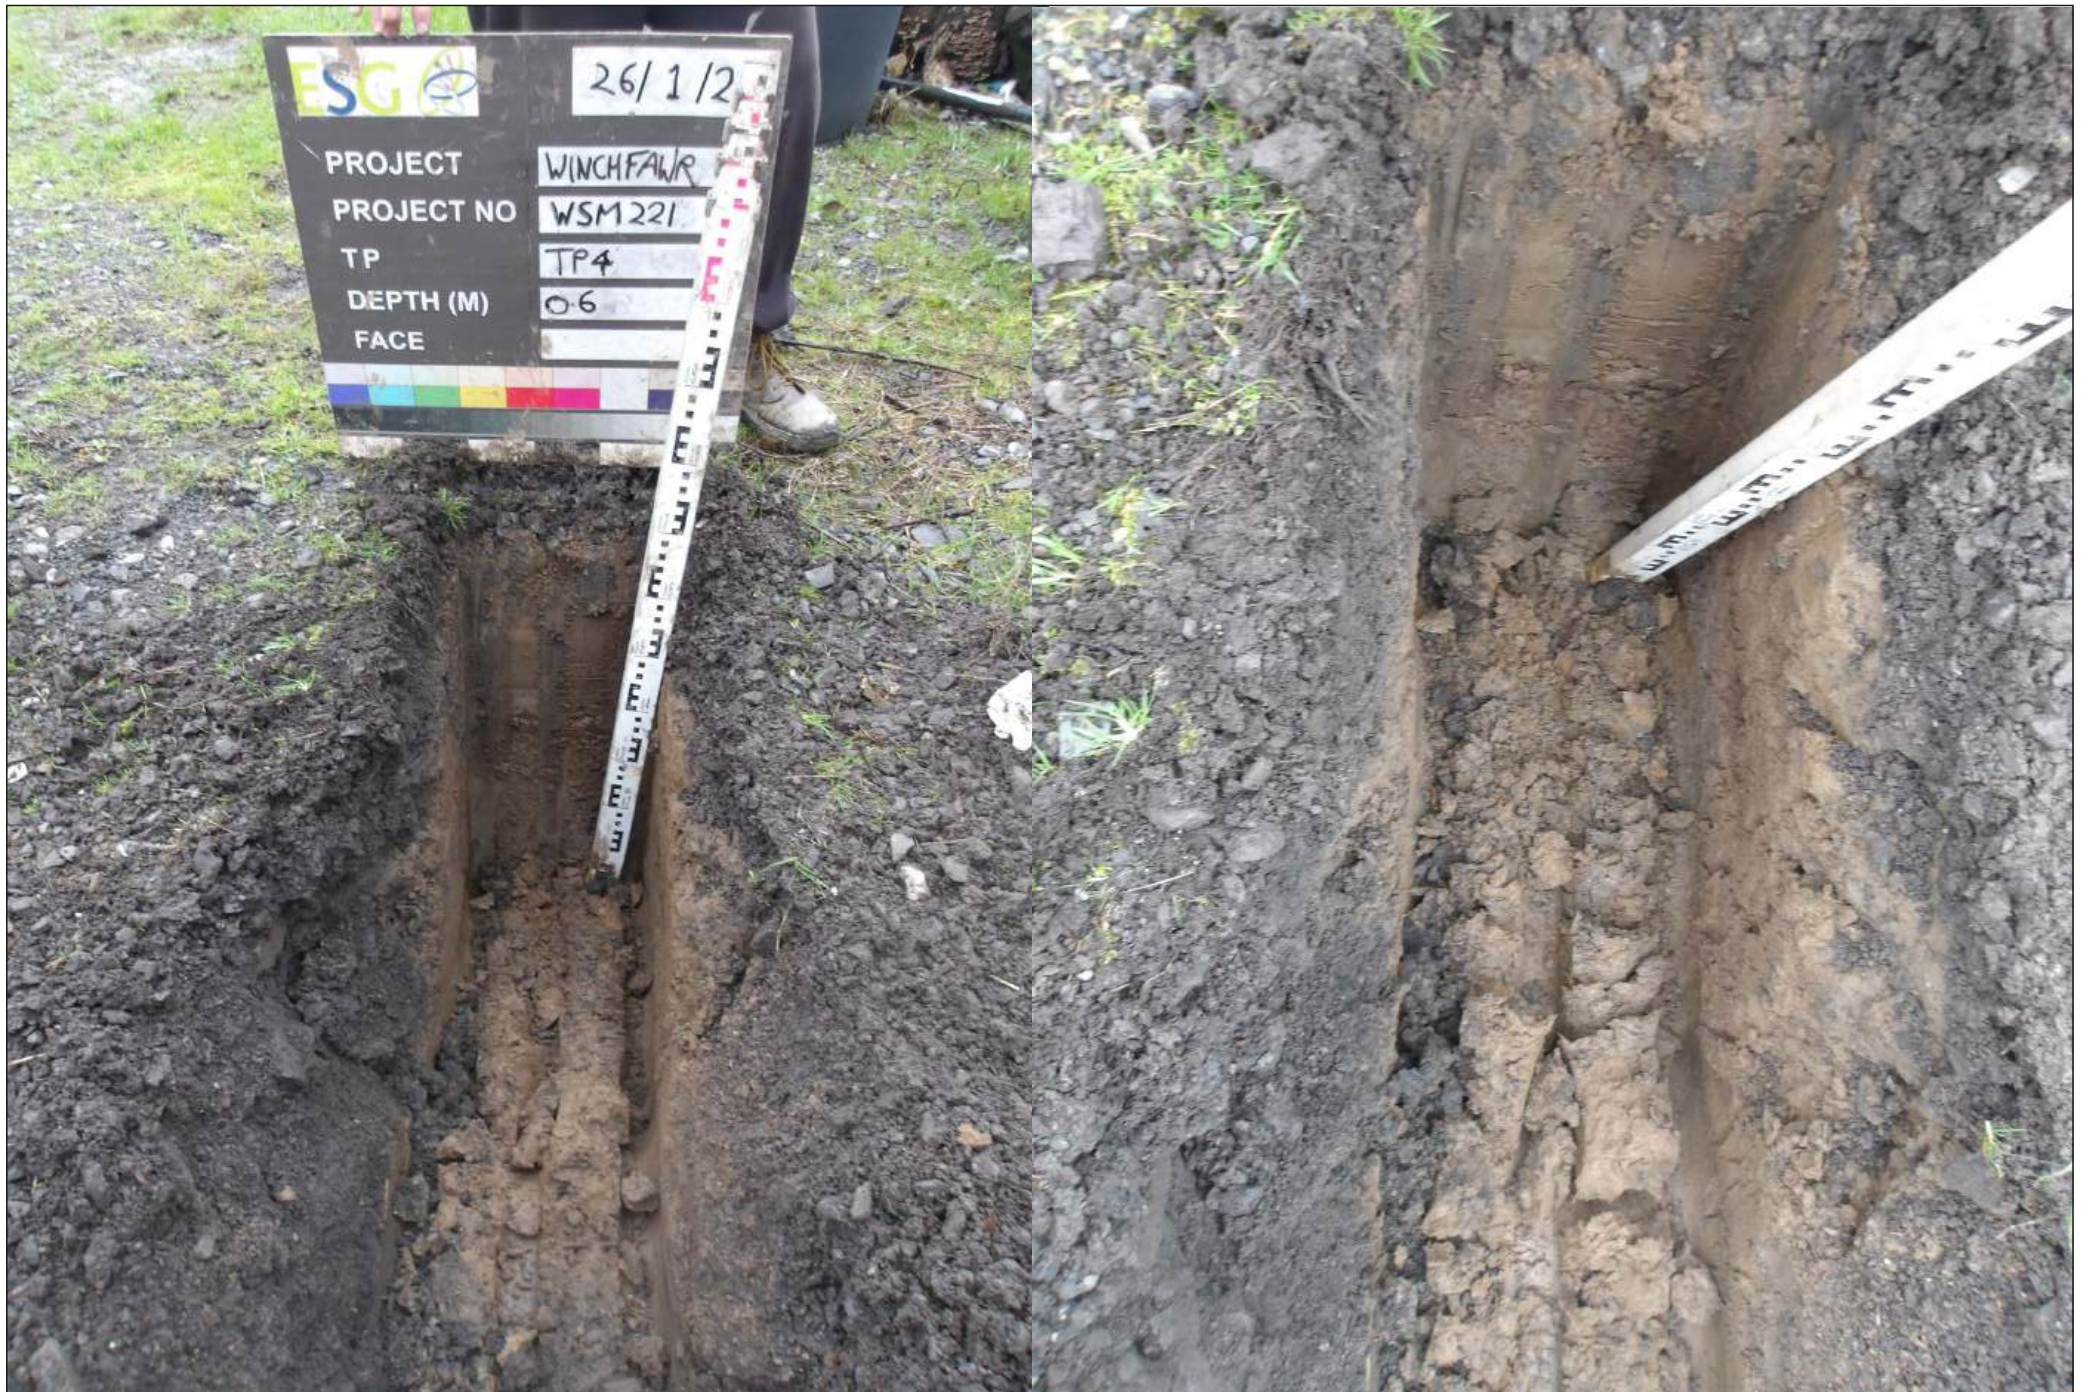
TP 4 22 WINCHFAWR

| Samples and Tests | | Strata | |
|---|---|---|---|
| | | G.L. | MADE GROUND. Loose to medium dense black sandy, slightly clayey GRAVEL. Gravel is angular, fine to coarse of Mudstone and siltstone, sandy component is small oal and ash (COLLIERY SPOIL) |

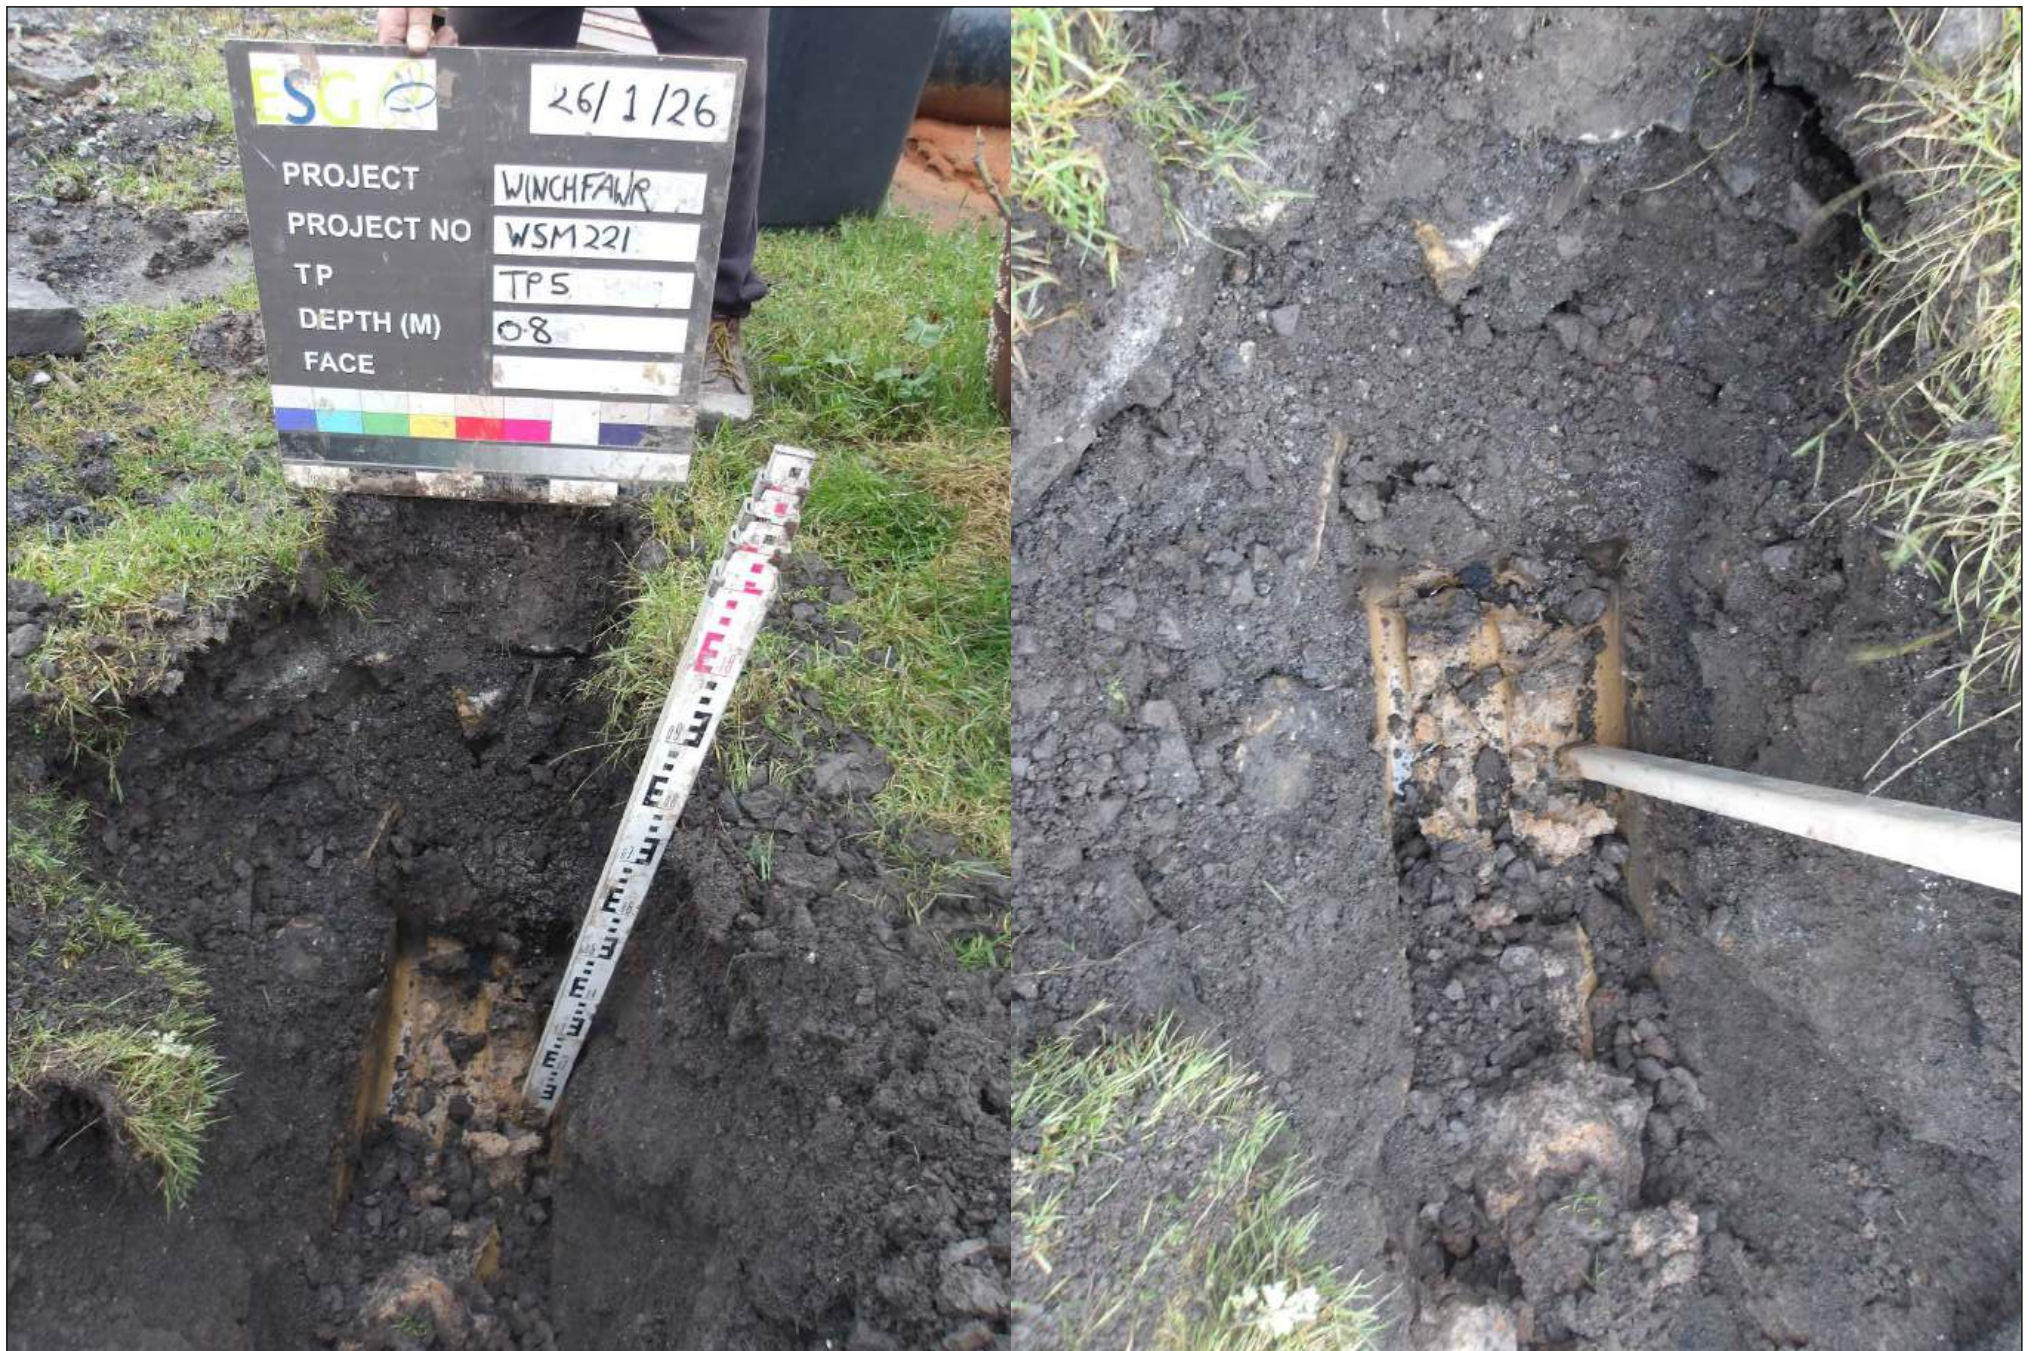
TP 5 22 WINCHWAWR

| Samples and Tests | | Strata | |
|---|---|---|---|
| | | G.L. | MADE GROUND. Loose to medium dense black sandy, slightly clayey GRAVEL. Gravel is angular, fine to coarse of Mudstone and siltstone, sandy component is small oal and ash (COLLIERY SPOIL) |
