**CYFARTHFA DENTAL PRACTICE, ROOKWOOD HOUSE,  
GWAELODYGARTH LN, MERTHYR TYDFIL**

**INITIAL BAT INSPECTION SURVEY**

**Bat Survey Report**

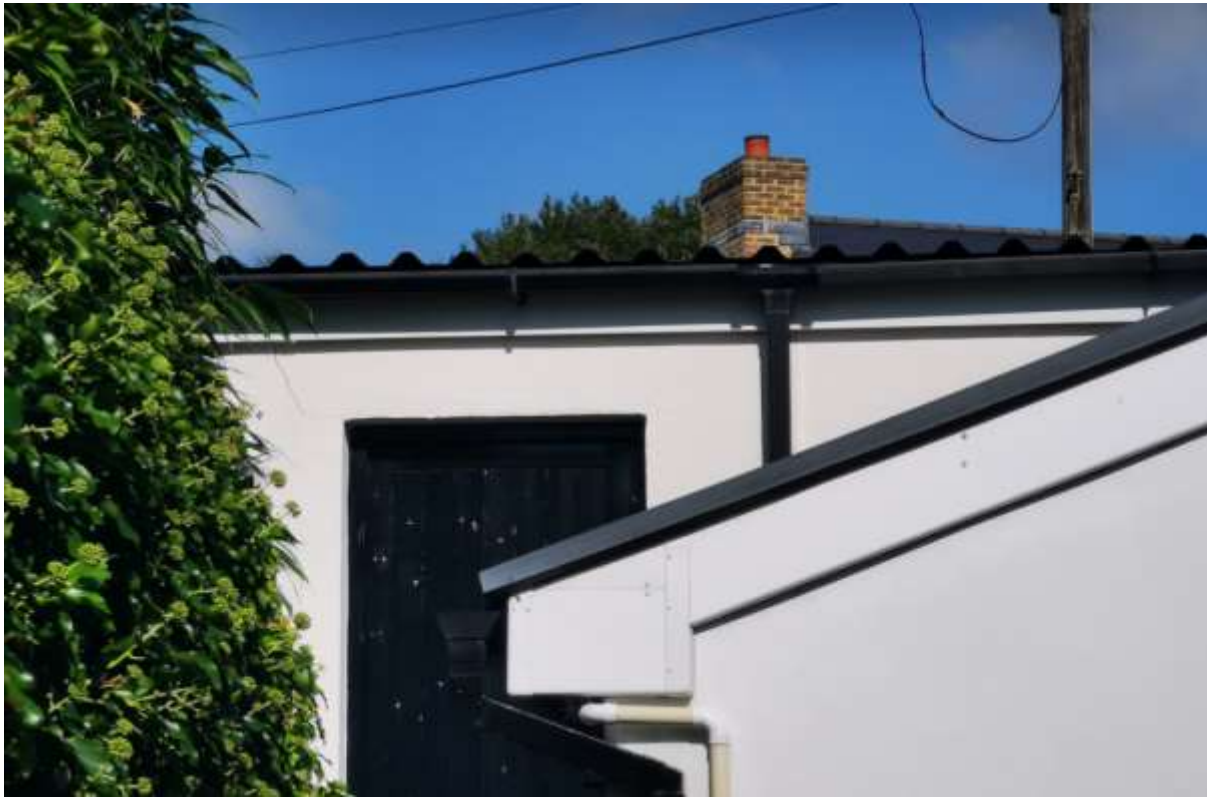
**Plate 1- Photograph of southern elevation**

There does not appear to be any access into the garage. It is possible that bats may fly through the gaps of the wiggly tin metal, however, this is considered unlikely. The fascia board on the southern elevation is tightly sealed to the wall. There is potentially a small gap above the roller shutter door, however, it is considered unlikely that it is a suitable access point for bats..

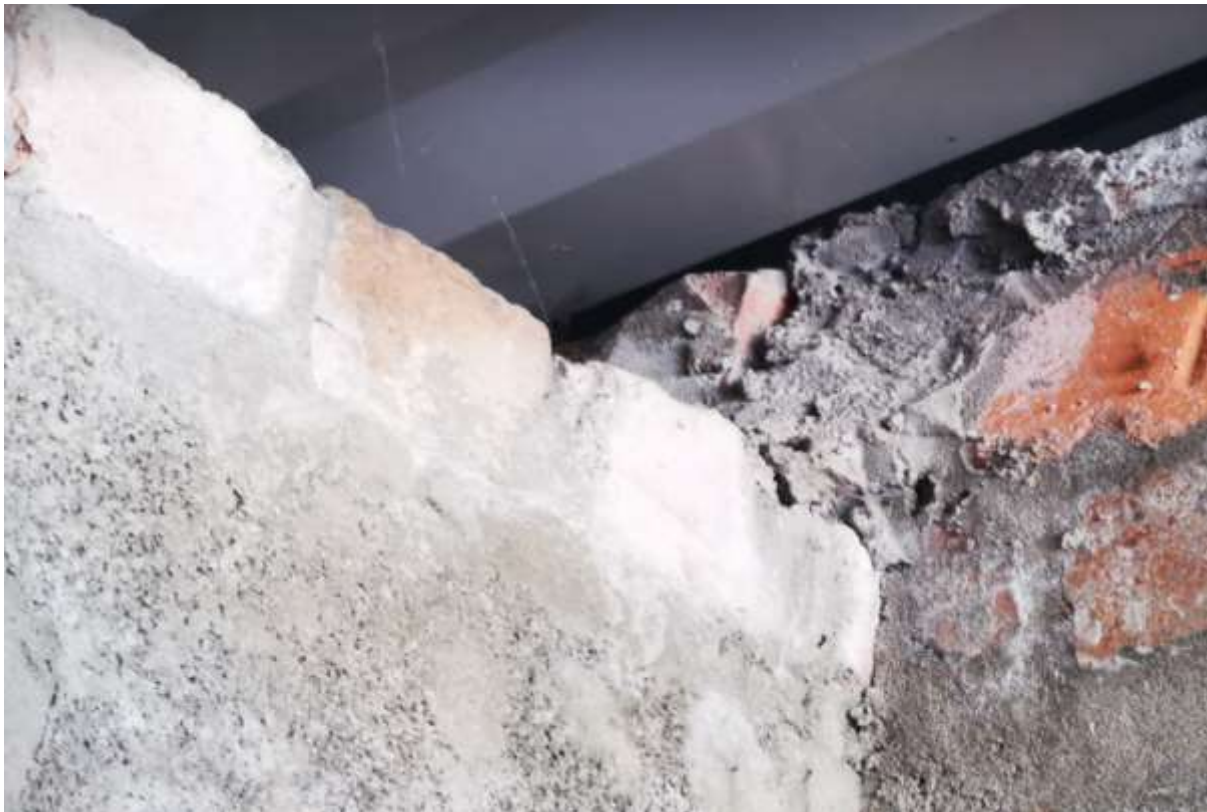
The wall plates are visible on the interior, however, there are no light ingress' within the building at wall plate level.

**Plate 2- Gaps at wall plate level with no light ingress'**

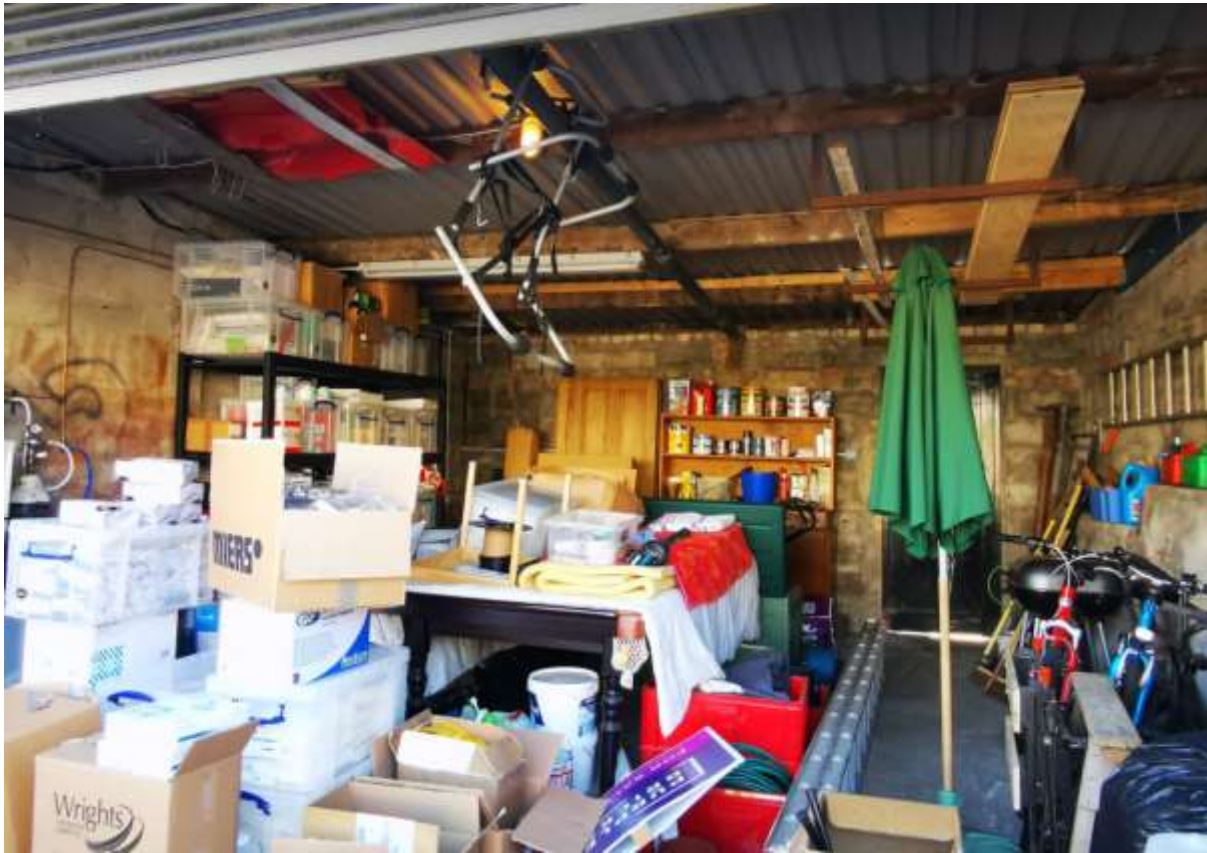
Internally the building is used for storing a compressor and other items associated with the dental practice.

The building is entirely lined with corrugated metal that is sat on timber joists. There does not appear to be any gap to the outside.

**Plate 3- photograph of garage interior**

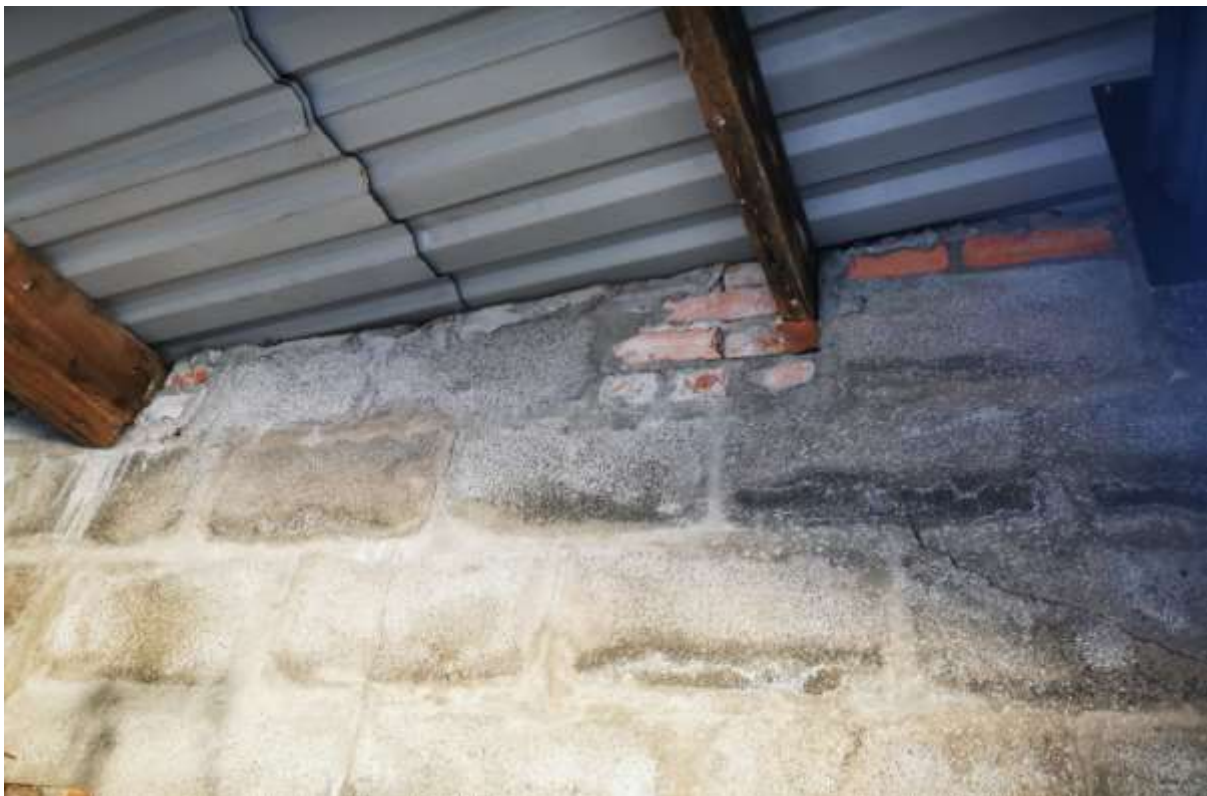
**Plate 4- Photograph of wall plate**
