**18 HIGH STREET, MERTHYR TYDFIL**

**BAT SURVEY**

**SEPTEMBER 2020**

### Bat Survey Report

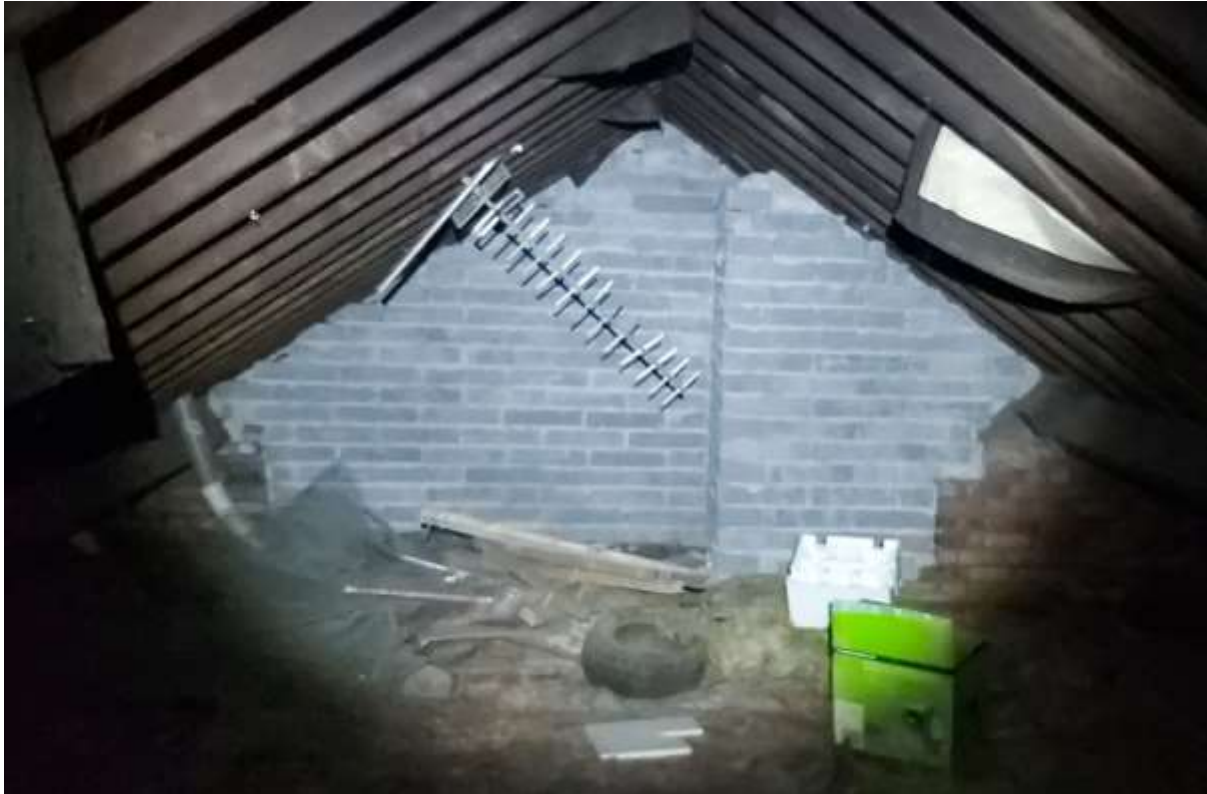
Plate 1- Photograph of roof void

There is a roof void above the property. The roof void spans the full width of the building and has an approximate joist to ridge height of approximately 1.5m. The roof void is situated above the dormer window. The dormer window provides access to the first floor.

Internally, the walls appear to be of stone. The only access into the void appears to be from the neighbouring terraces, above the wall plates. There is some torn felt but no obvious light ingress'. The roof is lined with bitumen felt.

No bats or evidence of bats was found in this location. Lots of evidence of rats was found in this location, however, the rat droppings appear to be old. It is thought likely that rats are entering the void either via wall cavities or over the wall plates from the adjoining properties.

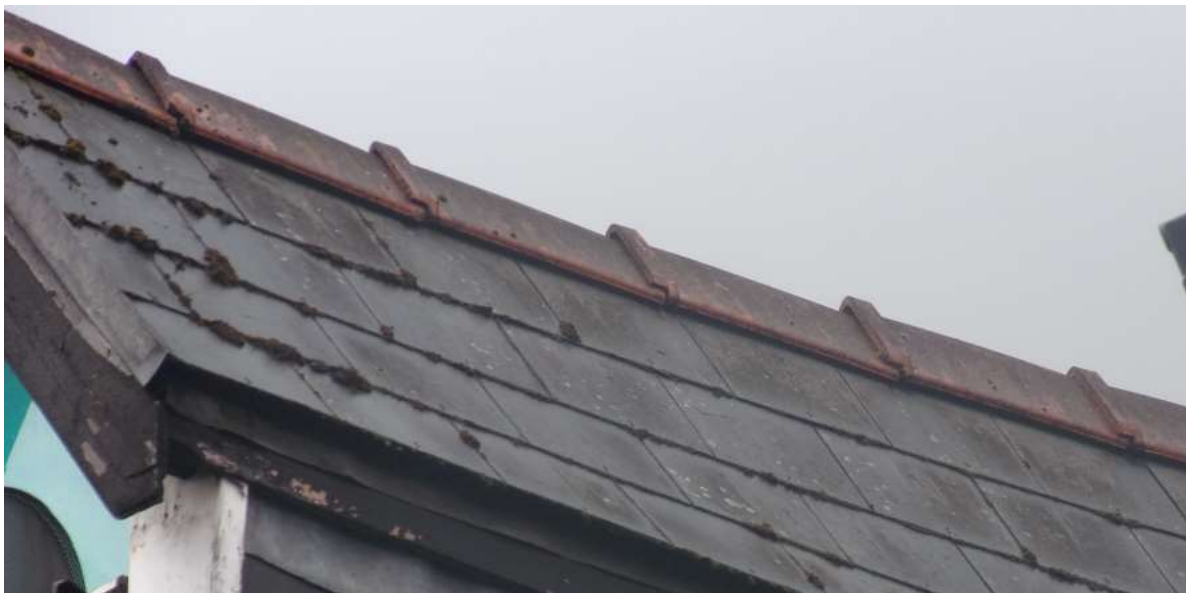
**Plate 4- photograph of dormer ridges**

- Small area of lifted lead flashing on a dormer window
- Possibly some access on the ridge of the dormer, however, they do appear to be relatively tight fitting.
- Possibly gaps at fascia level to the rear of the property (obscured by ivy).

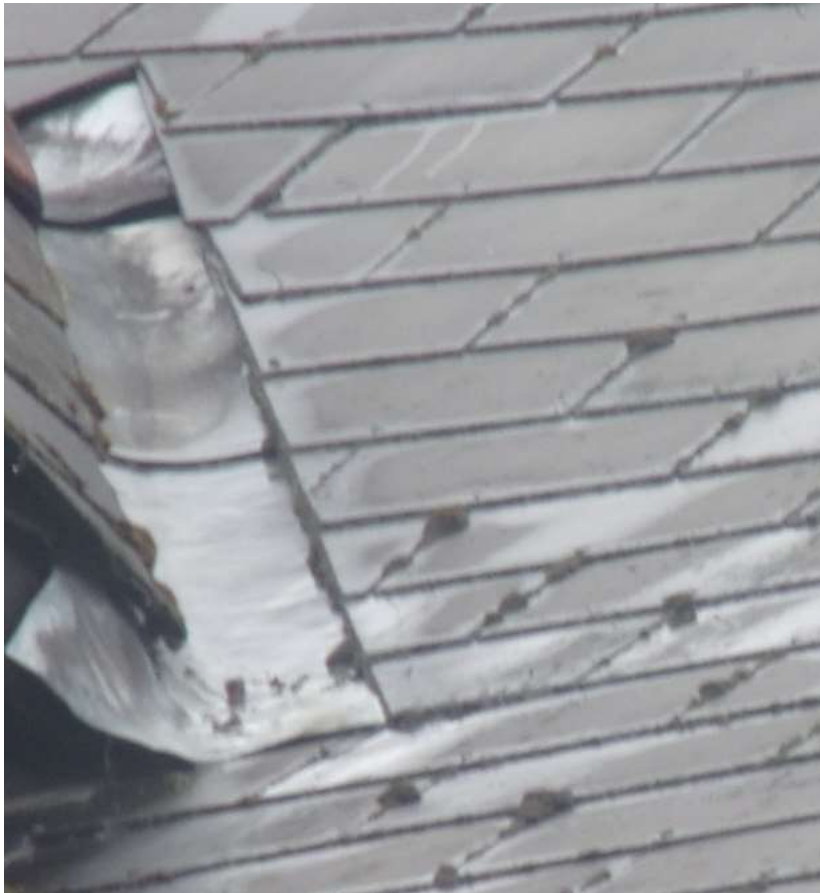
**Plate 5- photograph of lifted lead**

As such, the property was categorised as being of low potential for roosting bats and further emergence/re-entry surveys were recommended.

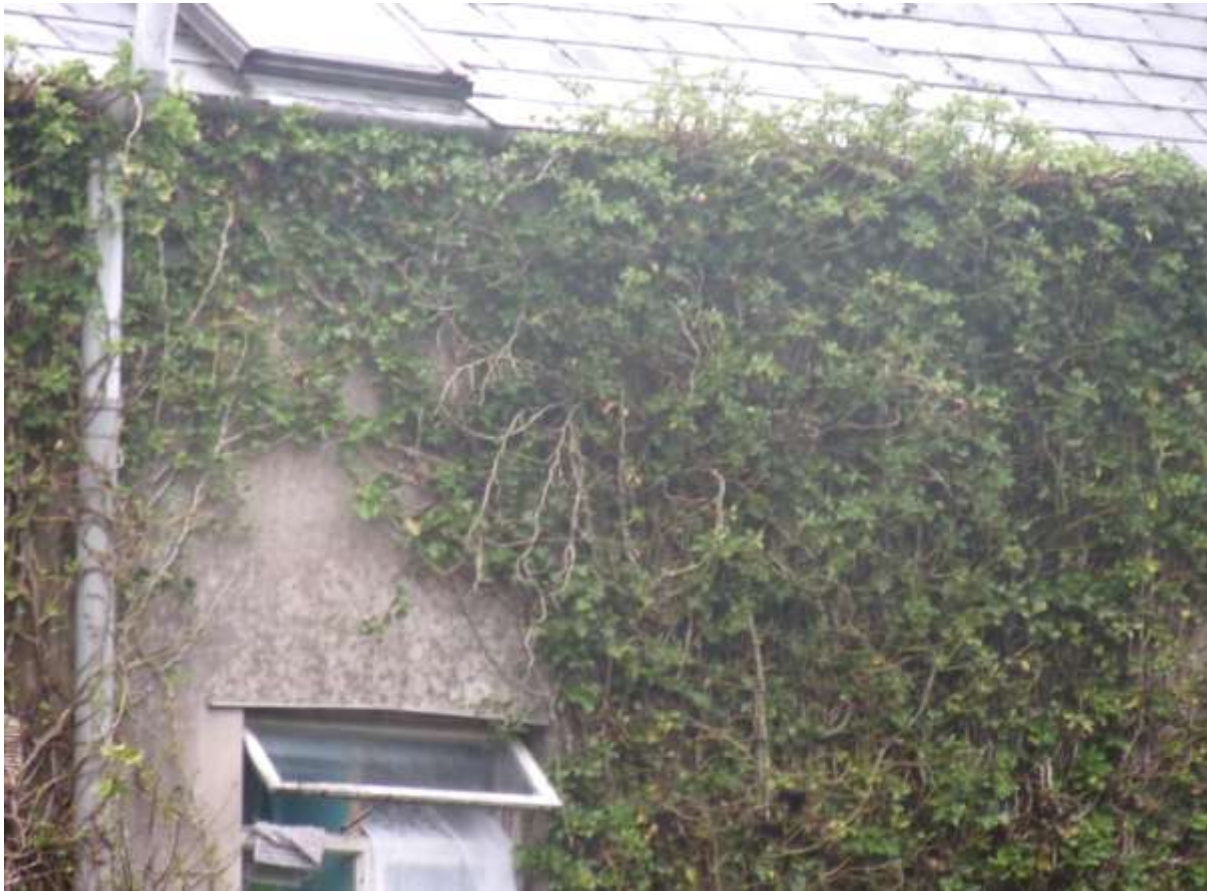
**Plate 7- photograph of ivy**

There is a vast amount of ivy cover to the rear of the building. However, the ivy is thin stemmed and young and does not appear to be large enough to support the thermal properties that roosting would require.

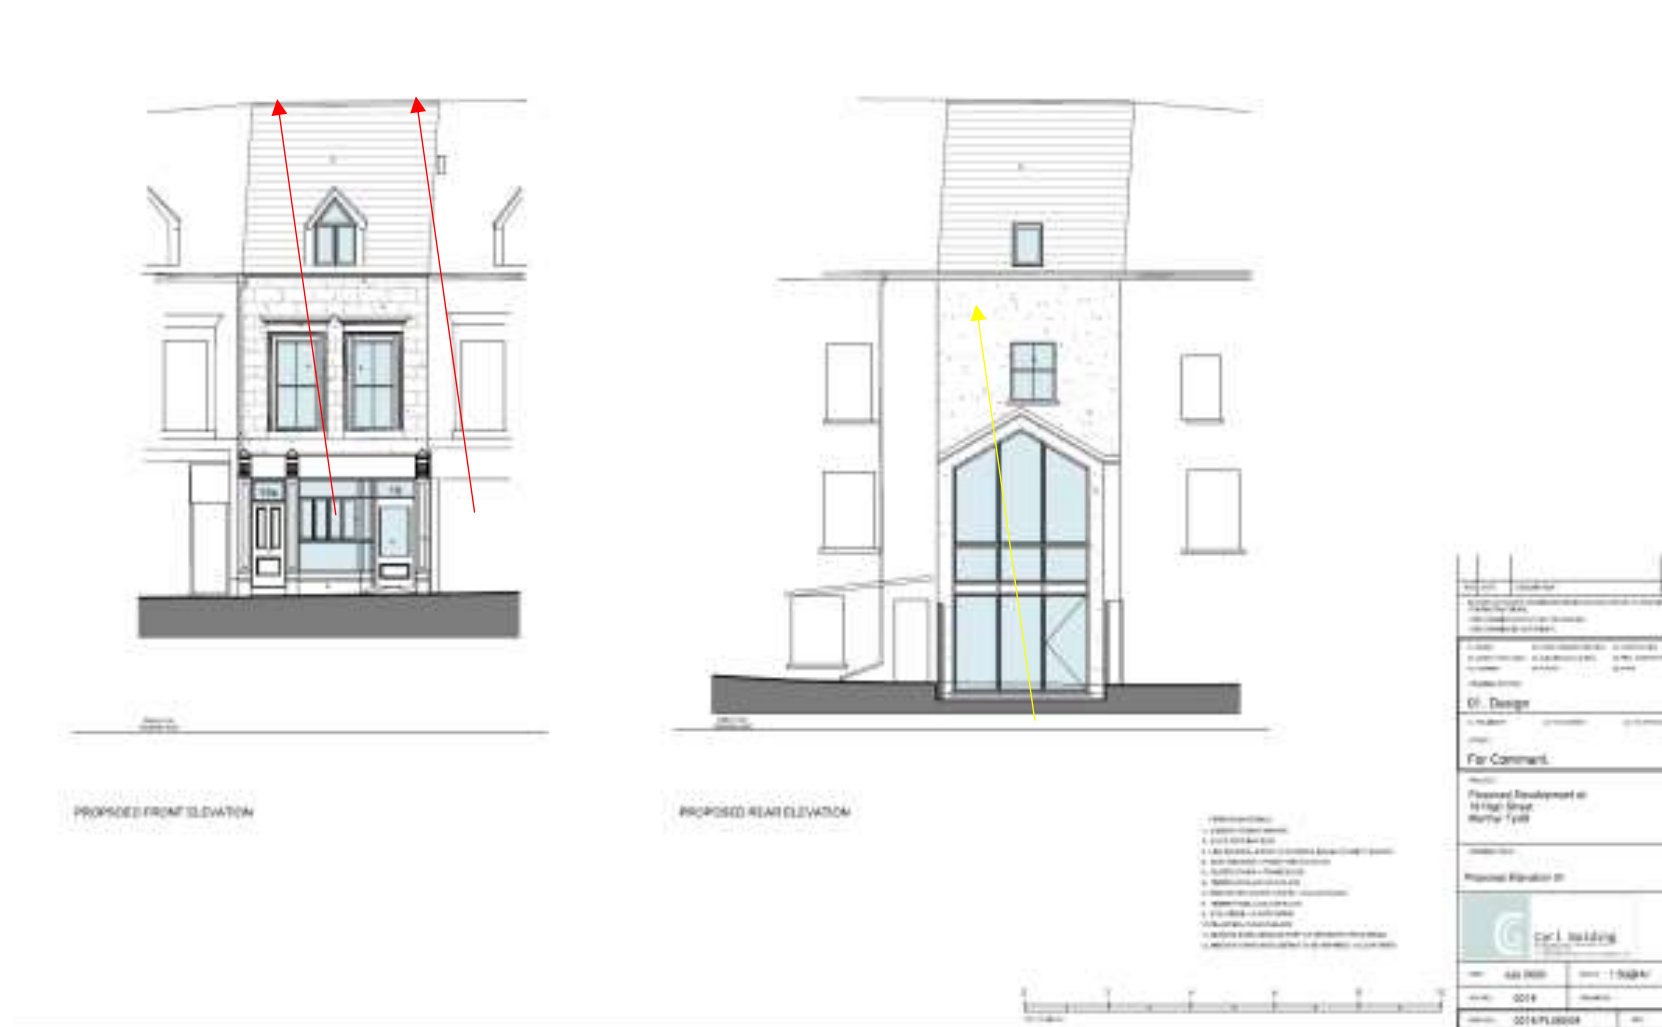
**Appendix B- Drawings showing enhancements (modified ridge tile arrowed red) (sparrow terrace arrowed yellow)**

Two modified ridge tiles will be installed on the property to allow bats access to the roof void at these locations. A small section of the ridge tile will be cut out in order to facilitate this. This will be overseen by the supervising ecologist.

A Schwegler 1SP Sparrow Terrace or the following <https://www.nhbs.com/sparrow-terrace-nest-box> will be attached to the rear elevation of the property.

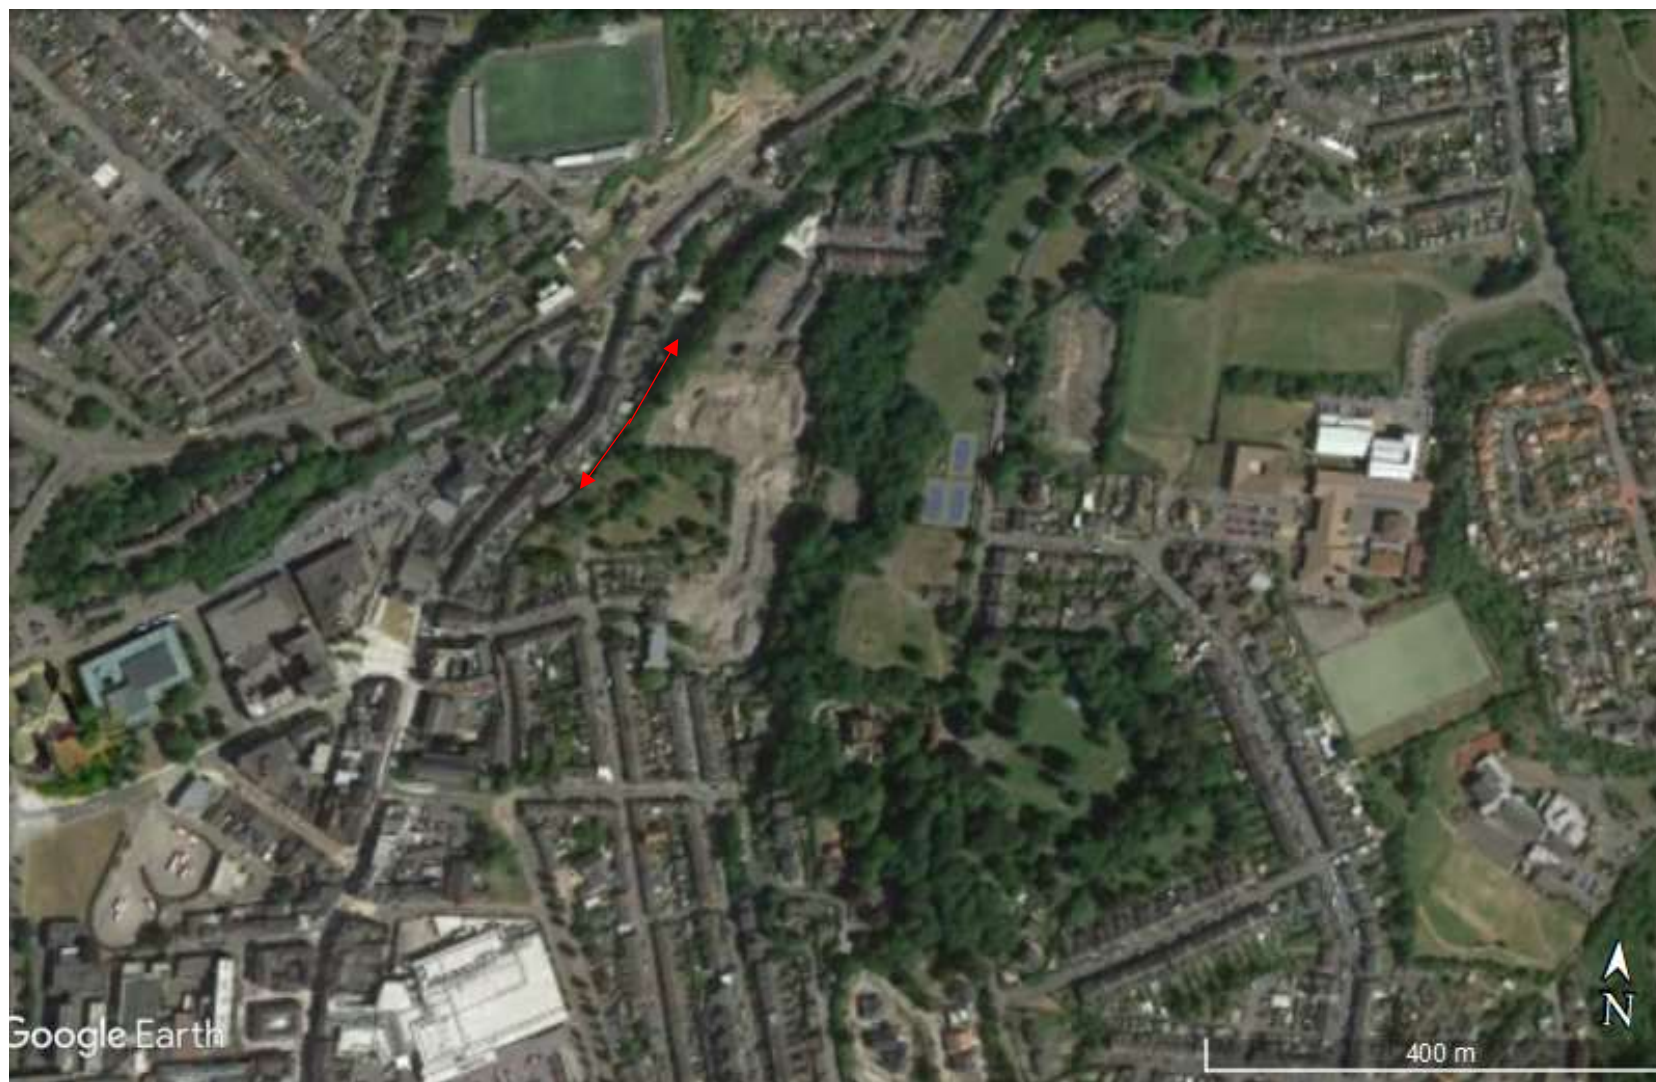
The surveyor to the rear of the property was stood next to a culvert that contains the River Taff as viewing access of the roof was difficult from the courtyard to the rear due to the buildings height. Activity here was extremely high with numerous common and soprano pipistrelles foraging along the water for the duration of the survey.

**Appendix C- Bat flight lines (all bats followed the river back and forth.**
