**Bat Survey:** Former Day Nursery, Brewery Road, Dowlais, Merthyr Tydfil  
CF48 3BU

**Reported by:** Ecological Services Ltd  
10 Mount Pleasant, Llanelly Hill, Abergavenny, Monmouthshire, NP7 0NT

| Author | Date | Version |
|---|---|---|
| Richard Watkins | June 2024 | V3.0 |

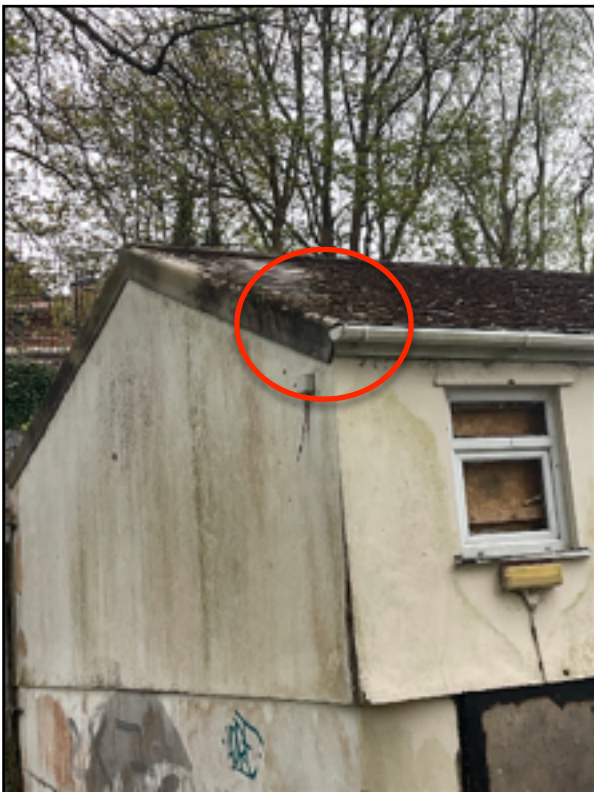
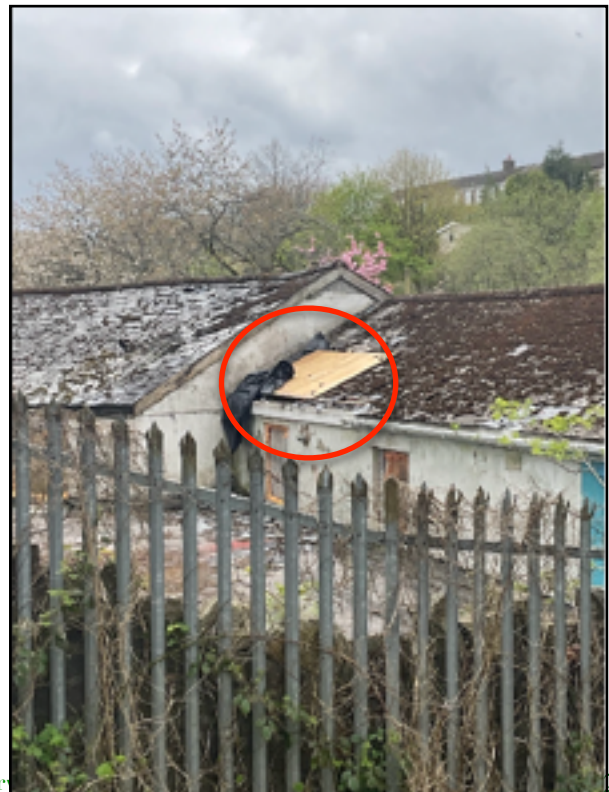
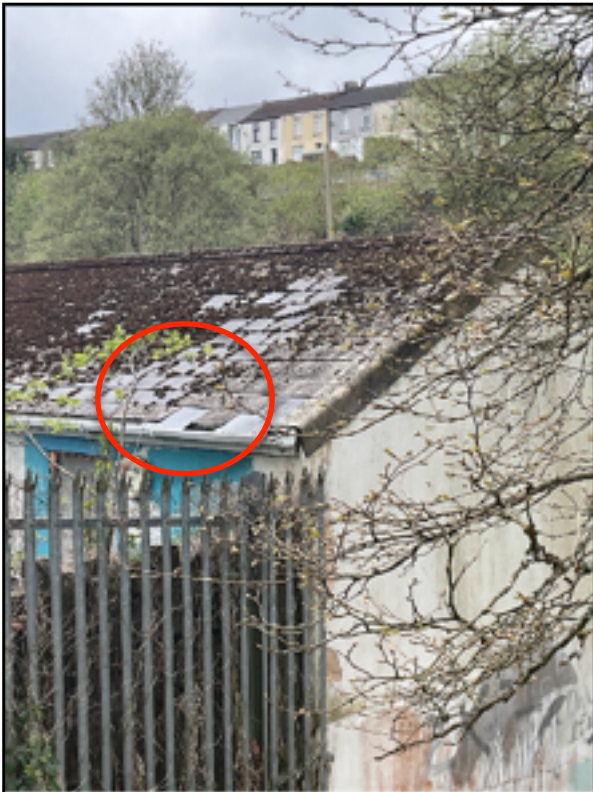
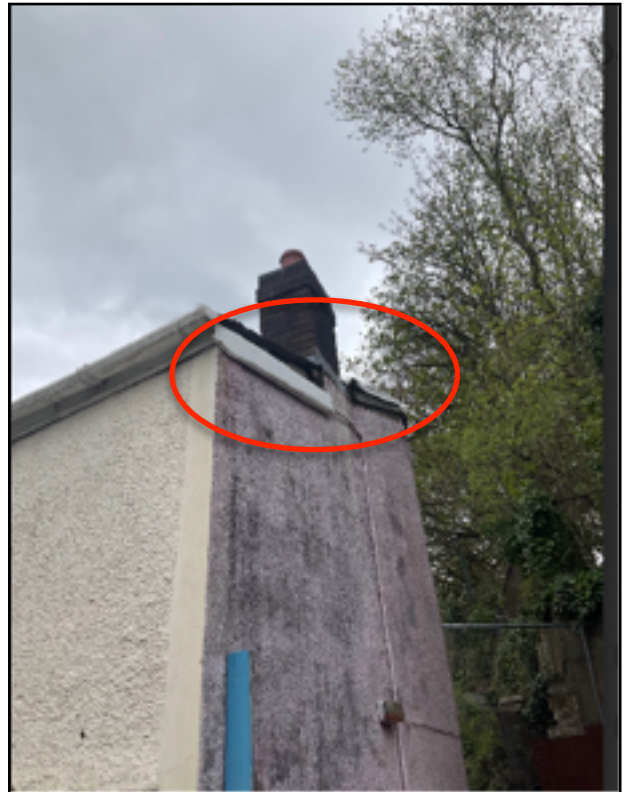
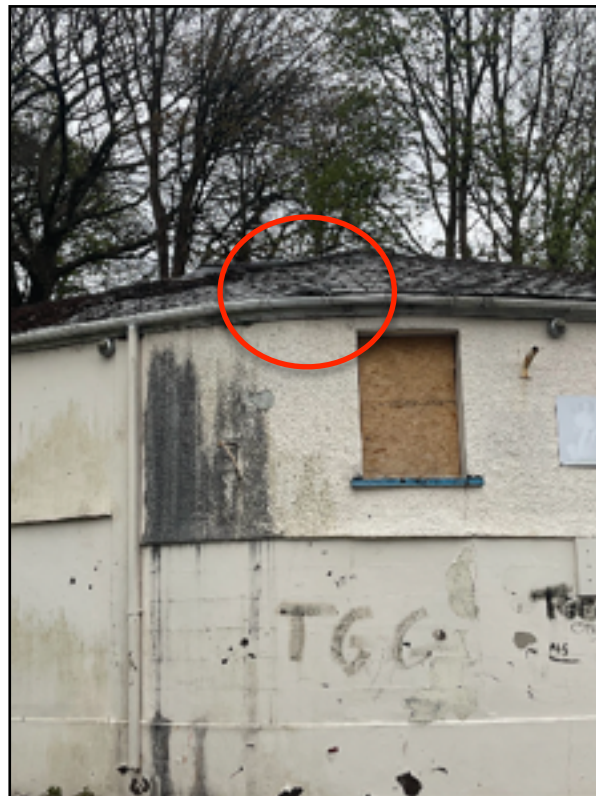
**6.3** Due to the age and condition of the building, there were a number of opportunities present for bats to access and use the building and those that were available were deemed as having moderate potential for roosting bats. There were a number of missing and slipped slates; raised ridge tiles and apertures underneath the fasciae and barge boards.

**6.6** Examples of apertures allowing access to cavities in the building:

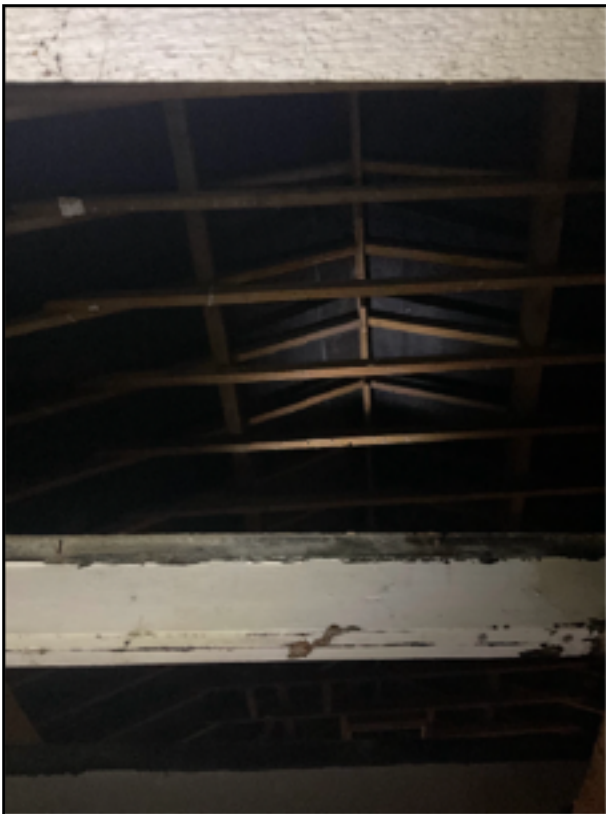
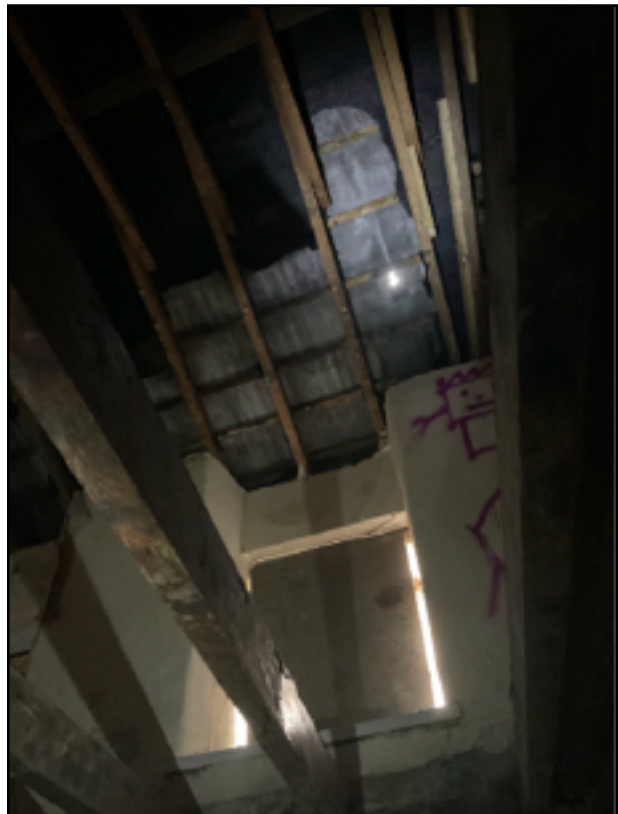
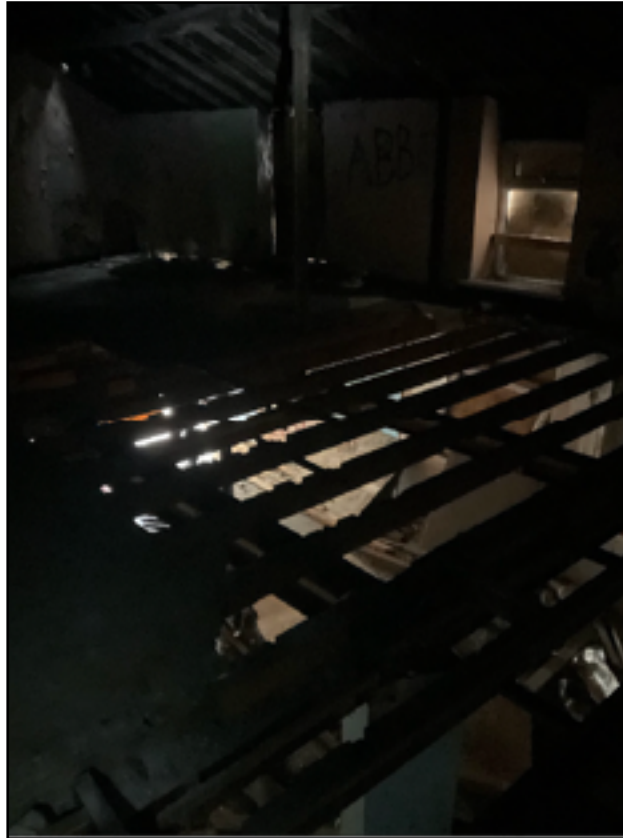
**7.2** The building has sustained high levels of vandalism and therefore the ceilings have been removed. The underside of the roof could be visualised from the stairs and the ground floor. The space was partially lined and of a traditional cut design. There were visible amounts of daylight present from a number of missing slates.

**7.3** No droppings or evidence of bats were discovered on any internal features, however, the building has sustained high levels of vandalism which made searching for bat droppings suboptimal.

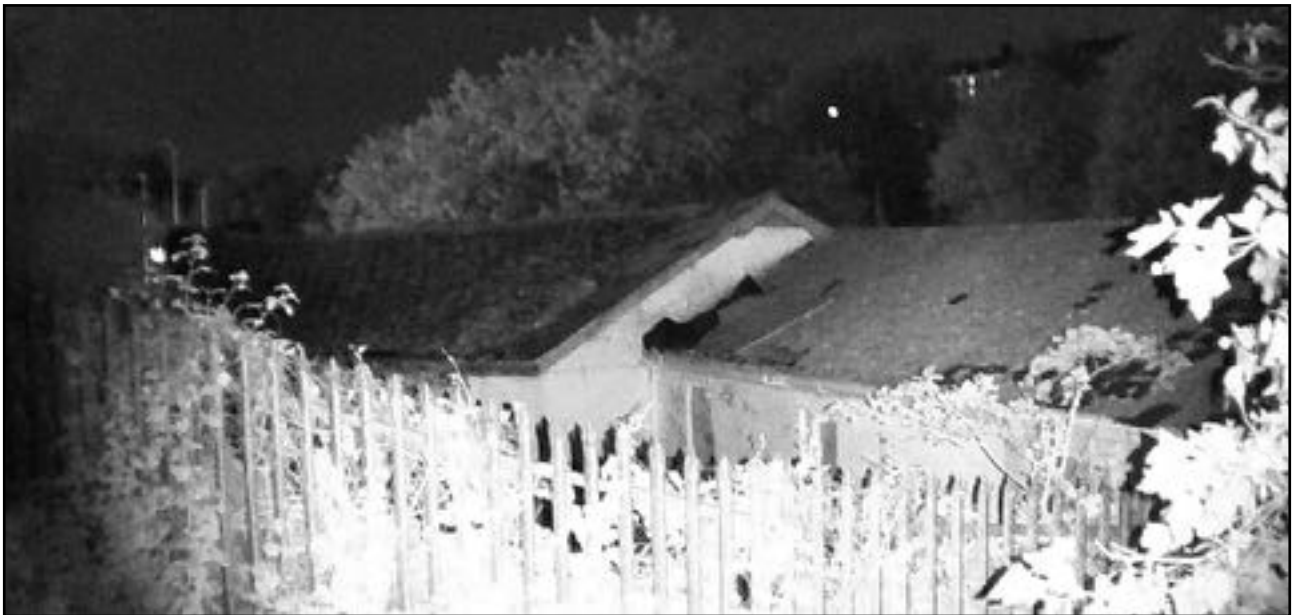
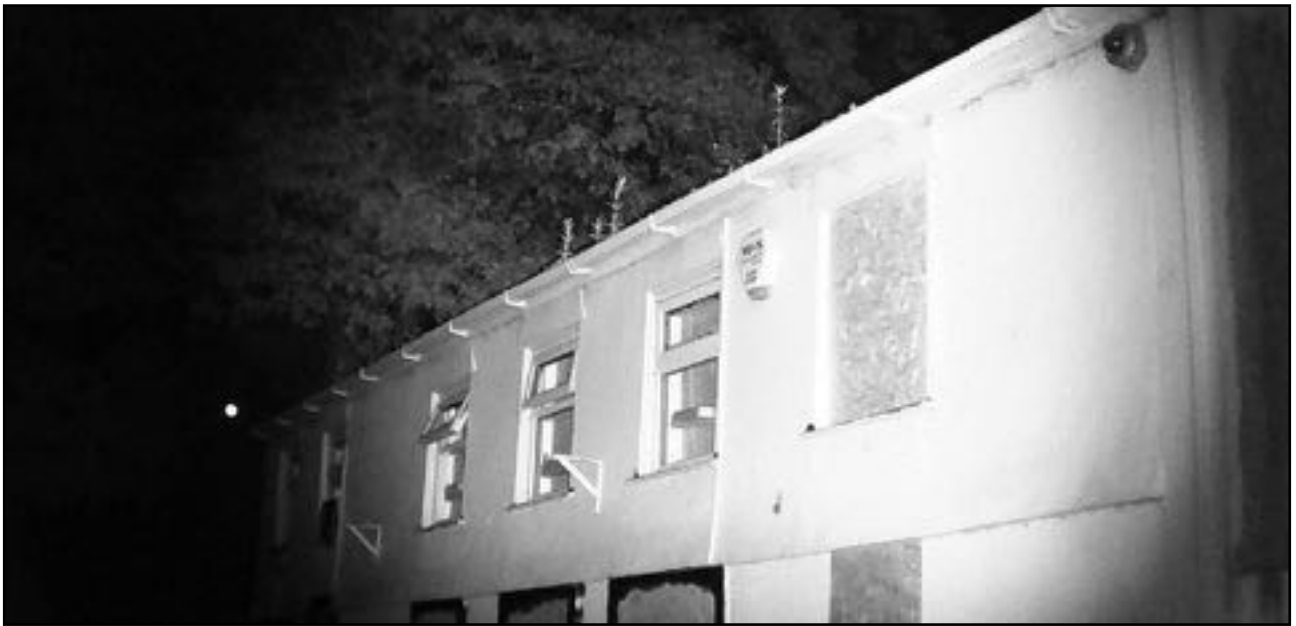
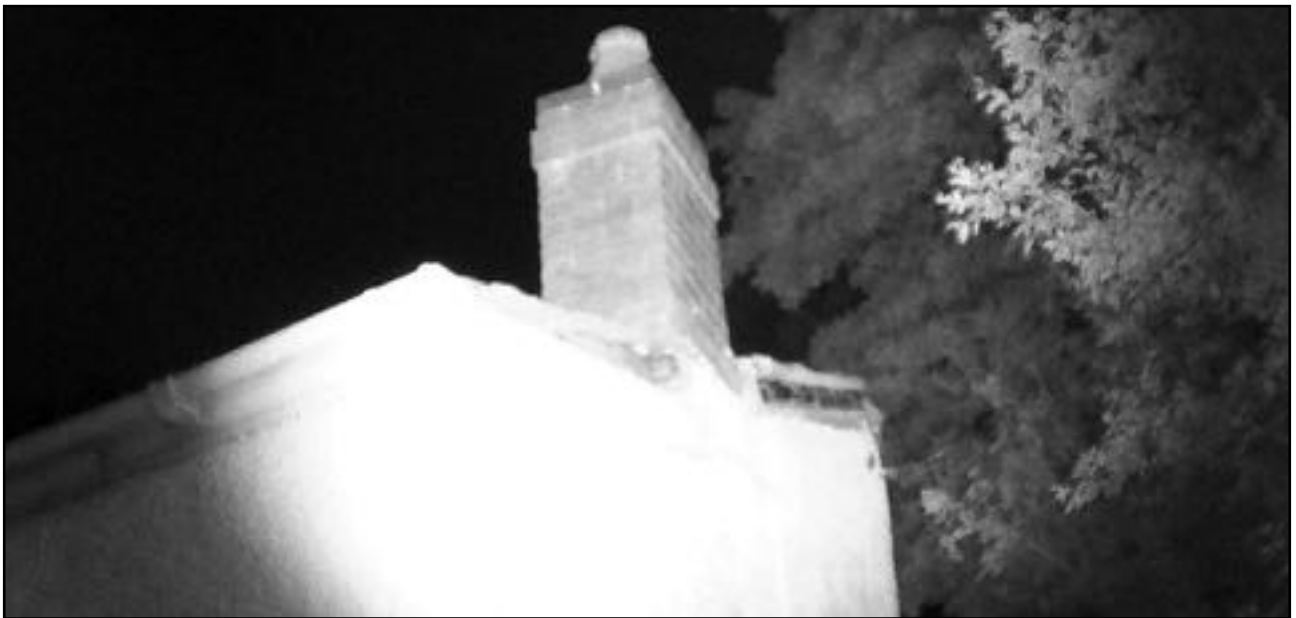
#### 8.10 Examples of NVA Still Shots:

**10.4 No evidence of nesting bird use of the building was observed during the surveys.**

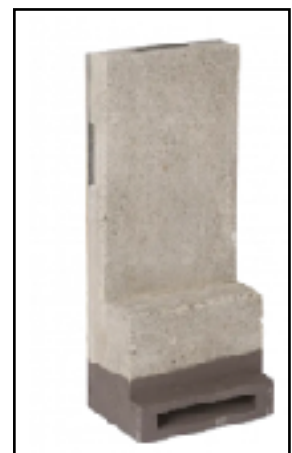
**11.7** It is proposed that further new roosting for bats be created by building one Vivara Pro WoodStone Bat Box into the block work on the southern elevation of the building.

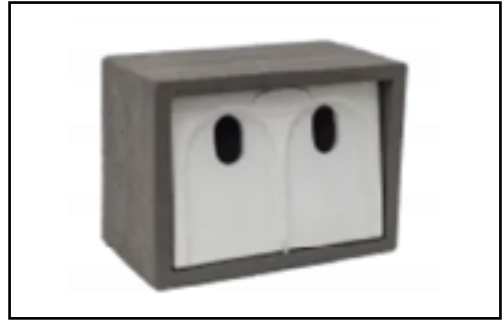
**11.9** One Vivara Pro WoodStone House Sparrow Nest Box will be built into the block work on the northern elevation of the new extension. **This will not be situated on a south facing elevation. Care must be taken not to obstruct the entrance holes.**

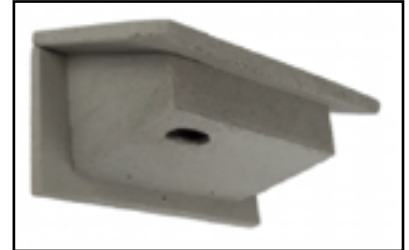
**11.10** One Vivara Pro WoodStone Swift Nest Box will be surface mounted on the northern elevation of the building. **This will not be situated on a south facing elevation. Care must be taken not to obstruct the entrance hole.**
