**Bryn-Rhedyn Farm**

**Bedlinog**

**Bat and Nesting Bird Survey Report**

**January 2021**

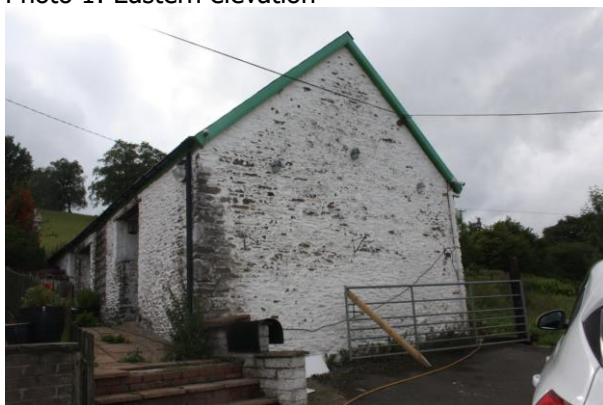
Photo 1: Eastern elevation

| External Walls | The eastern, northern and southern elevations' walls have several small crevices and gaps between the stonework in places (Photo 9), but are in good condition relative to the western gable end, which has numerous large crevices around the open window (Photo 3). The western gable end also has exposed beams where the dilapidated wall no longer meets the roof. There are bird boxes on the eastern gable wall (Photo 1). |

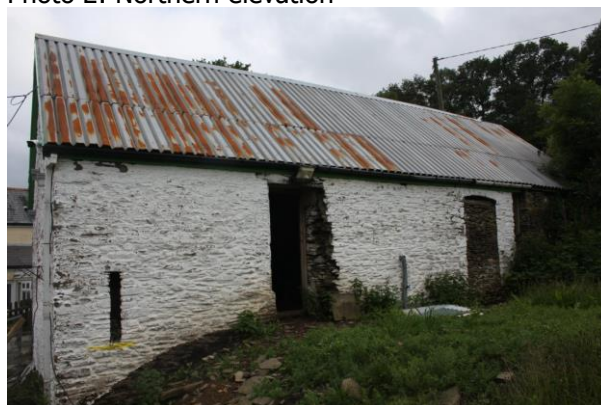
Photo 3: Western elevation

There are numerous potential access points for bats to gain entry into the interior through the gaps above the blocked up windows and doors (Photo 10), and through the gaps where the ridge has come away from the tiles on the southern elevation (Photo 6). There is also potential access at the western gable end, either through the open window or via the gaps where the stonework has eroded (Photo 3).

- R1 – Within the gaps between the ridge and tiles (Photo 6);
- R2 – Within the gaps in the stonework on the western elevation (Photo 3);
- R3 – Within the gaps in the stonework around the doors on the northern elevation (Photo 10-11);
- R4 – Underneath the fascia on the northern elevation (Photo 7); and
- R5 – Within the crevices in the external stonework (Photo 10).

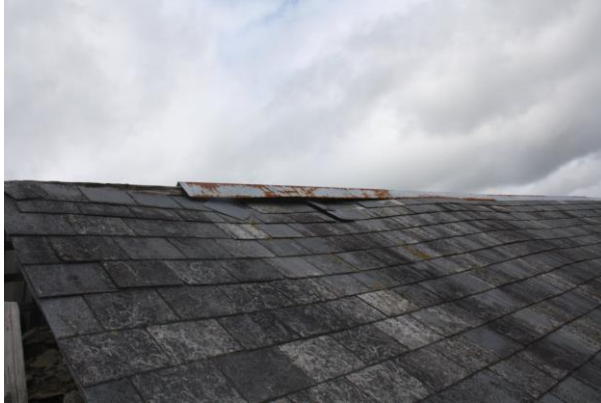
Photo 5: Slipped tiles on the southern elevation's roof

| Roof | The roof is pitched along an east-west axis. Its southern slope consists of slate tiles, most of which are in relatively good condition, however there are several slipped tiles towards the western gable end of the building (Photo 5). The northern slope consists of corrugated metal (Photo 2) which has rusted slightly towards the eastern gable end, but is generally in good condition. There is a metal ridge running the length of the pitch, which has some gaps underneath it where it has come away from the tiles (Photo 6). |

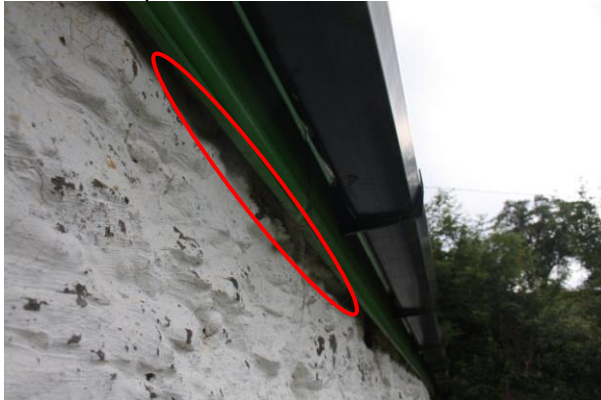
Photo 7: Gaps under fascia on northern elevation

| Soffits, Fascias and Bargeboards | The uPVC fascia and bargeboards are largely in good condition, however there are gaps under the fascia on the northern elevation (Photo 7). There is also a gap beneath the ridge at the eastern gable end (Photo 8). |

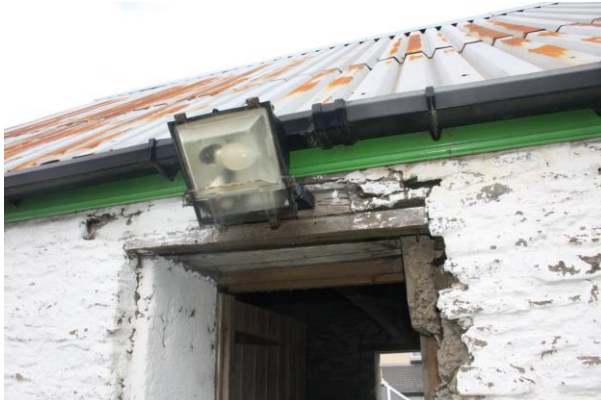
Photo 11: Gaps in stonework around door on northern elevation

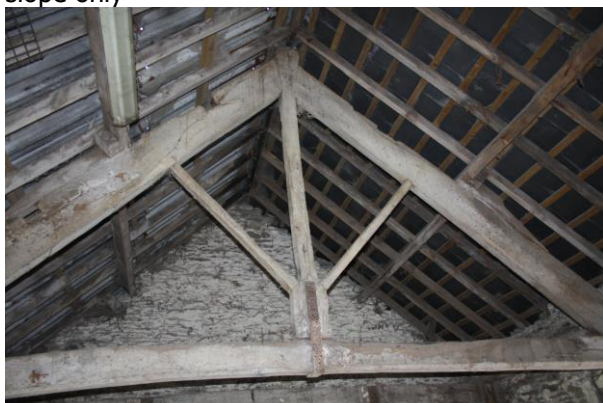
Photo 13: A-frame design with lining on southern slope only

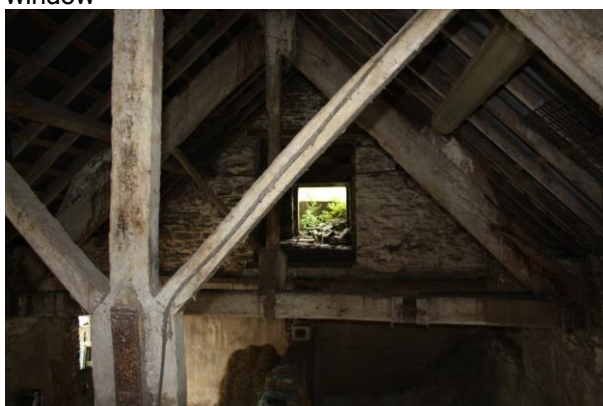
Photo 15: Access into void through western window

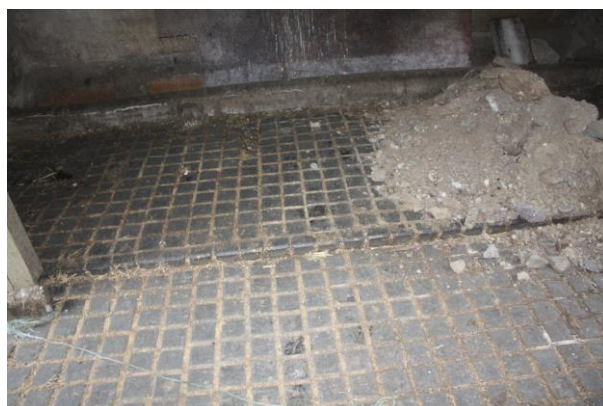
Photo 16: Example of the floor's condition

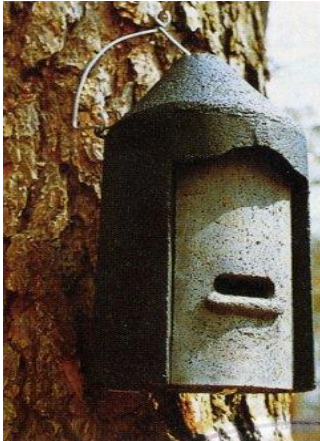
### Schwegler 2F General Bat Box

The Schwegler 2F General Bat Box is the standard and most popular bat box. Ideal for summer roosts and is constructed of woodcrete, providing a breathable, stable temperature within and is suitable for long-term mitigation projects.

**Position:** Ideal for trees, should be mounted on tree trunks at a height of 3m – 6m. Can be positioned in clusters of three, with each box facing west through a south-eastern aspect to provide a variety of micro habitats.

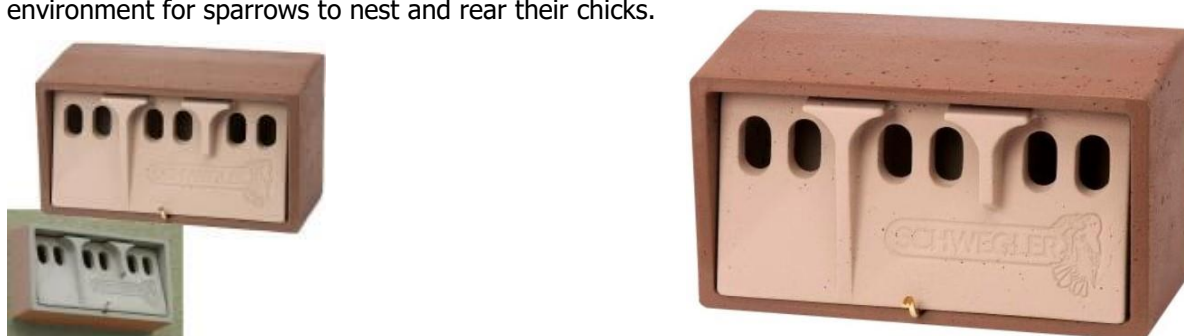
### Schwegler 1SP Sparrow Terrace

Sparrows are gregarious and prefer to nest close to each other, so this triple-nest box provides room for three families under one roof. It's made from long-lasting, breathable woodcrete to provide the optimum environment for sparrows to nest and rear their chicks.

**Positioning:** On buildings of all kinds in typical habitats including industrial buildings and barns at a height of at least 2m (e.g. under eaves).

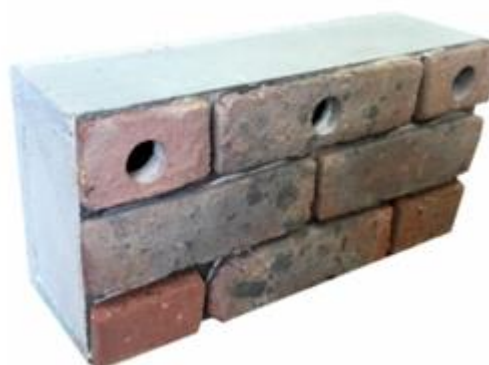
The Habibat Terraced Sparrow Box is a solid box made of insulating concrete which provides an internal roost space, and can be seamlessly integrated into the fabric of a building as it is built or renovated. The access hole in specifically design to accommodate sparrows.

The Habibat Terraced Sparrow Box can be faced with a number of products to suit the design build. This includes, brick, block, stone, wood or a rendered finish, ensuring the box is unobtrusive and aesthetically pleasing.
