## Preliminary Ecological Appraisal

Premier Inn Merthyr Tydfil, Duffryn, Pentrebach, Merthyr Tydfil, CF48 4BB

Premier Inn Hotels

The construction of an extension to the hotel for the construction of 16 additional rooms.

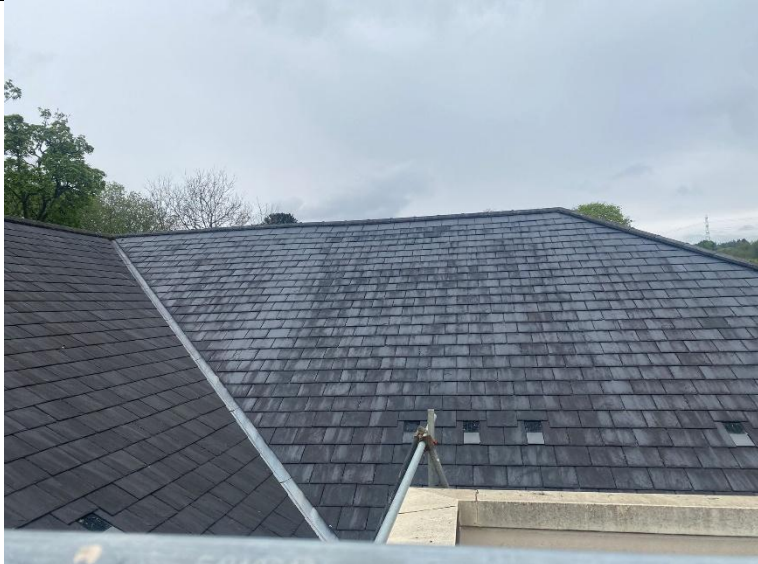
| | <p>&lt; Image 5:<br/>Looking northwest at the field tiles on the L of the building.</p> <p>&gt; Image 6: A close up of the minor, narrow, ridge gap on this northern elevation.</p> | |

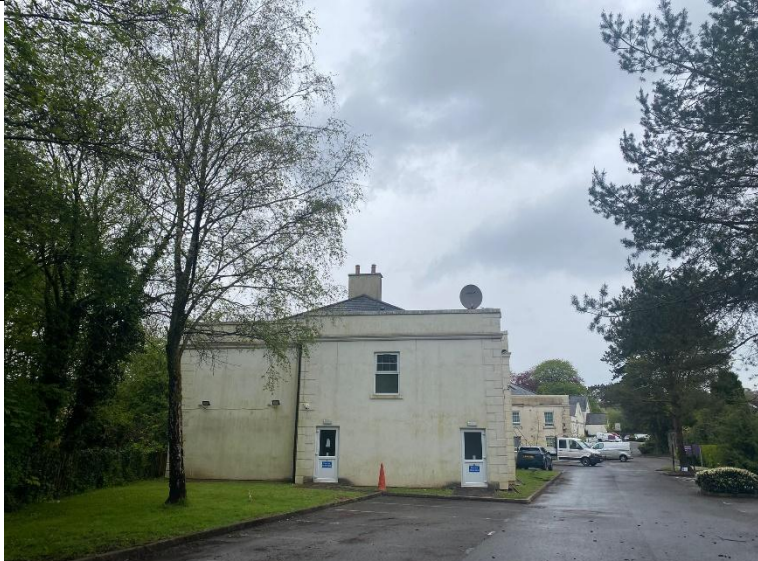
| | <p>&lt; Image 7: South elevation of B1 and T2 in front of it, which has no features present.</p> <p>&gt; Image 8: The exterior of B2. The west facing elevation.</p> | |

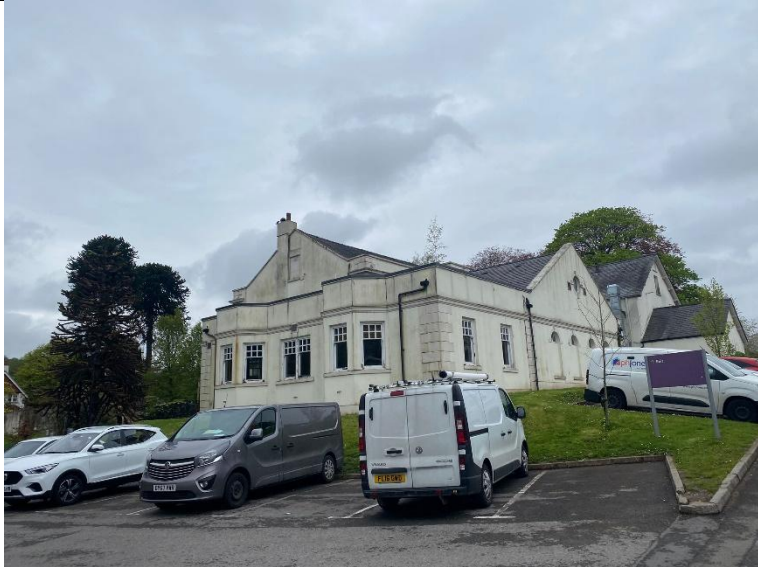
| | <p>&lt; Image 9: South and east elevations of B2.</p> <p>&gt; Image 10: The loft space of B1. There are undisturbed cobwebs along the ridge.</p> | |

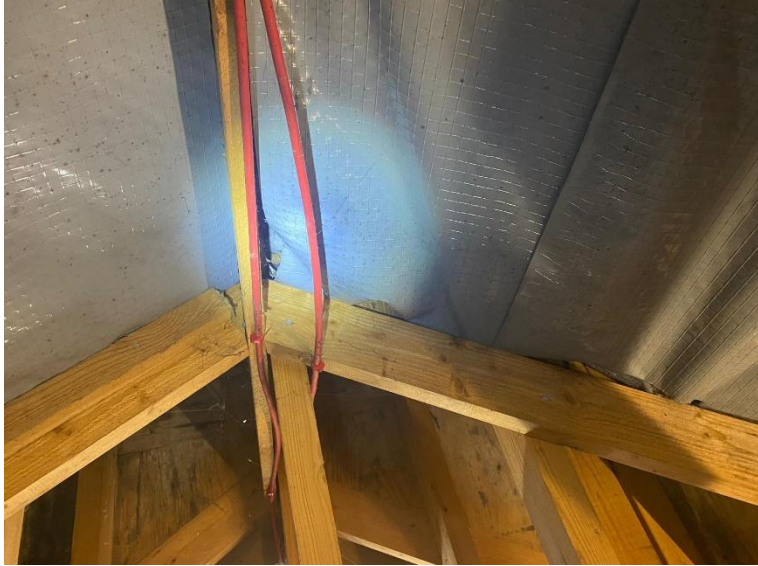
| | <p>&lt; Image 11: Close-up of some gaps along the ridge internally, but with no connection to the exterior of the building.</p> <p>&gt; Image 12: Green fire exit light on permanently within the loft space.</p> | |

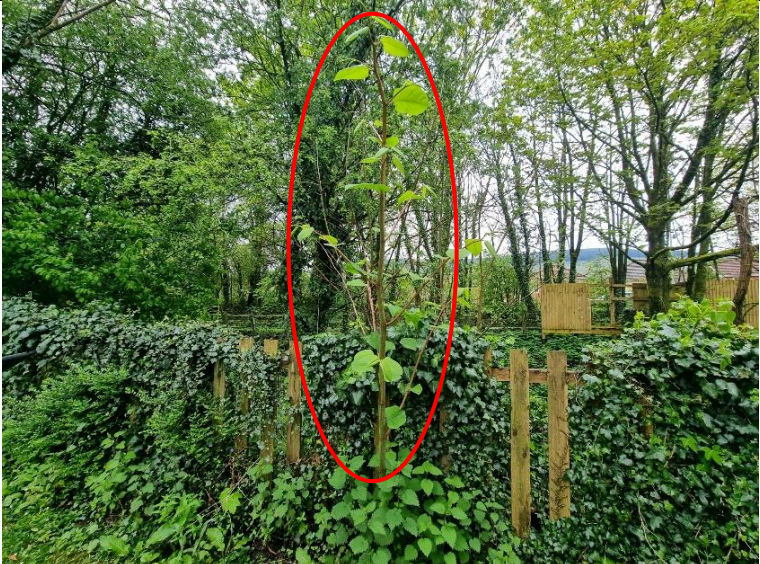
| | <p>&lt; Image 17:<br/>Mature beech trees, willow trees and short modified grass on site.</p> <p>&gt; Image 18: A large stand of JPK adjacent to the south-west corner of the building to be developed.</p> | |

| <p><i>Recommendations</i></p> | <p>Visible stands of JPK should have secure fencing installed with a buffer of 7m from the visible stands to prevent machinery, materials or persons entering the zones and to prevent accidental spread.</p> <p>An invasive species management plan will be required to control and/or eradicate Japanese knotweed which will likely include the injection of strong herbicides and will require a waste permit for removal of hazardous waste from site. Specialist contractors should be contacted for treatment and removal of JPK.</p> <p>Works should avoid areas of snowberry and cherry laurel to prevent the spread of these species.</p> |

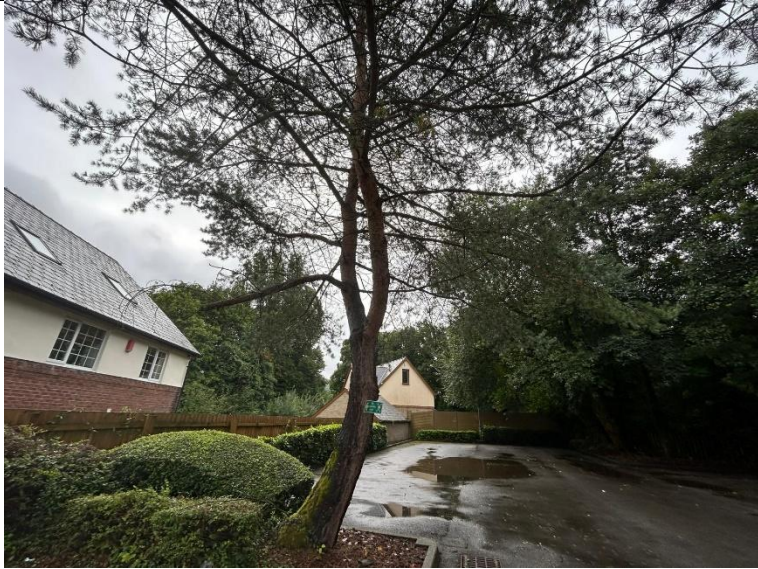
| | <p>T8 and T13 are Scott’s pine. T8 has east facing stem approximately 3m up. This crevice is open to the elements making this feature suboptimal. In addition, the feature is easily inspected and therefore can be checked prior to felling. There are no other features present on the tree. This tree is rated PRF-I.</p> <p>T13 has no suitable features on this tree for supporting roosting bat species.</p> <p>T10 and T12 are common holly, with no suitable features on this tree for supporting roosting bat species.</p> <p>T11 is horse chestnut with no suitable features on this tree for supporting roosting bat species</p> <p>Associated images of the buildings and trees surveyed can be found at the end of the report, Appendix 4</p> <p><i>Since completion of the Preliminary Ecological Appraisal, a number of trees have been removed from the site as part of a reactive safety programme (Tree Squadron Ltd, August 2024). This included a group of 11 mature ash trees (Fraxinus excelsior) and one ash sapling, all previously forming part of <b>Group G08</b> in the accompanying Arboricultural Impact Assessment (Arbtech, April 2025). This group represented the <b>woodland habitat described in the original version of this PEA/PRA</b>, and G08 and T32 in the original Arboriculture report. In addition, a single <b>monkey puzzle</b> (Araucaria araucana) tree, referenced as <b>T30</b>, was removed from the southern boundary. These works were undertaken after the initial ecological survey was completed. The trees were not assessed for bat roost potential at the time, and no evidence of protected species was recorded during or following removal.</i></p> <p><b>Foraging and commuting habitat</b></p> |

| | <p>&lt; Image 19: T8</p> <p>&gt; Image 20: T5 and T6</p> | |

| | <p><b>Roosting habitat</b></p> <p>As per Tables 6.3 and 7.1 of the Bat Survey Guidelines (2023) trees with PRF-I's only do not require further survey effort, however compensation for lost features should be installed prior to tree felling works, and works should be carried out under a precautionary working method statement (PWMS). The PWMS includes:</p> <ul style="list-style-type: none"><li>• Prior to any PRF removal, suitable compensation should be provided onsite (i.e. bat boxes in appropriate locations)</li><li>• Felling to be done under supervision by an ecologist</li><li>• An inspection of any features to be carried out by the arborist under supervision of the ground-based ecologist on site</li><li>• Any identified PRF-I feature(s) will be soft felled in conjunction with an experienced arborist. This will involve sections of the tree with the PRF to be cut away and lowered to the ground and inspected by a licenced ecologist</li><li>• Any PRFs felled will be left in-situ on the ground within a 10m exclusion zone for 24 hours</li><li>• In the unlikely event that a bat or evidence of bats is discovered during the development all work must stop and a bat licensed ecologist contacted for further advice.</li></ul> <p><b>Artificial lighting</b></p> <p>A low impact lighting strategy will be adopted for the site during post-development which outlines the areas of the site that will be retained as dark corridors. Parameters can be found on the Bat Conservation Trust website:<br/><a href="https://www.bats.org.uk/our-work/buildings-planning-and-development/lighting">https://www.bats.org.uk/our-work/buildings-planning-and-development/lighting</a></p> <p><b>Suggested biodiversity enhancements</b></p> <p>The installation of two bat boxes at the site will provide additional roosting habitat for bats. The bat boxes will be installed on the hotel and integrated into the design. Bat boxes should be positioned 3-5m above ground level facing in a south or south-westerly direction with a clear flight path to and from the entrance, away from artificial light. The bat box will be a specification suitable for crevice dwelling species such as Vivara pro building bat box, Integrated eco bat box for crevice dwellers, or a similar alternative. To compensate for the loss of tree T8, a woodstone or woodcrete bat</p> |

| | box will be added to a suitable mature tree on site. The bat box should be positioned 3-5m above ground level facing in a south or south-westerly direction with a clear flight path to and from the entrance, away from artificial light |
