**Bat Survey:** Dowlais RFC, Blaendowlais, Merthyr Tydfil

**Instructed by:** Dowlais RFC

**Reported by:** Ecological Services Ltd  
10 Mount Pleasant, Llanelly Hill, Abergavenny, Monmouthshire, NP7 0NT

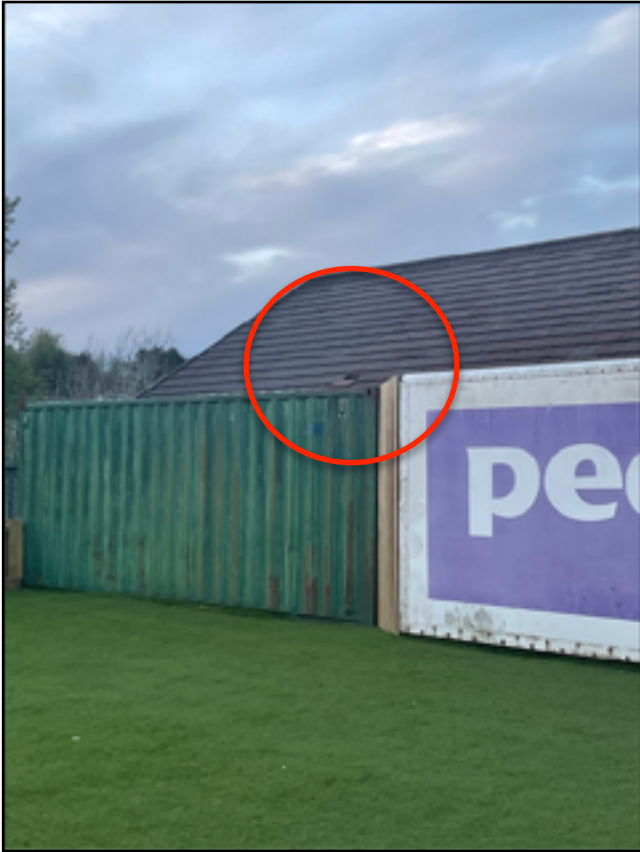
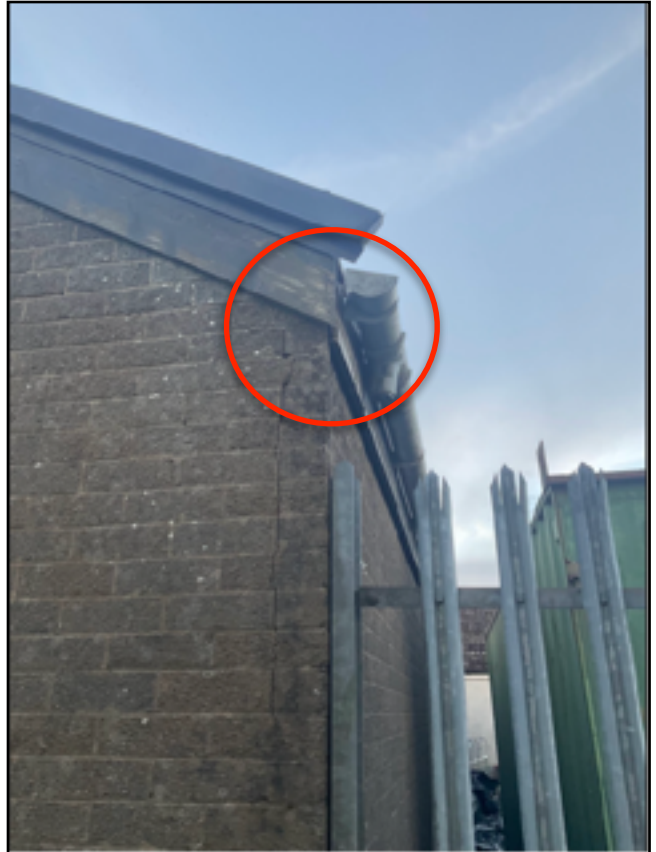
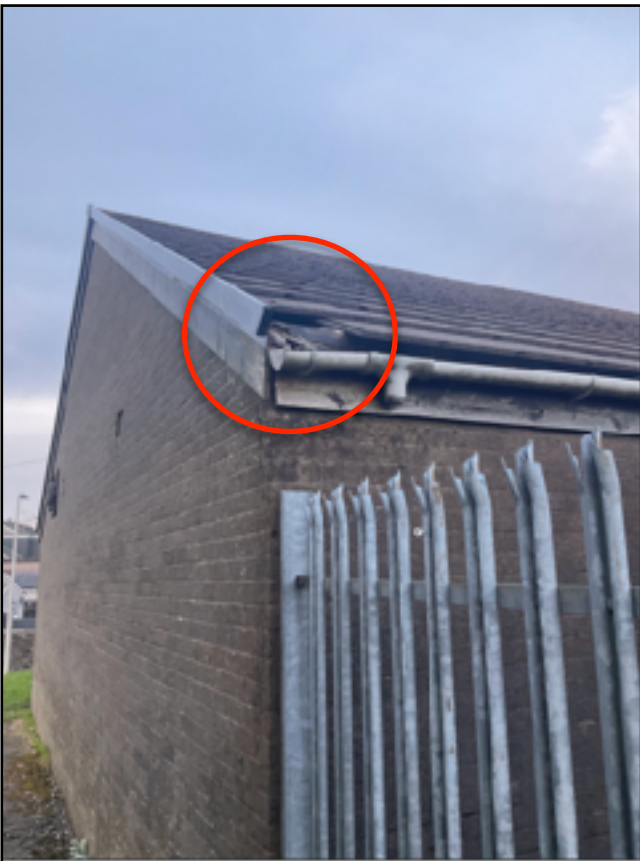
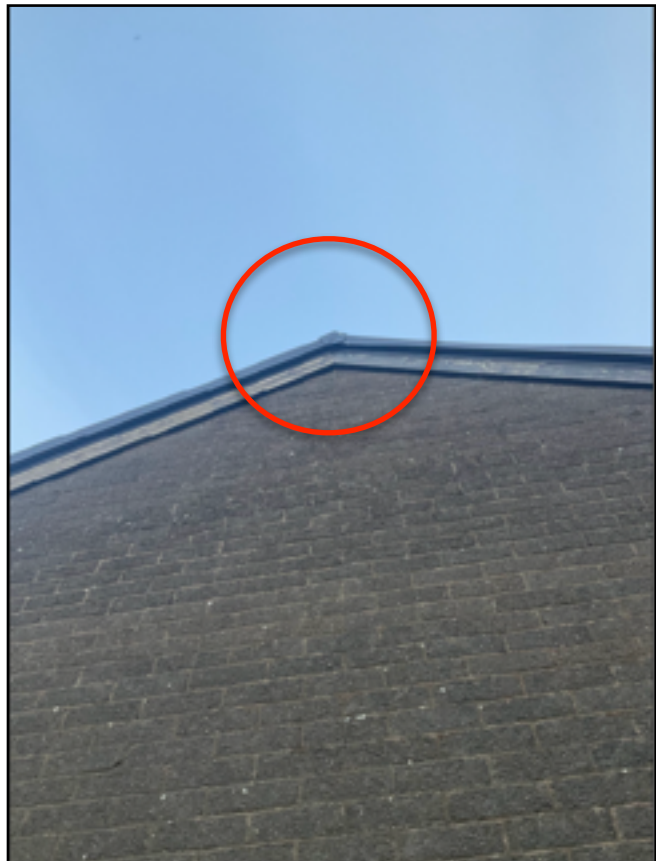
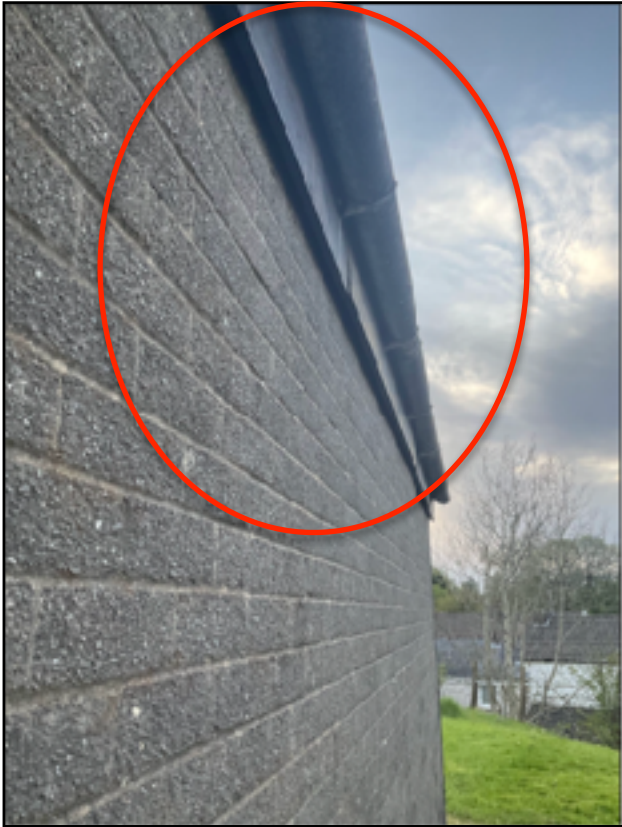
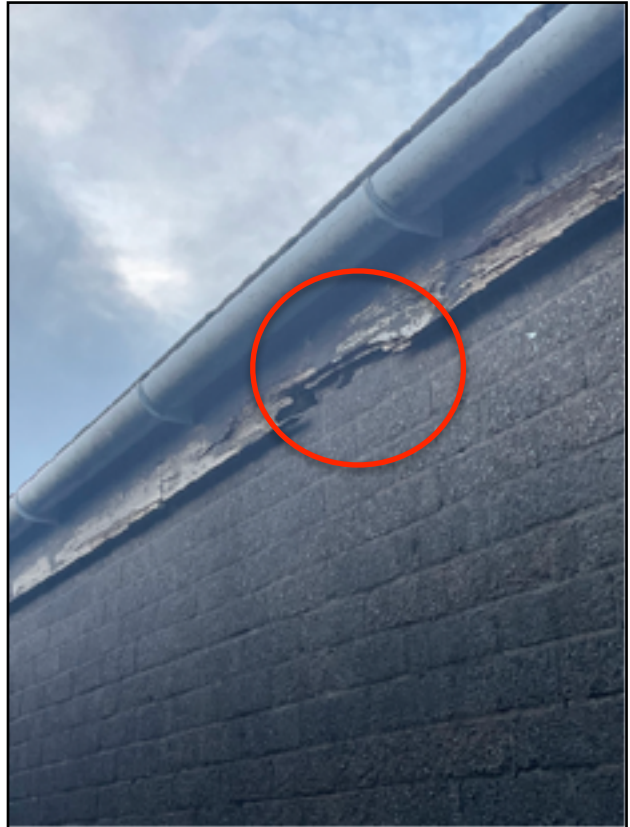
#### *Changing Room Block*

**6.4 Apertures between the fasciae and the walls were observed on the north eastern and south western elevations of the changing room block along with apertures between the barge boards and the walls on both gable ends (north western and south eastern elevations). There was a small aperture at the apex on the north western elevation of the building; areas of damage to the timber fasciae on the north western and south western elevations of the building and a small number of missing and damaged roofing tiles to the south western elevation. There were also very small apertures between a number of the roofing tiles. The changing room block was classed as having moderate potential for roosting use by bats.**

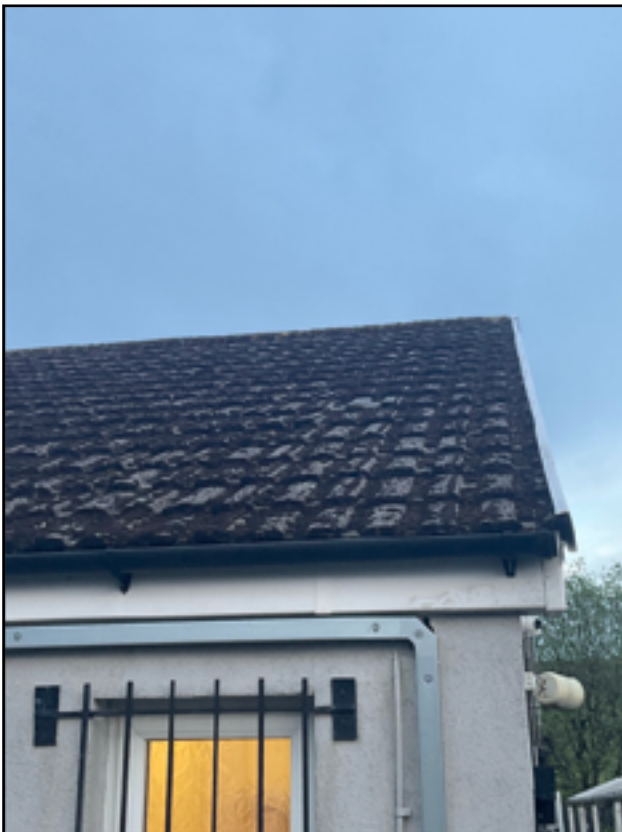
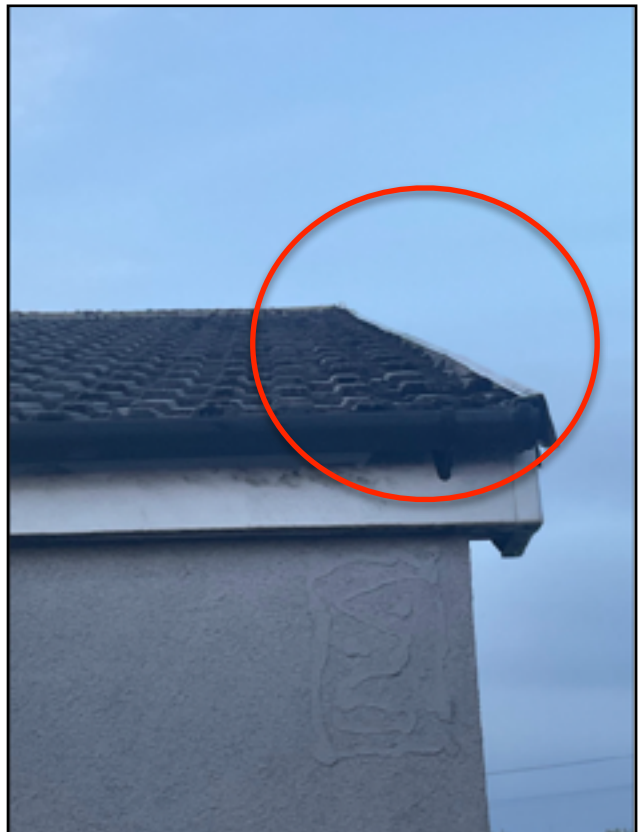
*Club House Building*

**6.3 The fasciae and barge boards on the club house building were tightly sealed with no apertures present suitable for use by bats. The roof of the building was in relatively good condition, however, there were a number of areas of missing mortar present between the roofing tiles. A small area of slightly raised lead flashing was also observed on the south eastern elevation and there was an aperture between the length of the uPVC barge board and the roof on the north western elevation of the building. The club house building was classed as having low to moderate potential for roosting use by bats.**

Areas of Missing Mortar Between Tiles

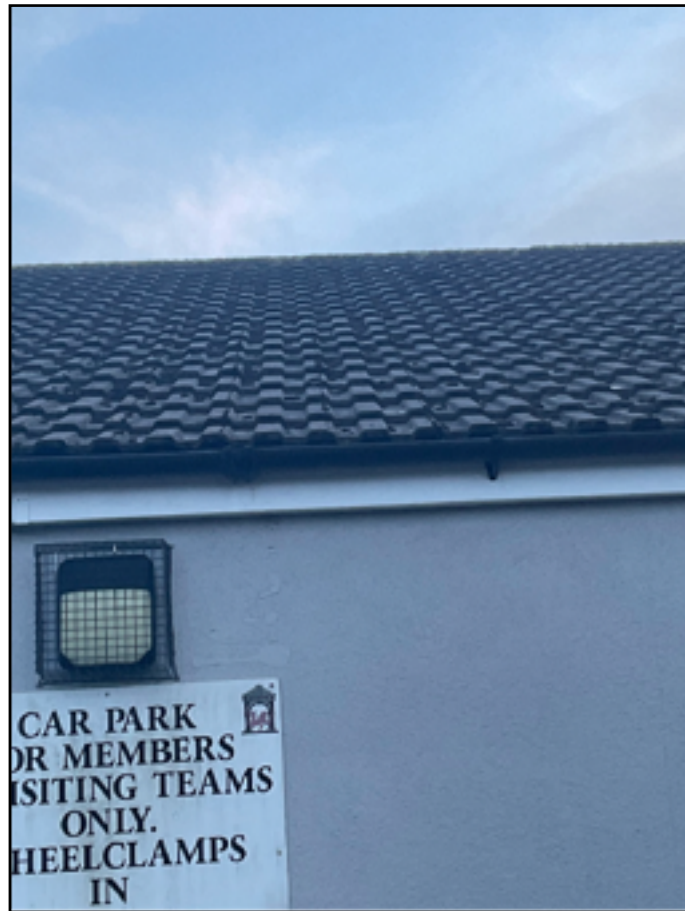
Areas of Missing Mortar Between Tiles

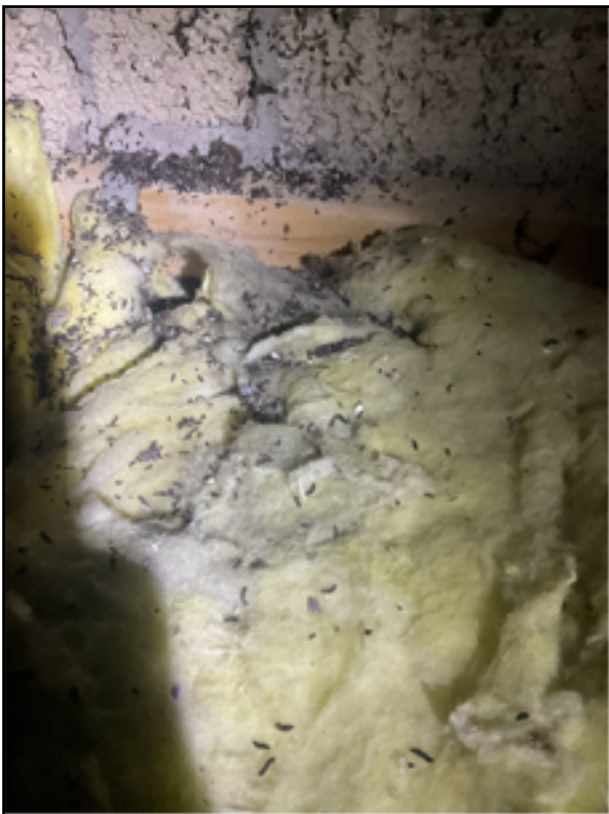
**7.3** A large accumulation (100s) of bat droppings were observed to the north western end of the attic space, below the apex. The droppings were indicative of a Pipistrelle Species (*Pipistrellus sp.*) of bat and there were a number of fresh droppings present. The odd singular bat dropping was observed around the south eastern end of the attic space also.

Accumulation of Bat Droppings (NW End)

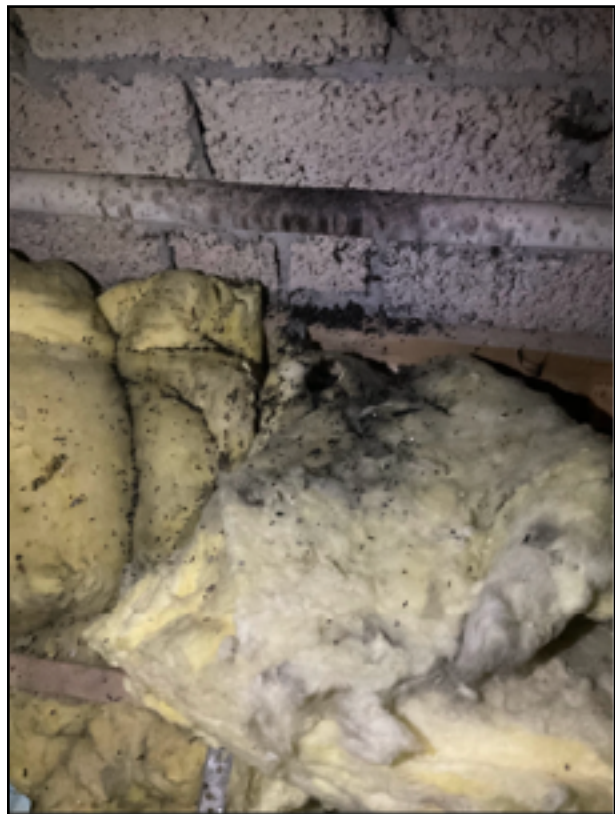
Accumulation of Bat Droppings (NW End)

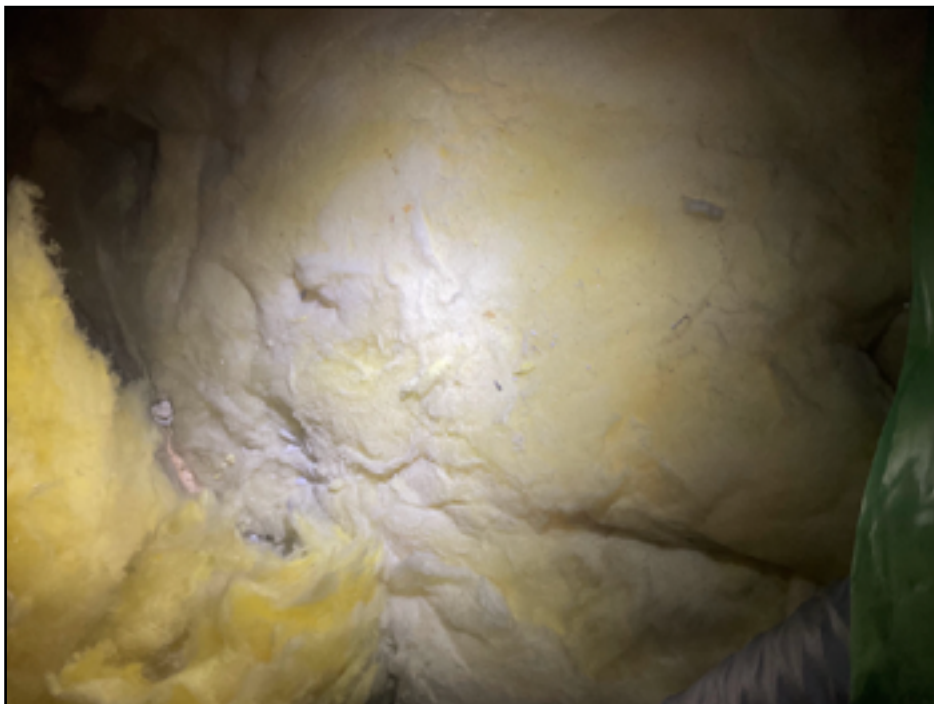
Single Bat Dropping (SE End)

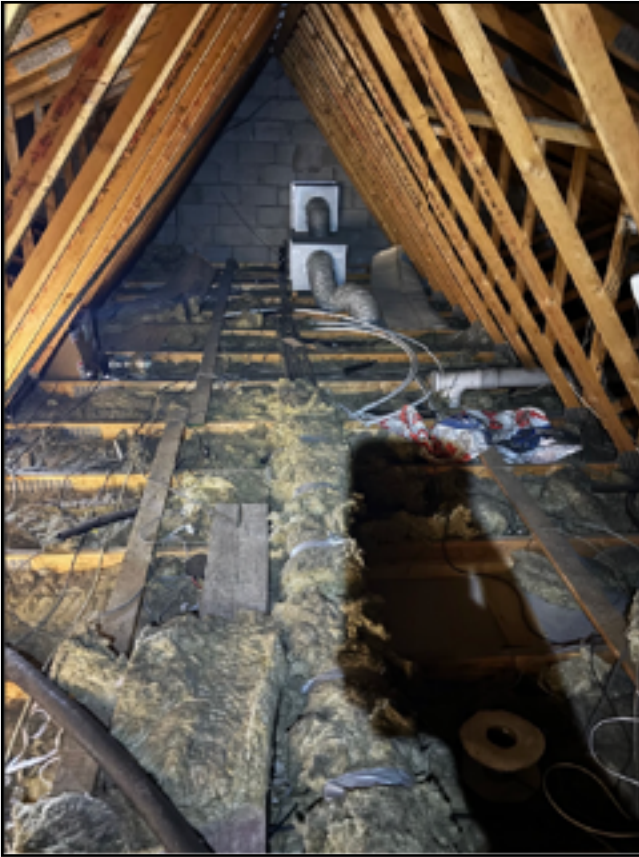
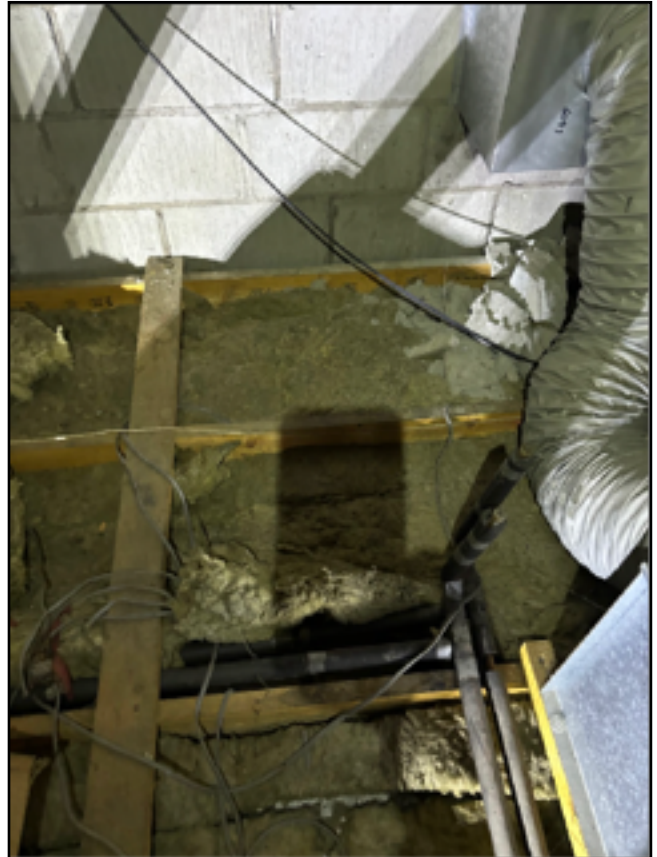
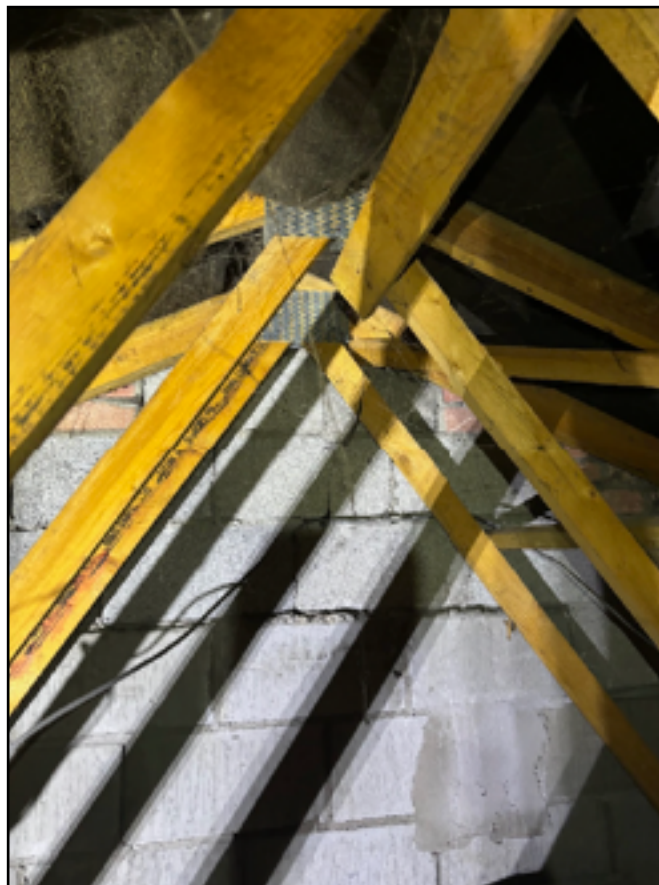
**7.4** There were two accessible attic spaces within the club house building. The attic spaces were of trussed designs and were partially boarded out with some insulation present on the floor. A small amount of light ingress was observed above the porch area.

**7.5** No droppings or evidence of bats were discovered on any internal features within the club house.

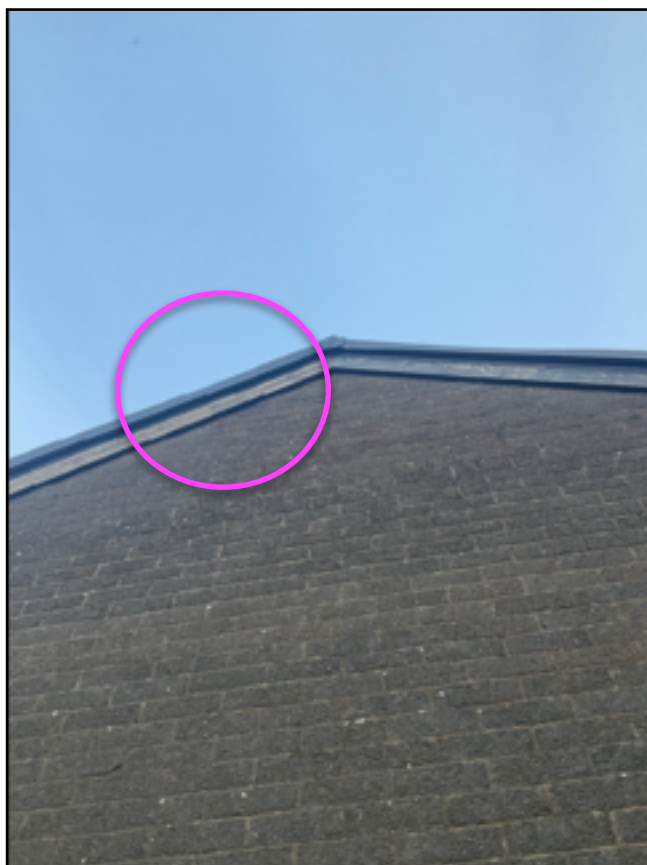
**16 Common Pipistrelles were observed emerging from an aperture underneath the barge boards to the north western gable end of the changing room block. The bat exit point is indicated in the below image.**

**11.3** The current bat access point into the changing room block on the north western gable end will be retained. The impacts of the scheme are very limited as the roof works are small scale and do not directly affect the confirmed bat roosting location within the changing room block.

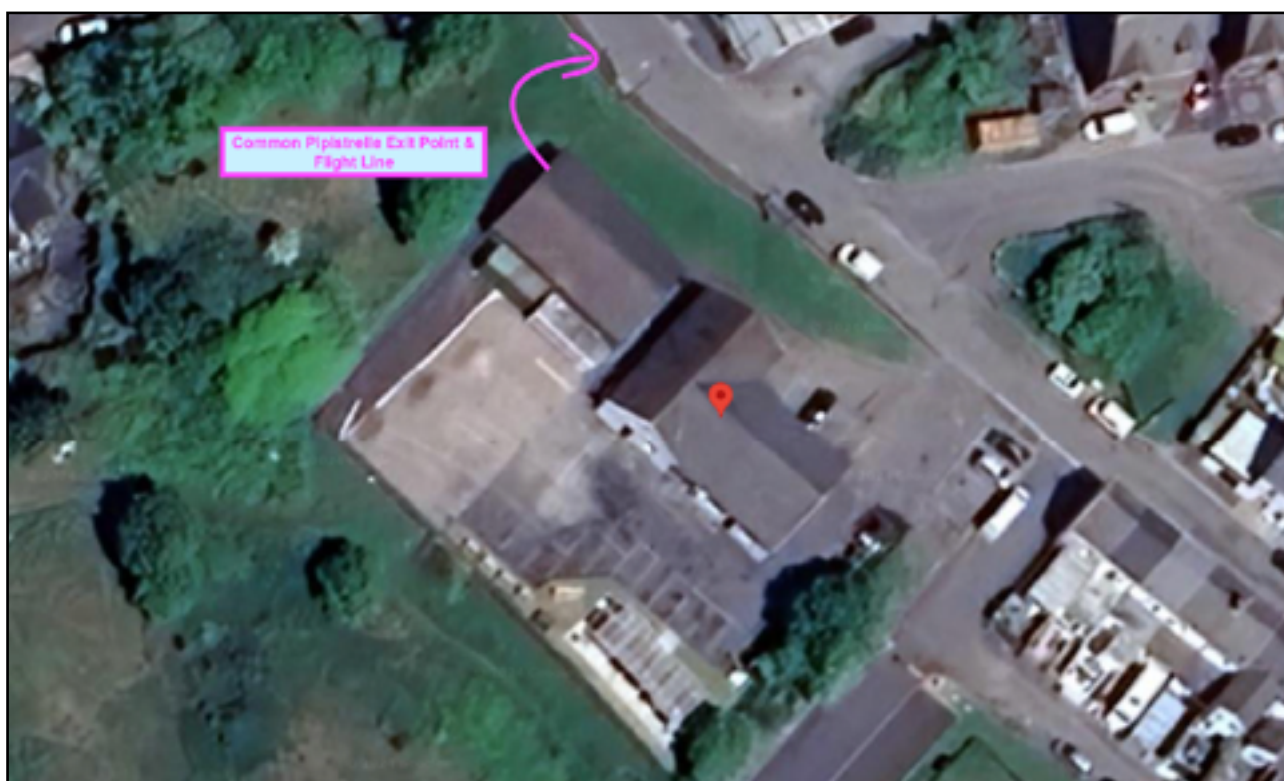
**8.11** During the first emergence survey on the club house building, a low number of bat calls were recorded. A Noctule was recorded but the bat was not observed. No bats were observed emerging from the club house building, however, 16 Common Pipistrelles were observed emerging from the changing room block.

BAT EXIT POINT - 22ND MAY 2024

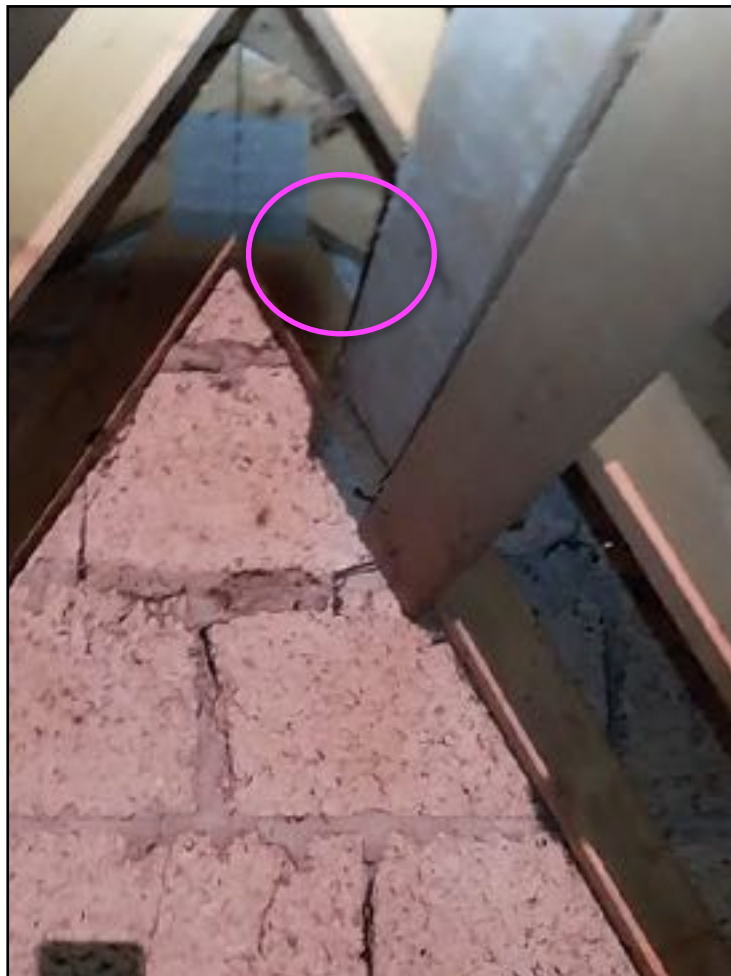
**9.3** When the static bat detector was collected from the changing room block on the 13th May 2024, a number of **Pipistrelle** bats (confirmed to be **Common Pipistrelles** during the 22nd May emergence survey) were observed roosting in a small gap between the timbers and the wall to the north western end of the attic space, below the apex.

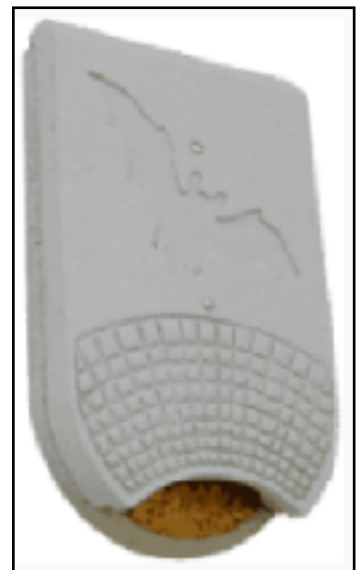
**11.4** It is proposed that an additional roosting provision for bats be created by fitting one Schwegler 1FQ surface mounted bat box on the southern elevation of the building. **Bat enhancement features will benefit from the southern elevation or an elevation where there is direct access to sunlight as the bats can tolerate and prefer high levels of temperature in their roost.**

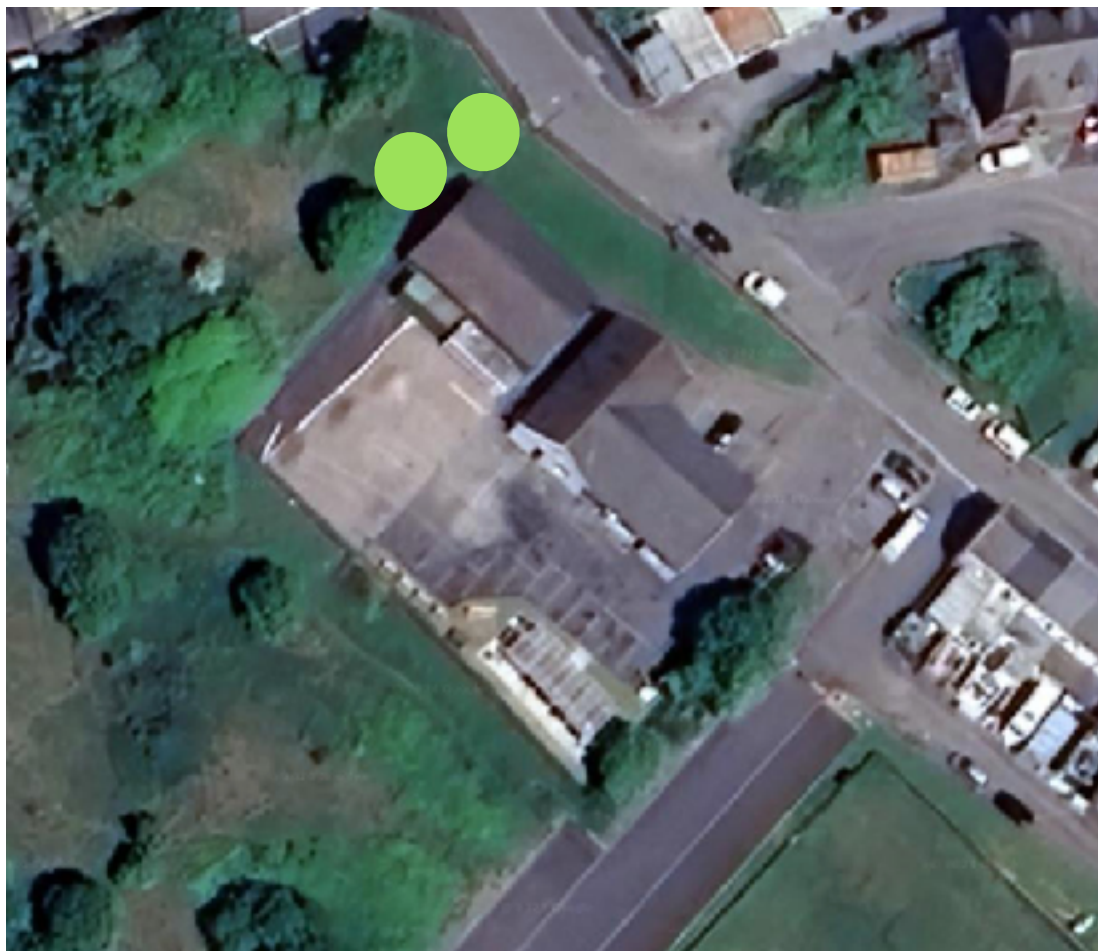
#### Southern Elevation

### 11.7 Recommended Locations of Bat Enhancements:

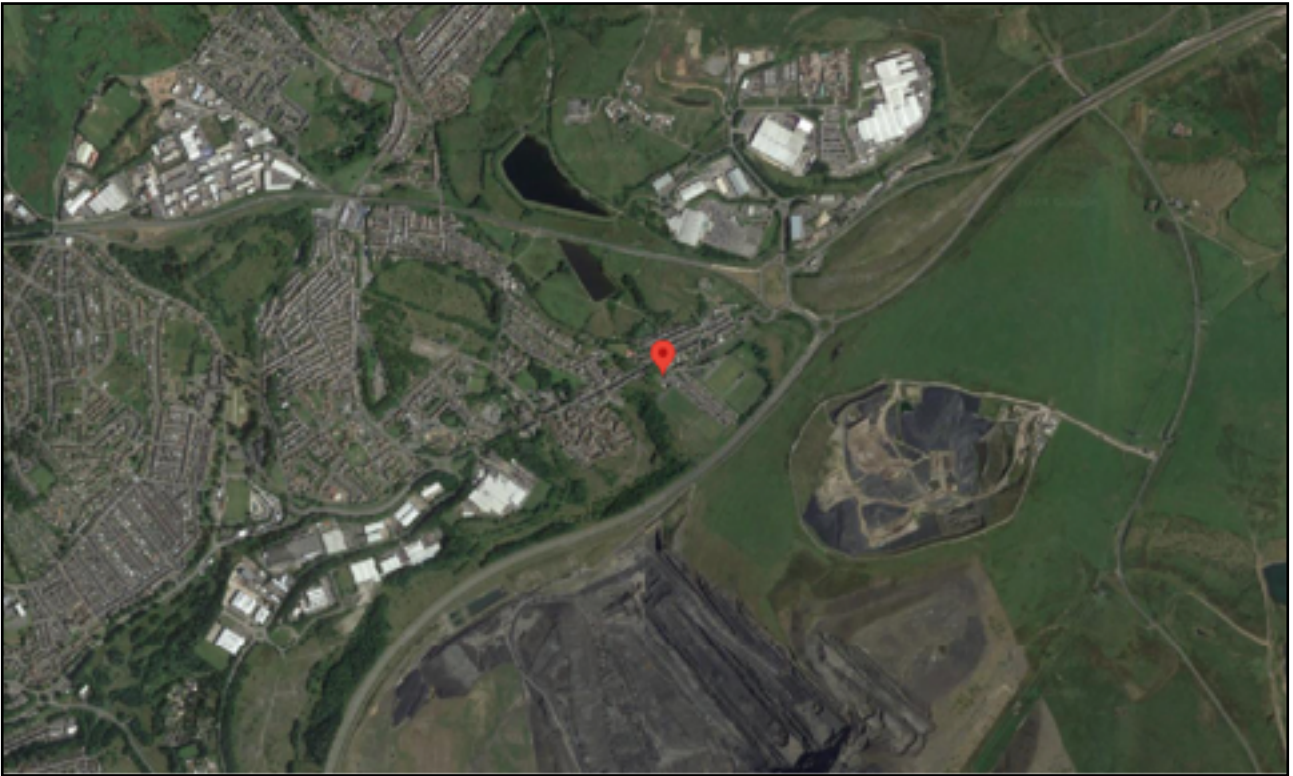
### **Appendix 1 Aerial Site Photograph**

**The site in its wider environment offering excellent ecological connectivity to the surrounding habitat.**
