Garth Farm  
Pant  
Merthyr Tydfil  
CF48 2YA

## A Supplementary Ecological Survey Report

Including Net Benefits for Biodiversity and a Green  
Infrastructure Scheme

September 2024

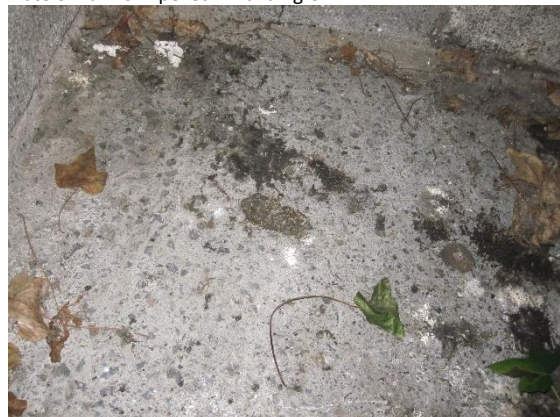
- 7.12 As noted in Table 7, internal survey discovered several (4) barn owl (*Tyto alba*) pellets inside Building C. None of the pellets were fresh, and were broken up and decomposing. Nonetheless, the pellets were the result of activity during 2024, likely in the early months of the year, and probably as a result of an individual animal foraging over the grassland south of the house when the grass was shorter in March to May.

Plate 6: Barn owl pellet in Building C

- 9.10 A barn owl box must be provided at the southern corner of the site. This could either be on a tree near the former railway embankment, but could be mounted on a telegraph pole. The box must not be in full sunlight, and ideally would face out towards the grassland south of the house. This is an appropriate level of mitigation given the limited evidence for presence noted. Suitable box designs are shown in Appendix V.

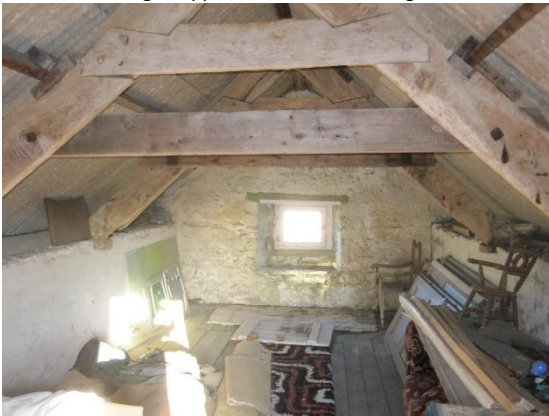
- 7.14 Building D was subject to day time inspection on 11 August 2024 by the two surveyors that arrived on site prior to the rest of the ecological team. The main structure of the building was found to be generally well sealed with no opportunities for access by bats. Focus was made of the roller shutter door/doorway, as bats have previously been found in such places by the surveyors. Nothing noteworthy was observed. When considering the two extensions to this structure, both were noted to have open doorways, enabling access by bats and/or birds.

Plate 11: Building D, upper floor interior looking east

- 9.8 Modification to the upper floor door of Building D will include the provision of an entrance slot high up in the door, approximately 300mm (w) by 200mm (h) in size. Such a provision can easily be made by a competent carpenter, and can be carried out in short order, but certainly prior to any demolition works being undertaken. At the same time, the entrance doors to the two lean-to structures can be repaired or replaced, and similar sized access slots provided in both. Lesser horseshoe bats will therefore be able to exploit three different environments for roosting, as they desire. The night roost provision is also close to the identified day roost in a third-party property. A timescale cannot be provided because it is not known how long the application will be under consideration at this time, but it is realistic to consider that this provision can be made within 48 hours of instruction.

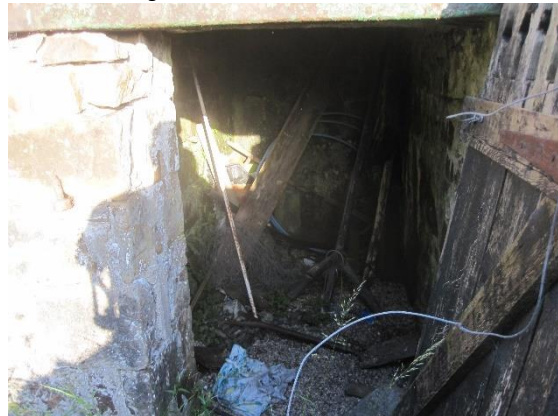
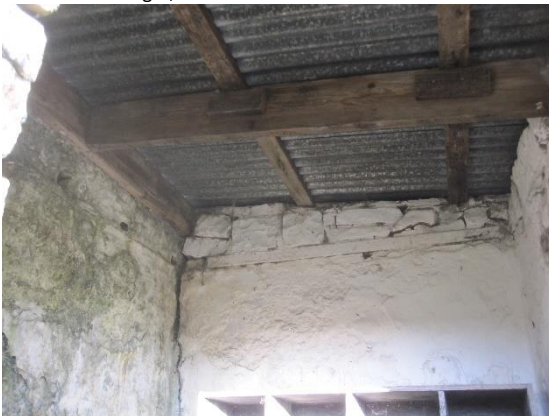
- 8.11 It is not known why Mott MacDonald chose to ignore Building D in their deliberations. Although it is generally well sealed, and in good condition, the two lean-to structures have open doorways, and bats could enter or exit. Given that they considered Building A (which also had open doorways), it is puzzling that D was not assessed. Nonetheless, the latest appraisal of the structure in August 2024 failed to find signs of bats, or nesting birds. The building does however lend itself to providing an element of the mitigation package for bats.

Plate 12: Building D, interior of western lean-to

Plate 13: Building D, interior of southern lean-to

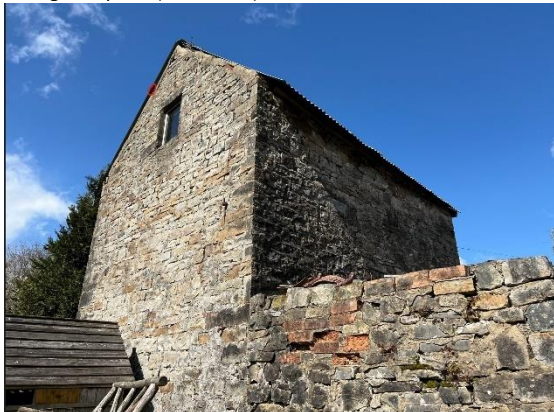
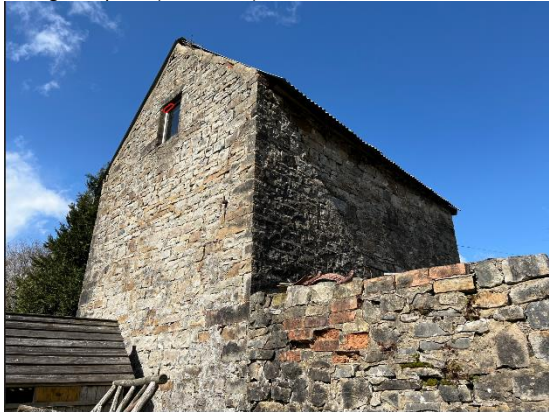
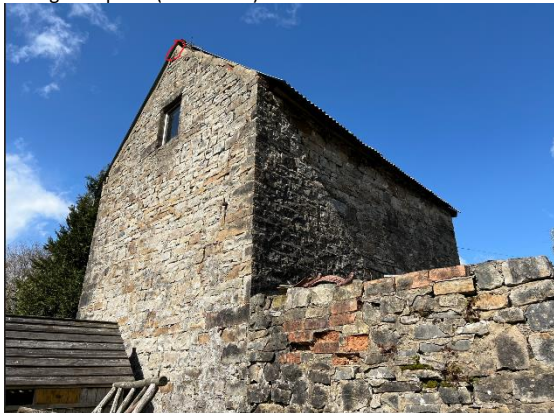
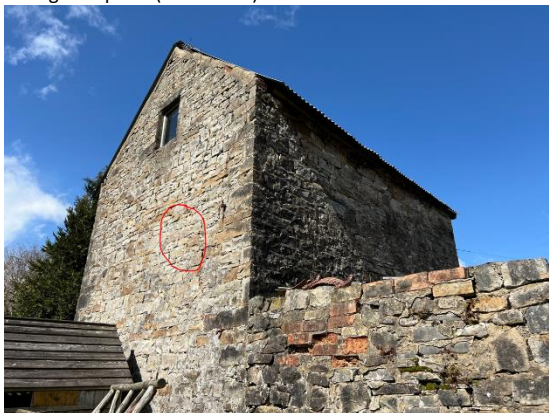
- 7.8 The 2022 survey effort noted the emergence of four common pipistrelle bats in late September from Building B. The species was not recorded using the building on any other date, either during 2022 or 2023, although the Morgan Ecology observation in July 2023 recorded a common pipistrelle bat briefly fly inside the first-floor room and back out again. The locations of the day roosts noted in 2022 are shown in Plates 18 – 21 (see Appendix II)

Plate 18: Building B, southern gable showing common pipistrelle emergence point (circled red)

Plate 19: Building B, southern gable showing common pipistrelle emergence point (circled red)

Plate 20: Building B, southern gable showing common pipistrelle emergence point (circled red)

Plate 21: Building B, southern gable showing common pipistrelle emergence point (circled red)

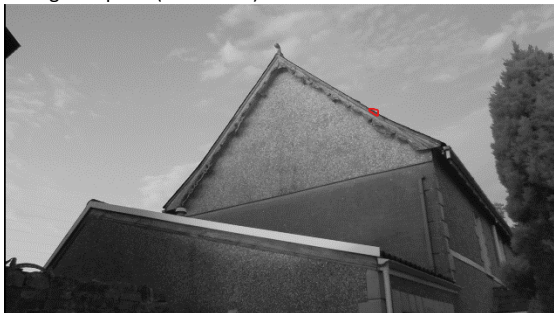
- 7.4 None of the internal surveys of the house found evidence of bats, and no emergence activity was noted from any part of the house other than the southern slope of the roof on the western gable, where the bat was seen to emerge from the same precise location during each of the 2022 observations (see Plate 22). The 2022 survey data indicates that the house is a day roost for a common and widespread species – common pipistrelle bat (*Pipistrellus pipistrellus*). No bird nesting activity was recorded in relation to the house. The 2023 Morgan Ecology appraisal of the house found no evidence for bat presence.

Plate 22: House, western gable showing common pipistrelle emergence point (circled red)

- 9.6 Dealing with more specific mitigation measures for the bats present at Garth Farm, an integrated bat box will be provided close to the apex at the western gable, as specified in the original Morgan Ecology report (July 2024). Given that additional roost locations are now appropriate, it is considered that a similar integrated box must also be provided at the eastern gable, as close to the proposed chimney as possible, and ideally on the southern side of the stonework. Temporary mitigation for bats found during works can be provided with Building D, which offers several aspects where a bat can safely be located. There are several 'off the shelf' products available currently, and ideally two Schwegler 1FR bat tubes will be built into the upper walls. Other designs can be used, and different types are illustrated in Appendix V, along with an example of an installation.

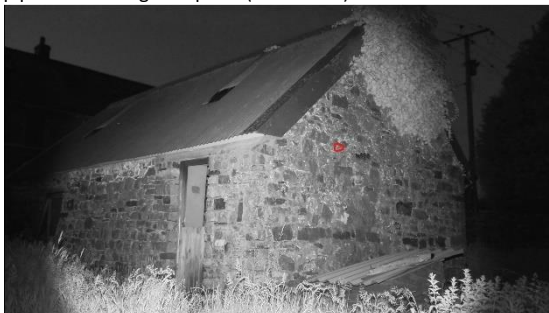
- 7.10 Building C was the only structure at Garth Farm which was subject to assessment by Mott Macdonald in 2023 – see Table 7. The dusk observation in May 2023 found no evidence of bats and recorded no emergences. However, during 2022 they did record the emergence of a common pipistrelle bat from a crevice in the south-western gable of the building (see Plate 23). This was the only emergence activity record with relation to this structure, and indicates that Building C is a common pipistrelle bat summer day roost. The Morgan Ecology dusk observation on 11 August 2024 did not record any emergence activity with respect to the building.

Plate 23: Building C, south-western corner, showing common pipistrelle emergence point (circled red)
