# Merthyr Labour Exchange, Merthyr Tydfil: Archaeological Excavation and building recording

A report for Wales and West  
Housing  
by Johnny Crawford BSc MA MCIfA

GGAT report no. 2020/081  
Project no. P2003

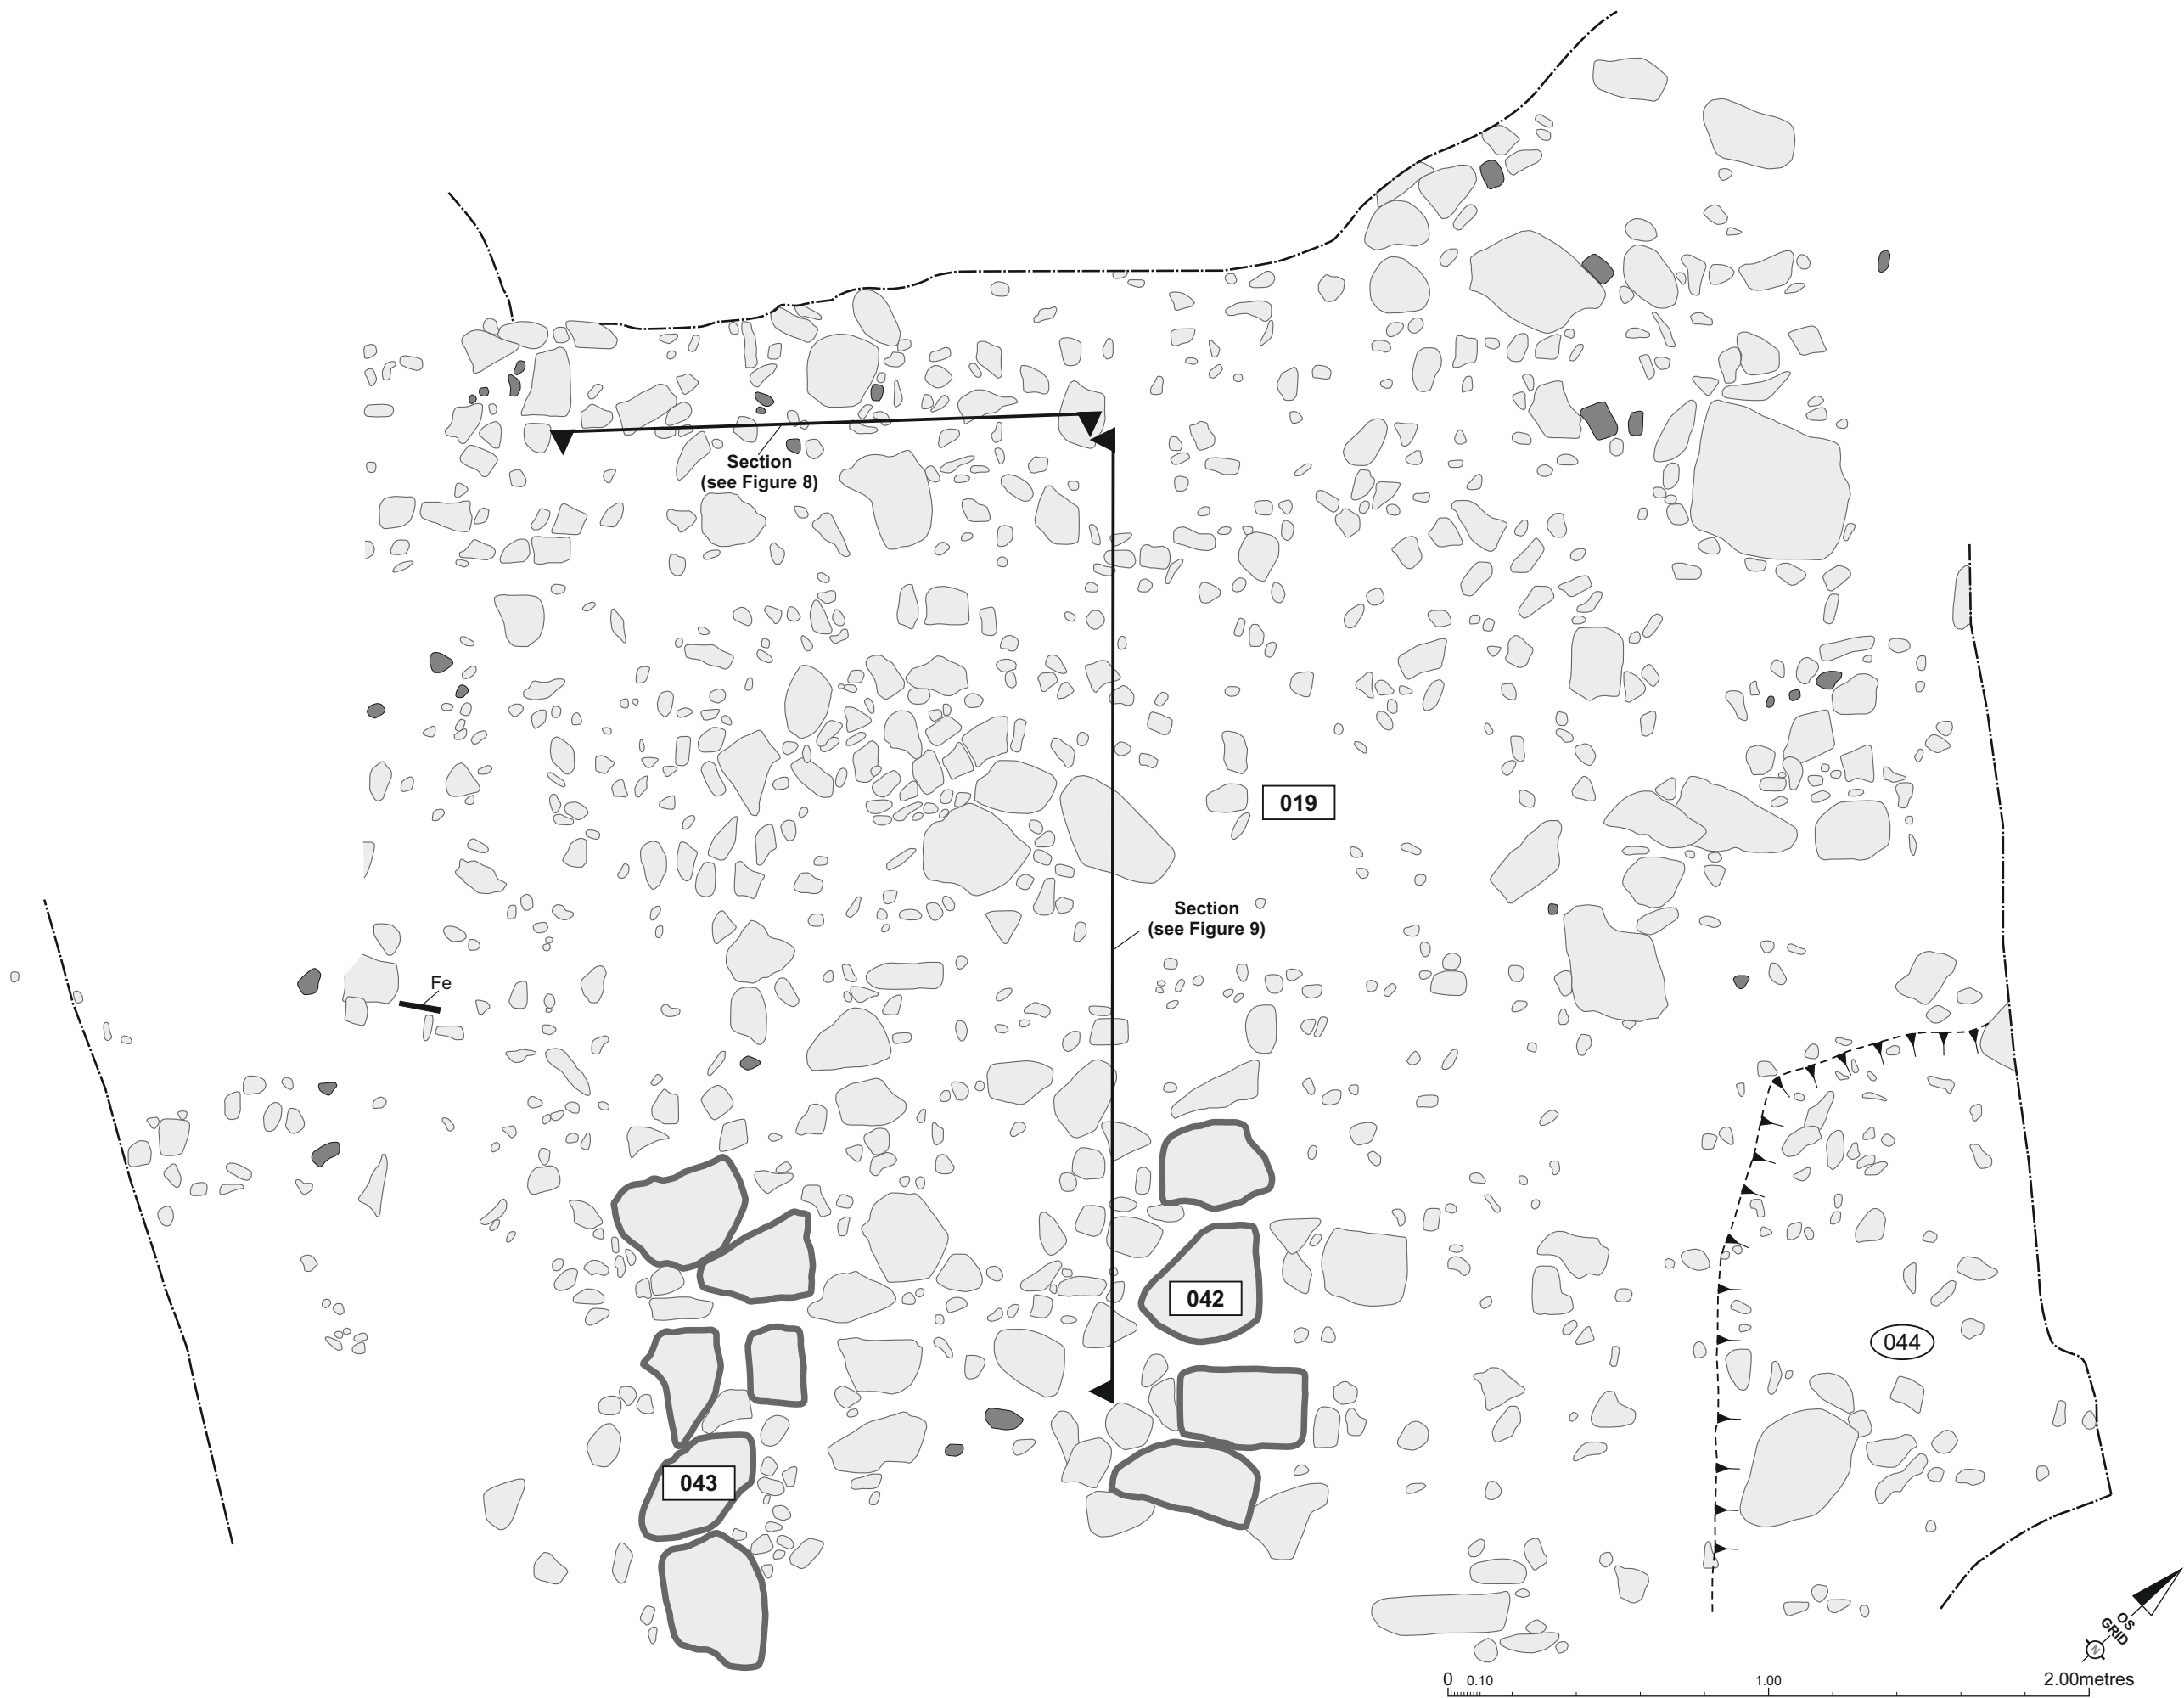
Figure 7. Plan of Roman surface 019 showing location of section Figures 8 and 9 (see Figure 2 for location).

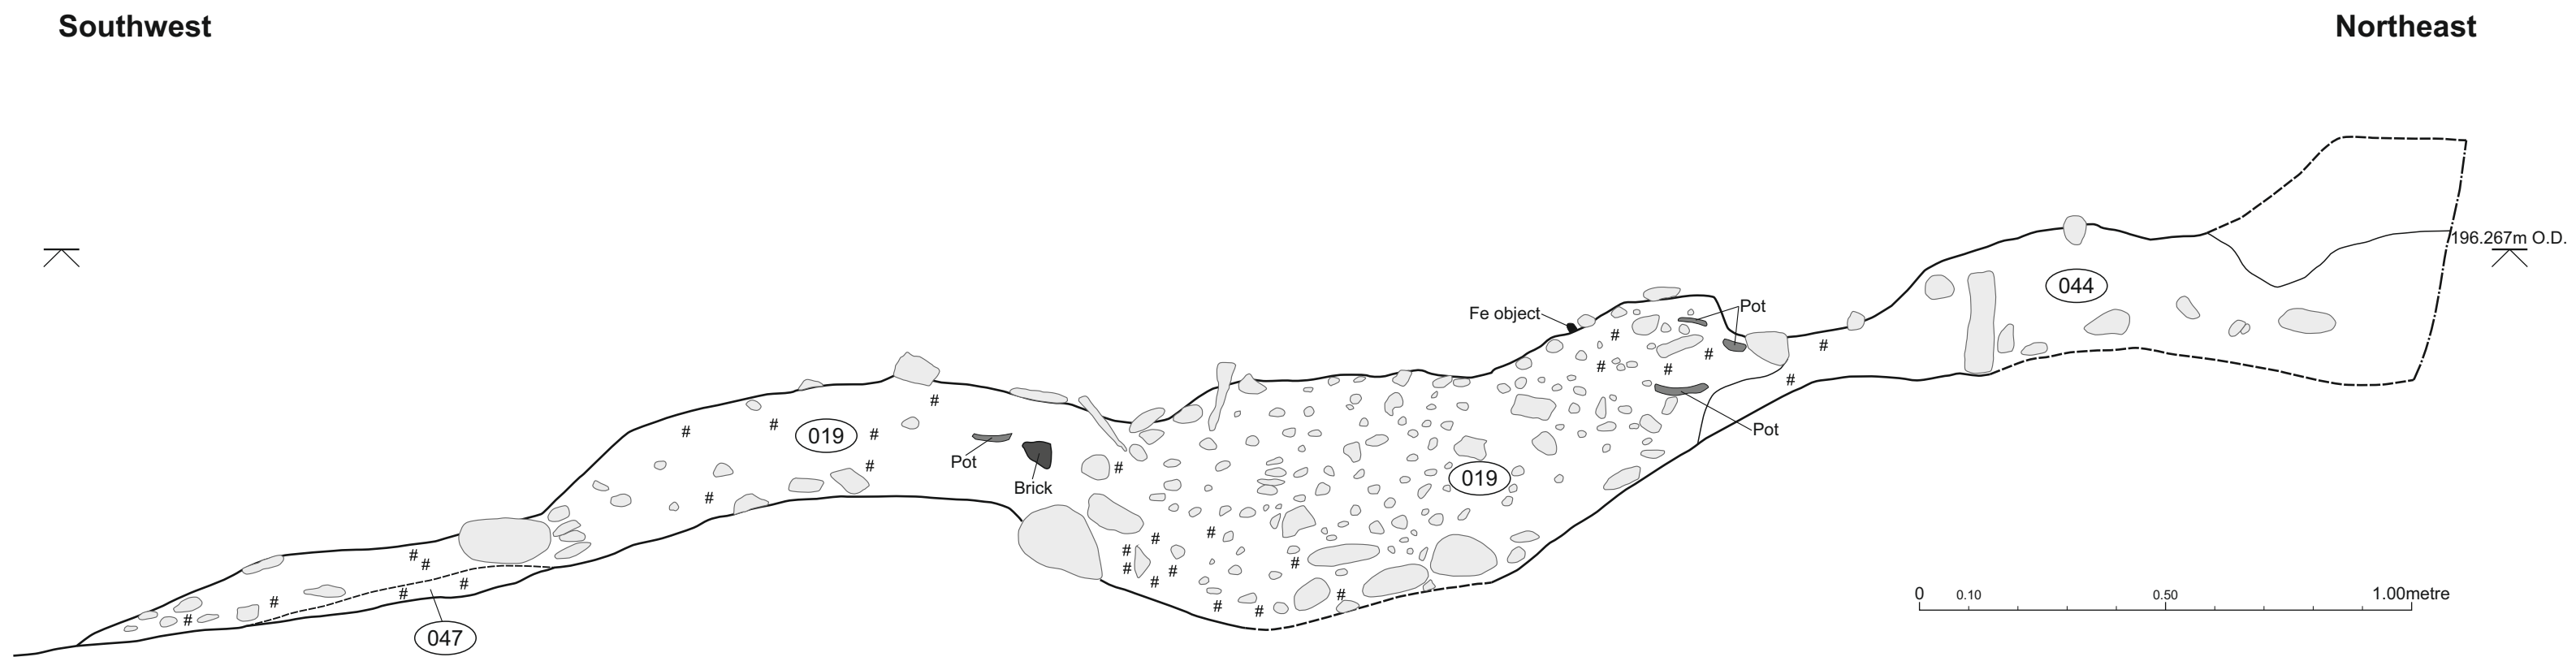
Figure 10. South east facing section across surface 019 (see Figure 2 for location).

| <b>Figure 10. South east facing section across surface 019 (see Figure 2 for location)</b> ..... | <b>81</b> |

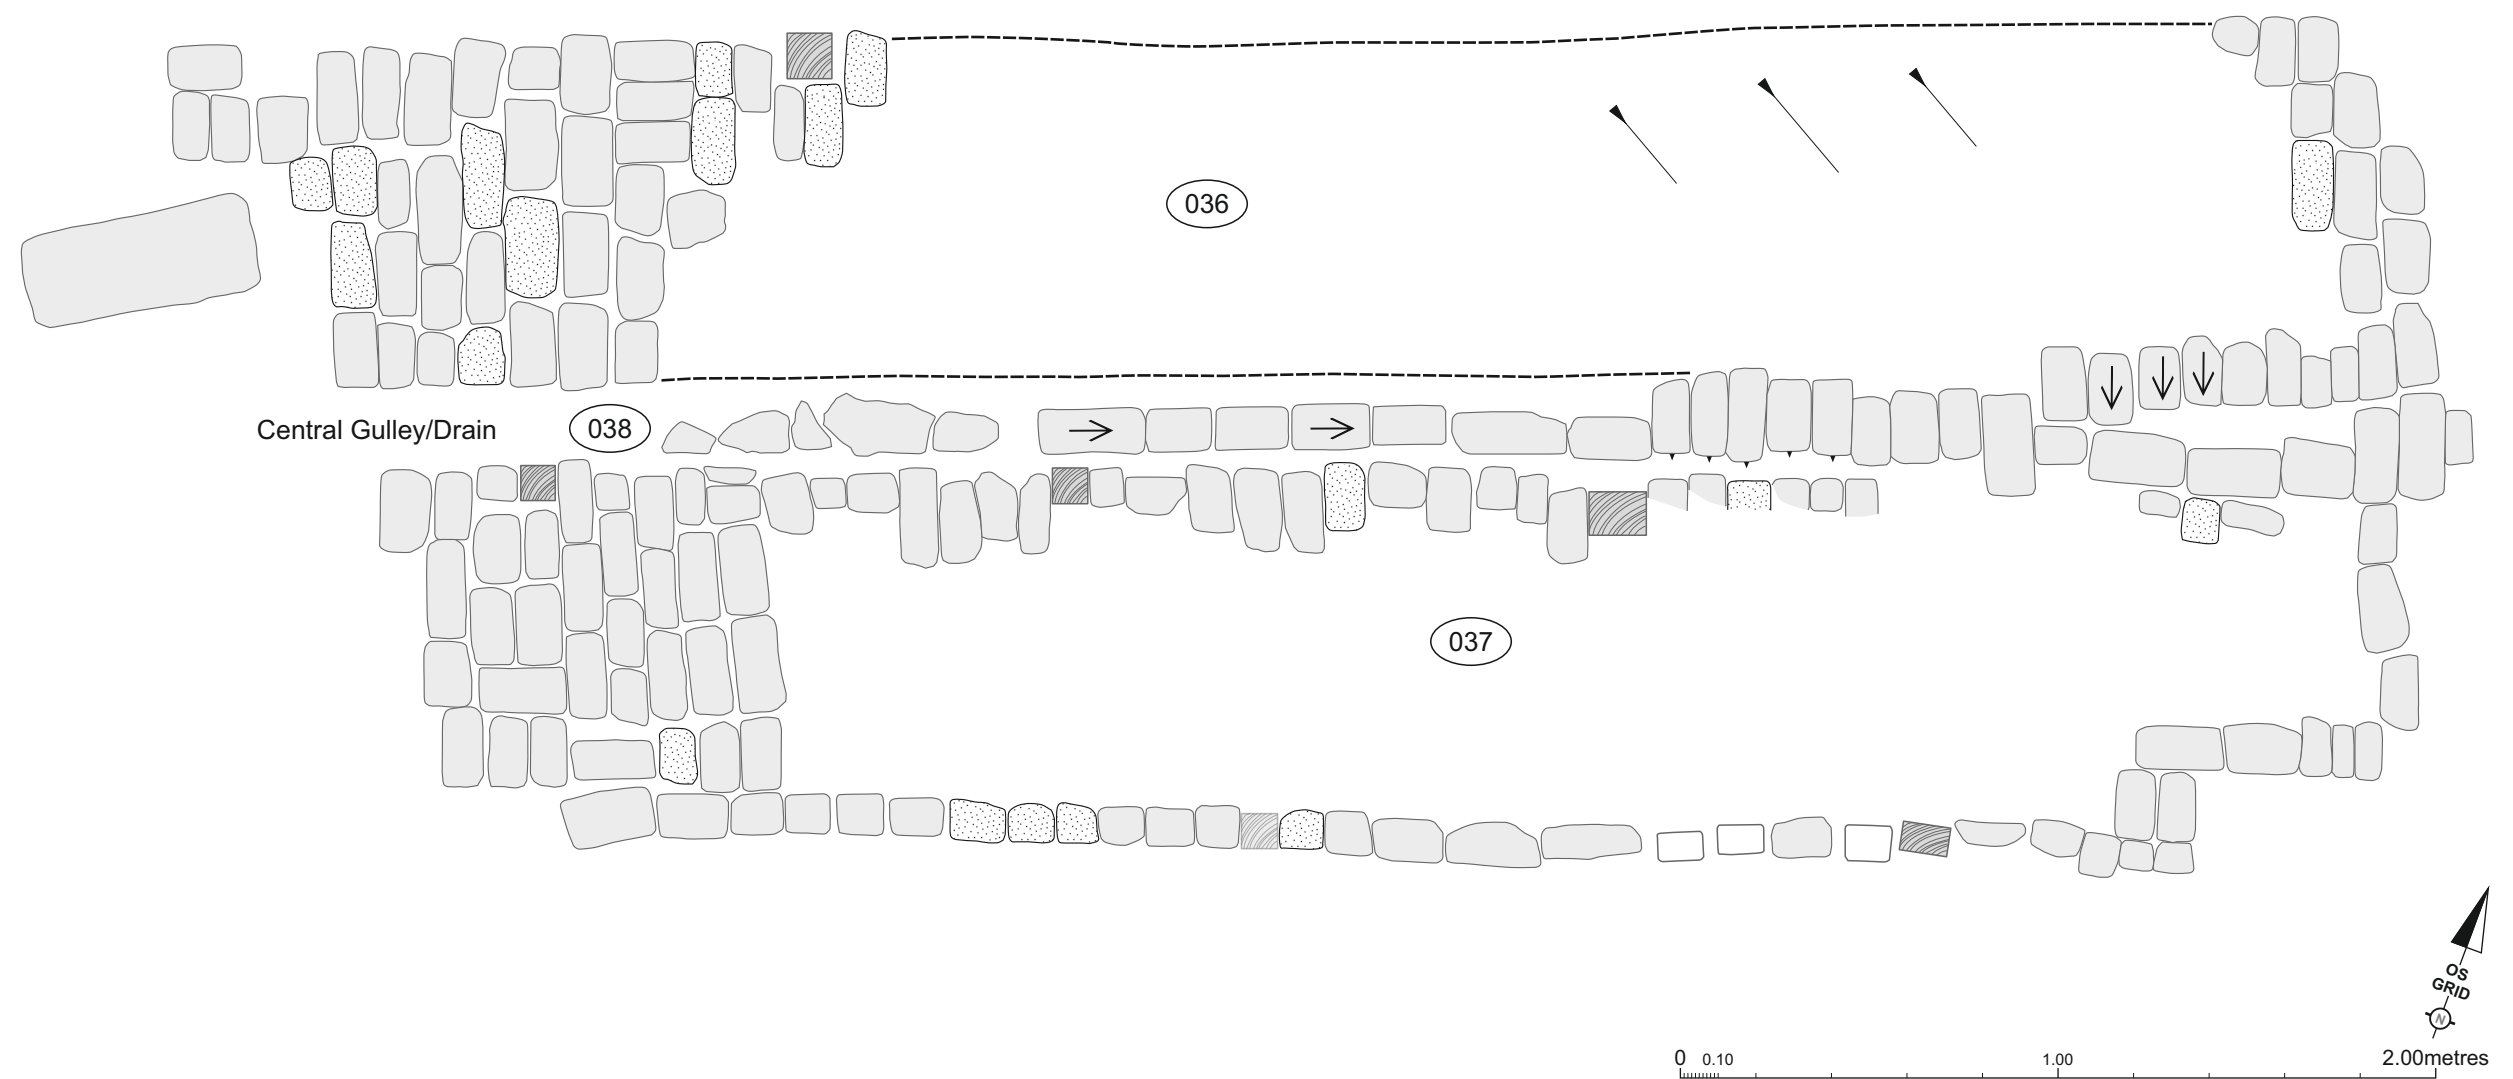
**Figure 12.** Cobbled surface area 036/037 representing the remains of probable turnstiles for the football ground (see Figure 2 for location).

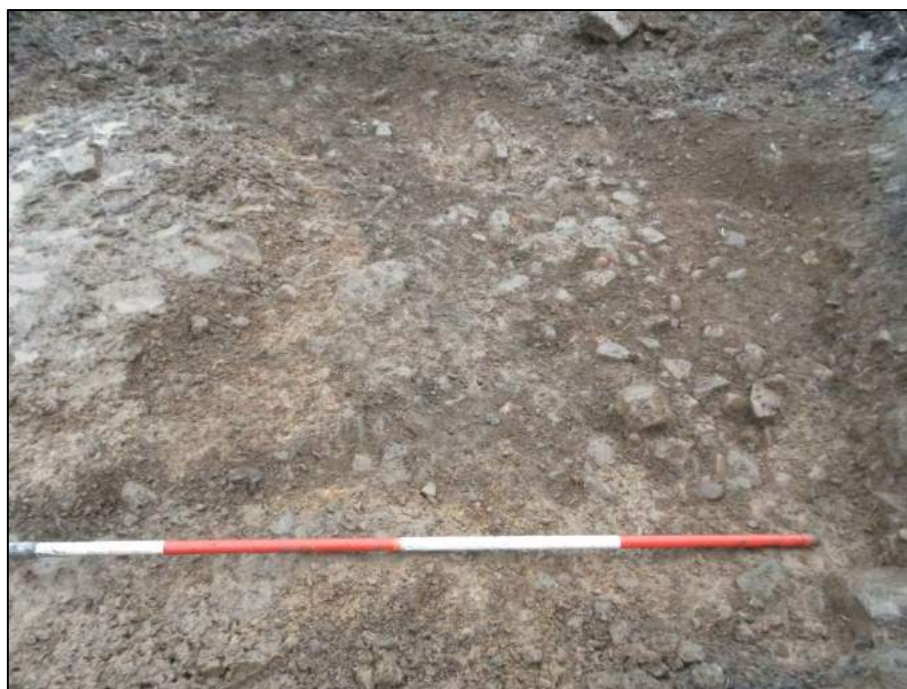
**Plate 3.** Feature 035 consisted of an ephemeral deposit of material rich in Roman finds, including coins, pottery and brooches. Scale divisions 0.5m, view to south/south west.

| Plate 3. Feature 035 consisted of an ephemeral deposit of material rich in Roman finds, including coins, pottery and brooches. Scale divisions 0.5m, view to south/south west. .... | 91 |

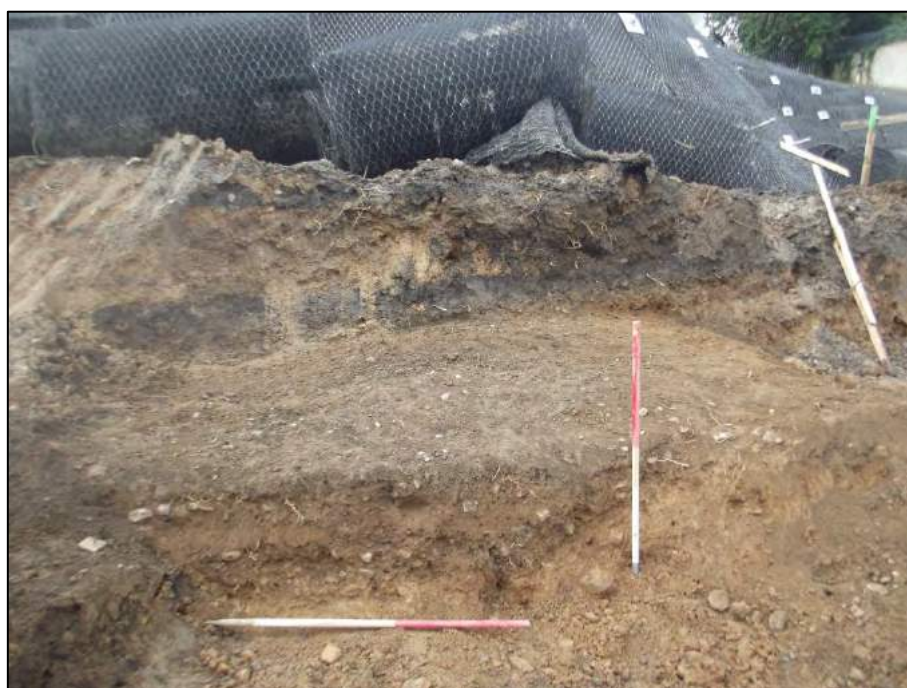
**Plate 4.** Deposit 075. This deposit is probably the same as 035, which had been noted in the same area the previous year. Both deposits were rich in Roman finds. Scale divisions 0.5m, view to north.

| Plate 4. Deposit 075. This deposit is probably the same as 035, which had been noted in the same area the previous year. Both deposits were rich in Roman finds. Scale divisions 0.5m, view to north. .... | 91 |

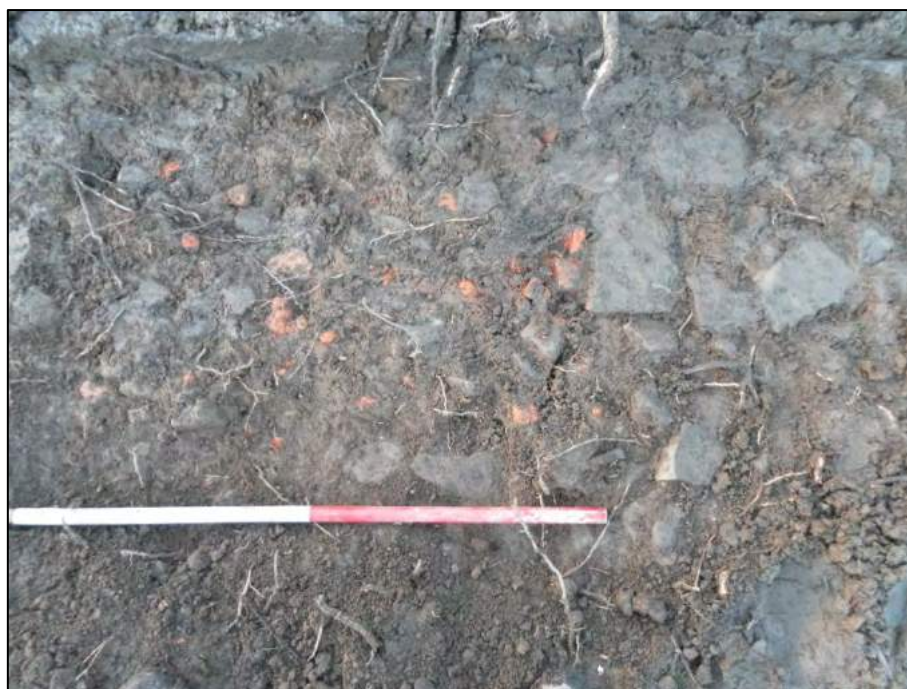
**Plate 5. Metalled surface 019 showing ceramic building material remains. Scale division 0.5m**

| Plate 5. Metalled surface 019 showing ceramic building material remains. Scale division 0.5m..... | 92 |

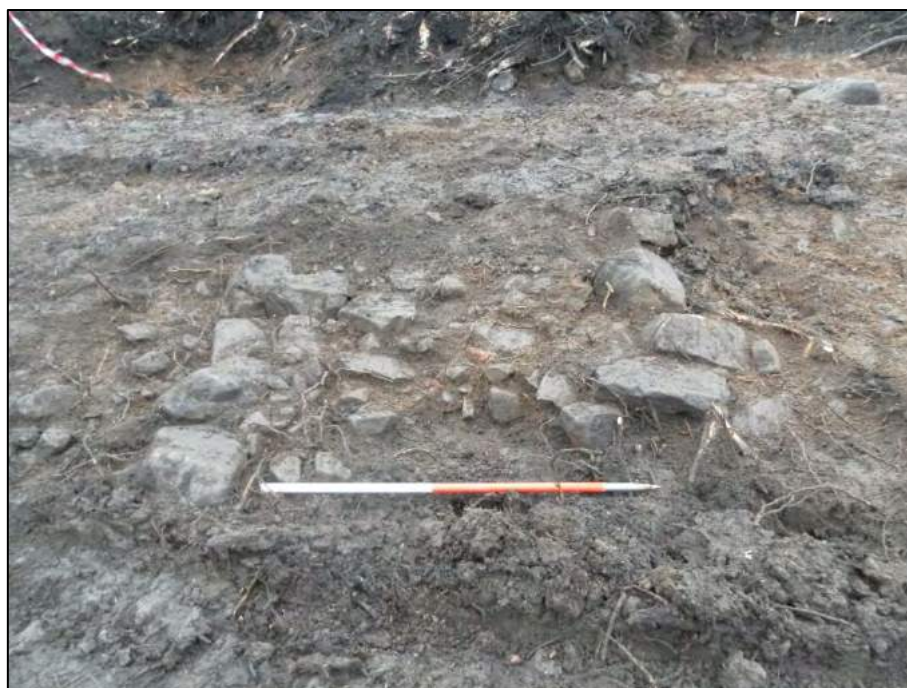
**Plate 6. Possible kerbing located either side of a metalled area 019. This feature was ephemeral and little more was discerned on further excavation.**

| Plate 6. Possible kerbing located either side of a metalled area 019. This feature was ephemeral and little more was discerned on further excavation. .... | 92 |

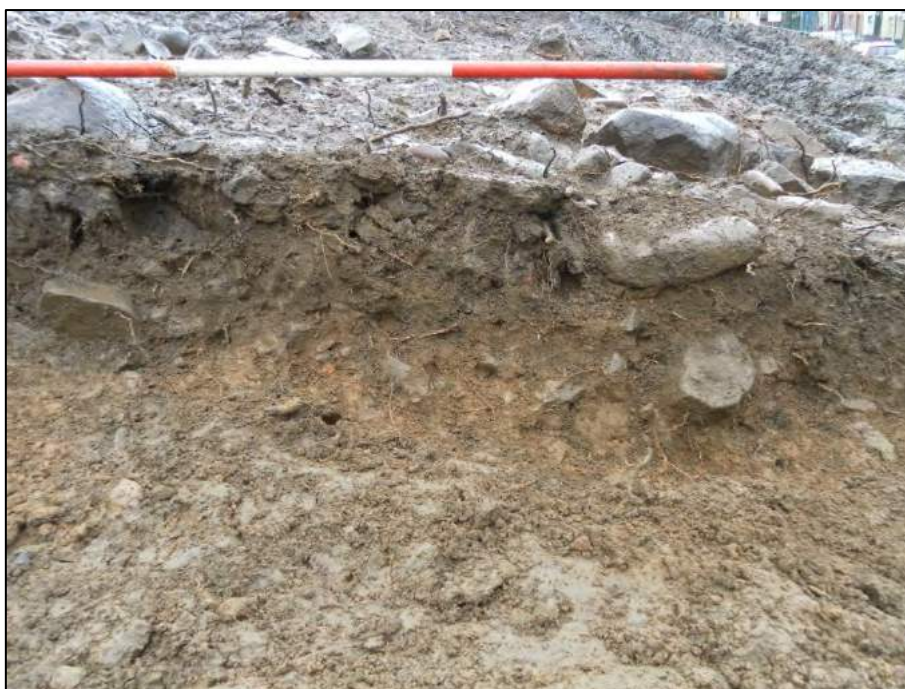
**Plate 7. South west facing section through metalling 019 showing the ephemeral nature of the construction. Scale divisions 0.5m.**

| Plate 7. South west facing section through metalling 019 showing the ephemeral nature of the construction. Scale divisions 0.5m. .... | 93 |

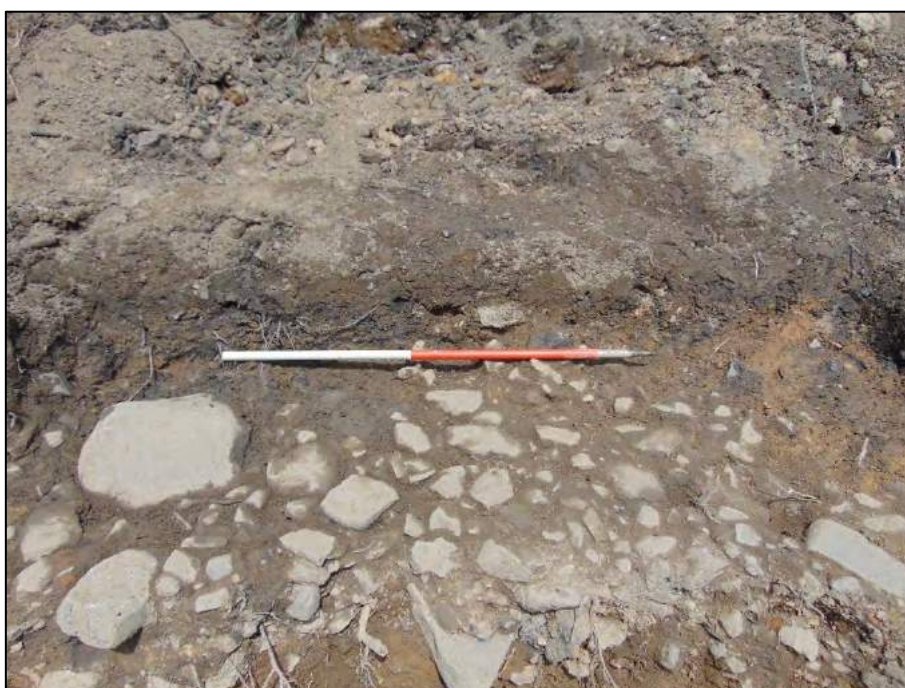
**Plate 8. Surface 113 was a possible Roman trackway found close to metalling 019 and is likely to have been the same deposit. Scale division 0.5m, view to north.**

| Plate 8. Surface 113 was a possible Roman trackway found close to metalling 019 and is likely to have been the same deposit. Scale division 0.5m, view to north. .... | 93 |

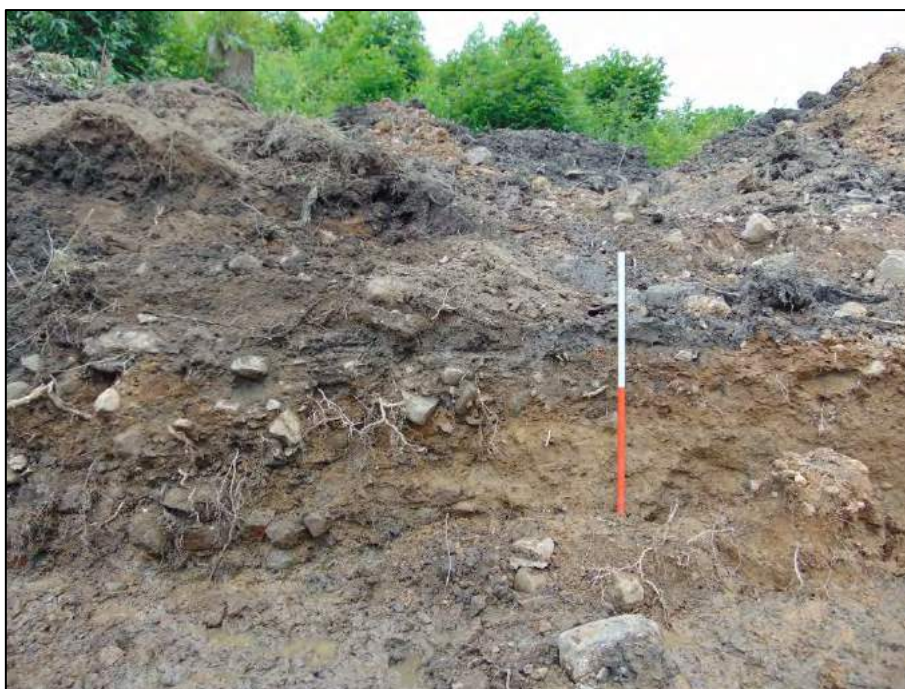
**Plate 9. Cut 106 and fill 107, located close to the Post medieval structure 111. View to north east, scale divisions 0.5m**

| Plate 9. Cut 106 and fill 107, located close to the Post medieval structure 111. View to north east, scale divisions 0.5m..... | 94 |

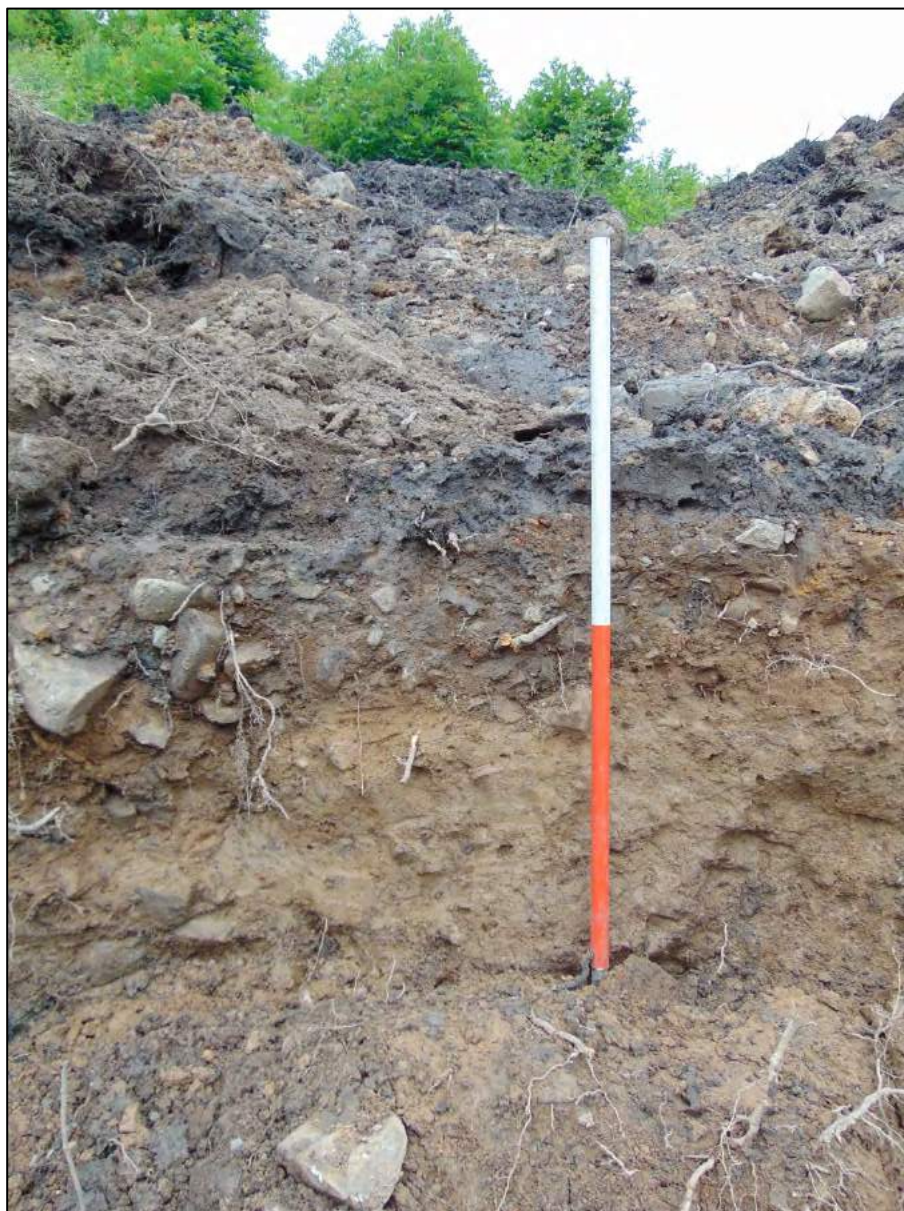
**Plate 10. Closer view of south facing section through deposit 107, contained within cut 106. Scale division 0.5m.**

| Plate 10. Closer view of south facing section through deposit 107, contained within cut 106. Scale division 0.5m..... | 95 |

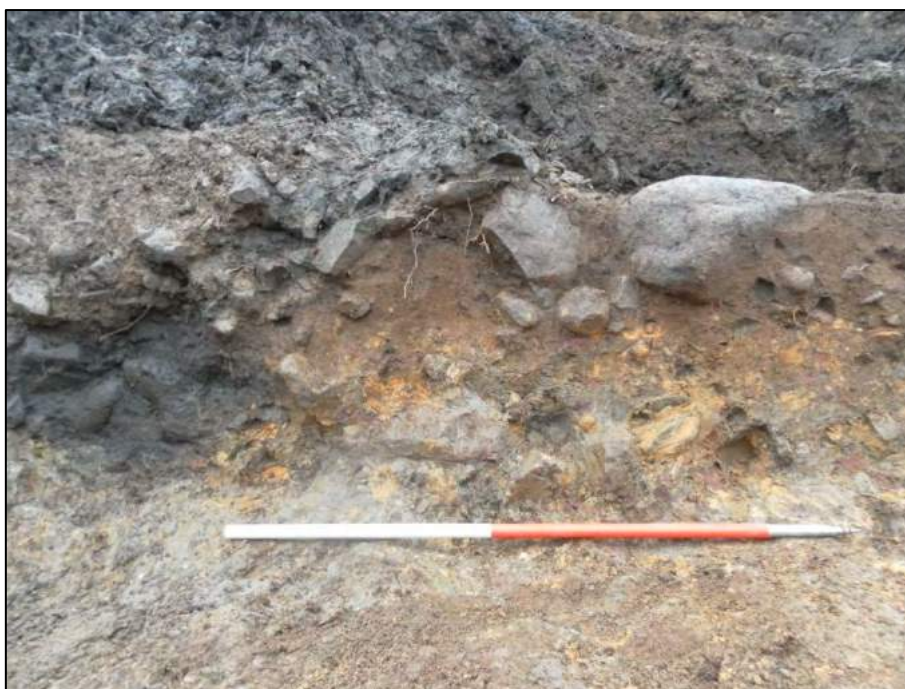
**Plate 11. Fill of feature 017, a deposit of ironstone, clays and stone that included Roman ceramics. This was possibly the fill of a drainage ditch.**

| Plate 11. Fill of feature 017, a deposit of ironstone, clays and stone that included Roman ceramics. This was possibly the fill of a drainage ditch. .... | 96 |

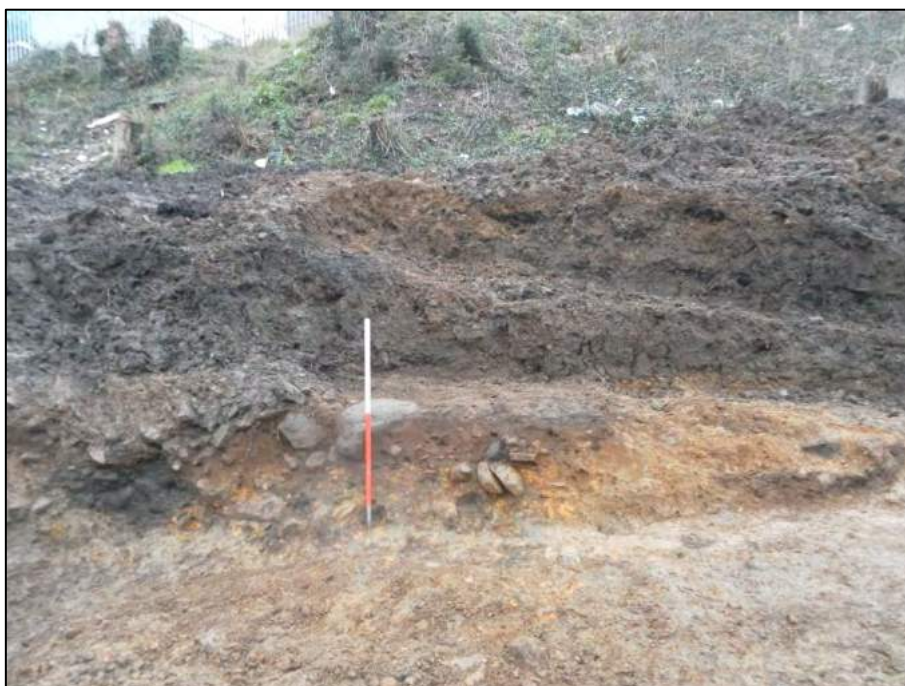
**Plate 12. Contextual view of deposit 017 within the bank. Scale divisions 0.5m, view to north.**

| Plate 12. Contextual view of deposit 017 within the bank. Scale divisions 0.5m, view to north..... | 96 |

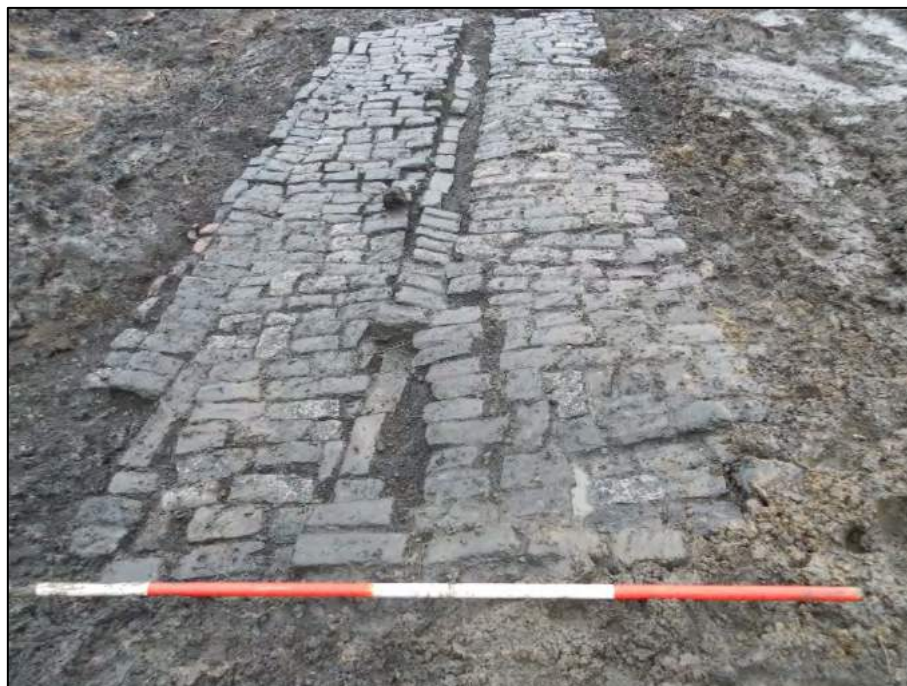
**Plate 13.** Foundation 020, belonging to a probable Post-medieval turnstile. The structure was inset with a number of upright wooden posts to support a superstructure. Scale divisions 0.5m (see Plate 11)

Two Post-medieval structures were also recorded towards the north side of the site (Zone 3). One (020) a paved area of stone setts with a series of timber uprights (Plates 13, 14 and Figure 4) and the other structural feature (021), the foundation of a wall and an associated cinder pathway. These were initially believed to have been possible dog kennels as the former athletics track was allegedly used as a dog racing track from the 1930s to the 1960s but in fact are almost certainly the remains of turnstiles for the football ground, built between 1912 and 1915.

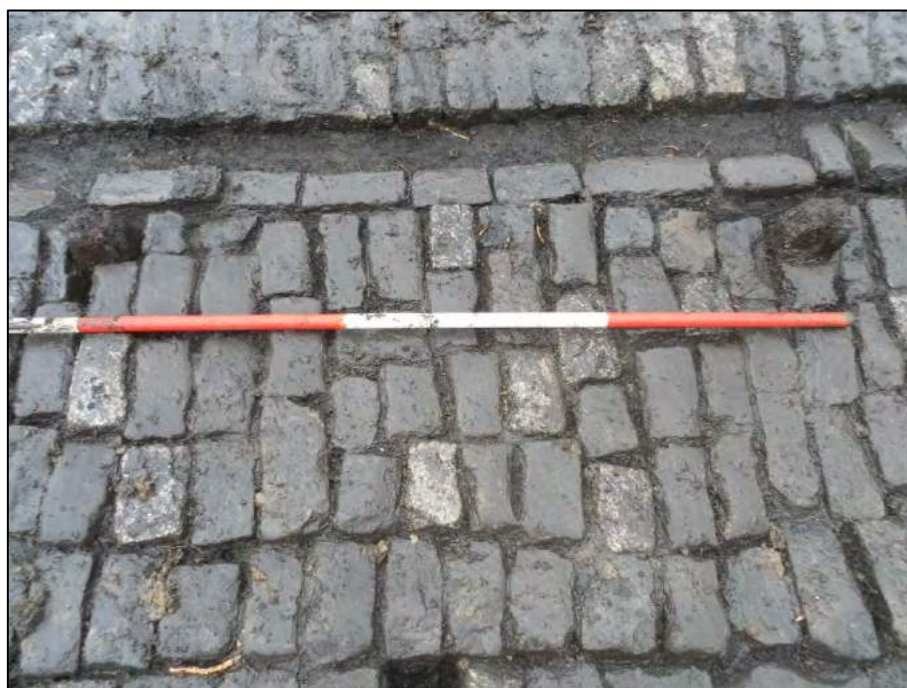
**Plate 14.** The remains of wooden posts that probably once supported the superstructure of the turnstile.  
Scale divisions 0.5m

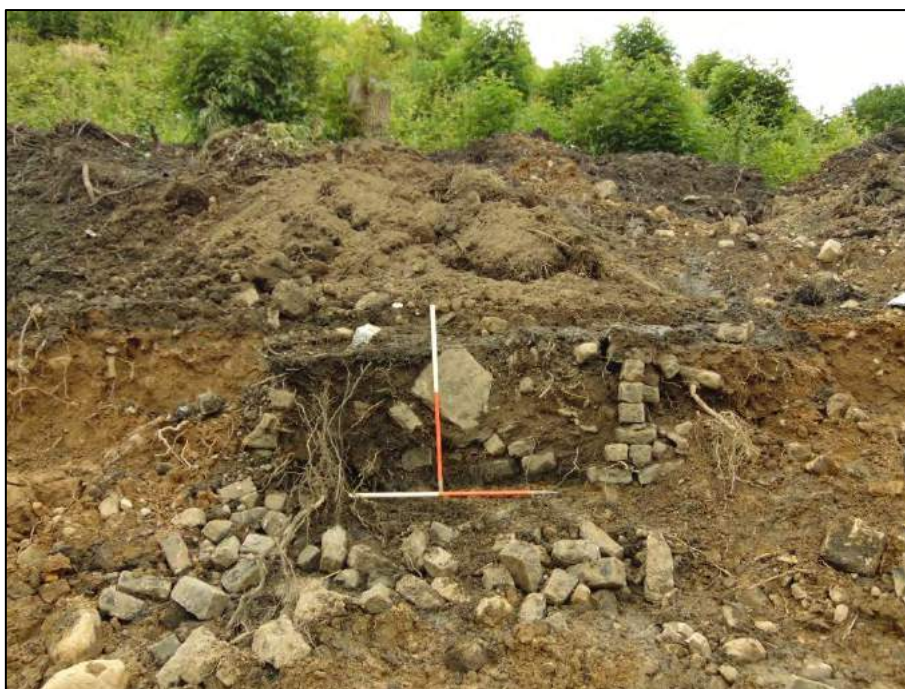
**Plate 15. South facing section of Post-medieval structure 111. Scale divisions 0.5m**

A further Post-medieval stone built structure (111) was subsequently discovered within Zone 2 of Area A (Plates 15 and 16) but the structure was damaged and little could be discerned about the original form or function. This feature was possibly a chamber for water management, as a similar one (010, Plate 17) had been discovered within Zone 1 of Area A the previous year.

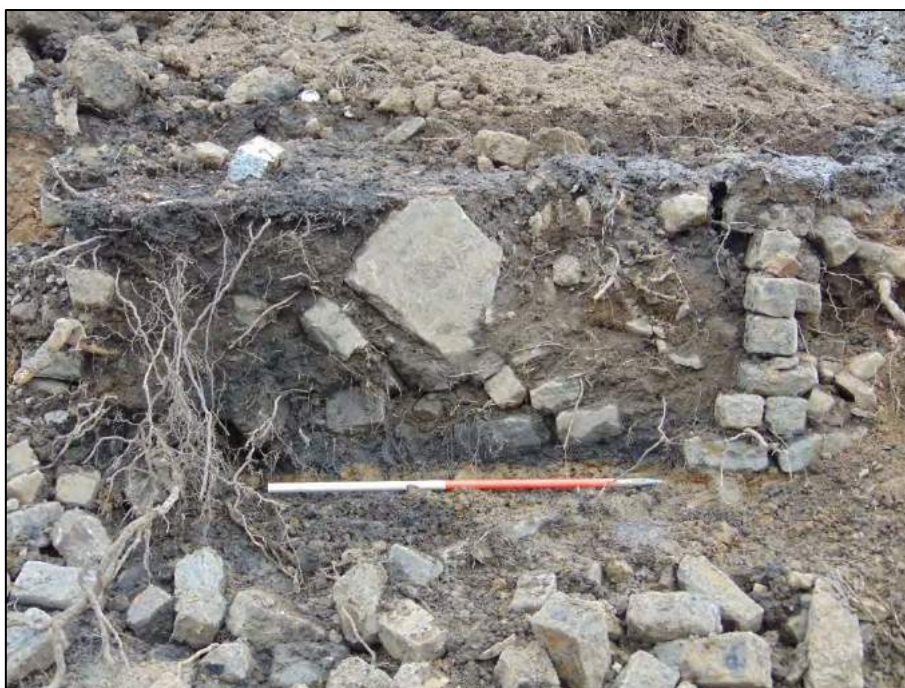
**Plate 16. Closer view of structure 111. This appeared to have been a chamber and was possibly similar in function to chamber 010.**

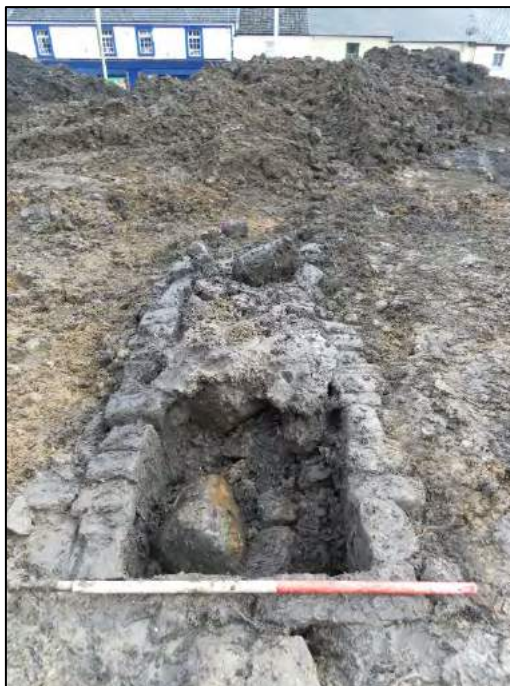
Plate 17. Post-medieval chamber 010 located in Zone 1 of Area A. View to south, scale division 0.5m

| Plate 17. Post-medieval chamber 010 located in Zone 1 of Area A. View to south, scale division 0.5m..... | 99 |

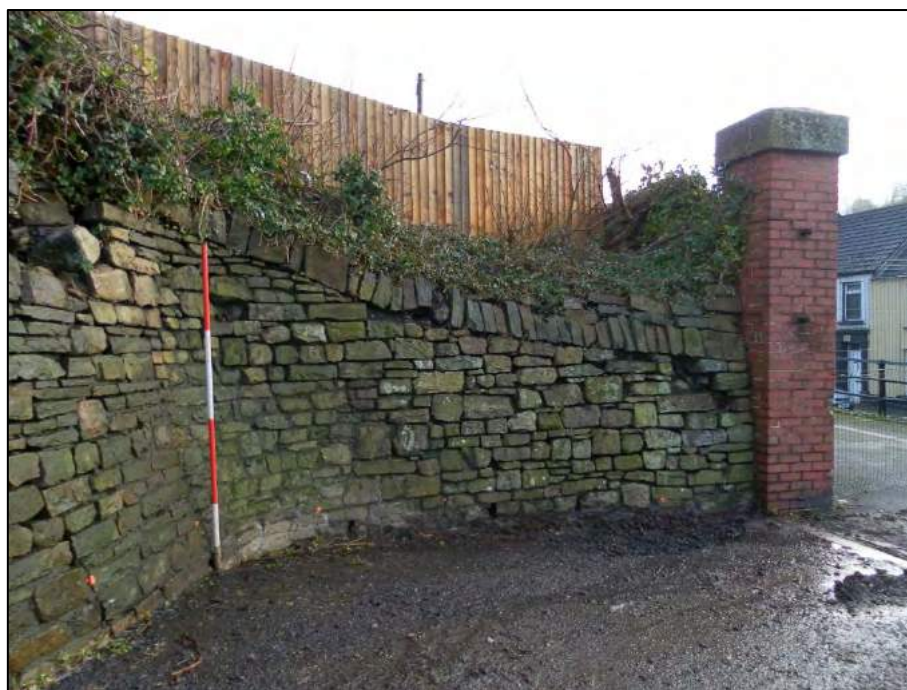
Plate 18. General view of the retaining wall 014 separating Areas D and Area A, view to south east. Scale divisions 0.5m

| Plate 18. General view of the retaining wall 014 separating Areas D and Area A, view to south east. Scale divisions 0.5m ..... | 99 |

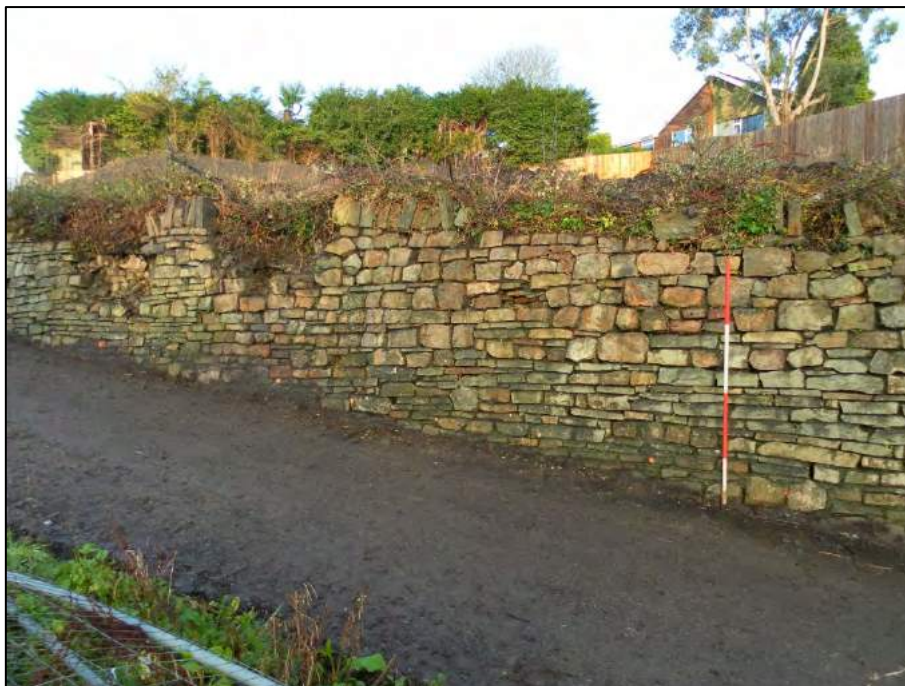
**Plate 19. General view of a typical section of retaining wall 014 separating Area D and Area A showing method of laying the stone. Scale divisions 0.5m**

The wall was located on the eastern side of the site, and consisted of a masonry structure aligned broadly south east to north west. It functioned as a retaining wall to hold back the upper part of the slope to the north and acted as a boundary for a tarmacked pathway up towards the football ground. Although one gate-post survived, the opposite side was missing and neither was there any sign of another wall on the other side of the path, although one is depicted on mapping. This retaining wall was clearly of Post-medieval construction, consisting of roughly coursed local stone featuring a brick built pillar for a gate at the south eastern terminus (the opposite side was missing). Coursing was visible in some areas but other areas presented an irregular appearance. 'Weep holes' were visible at intervals along the bottom, these bring one course deep (0.12m deep 50-60mm wide). The largest stone in the wall measured 0.59 x 0.14 x 0.21m, the smallest 40mm x 60mm. The wall incorporated bricks stamped with 'Cyfarthfa' as well as random insertions of yellow brick, some with vitrification. The stone consisted primarily of undressed local blocks with occasional stringing courses of thinner stone to bring back to level. The top of the wall was finished with vertical coping stones of sandstone, though much of this was missing or damaged. There were no positive signs of repair; however, mortar on the bend was better preserved than elsewhere having possibly been protected by undergrowth (a tree had been located above it). The gate pillar measures 705mm square and was a stretcher bond red brick topped feature with rusticated sandstone single coping stone. The pillar retained two iron hinges for mounting gates.

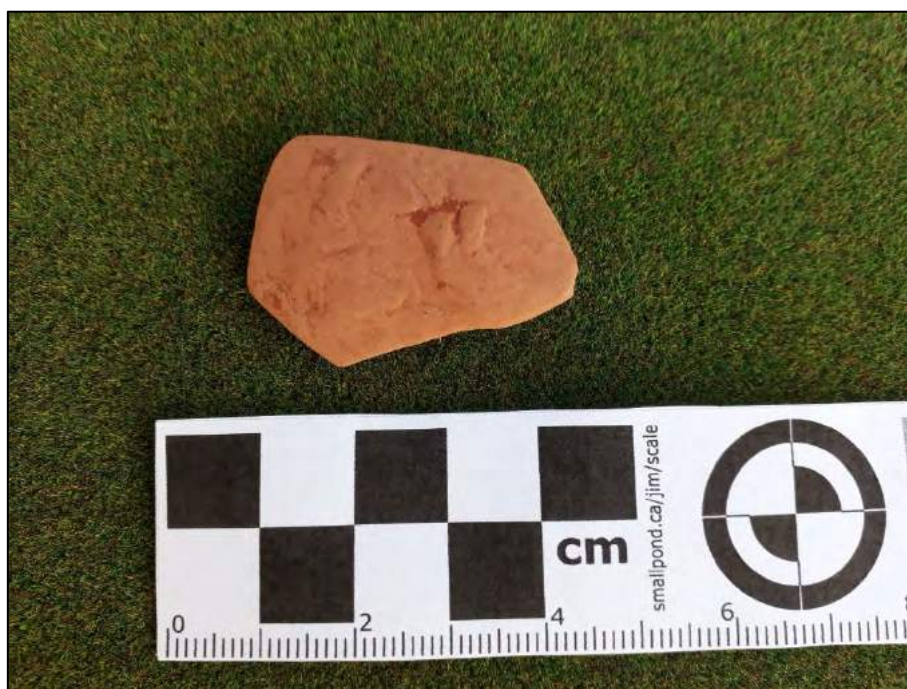
Plate 20. 017 Body sherd, Dr.29 or 37, fabric LG, forelimbs of running animal, possibly a rabbit, deer or hound. AD43-110

| Plate 20. 017 Body sherd, Dr.29 or 37, fabric LG, forelimbs of running animal, possibly a rabbit, deer or hound. AD43-110..... | 101 |

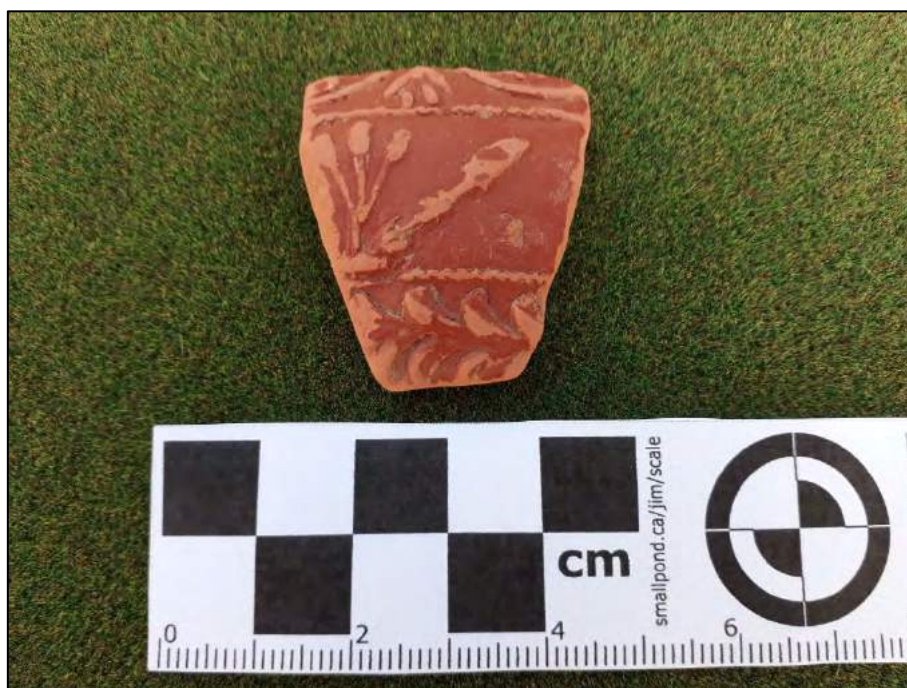
Plate 21. 035 Body sherd, Dr.37, fabric LG, wreath below plant motif terminating in poppyheads. AD70-110

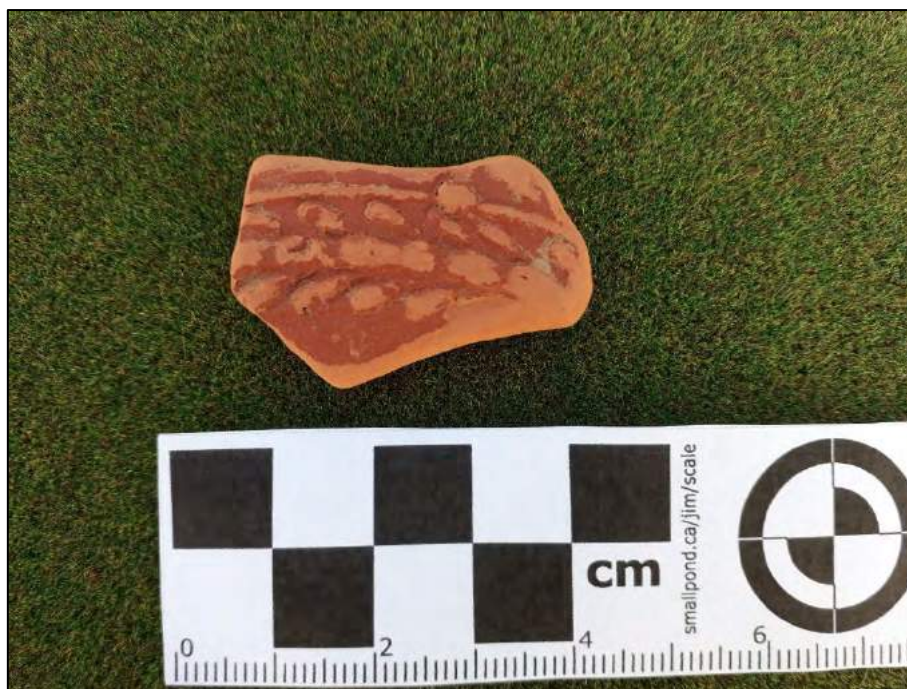
Plate 22. 035 Body sherd, Dr.37, fabric LG, basal wreath. AD70-110
