# Merthyr Labour Exchange, Merthyr Tydfil: Archaeological Excavation and building recording

A report for Wales and West  
Housing  
by Johnny Crawford BSc MA MCIfA

GGAT report no. 2020/081  
Project no. P2003

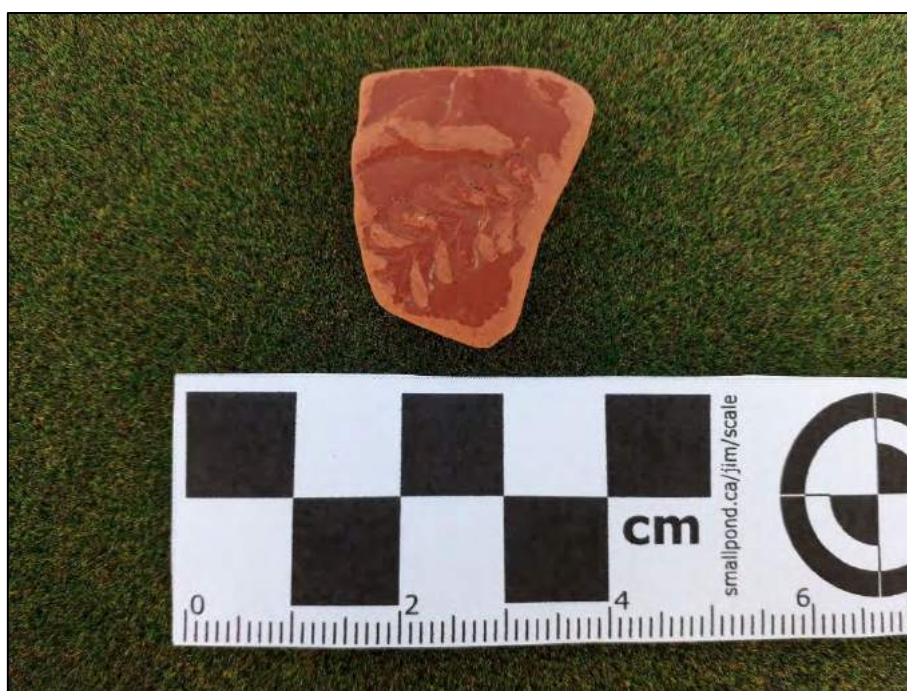
Plate 23. 075 Body sherd, Dr.29 or 37, fabric LG, band or wreath of chevrons below motif of indeterminate type. AD43-110

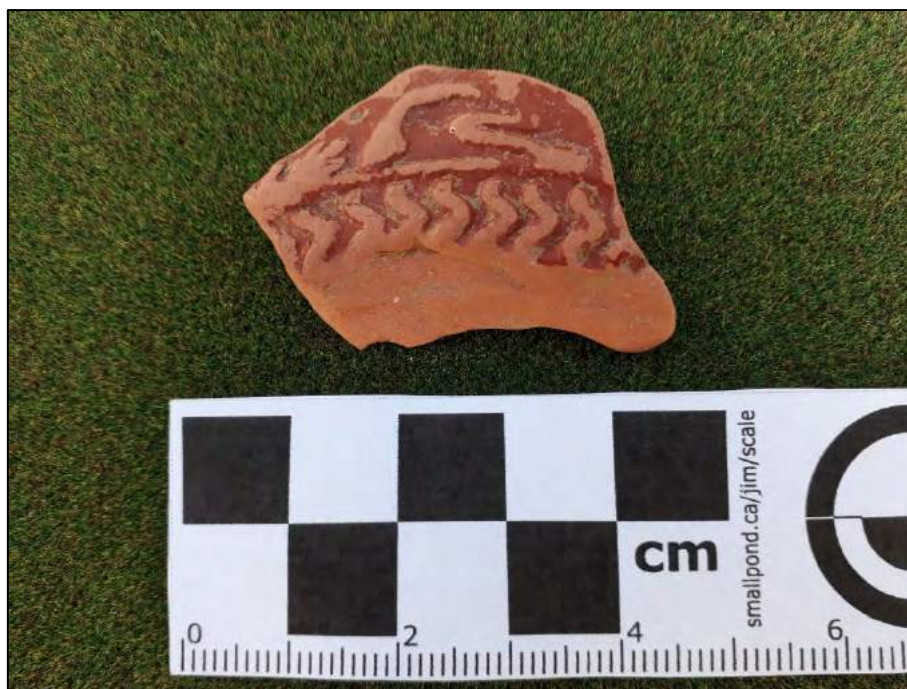
Plate 24. 107 Body sherd, Dr.37, fabric LG, band of chevrons below plant or animal motif. AD70-110

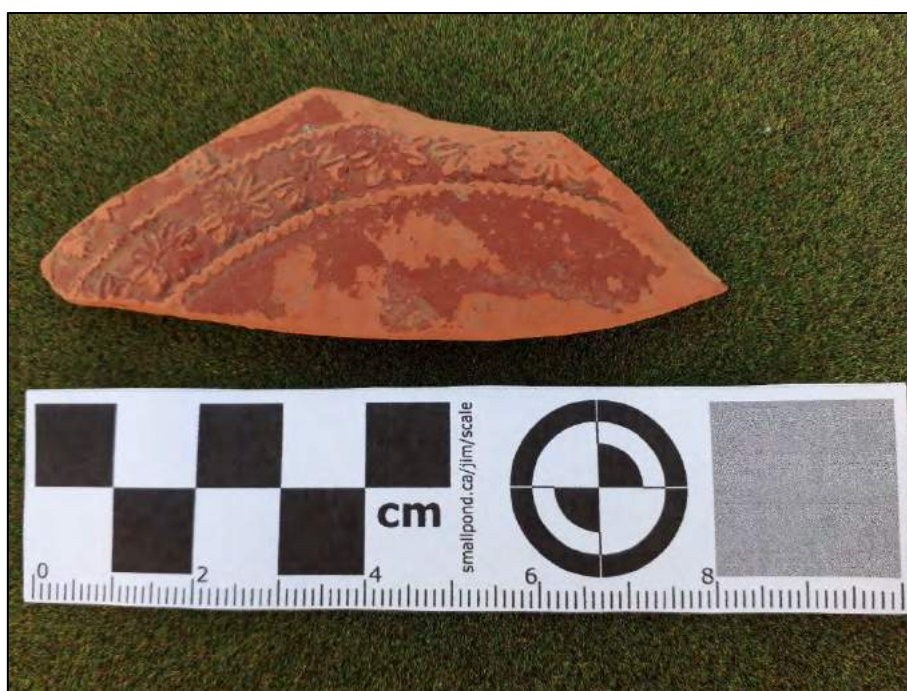
Plate 25. 107 Body sherd, Dr.37, fabric LMV, basal band of rosettes, style of Donnaucus (Stanfield and Simpson 1958, pl. 46, no. 547). AD100-120

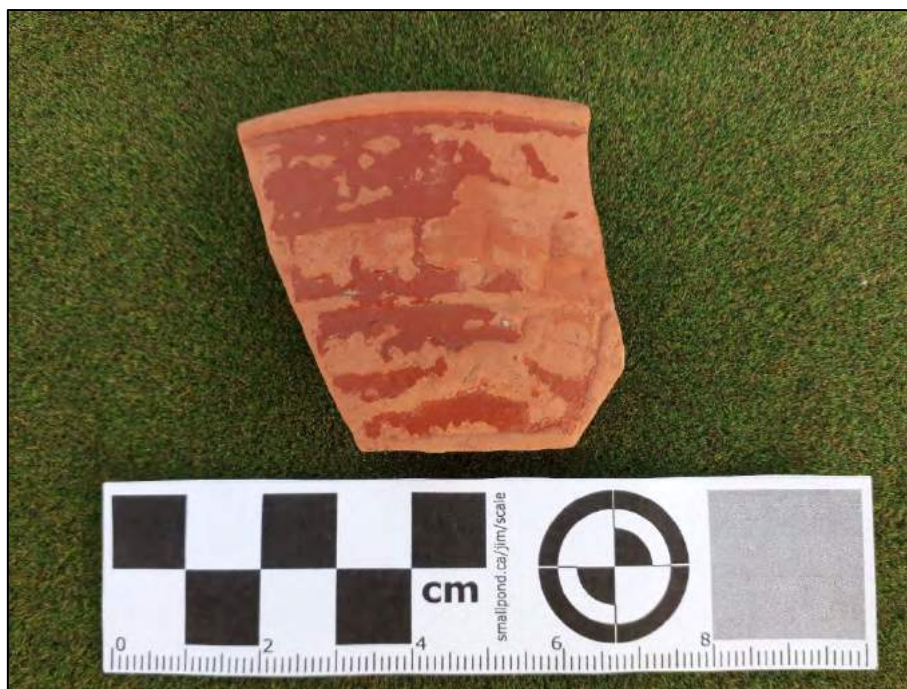
Plate 26. Unstratified Rim sherd, Dr.37, fabric LG, running hound below indistinct ovolo. AD70-110

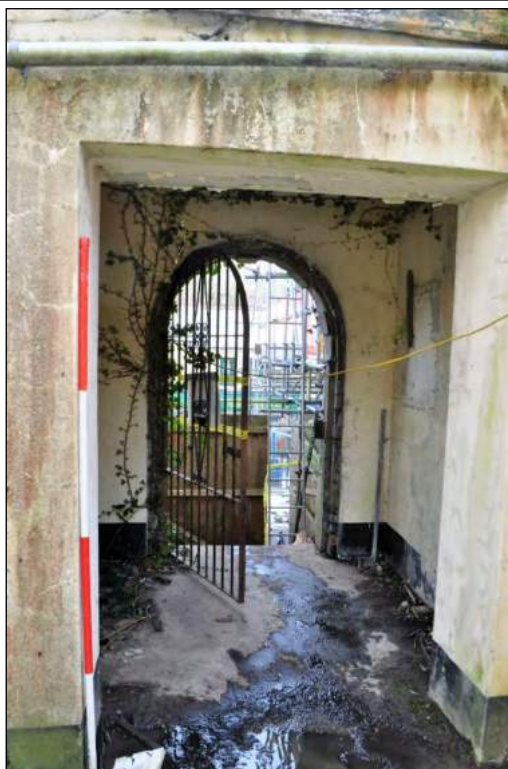
**Plate 5.** Internal aspect from right side entrance way

(**Plates 6 and 7**) with a rough sandstone and brick walling behind it that had been faced with plaster and painted (**Plate 5**). The internal reception/covered area within these two entrances measured 2.26m high by 2.13m wide by 1.84m deep and was exited by means of a plain non-doored/gated opening on its north facing side (**Plate 5**).

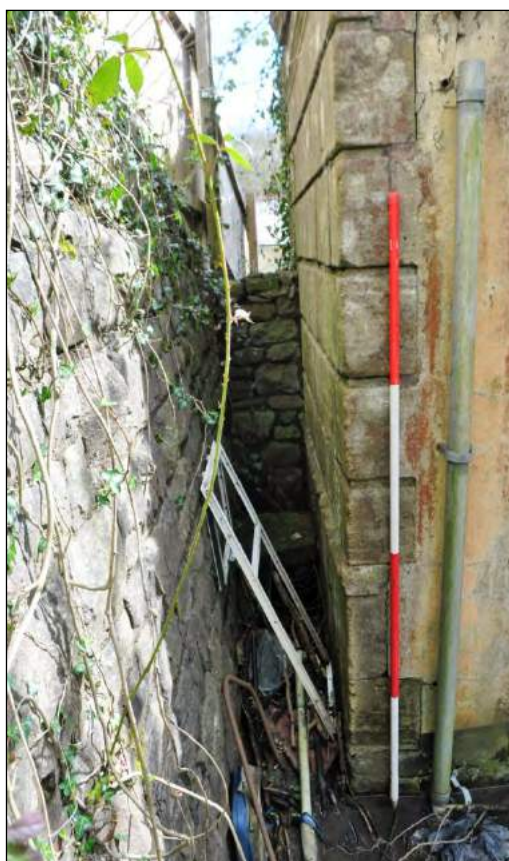
**Plate 6.** Detail of faced walling at the entrance

The entrance ways at either end were flat roofed (formerly with ornate sandstone-moulded balustrade). The exterior of these entrances was constructed from dressed sandstone facing

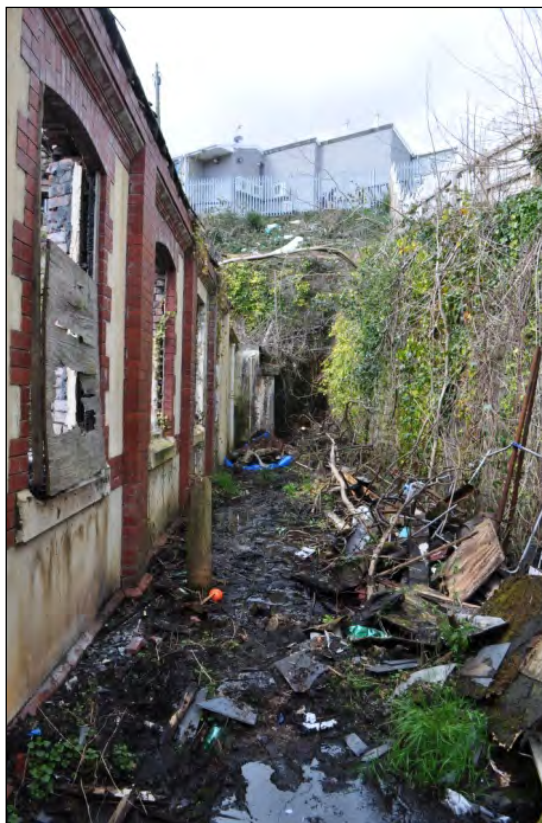
**Plate 8.** The exterior wall to the Labour Exchange/Chapel and perimeter retaining walls  
(north and east)

The original northeast side wall to the church (**Plates 8 and 9**) recorded a height of 4m by a length of 18.5m. This was further extended by a modern extension to the rear during its conversion to part of the Labour Exchange, giving a total length of 26.9m. Set within the original wall were four windows and a doorway.

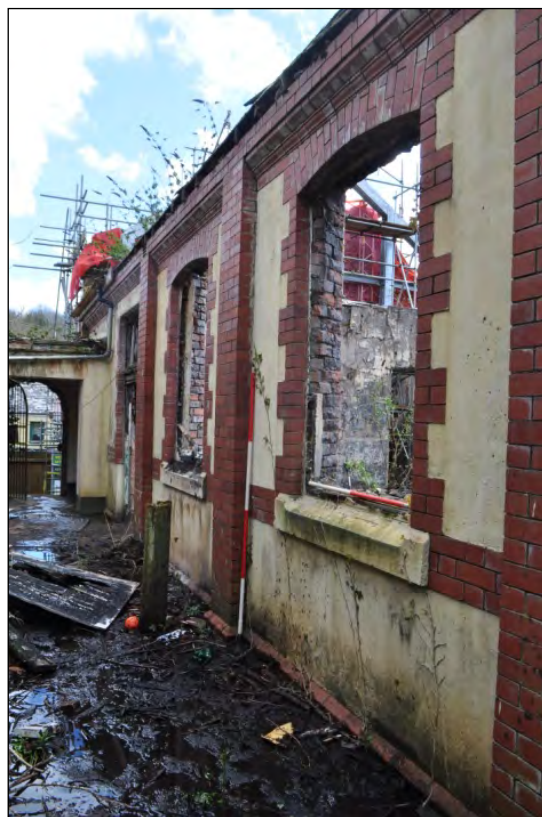
**Plate 9.** East wall of church looking south towards entrance

The windows had a red brick decoration with shallow-curved segmental arched headers (**Plates 9 and 11**) supported by crenulated-style surrounds and sloping concrete-cast sills. The sills were set into a triple red brick Flemish bond string line that ran as decoration along the exterior wall. Breaking the spaces between each window were four red-brick buttresses, two bricks wide and built in a Flemish bond style. Each buttress ran from floor to the ornate brick cornice that comprised a moulded red brick underlying an angled brick beneath a double brick row, all of which sat above a single line of bricks that linked each window and buttress. The bricks were set in a dark grey mortar. The base of the exterior wall was beaded with moulded red brick. The outer face of the wall comprised a cream-painted concrete render that was highlighted by the framing red brickwork. The doorway into the chapel (**Plates 12 and 13**) was 1.1m wide by 3.25m high to base of the concrete lintel. It was obvious that much alteration had been undertaken on the doorway which would have originally matched both header shape and brick decoration of the windows. The doorway had also suffered as a result of recent fire damage, but had a pull down drop vent window light above the door with curved frame matching the walls' window frames, possibly original. The opposite wall had mirrored the same layout but the doorway (**Plate 15**) had been extensively altered with a steel panelled security door below a steel grille covering the remains of a window (**Plate 16**). This doorway gave access into the west entrance of the church and later the 1930s Labour Exchange building.

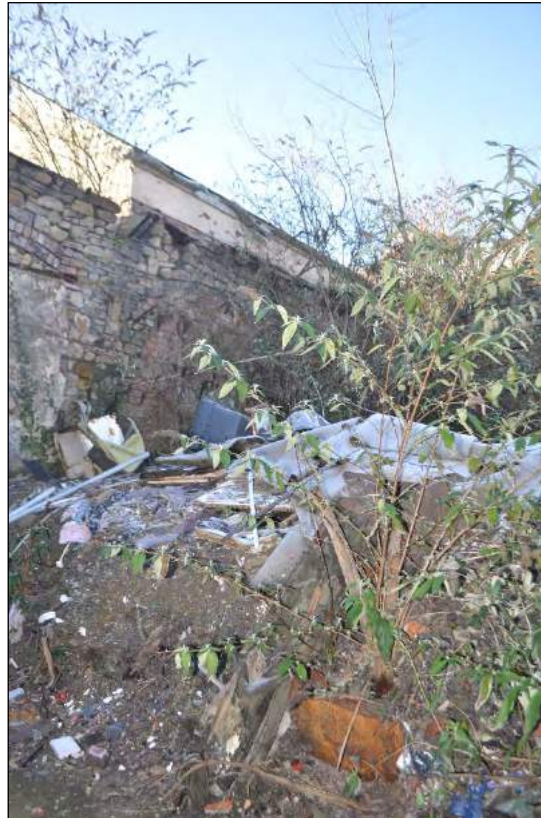
**Plate 14.** Showing mass of rubble abutting west wall of church building

Access to examine and record this wall was greatly restricted by the many tons of debris and rubble that abutted it (**Plate 14**). This wall acted as the east wall of the Labour Exchange building. From restricted observation it was obvious that wall had originally mirrored the east wall of the church.

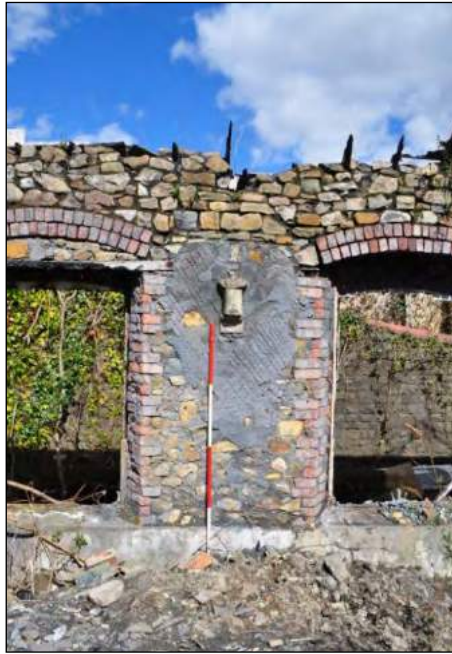
**Plate 17.** Internal aspect of window structure east side of church hall with Corbel bracket

The inside of the east wall of the Church displayed a rough stone wall held by a dark grey mortar. The walls had been sealed with a rough mortar base before being plastered and painted: only fragments of this mortar sealant and painted plaster remained (**Plate 17**). This was again

It is uncertain whether the Church interior had been fully plastered or if this was representative of the redevelopment of the Church into the Labour Exchange. Set into the interior side walls were a set of corbel/bracket piers. Each corbel/bracket was set midway between the window

placements (**Plate 17**) and just lower than the bottom of the window header arch. It remains uncertain what the corbels/brackets were supporting. The corbels/brackets had a rustic ornate base, cylindrical shafted body and Tuscan-style capital. Due to the level of redevelopment that had occurred and the subsequent fire damage and roof collapse within the interior of the church building it was difficult to imagine its original layout, features and design.

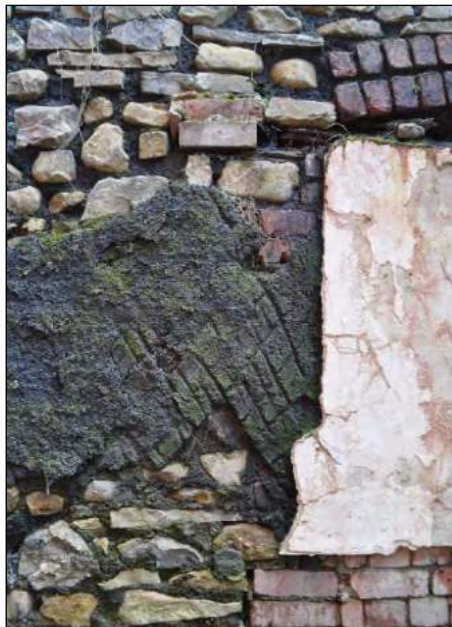
**Plate 18.** Filled in window on west side of church hall

mirrored on the Church's southwest wall though all windows on the southwest had been closed-in (**Plate 18**) during the Church's redevelopment and reuse as part of the Merthyr Labour Exchange building. The brick-arched header and brick-decorated sides were similar to the exterior; however, it was evident that the windows brickwork had been plastered over.

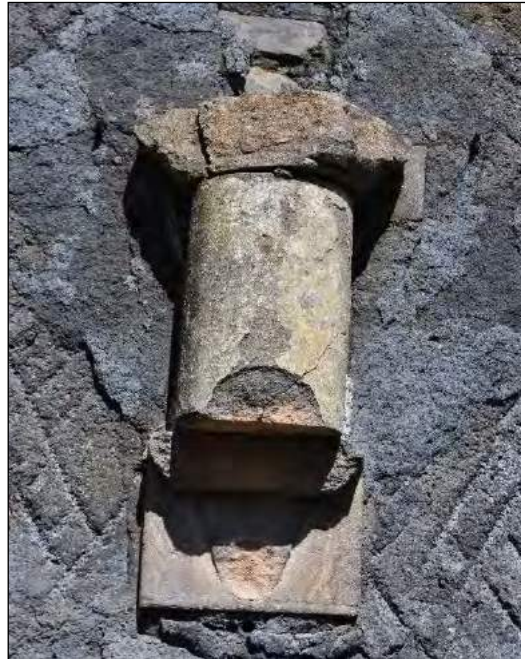
**Plate 19.** Detailing Corbel bracket set in east wall of the church hall

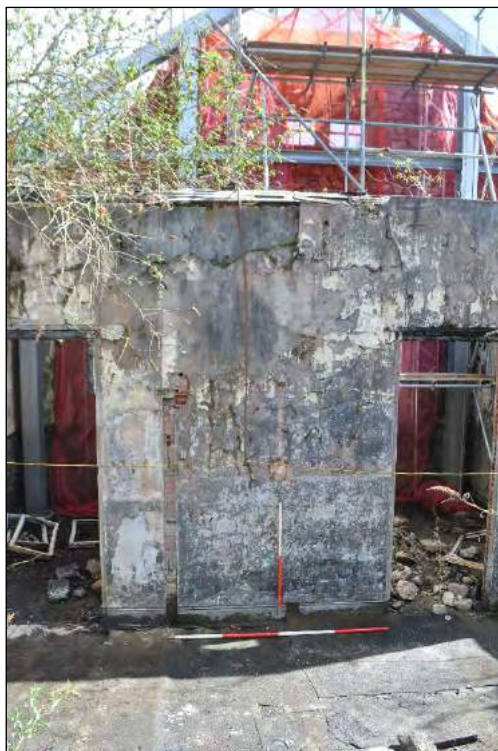
**Plate 21.** Rooms built into the rear of the front wall of the church looking south

Set within the front of the building were three individual rooms, each accessed from central doorways (**Plate 21**). All were 4m in length but room 1 was 2.90m wide, room 2 was 4.3m wide and room 3 was 2.15m wide. It is probable that these three rooms relate to the redevelopment of the church into the Merthyr Labour Exchange or possibly a redevelopment of the Labour Exchange at a later date. The walls that divided and enclosed the rooms were constructed from a single modern brick and plastered on both inner and outer faces. Within each room was low-level tongue-and-groove panelling (**Plates 22 and 23**) that stood 0.8m above the 0.18m wide skirting board and was capped with a broad dado rail c.0.18m wide: much of the panelling was destroyed or missing. The flooring that had survived and remained visible within the rooms and the hall was made of herringbone-pattern parquet oak blocks (**Plate 24**). The remains of a cross beam sat across the front wall to the rooms with scant remains of roof slats suggesting a ceiling and possibly an upper floor, lit by the central upper windows in the front of the building.

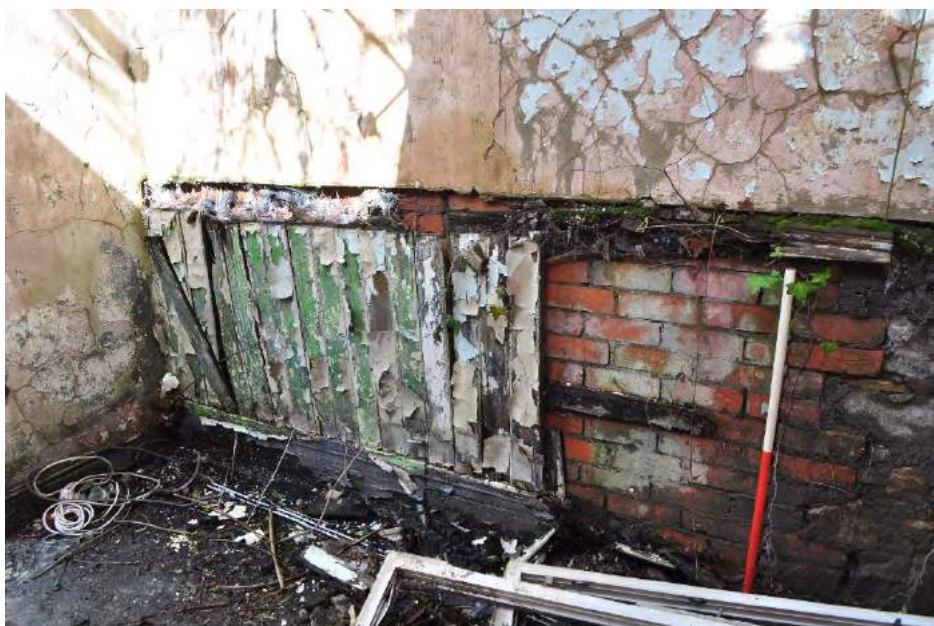
**Plate 23.** Room 1, displaying detail of walling with remnant original stone walling

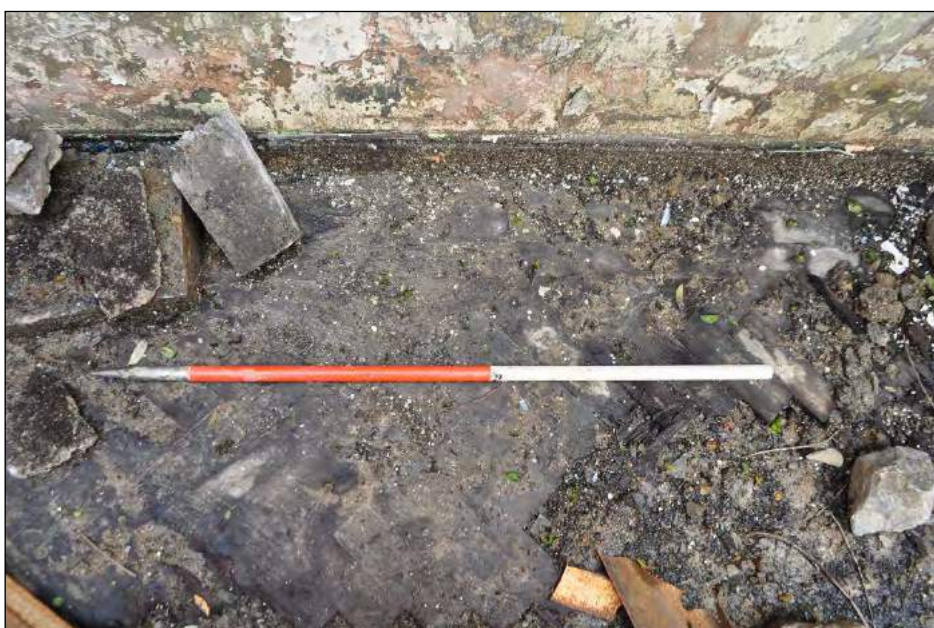
**Plate 24.** Parquet oak block flooring

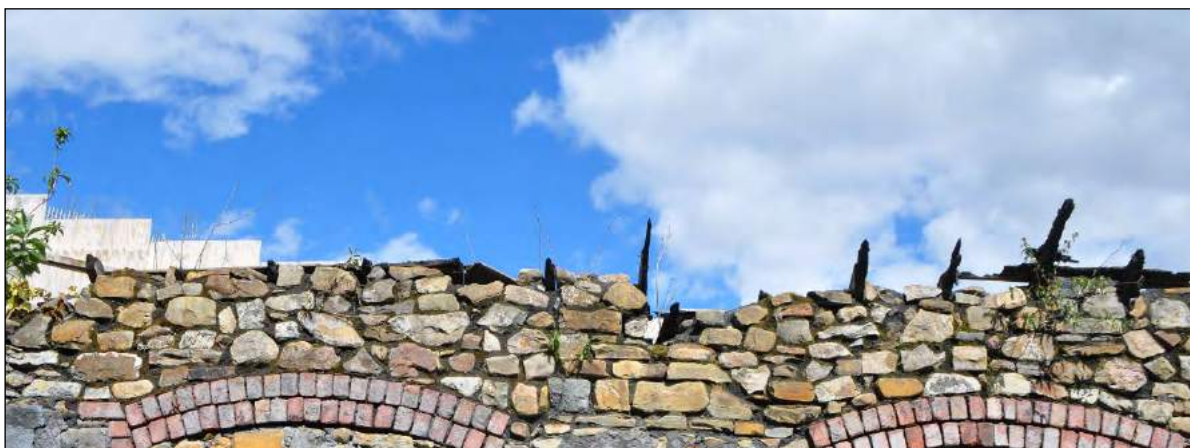
**Plate 25.** Remains of the burnt ceiling rafters set into the east wall

Little remained of the roof to the former church – most of it was massed as debris following its collapse within the former church hall. It was evident from the debris that the roof had been constructed with Welsh slate. The remains of the burnt ceiling rafters (**Plate 25 and 26**) could be seen sitting at the top of the side walls. No evidence for ceiling joists could be observed within the side walls of the hall.

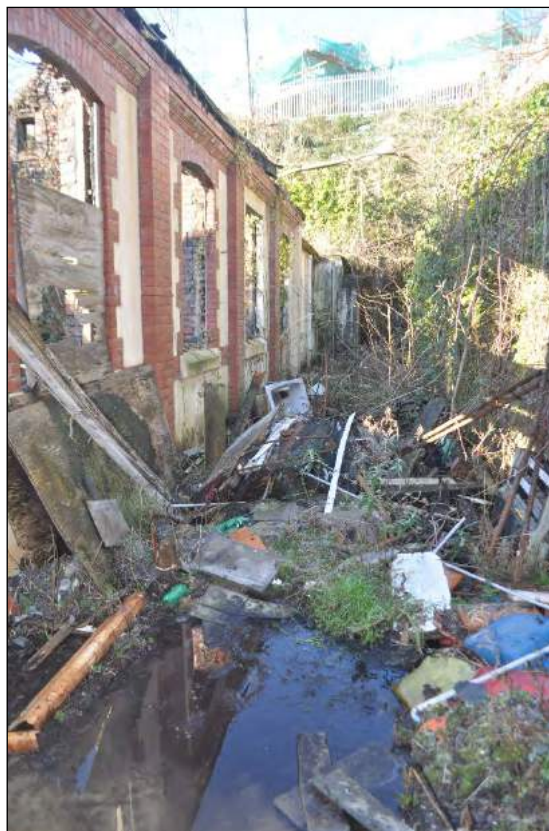
**Plate 27.** Showing debris and overburden associated with east side church and retaining walls

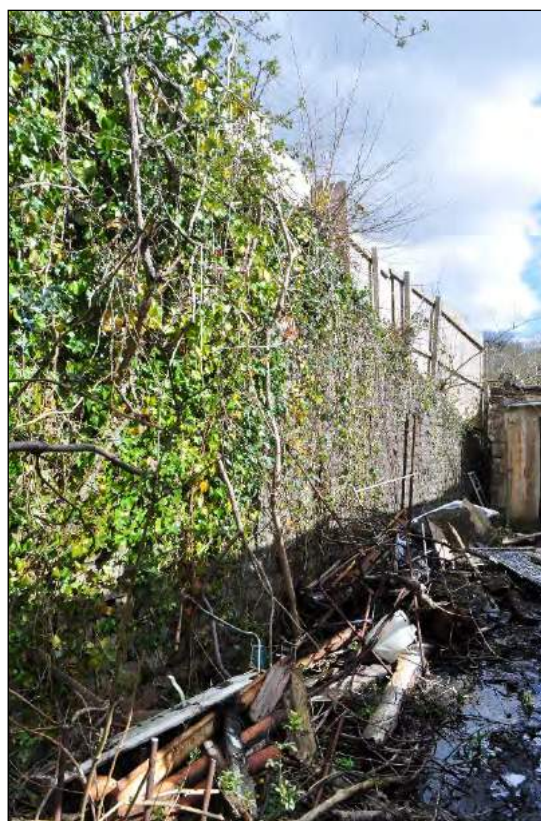
**Plate 28.** East side retaining wall

The retaining wall which enclosed the Church building and later the Labour Exchange closely protected the Church building on two of its sides (north and West (rear)) from the embankment the building had been terraced into. The walling was constructed out of roughly dressed pennant stone blocks, as shown in **Plates 27 and 28**. A vast amount of self-setting foliage could be seen growing through the rear and side walls, including a substantial amount of Japanese Knotweed. The wall was capped with half-round ceramic copings. The side wall inclined from a height of 1.5m near the side entrance to the rear wall which was c. 6m high. The walling was a feature contemporary with the original church.

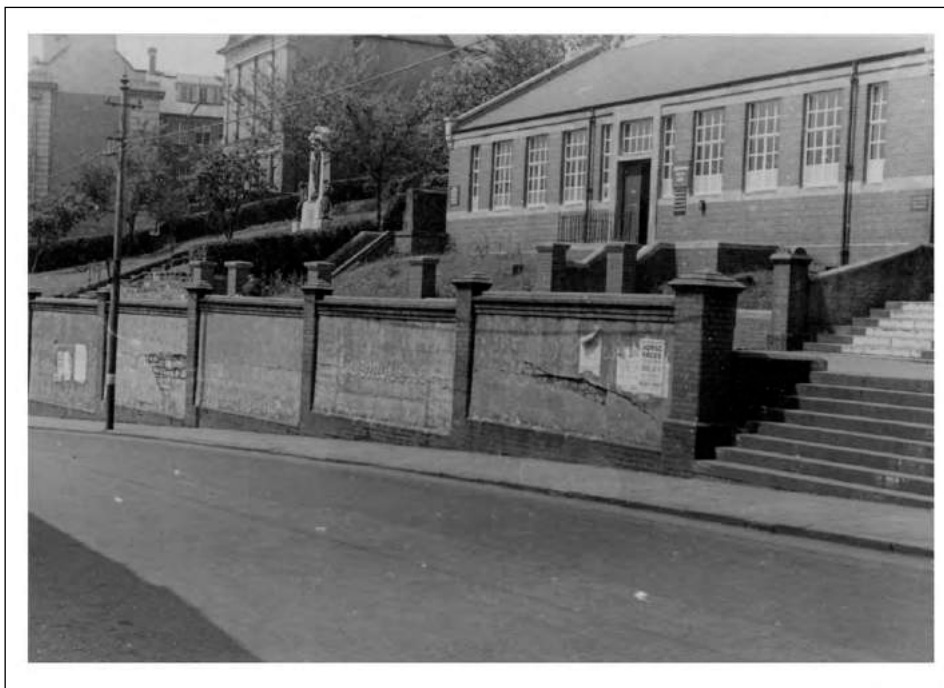
**Plate 29.** The Labour Exchange Building that extended and incorporated former mission church

The building was a typical inter-war public building (**Plate 29**) with basic architectural design made palatable by its incorporation of the former chapel. The Labour Exchange was modified and altered during the 1950s. A cellar/boiler room was discovered underlying the northern side of the building but was deemed too unsafe to enter. A separate element of cellarage – a possible document store – was revealed to the west of the building during excavation of the site.

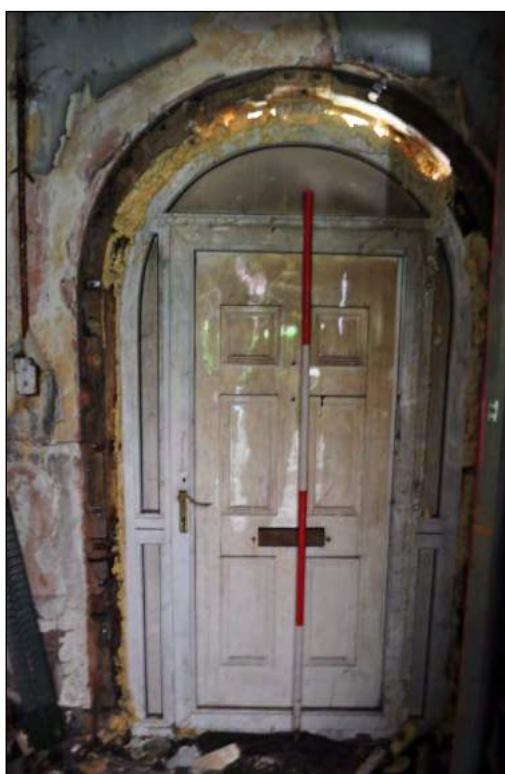
**Plate 30.** Internal aspect of church west ornate entrance now within the Labour Exchange Building

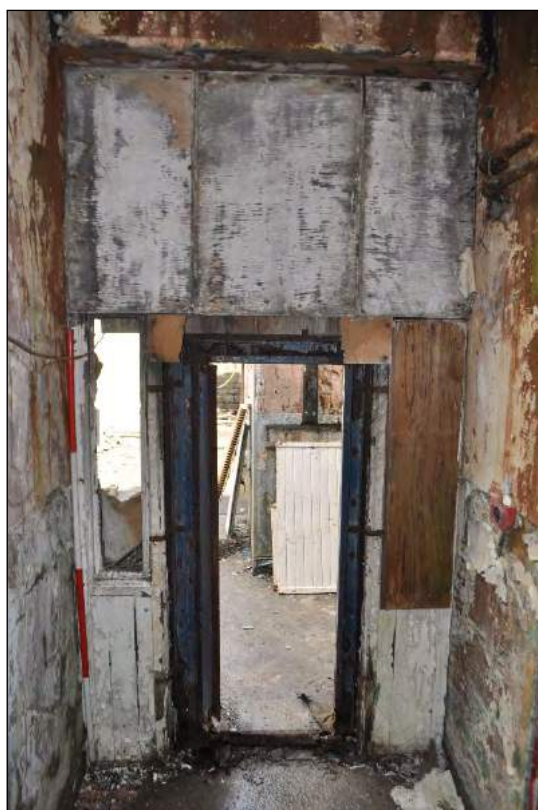
**Plate 31.** Western doorway into church hall from former ornate entrance (**Plate 30**)

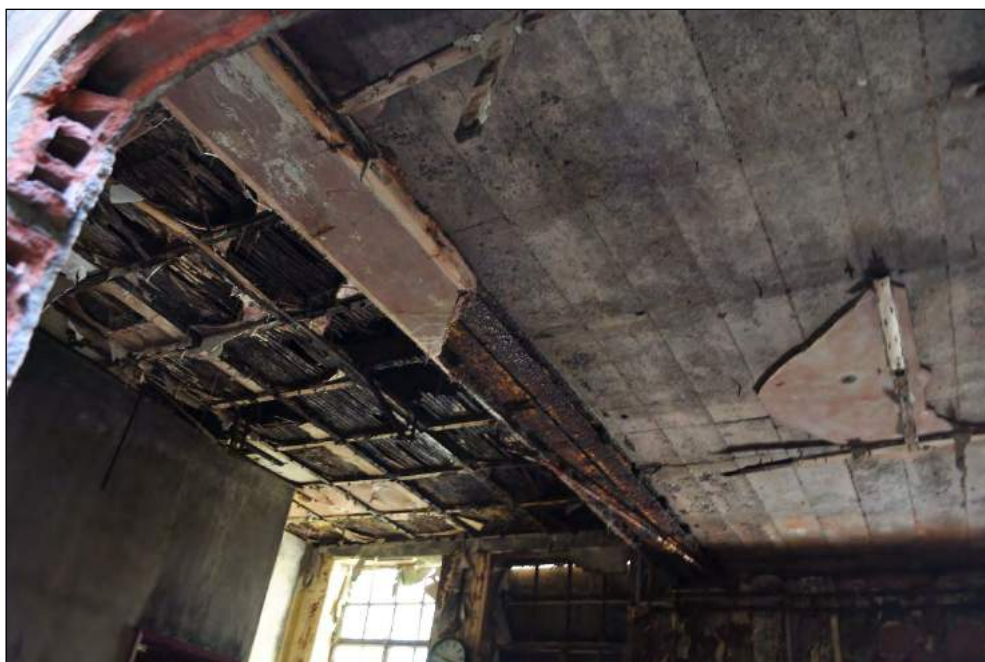
**Plate 32.** Concrete ceiling with burnt out fittings the first room accessed within the Labour Exchange fronting the road looking south (the clock had survived the fire)

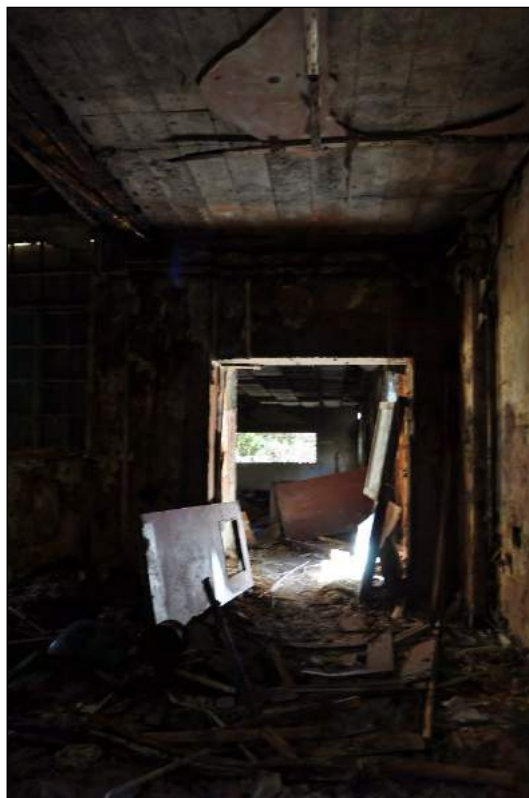
**Plate 33.** Show the level of debris within rooms looking west towards exterior wall of building

The survey of the Labour Exchange Building was greatly reduced as a result of limited safe access, lack of adequate lighting, floor debris (**Plate 33 and 34**) and asbestos removal happening at the time of recording. However, a primary photographic record was still undertaken where possible using the camera flash to illuminate the rooms within the building, as agreed at the time of recording with the Archaeological Curator at GGAT.

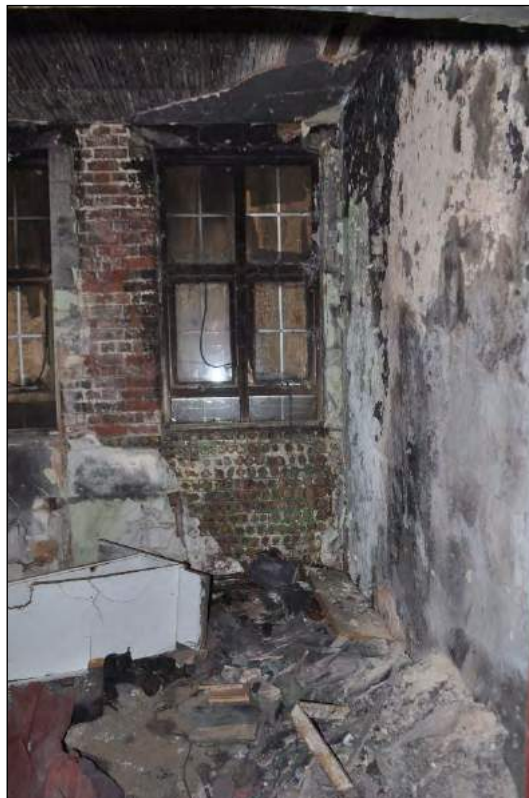
**Plate 34.** End room west end of Labour Exchange with lath and plaster ceiling unlike concrete panel ceiling in previous rooms

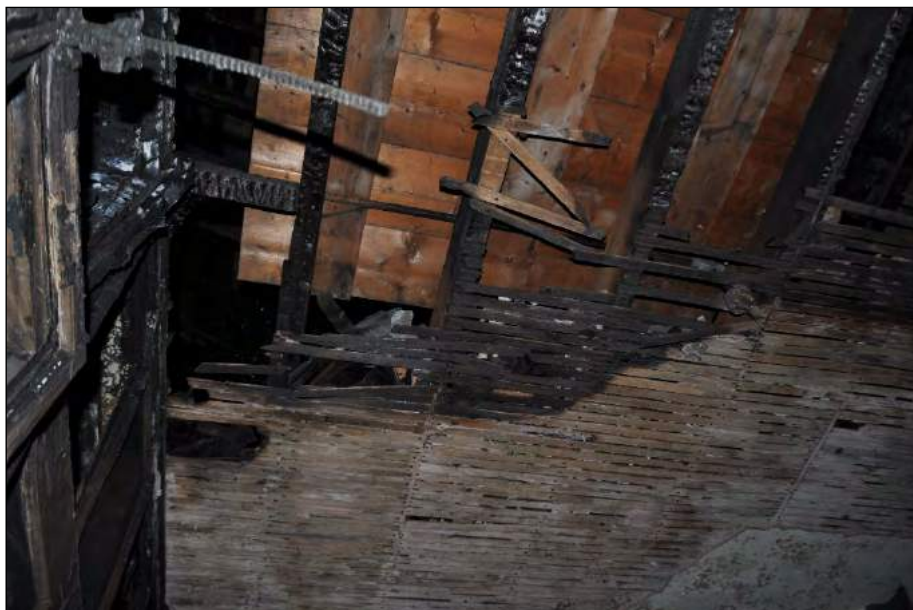
**Plate 35.** Fire damage to ceiling in Labour Exchange building

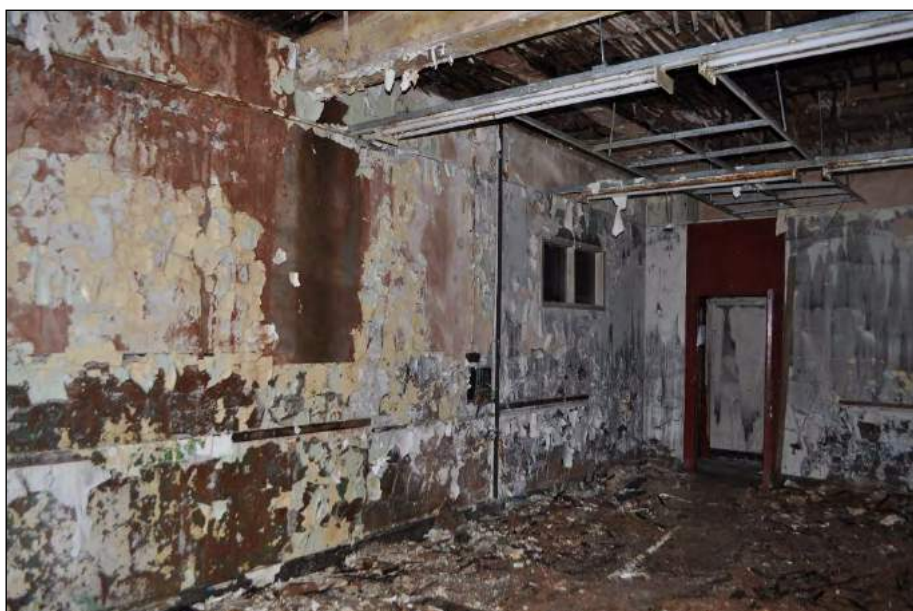
**Plate 36.** Large meeting room to rear of Labour Exchange

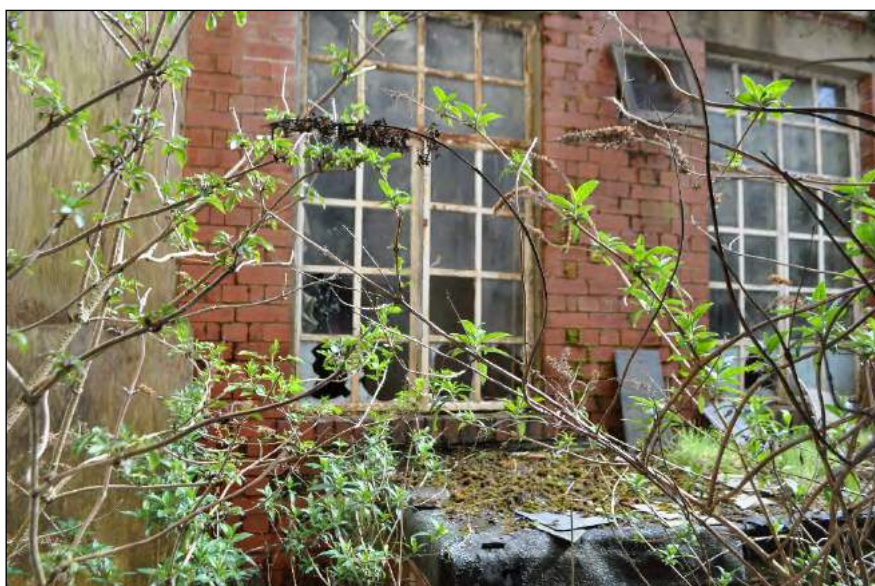
**Plate 37.** Rear (north side) of Labour Exchange

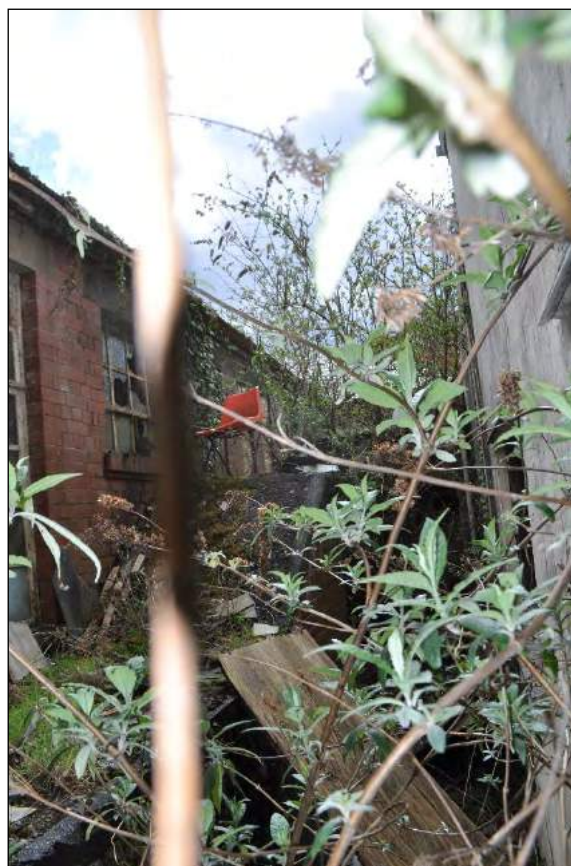
**Plate 38.** Rear (north side) of Labour Exchange showing level of overburden and debris

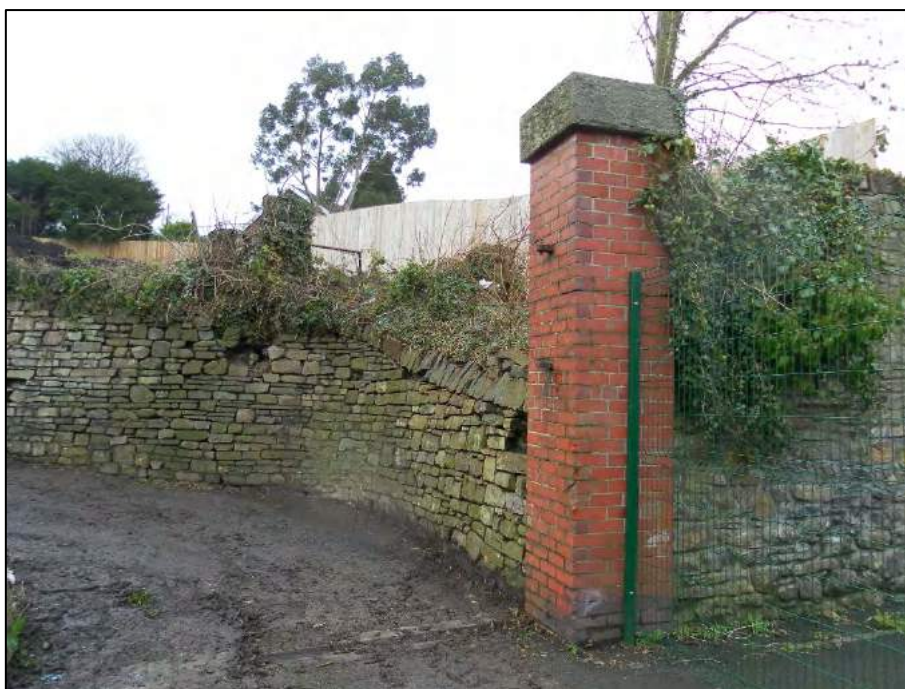
**Plate 27.** General view of surviving gatepost, View to north east

The wall was located on the eastern side of the site, and consisted of a masonry structure aligned broadly south east to north west. It functioned as a retaining wall to hold back the upper part of the slope to the north and acted as a boundary for a tarmacked pathway up towards the football ground. Although one gate-post survived, the opposite side was missing and neither was there any sign of another wall on the other side of the path, although one is depicted on mapping. This retaining wall was clearly of Post-medieval construction, consisting of roughly coursed local stone featuring a brick built pillar for a gate at the south eastern terminus (the opposite side was missing). Coursing was visible in some areas but other areas presented an irregular appearance. 'Weep holes' were visible at intervals along the bottom, these bring one course deep (0.12m deep 50-60mm wide). The largest stone in the wall measured 0.59 x 0.14 x 0.21m, the smallest 40mm x 60mm. The wall incorporated bricks stamped with 'Cyfarthfa' as well as random insertions of yellow brick, some with vitrification. The stone consisted primarily of undressed local blocks with occasional stringing courses of thinner stone to bring back to level. The top of the wall was finished with vertical coping stones of sandstone, though much of this was missing or damaged. There were no positive signs of repair; however, mortar on the bend was better preserved than elsewhere having possibly been protected by undergrowth (a tree had been located above it). The gate pillar measures 705mm square and was a stretcher bond red brick topped feature with rusticated sandstone single coping stone. The pillar retained two iron hinges for mounting gates.

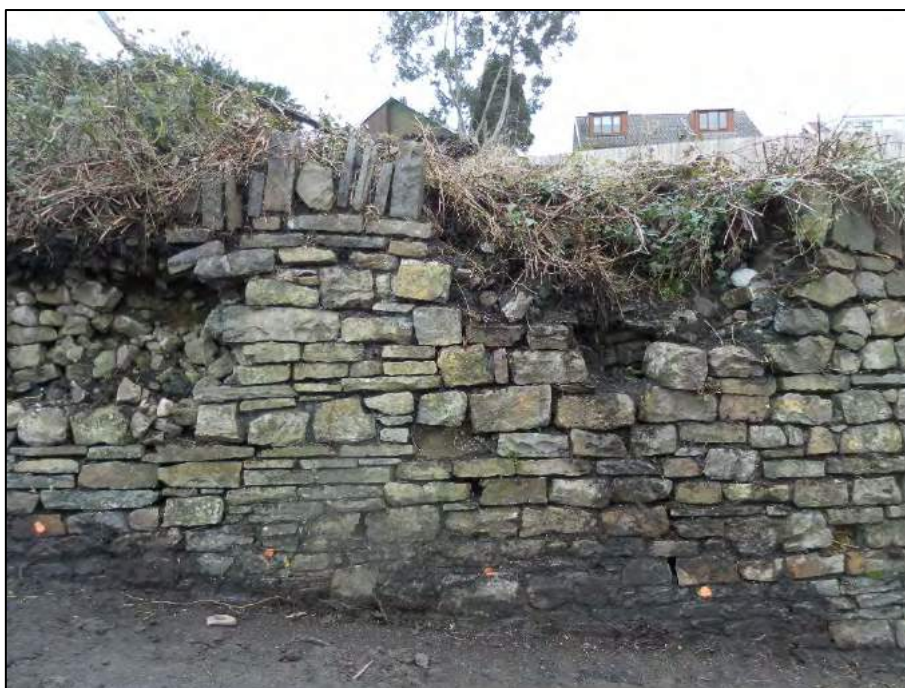
**Plate 1.** General photograph of the wall in the area of elevation drawing Figure 15a

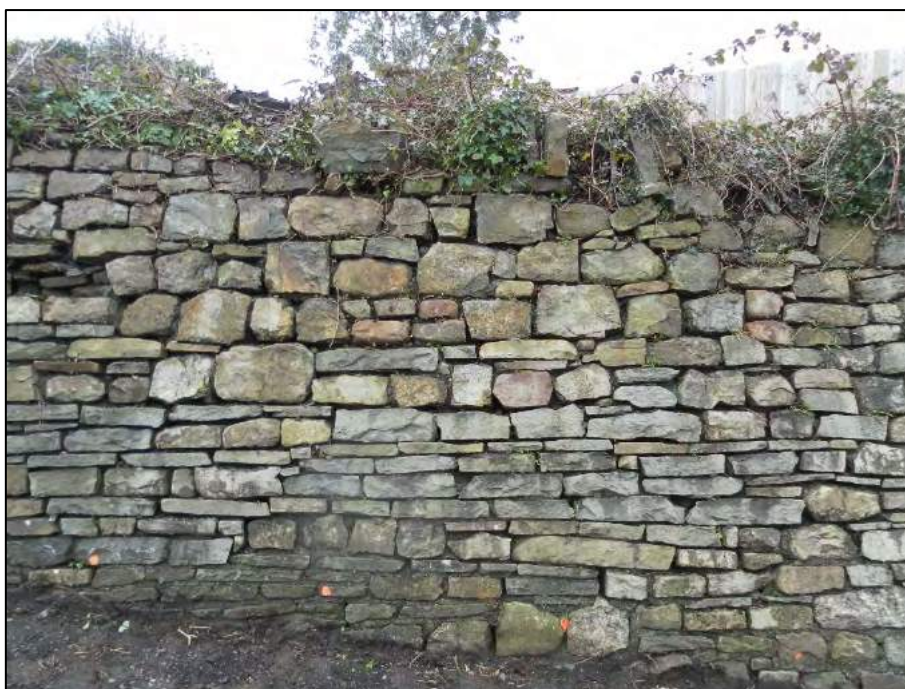
**Plate 2.** General photograph of the wall in the area of elevation drawing Figure 15b

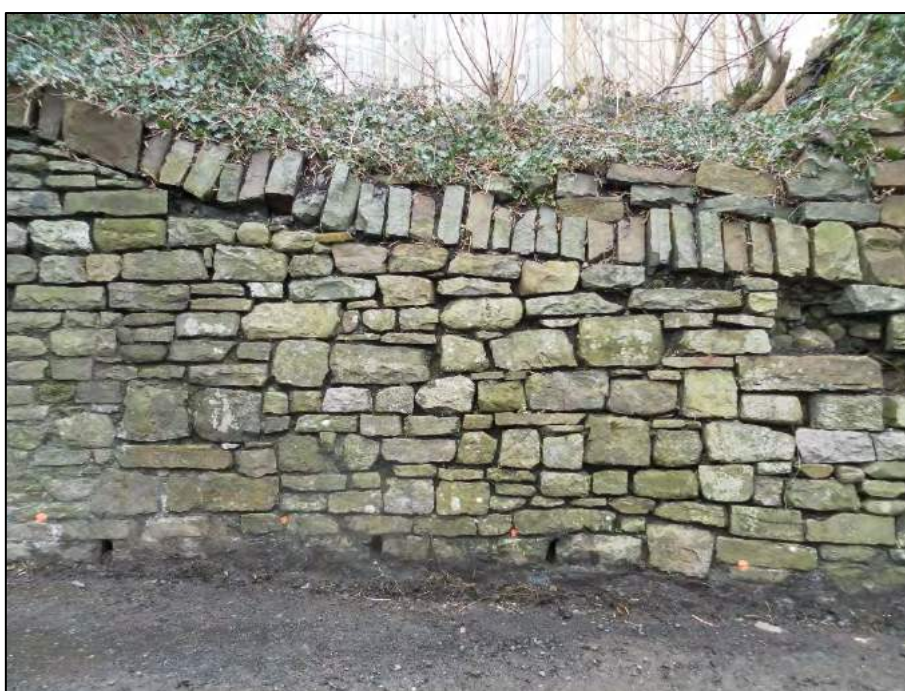
**Plate 3.** General photograph of the wall in the area of elevation drawing Figure 15c
