# Ysgol Rhyd Y Grug, Merthyr Tydfil

## Drainage Strategy Report

**Client:** Merthyr Tydfil County Borough Council

**Project Ref:** CC2594

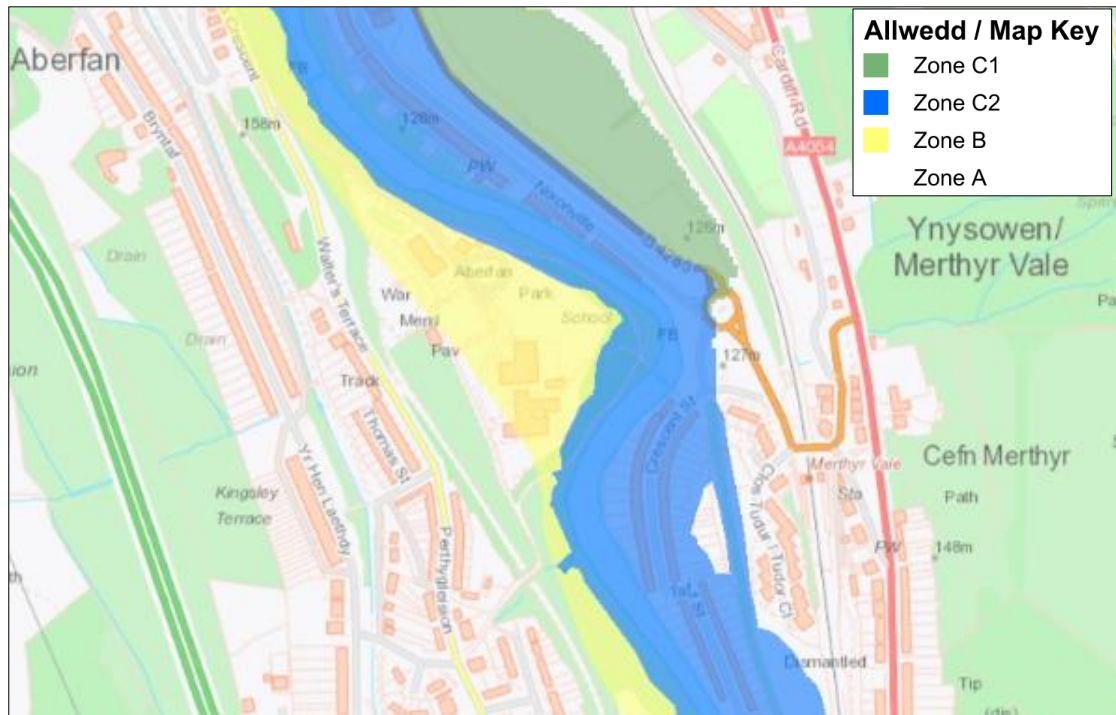
*Figure 2-2 – Extract from NRW Development Advice Map*

- 2.4.1 The NRW Development Advice Map currently shows the development area and the majority of the site situated in Flood Zone B (areas known to have flooded in the past as evidenced by sedimentary deposits). This indicates a precautionary approach 'where site levels should be checked against extreme (0.1%) flood level. If flood levels used to define adjacent extreme flood outline there is no need to consider flood risk further'. In this instance site levels are higher than the flood levels used to define extreme flood outline, therefore there is deemed to be no flood risk.
- 2.4.2 The lower south western area in currently situated in Zone A (little or no risk of fluvial or coastal/flooding).

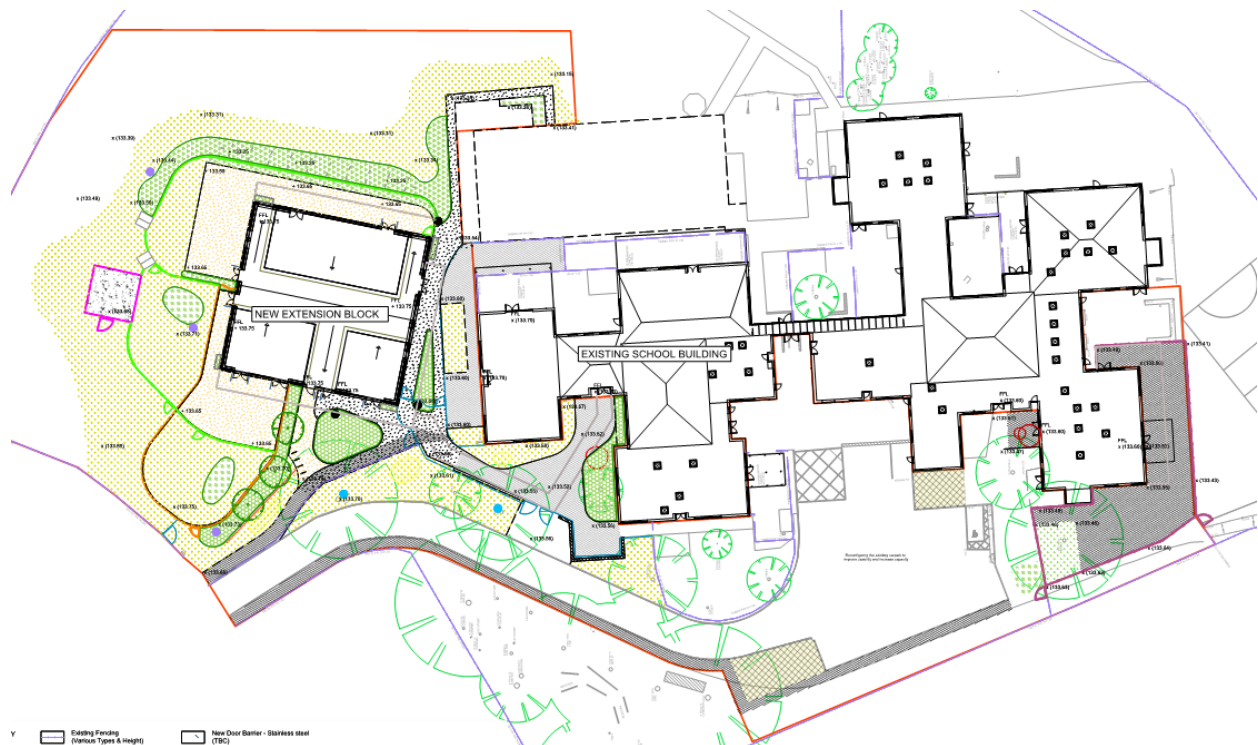
*Figure 2-4 –Landscape General Arrangement (AtkinsRealis)*

- 2.5.1 The project comprises extensive refurbishment to the existing Ysgol Rhyd Y Grug building. Internal structural alterations are proposed to the South Area of the building, to provide new room layouts with improved circulation and access. There is to be a new build extension to the scheme which will all for 60 FTE Nursery and 24 Meithrin. The Nursery and Meithrin will be connected to the existing school building via a covered walkway.
- 2.5.2 The proposed site layout and landscaping scheme has been produced by AtkinsRealis, an extract of the landscaping layout is shown in Figure 2-4 below and included in *Appendix B*.

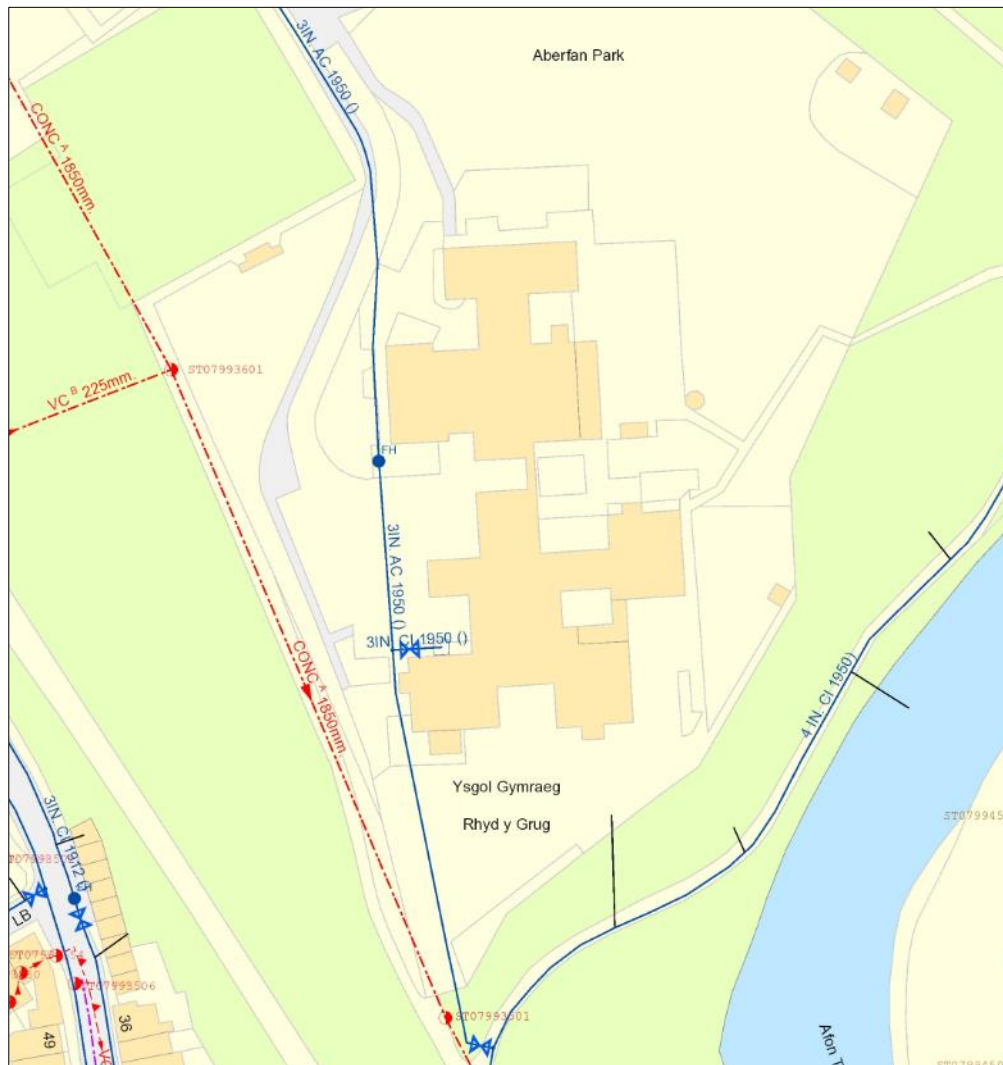
*Figure 3-1 –Welsh Water Record Plan*

- 3.1.1 Welsh Water record maps show a 1850mm diameter combiner sewer running along the western boundary of the site. Solum Surveying utility surveys show that the foul from the school connects into this sewer to the west via two gravity connections
