**HOPE CHURCH, MERTHYR TYDFIL**

**BAT SURVEY**

**ISSUE 1, VERSION B**

**JULY 2023**

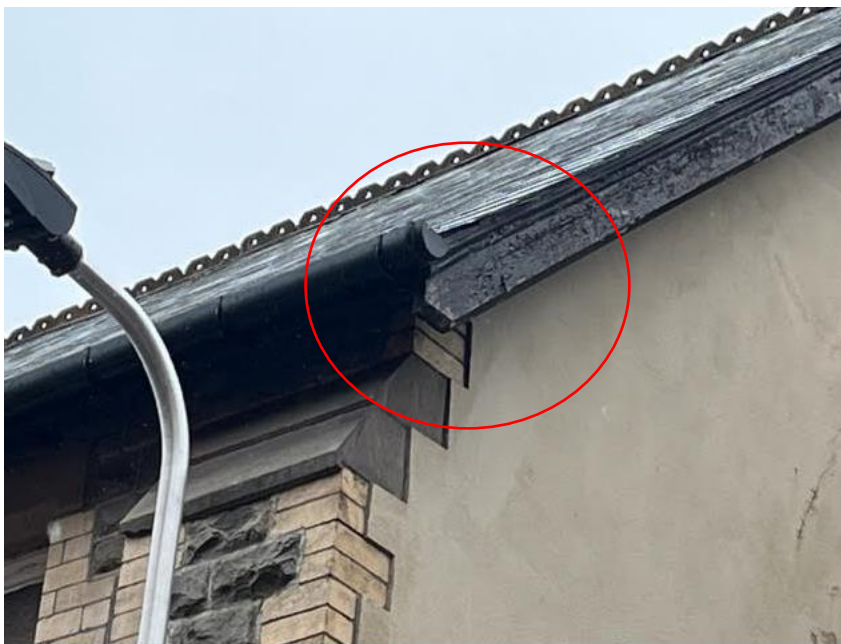
The first bat heard was a common pipistrelle, the bat was seen at 21:44. The exact exit point was not able to be identified, however, it was likely to be from beneath the barge board of the higher storey on the eastern gable before commuting north. Despite, the fact an exact access point was not identified, the bat was not seen by any other surveyor approaching the building. The bat dropped towards the ground before commuting north, typical of emergence.

Figure 3: Photograph of approximate emergence point circled red

A gap will be left on the rear of the building between the wall and barge boards of the upper eastern gable. . Access points for crevice-dwelling bats can be as small as 15-20mm high x 20-50 mm wide. These gaps will be left beneath either side of the apex of the eastern gable where the bat was identified roosting.

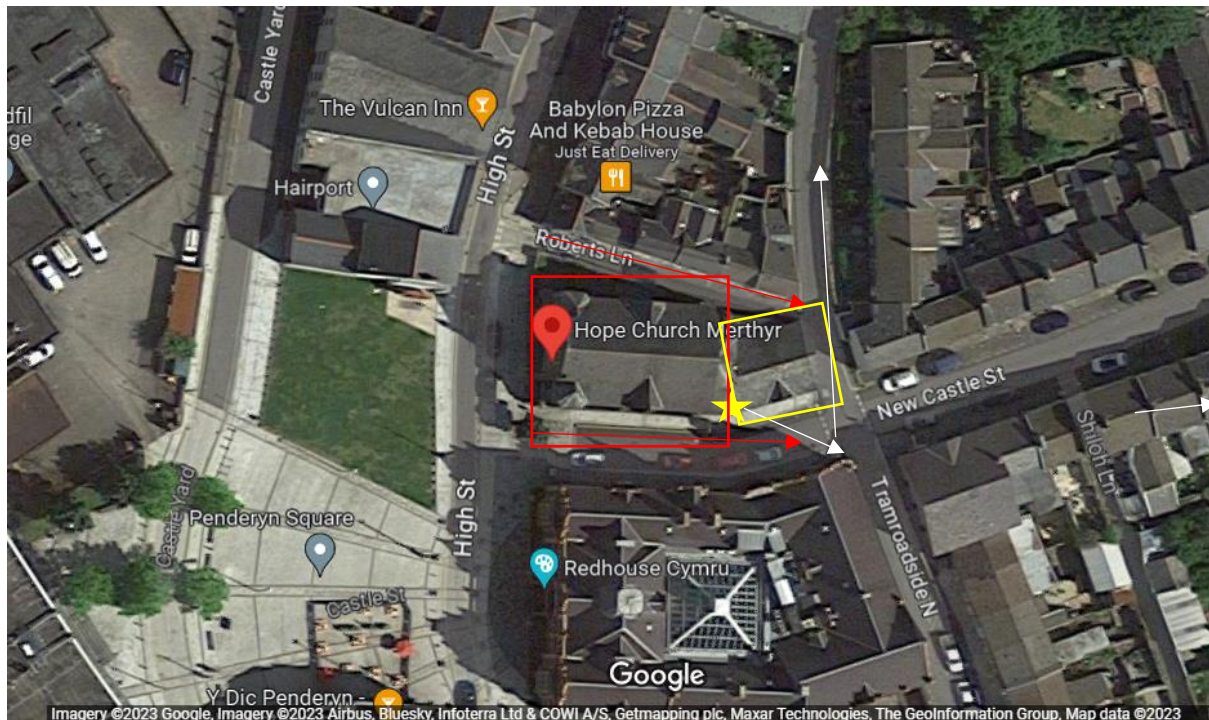
#### 4.4.3 Identified flight paths (arrowed red); roost location starred yellow

Figure 4: Identified flight paths and roosting location; white arrow indicates flight behaviour of emerging bat (Google Maps, 2023)

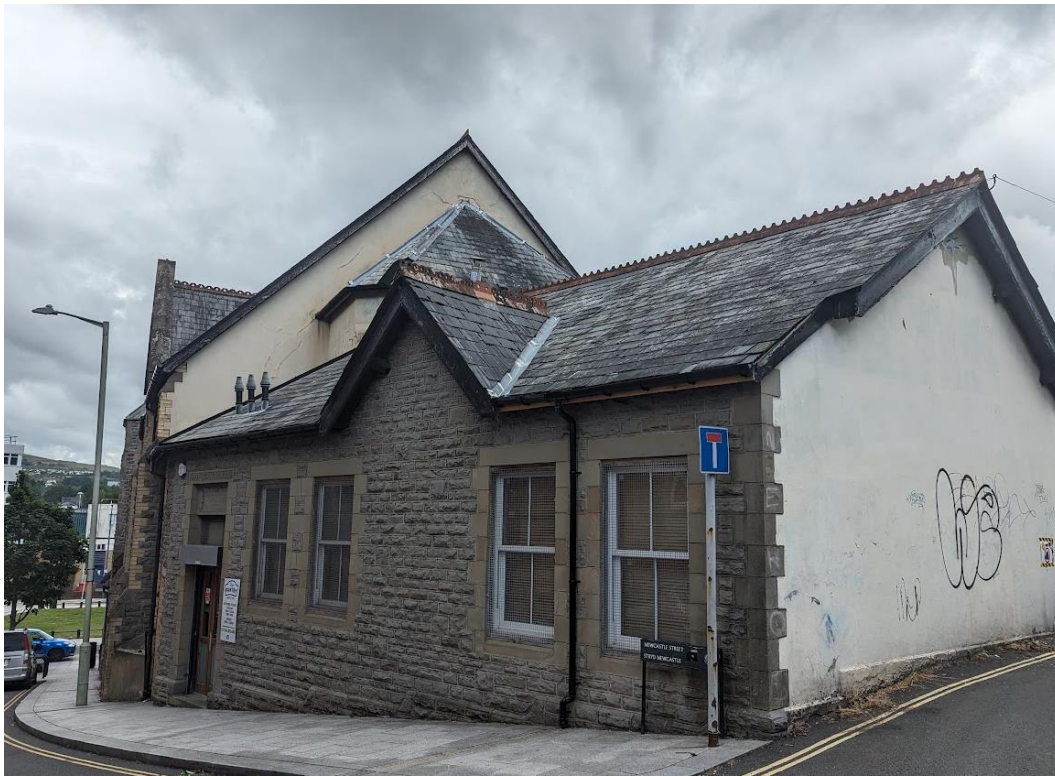
**Plate 5- lower storey to east of site**

It is considered that as the area to the east (figure 5, boxed yellow) is subservient to the area of roof where the bat was found to be roosting, works to this area can proceed without a licence being obtained from Natural Resources Wales providing it is undertaken in line with a detailed method

**9 METHOD STATEMENT for the lower storey to the east (figure 5, boxed yellow)**

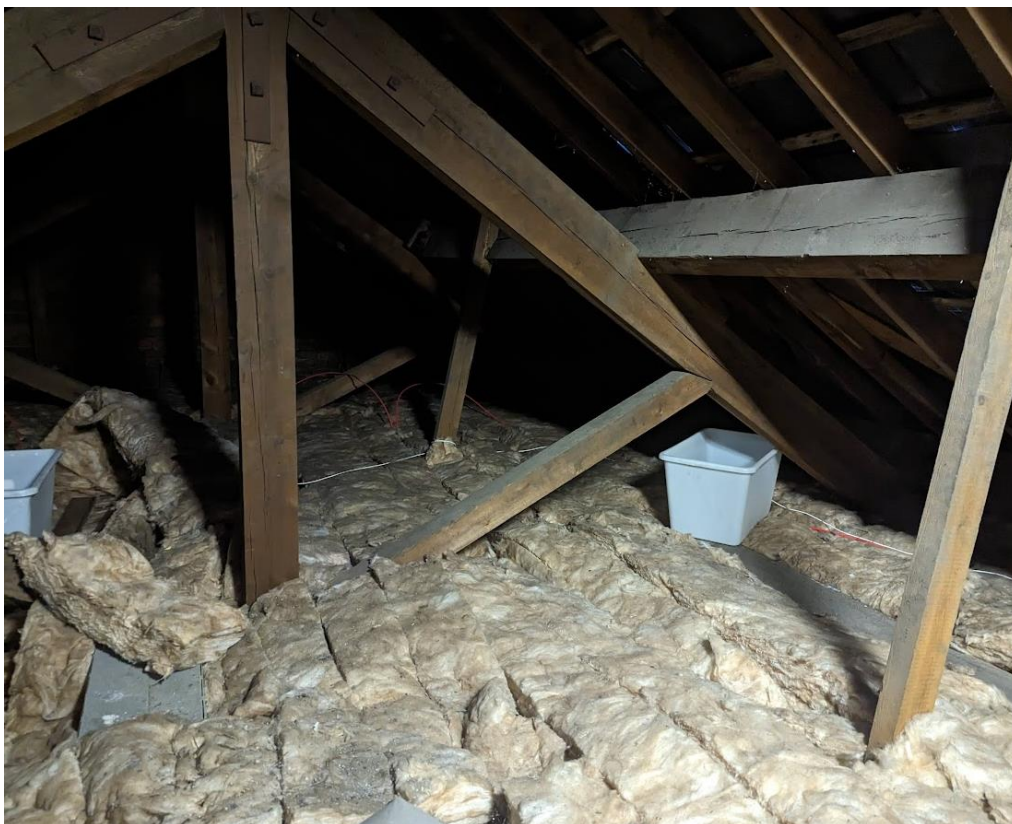
The eastern section of the building has a roof space that is currently used for storage. The void is approximately 3m in height in places. The roof is unlined and the joists are lined with fiberglass insulation. It is not safe to walk on some areas due to the insulation obscuring the joists. No bats or evidence of bats was found in this location.

**Plate 6- photograph of accessible roof void**

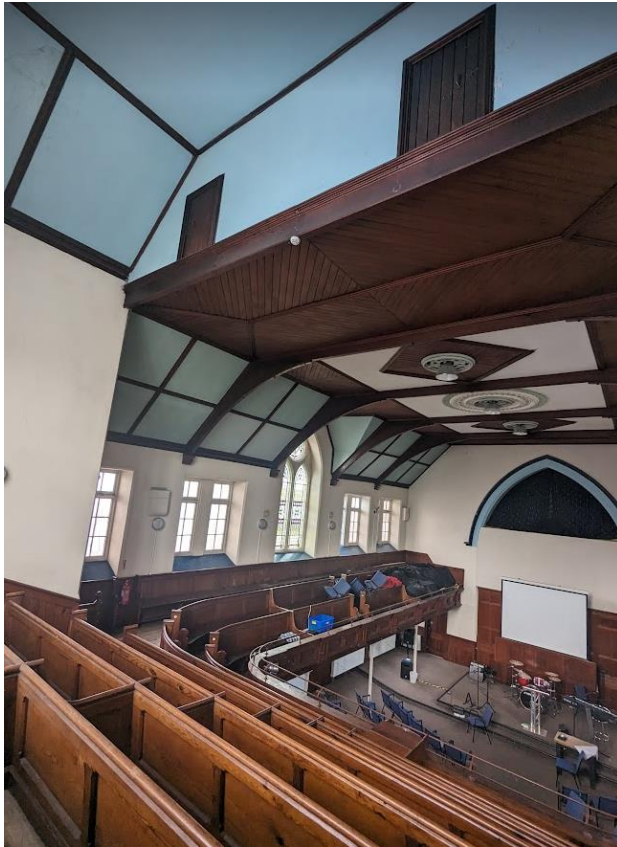
Internally, the property has a roof space that is accessed from the main church hall. The access is hatches are difficult and would require balancing a ladder from the pew to the hatch. Therefore access to this area was deemed unsafe and the area was not inspected.

**Plate 7- photograph of access hatches that were not able to be entered for health and safety reasons**

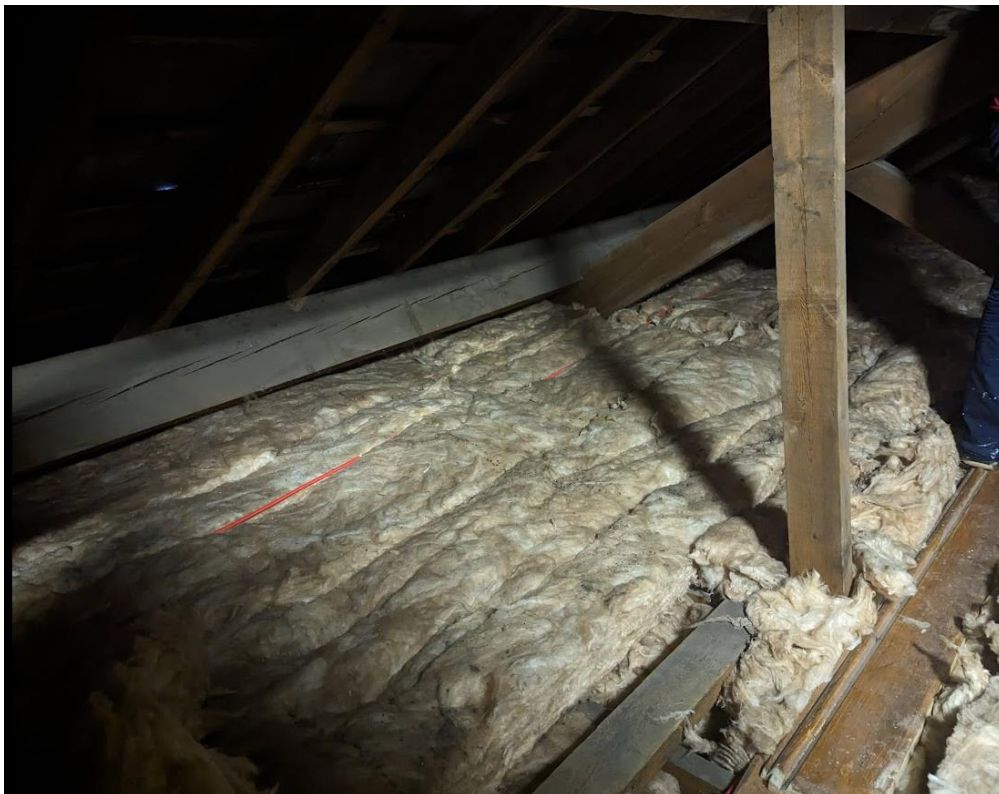
**Plate 8- photograph of accessible roof void**

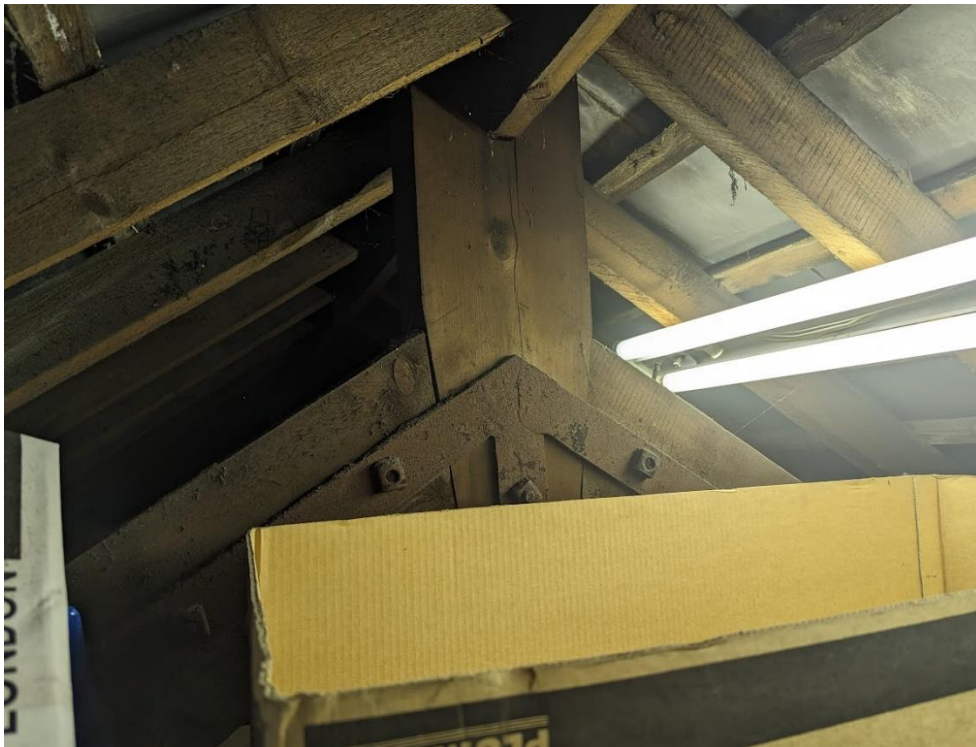
**Plate 9- photograph of smaller area off roof void**

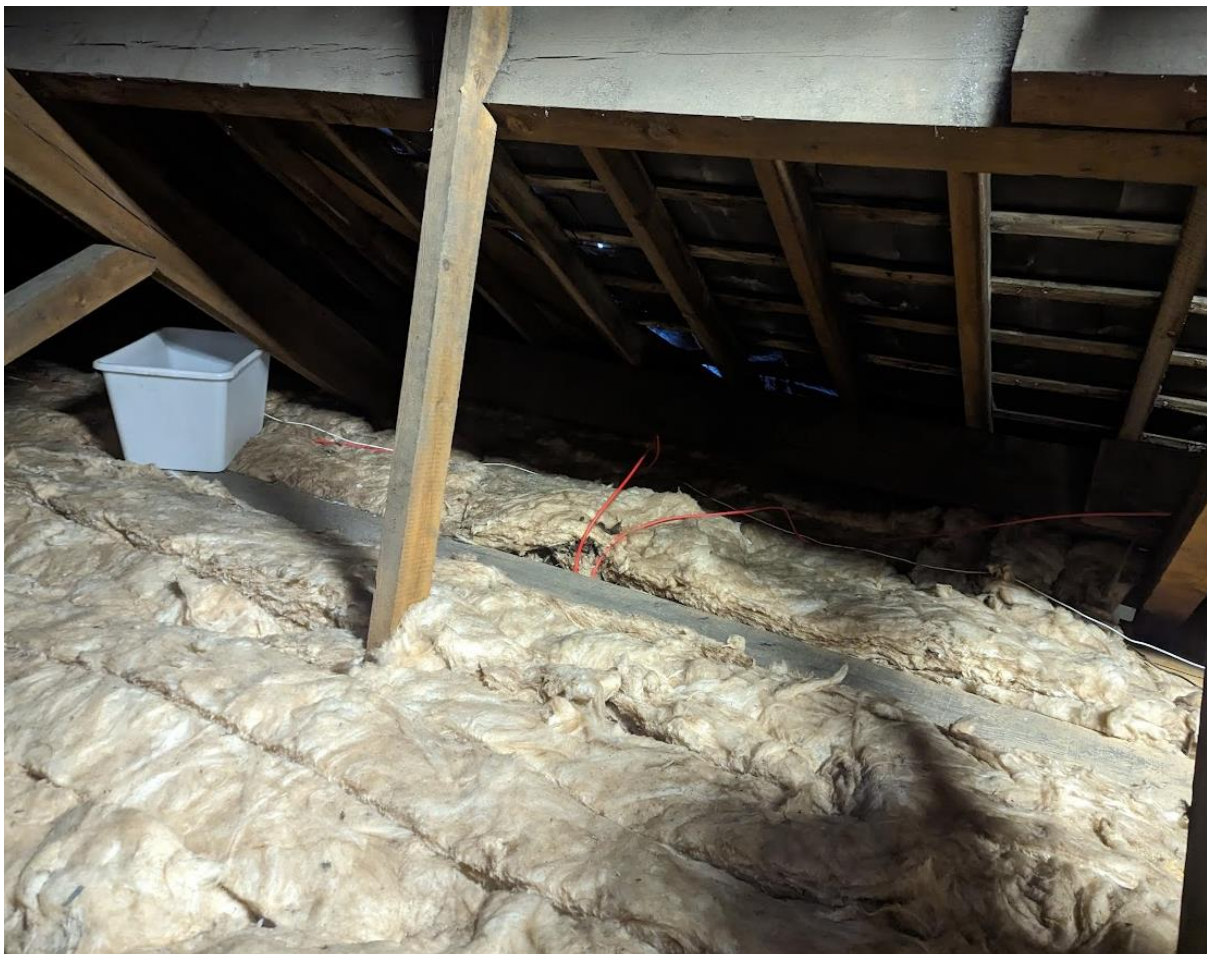
**Plate 10- photograph of roof void**
