Garth Farm  
Pant  
Merthyr Tydfil  
CF48 2YA

An Ecological Survey  
Report (Revision 1)  
Including Net Benefits for Biodiversity

July 2024

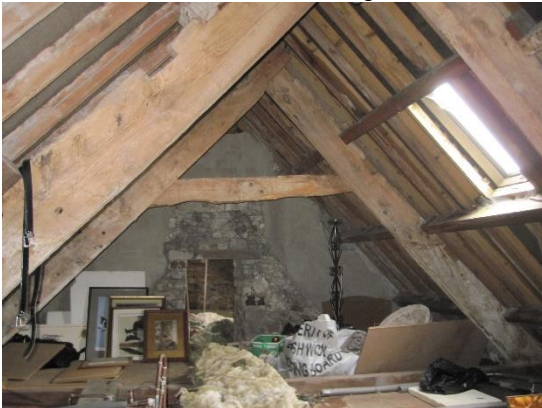
- 8.2 Assessment commenced with the interior of the house, which although not currently resided in, was found to be in good condition. The attic spaces were inspected for the presence of bats, and/or evidence of bat presence. Features normally used by bats were checked, and the floor, and stored items examined for bat droppings or signs of insect remains, which might indicate a bat feeding perch. No evidence of bat presence was noted, or that of nesting birds.

Plate 3: Internal view of main attic, looking south-east

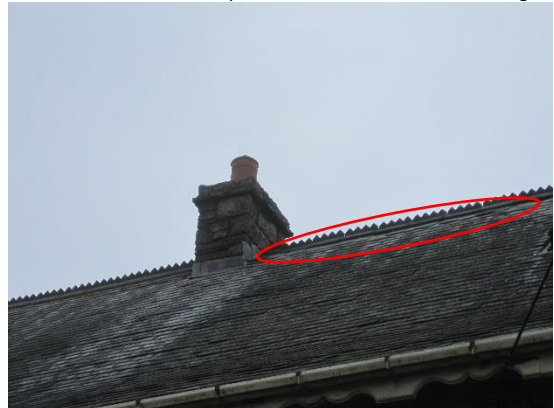
- 8.4 Examination of the roof of the house indicated several locations where bat access would be possible. These Potential Roost Features (PRF's) included where the ridge tiles were not sitting tightly on the surrounding slates, and any mortar previously present had been lost, creating gaps which bats might exploit to use the area beneath the ridges. Numerous lifted slates were also noted on the roof, permitting bat access. Additionally, and with respect to both chimneys, the lead flashing was lifted in a few places around the base of each chimney, permitting access to these locations. Overall the house was judged to offer a moderate level of potential to be used for roosting by bats.

Plate 4: South-western aspect of roof, with raised or missing slates

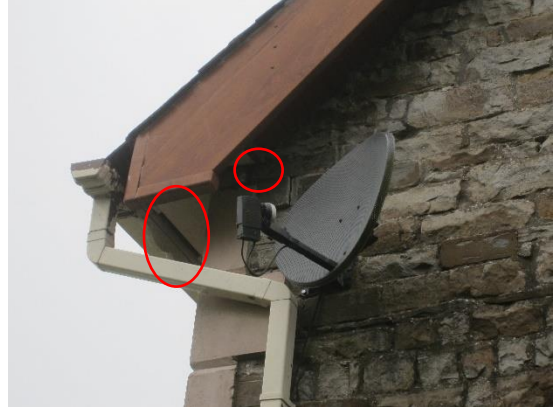
Plate 6: Gap in stonework at south eastern gable and slot in soffit

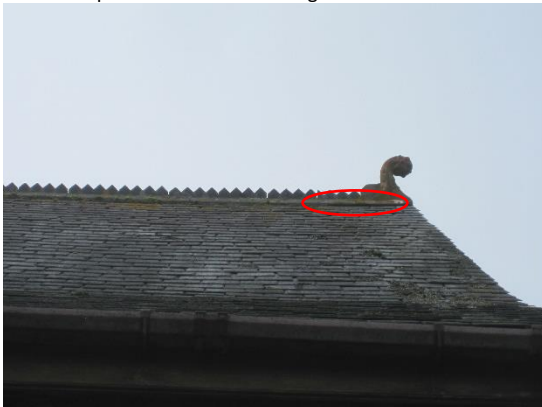
Plate 7: Gap on northern side of ridge and western end

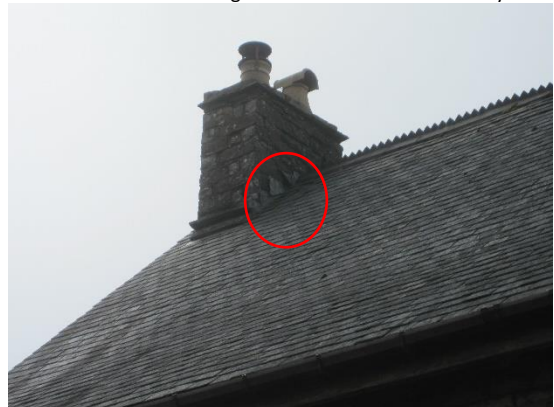
Plate 8: Lifted lead flashing around eastern most chimney

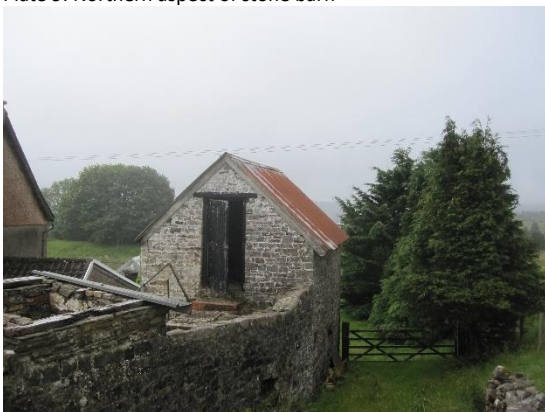
- 8.6 The stone barn was found to offer low to moderate potential to be used by bats. The two entrance doors, one at ground floor level on the south-east elevation, and the other on the north-east gable, at first floor level (at the top of a stone stairway), were open, permitting free access to bats and birds. Although the roof was covered in corrugated and asbestos cement sheets, there was still potential access to the ridge area, and at the eaves and gable ends. Whilst no evidence of bat presence was established, an historic wren nest was noted inside the door lintel on the first floor. What was thought to be an historic jackdaw nest was also noted on top of the wall plate at the south-west gable end. Consideration was made of the potential of the structure

Plate 9: Northern aspect of stone barn

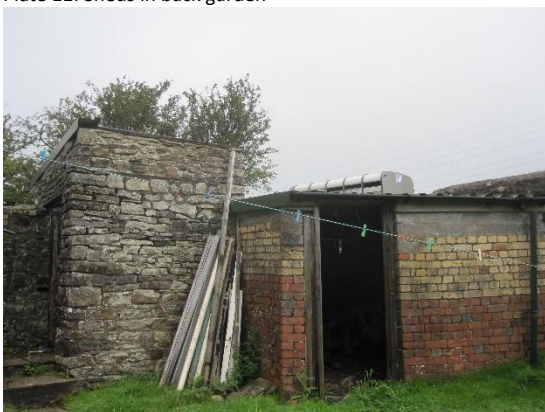
- 8.7 Attention next focussed on the two shed structures, just to the east of the stone barn. The stone shed was found to lack a roof, but this was only apparent upon opening the door on the western elevation, or, looking at it over the boundary wall from the east. It was considered to offer no potential to be use by bats for roosting, or birds for nesting. The adjoining brick shed, whilst sporting a tin roof in good condition was still very open. Access for wildlife to this structure would be relatively easy, but no evidence was found to suggest that any use was occurring. Hibernation potential was dismissed, due to a lack of low-level gaps, and despite the access, the actual potential of either shed was negligible given their ramshackle condition.

Plate 11: Sheds in back garden

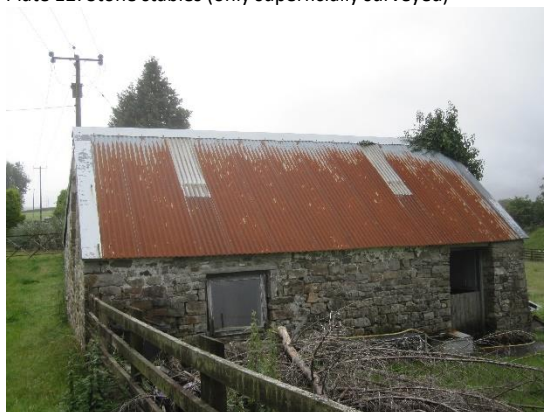
- 8.8 The stables, to the south-west of the house was inspected, but not in a detailed fashion, as a lack of ecological resources meant it would be impossible to include it in any additional survey, if this proved necessary. However, inspection of the interior noted bird droppings inside, but no obvious nests. No bat droppings were seen, and the inside was found to be well lit. Ivy growth on the south-west gable end was considered to offer birds potential nesting locations, and overall, from a bat roost viewpoint, the building was considered to have low potential to offer roost sites.

Plate 12: Stone stables (only superficially surveyed)

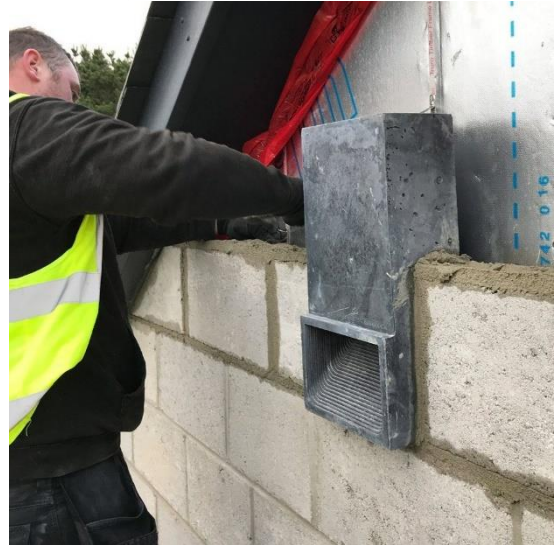
Plate 17: Integrated box in place

- 10.7 A new development provides the opportunity to enhance the biodiversity of the site, and to comply with Planning Policy Wales 11 (PPW11), several enhancements are recommended as suitable for a site of this size. As the bat roost potential of the existing structures at the site will be lost, it is appropriate to provide new potential, in the event that bats choose to use such provision in future. It is therefore recommended that two integrated bat boxes are built into the design of the new dwelling. There are a number of 'off the shelf' products available currently, and ideally two Schwegler 1FR bat tubes will be built into the upper walls. Other designs can be used, and different types are illustrated in Appendix V, along with an example of an installation.

- 10.8 The boxes would ideally be located on different aspects of the new house, ideally at a gable end, or beneath the eaves. The placing of the box is crucial, and they must not be located close to, or above, windows or doors, where bat droppings may become a nuisance if the boxes are used. It is vital that no satellite dishes, guttering, vents, lights, or air conditioning units are located within close proximity of the bat mitigation arrangements.
