# **Dragon Parc – Construction Environmental Management Plan**

BMQ-JBAU-XX-XX-RP-EN-0001-S3-P01-CEMP

**October 2019**

This outline Construction Environmental Management Plan (CEMP) summarises the recommendations for environmental management during the construction phase of the Dragon Parc Swale Flood Alleviation Scheme. It outlines the likely roles and responsibilities of those involved in the project and sets out the environmental actions required to achieve a series of environmental management objectives identified for the scheme.

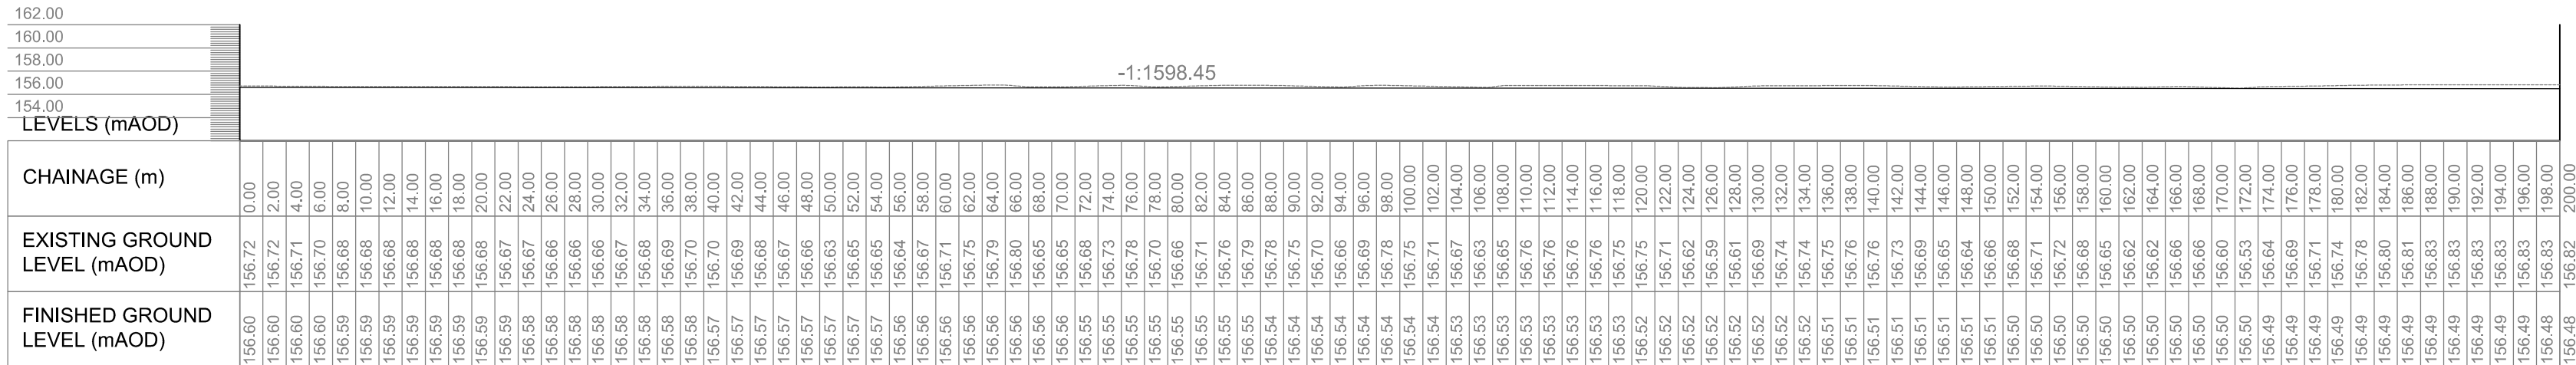
CHANNEL LONG SECTION

CH: 0.00 - 200.00m

EXISTING GROUND LEVEL. APPLIES TO ALL LONG SECTIONS  
PROPOSED GROUND LEVEL: GRASSED LINED CHANNEL.  
APPLIES TO ALL CHANNEL LONG SECTIONS

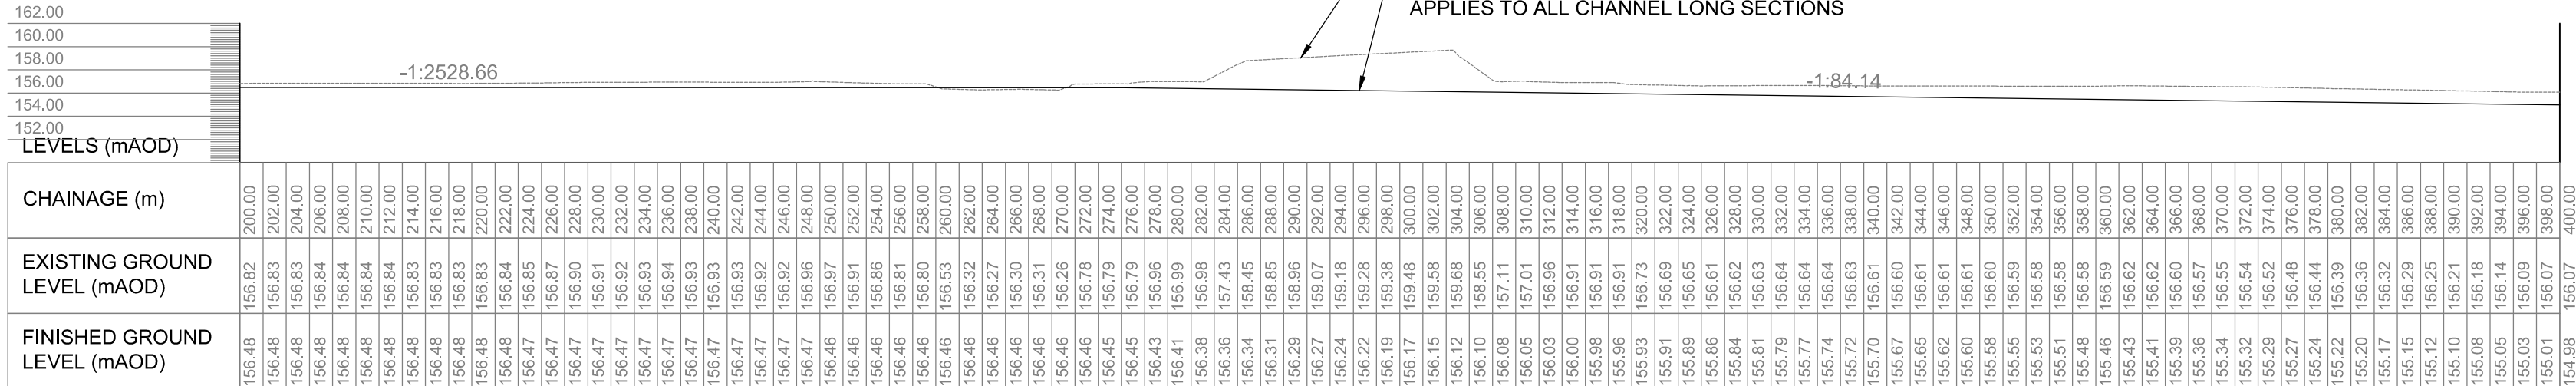
CHANNEL LONG SECTION

CH: 200.00 - 400.00m

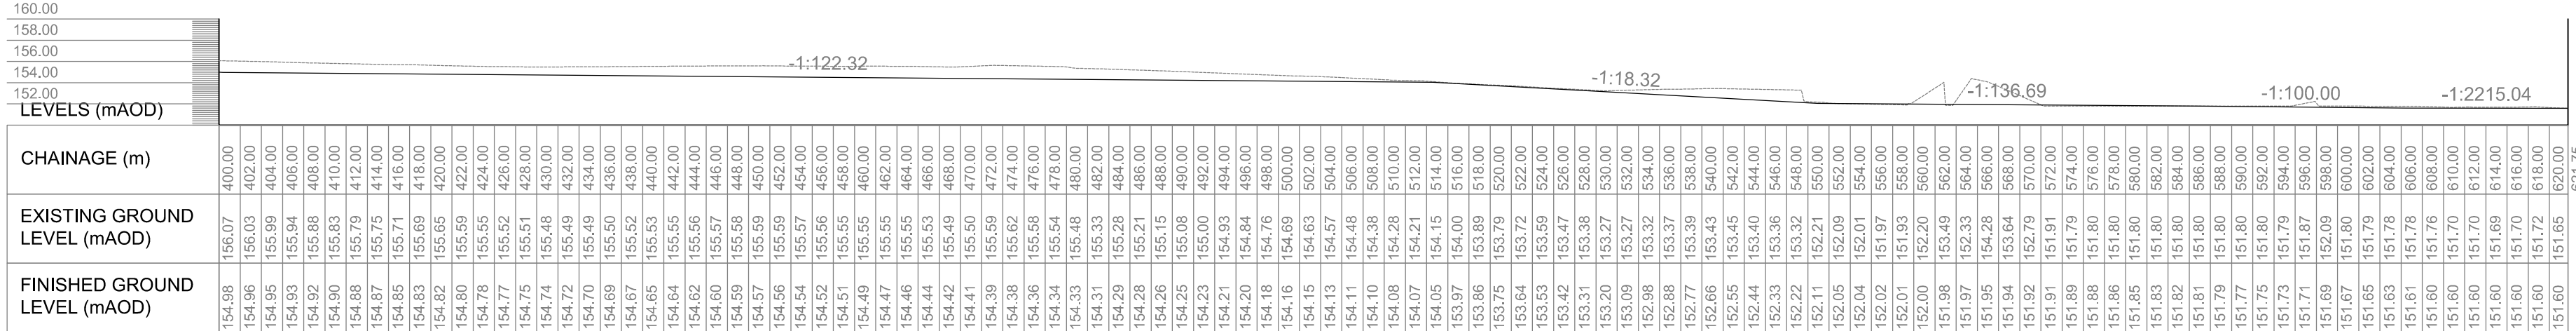
CHANNEL LONG SECTION

CH: 400.00 - 621.75m

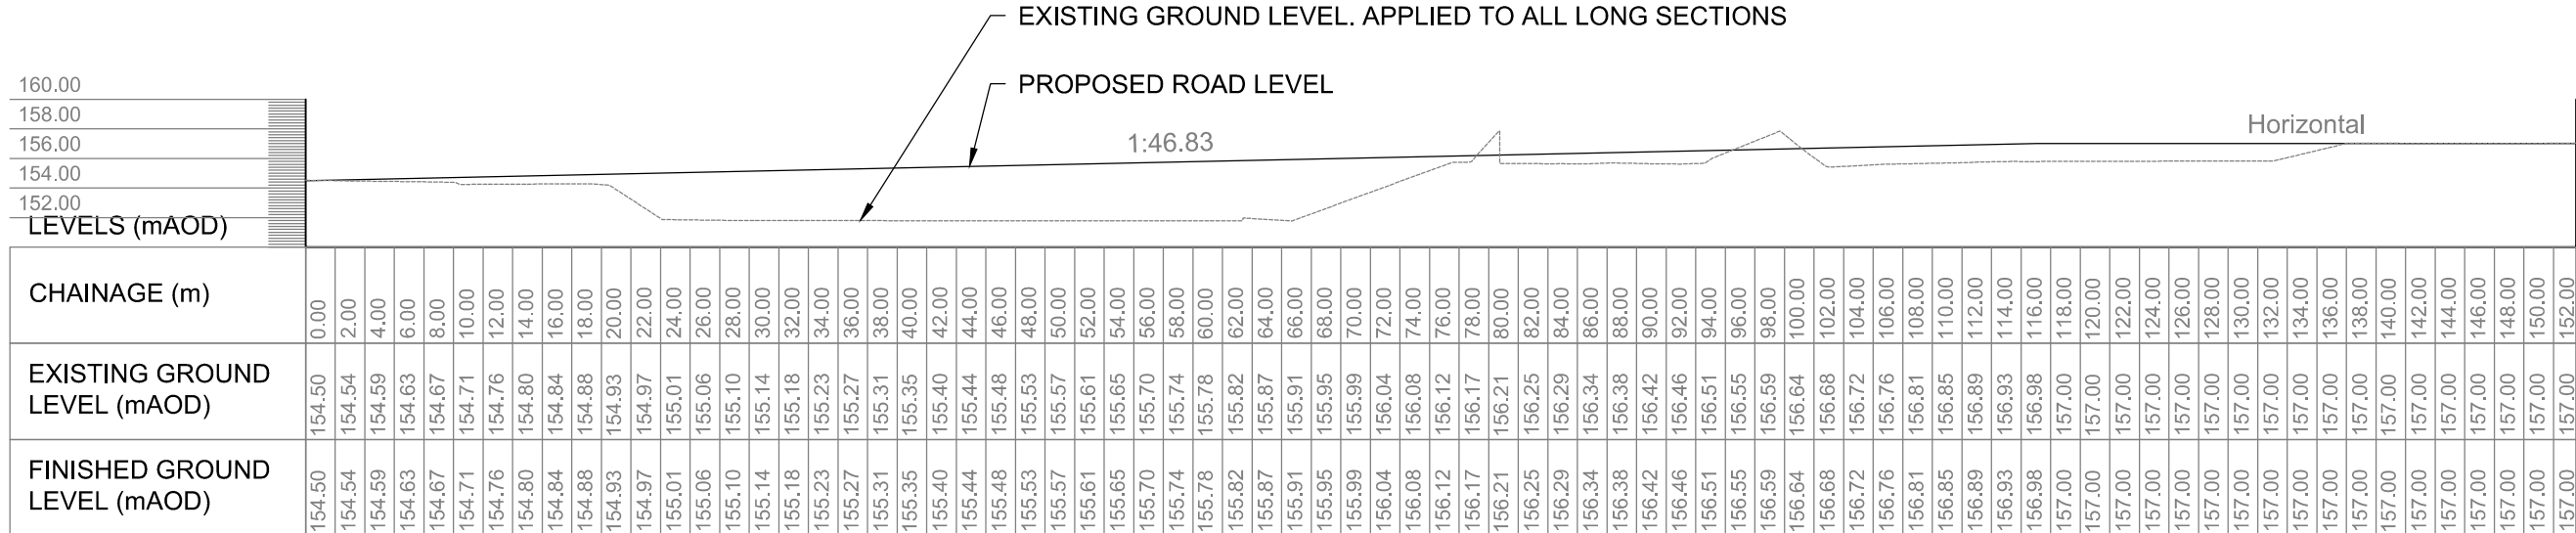
ACCESS ROAD LONG SECTION

CH: 0.00 - 153.51m

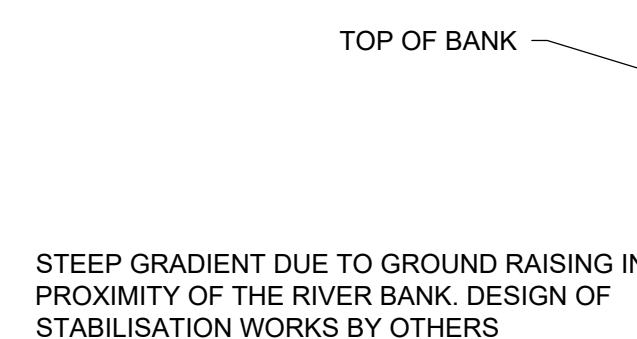
PLAN  
1:100

RIGHT HAND BANK OF RIVER TAFF. TOPOGRAPHY  
UNKNOWN AND TO BE CONFIRMED VIA SURVEY

EMBANKMENT SLOPE AT 1:3

STEEP GRADIENT DUE TO GROUND RAISING IN PROXIMITY OF THE RIVER BANK. DESIGN OF STABILISATION WORKS BY OTHERS

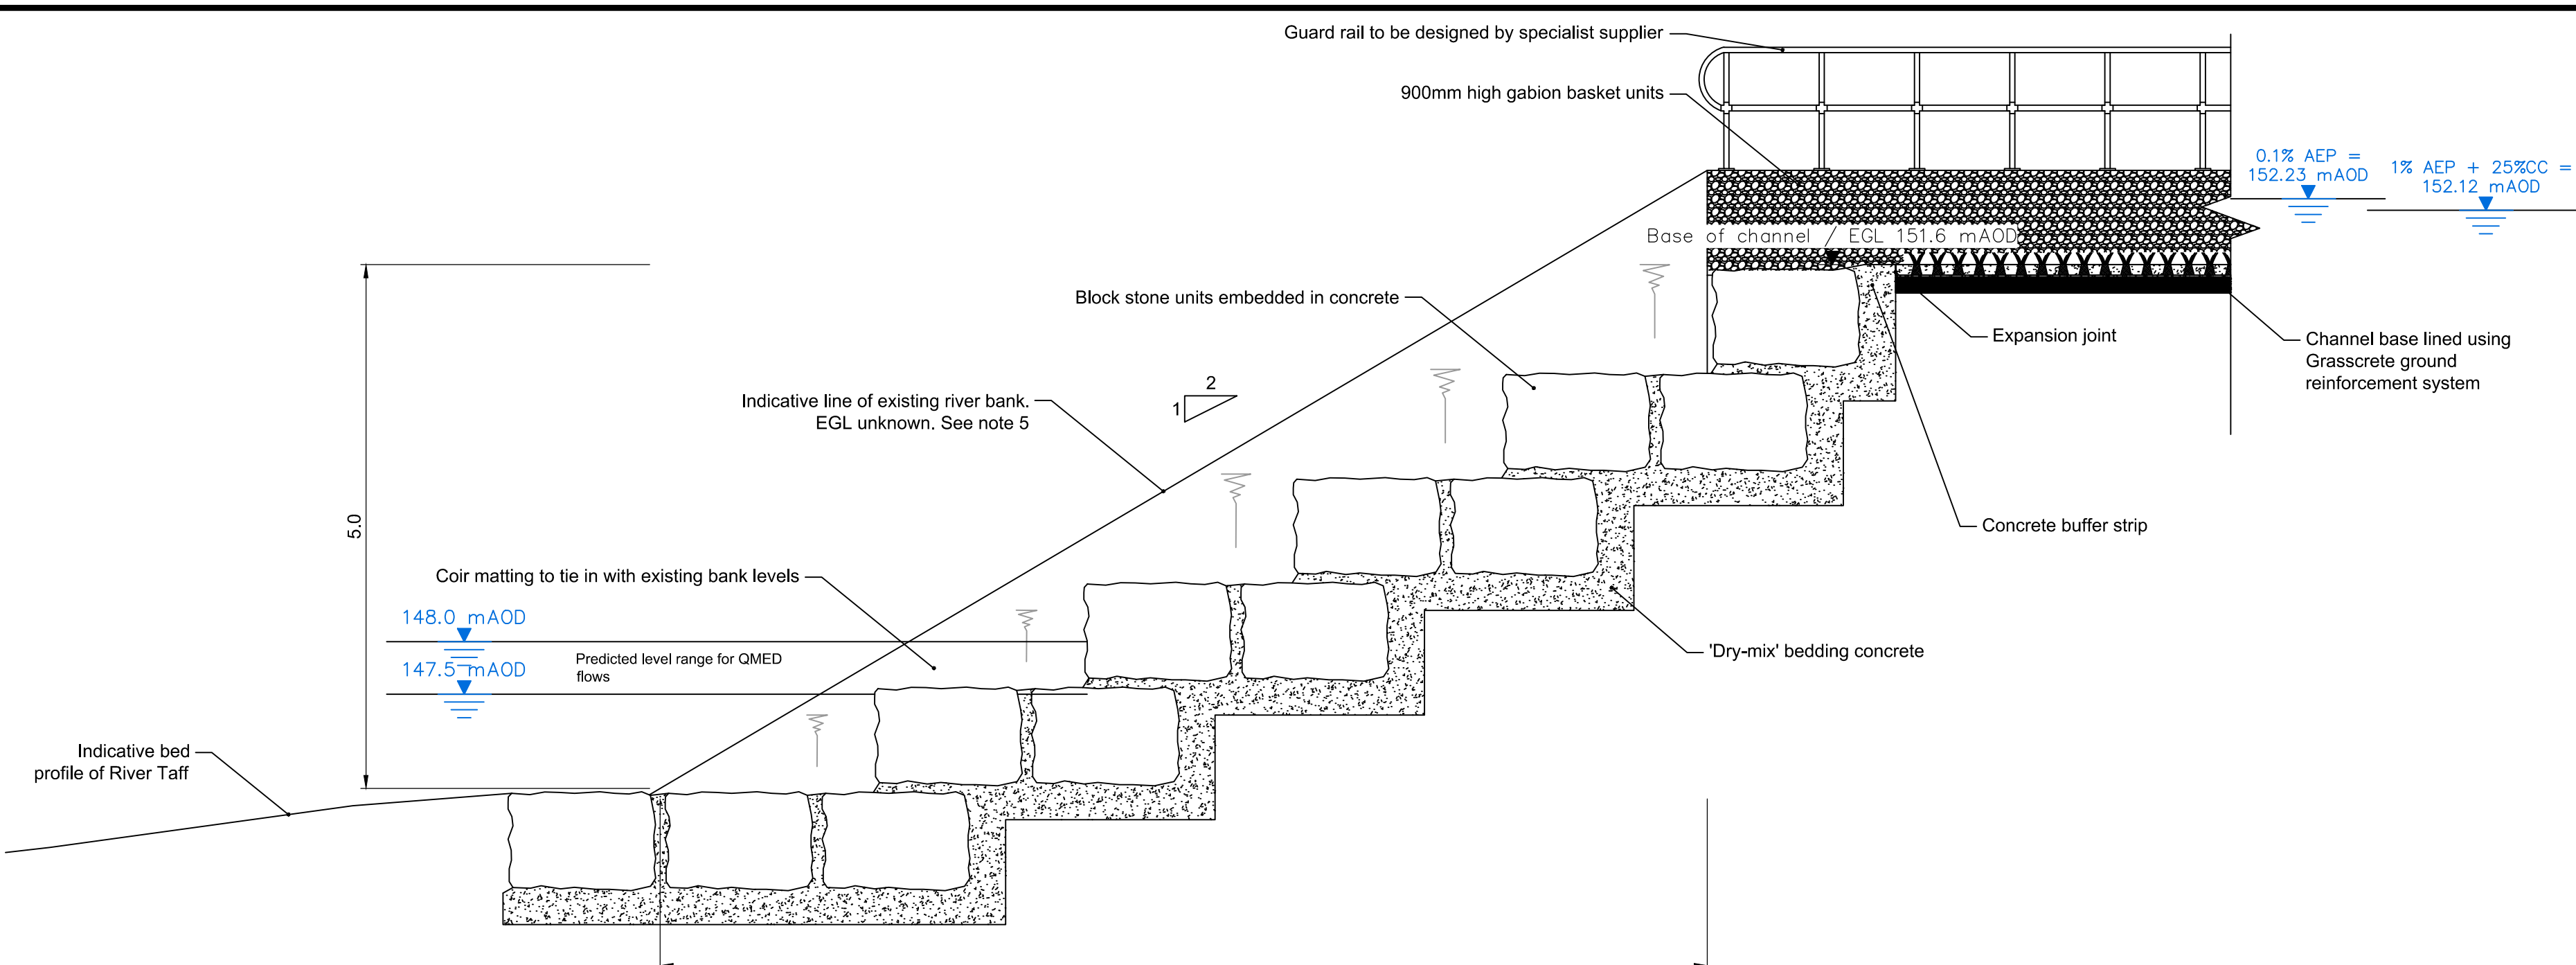
SECTION A-A  
1:50

✓ STEPPED BLOCKSTONE CASCADE / OUTFALL

COIR MATTING

900mm HIGH GABION BASKETS FORMING CHANNEL WALLS

BASE OF CHANNEL LINED USING GRASSCRETE REINFORCEMENT SYSTEM

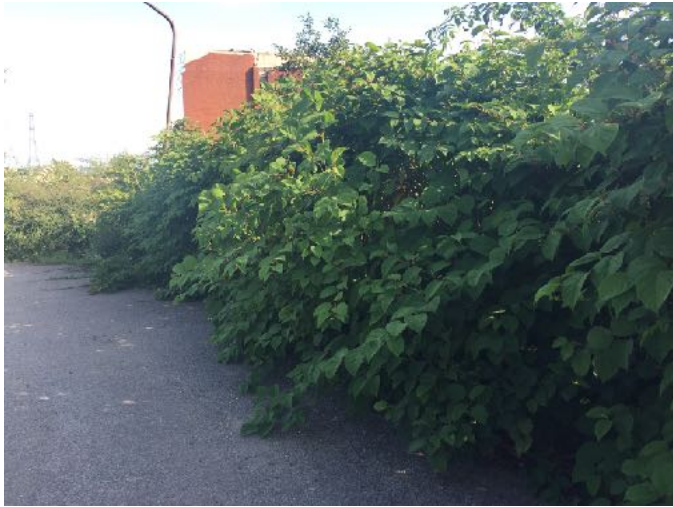
View of Japanese knotweed along south entrance

A dense stand of Japanese knotweed was noted to the south east of the site along the access road off the adjacent small roundabout. Some scattered stands of knotweed were also observed along the banks of the rRiver Taff to the south east of the site. Access along the the full extent of the river bank wasn't possible due to steepness however it would seem likely that knotweed is present along most of the river bank adjacent to the site. Japanese knotweed is listed under Schedule 9 of the Wildlife and Countryside Act (1981) which makes it an offence to plant or allow to grow in the wild. Under the Environmental Protection Act 1990, Japanese Knotweed is classified as controlled waste.

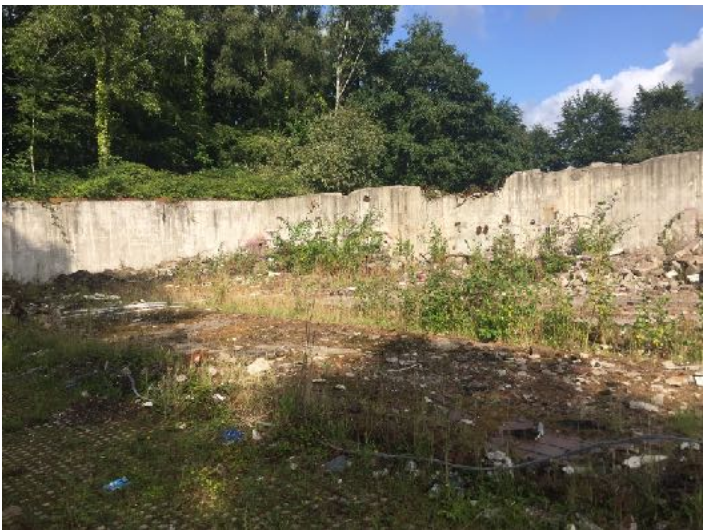
View of building foundations

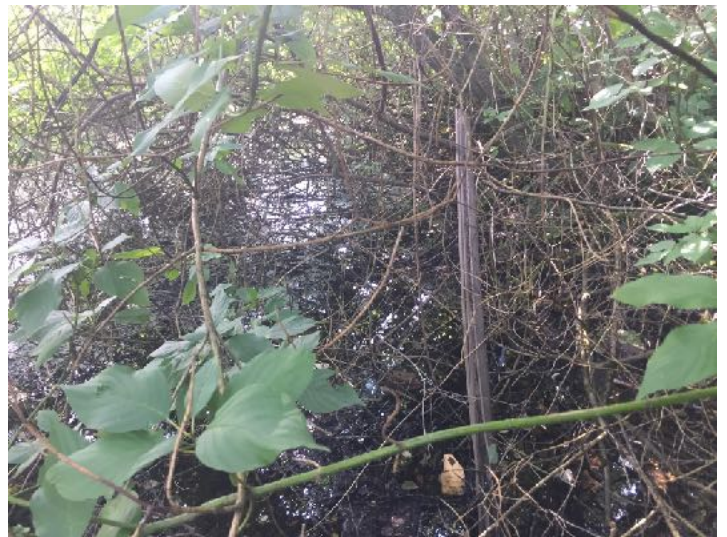
View of overgrown pond to west of site

The pond was slightly more open during the 2016 surveys completed by RPS and a Habitat Suitability Index (HSI) assessment was completed on it. The HSI assessment completed by RPS found the pond to have poor suitability for GCN. Based on the continued degradation of the pond since 2016 no additional detailed assessment of the pond for GCN has been undertaken.

The current pond has very poor suitability for use by GCN, the site is located in an urban setting being immediately surrounded by housing, the River Taff and light industrial units making it fairly isolated from any surrounding habitat which maybe suitable for GCN. Given the lack of close records for GCN as well, it is considered highly unlikely that they are present within the site boundary. No further surveys are recommended for this species.
