**Bat Survey:** Brynhyfryd Chapel, Thomas Street, Treharris, CF46 5AA

**Instructed by:** Steve Groucott

**Reported by:** Ecological Services Ltd  
10 Mount Pleasant, Llanelly Hill, Abergavenny, Monmouthshire, NP7 0NT

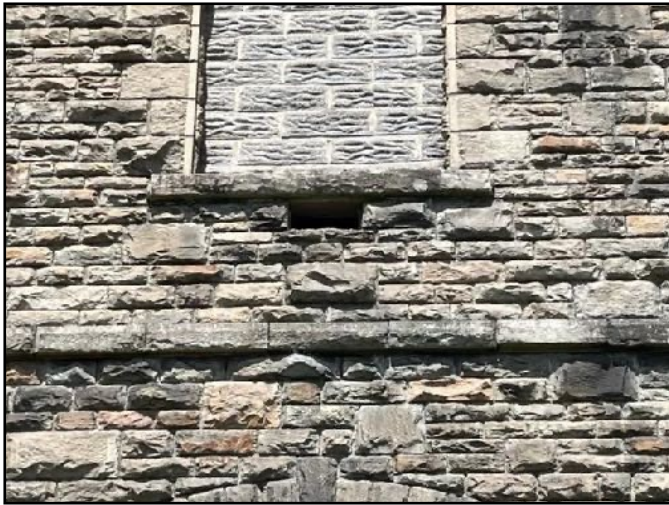
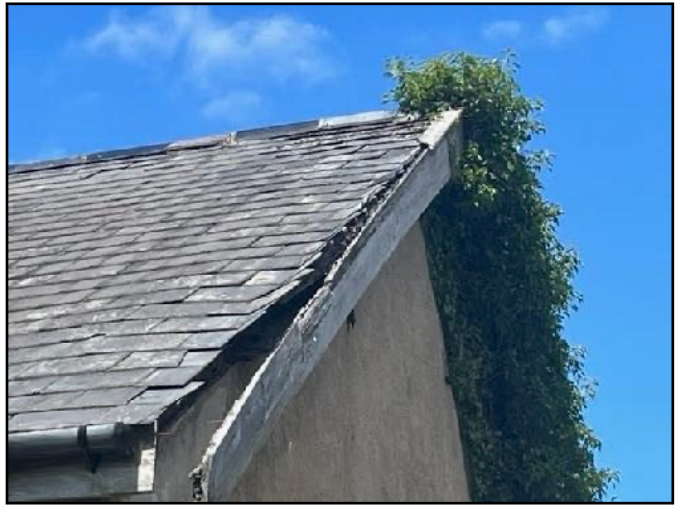
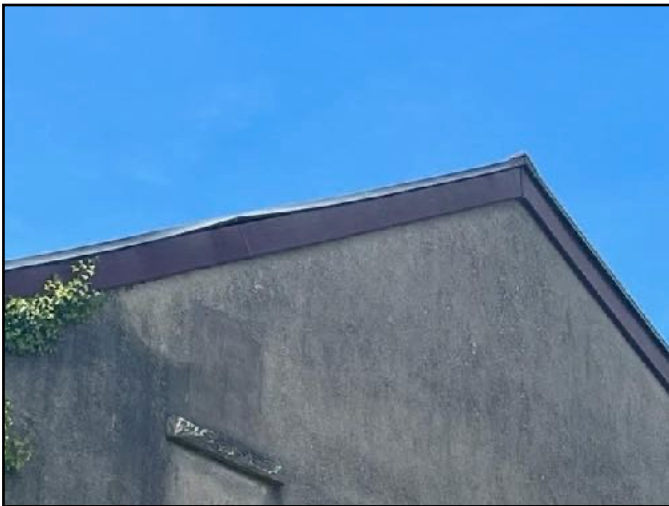
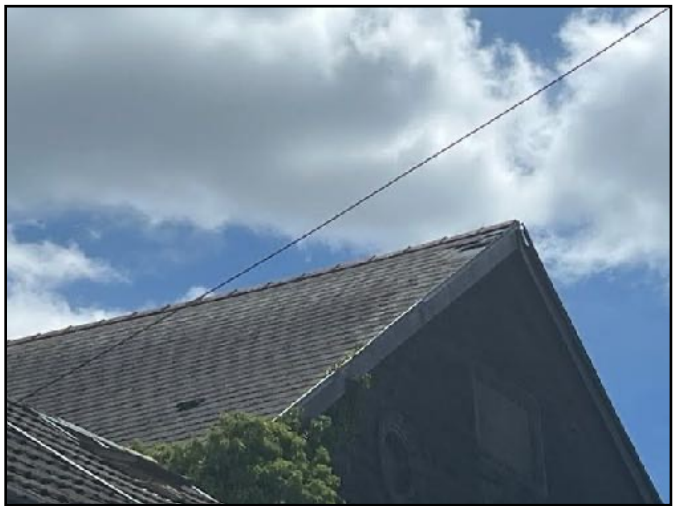
## 6.7 Examples of apertures allowing access to cavities in the building:

**6.3** Due to the age and condition of the building, there were numerous opportunities present for bats to access and use the building and those that were available were deemed as having high potential for roosting bats. There were missing slates at the front of the main roof; an area of raised dry verge to the rear and a missing stone below a bricked up window on the side elevation. There were also slipped and raised slates and apertures underneath the ridge tiles on the single storey extension. The uPVC fasciae and soffits appeared to be relatively tightly sealed, however, there were a small number of apertures behind the concrete cornice below the fasciae.

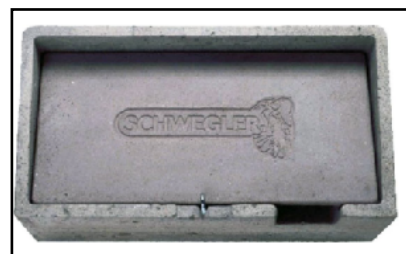
**10.5** It is presumed that the building already has 1F bitumastic roofing felt. If this is not the case then bats will be restricted to the void in the underside of the ridge tile by using a continuous piece of 1F bitumen felt as a base liner. This will be fixed in location over the top rafters as per adjacent image.

**10.7** Breathable membrane is dangerous for bats, therefore it is essential if any roof areas are breathable felt then the detail contained in the adjacent drawing is followed exactly and is to be fitted under direct ecological supervision by a suitably qualified ecologist.

**10.2** It is proposed that new roosting for crevice dwelling species of bat will be created underneath the entire row of ridge tiles. This will be accessed by 5 number raised ridge tiles.

**10.3** The raised ridge tiles will have two access apertures measuring 100mm long by 25mm high; one on the front elevation and one on the rear.

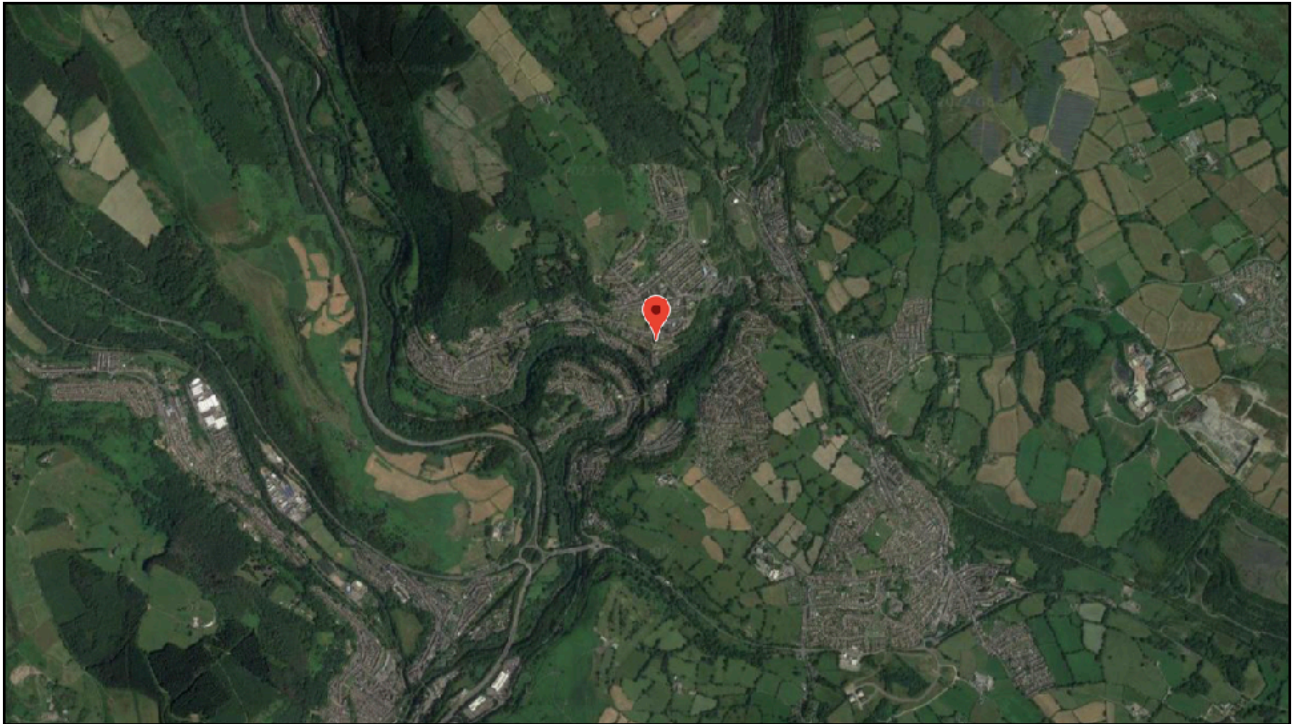
### **Aerial Site Photo**

**The site in its wider environment offering excellent ecological connectivity to the surrounding habitat.**
