# **PRELIMINARY ROOST ASSESSMENT AND OBSERVATION SURVEY, 8 PONTMORLAIS, HIGH STREET, MERTHYR TYDFIL.**

**FERGUSON-MAN ARCHITECTS LTD**

**September 2019**

Ref: HE/88/2018  
Issue 2: 23<sup>rd</sup> September 2019

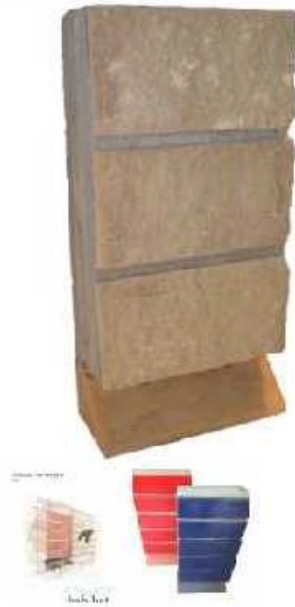
**FIGURE 3**  
**TYPICAL INTEGRAL BAT BOX, A HABITAT CUSTOM STONE FACED BOX**

Figure 2, Typical Integral Bat Box, a Habitat Custom  
Stone faced box

**Dimensions:** 215 mm wide x 440 mm high x 102 mm deep

The Habitat Bat Box is a large, solid box made of insulating concrete which provides an internal roost space, and can be seamlessly integrated into the fabric of a building as it is built or renovated. Suitable for most species commonly found in the UK, this single chambered unit features an integrated V system to increase the surface for bats to roost against, whilst allowing them to move around.

- 8.1 An Ecological Clerk of Works will be appointed to oversee ecological issues through the development period. The ECW will be available on standby to assist in the case of unforeseen ecological issues arising. Prior to works commencing a toolbox talk will be given by the ECW with all staff involved in the roof strip.
- 8.2 The removal of asbestos sheets and slates will be undertaken by hand and under the supervision of the ECW. Should evidence of bat use such as droppings or live or dead animals be found, work will cease and advice given on how best to proceed. In this instance, it may be necessary to obtain a derogation licence to allow works to proceed.
- 8.3 Integral bat tubes should be built into the gable walls nearest the Nant Morlais corridor, suggested locations are shown in Figure 2 and a typical example shown in Figure 3.

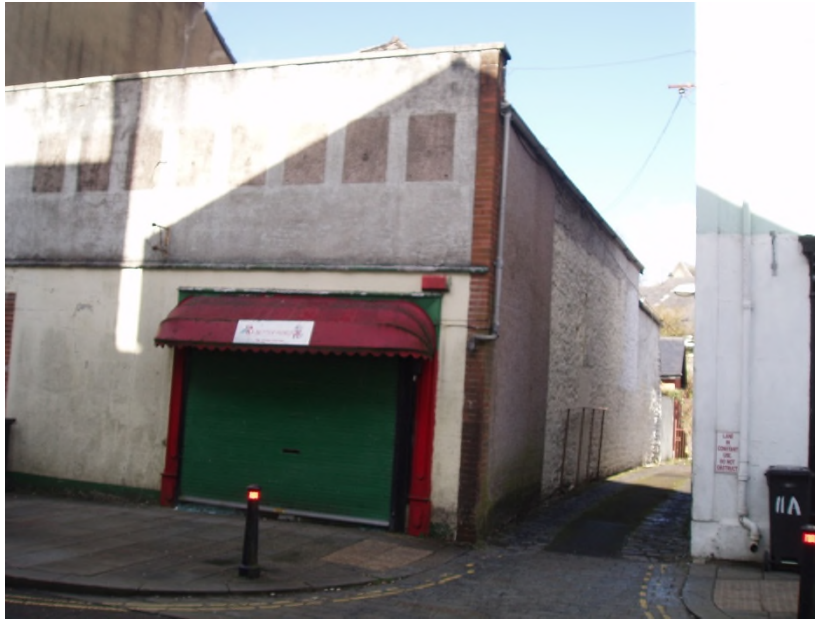
The High Street frontage and Old Mill Lane

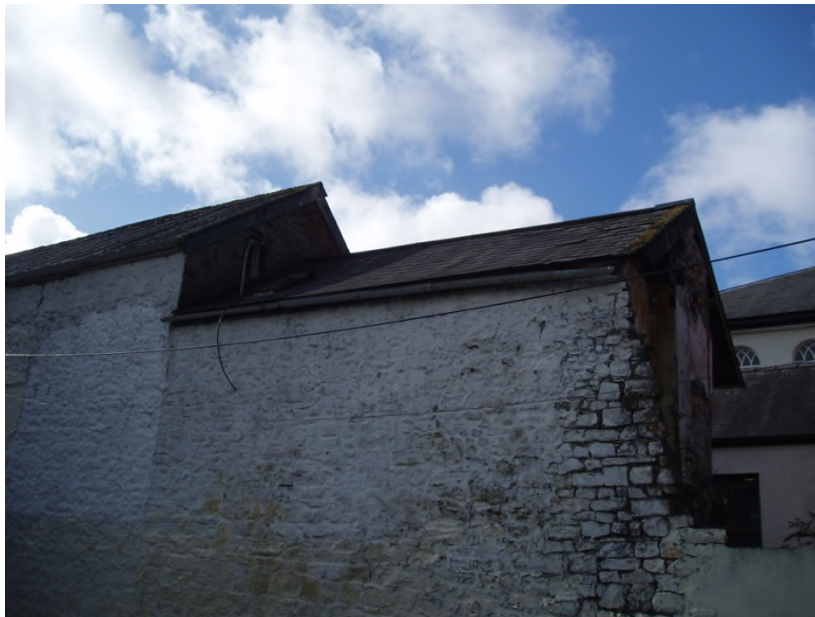
The side elevation of the building in Old Mill Lane

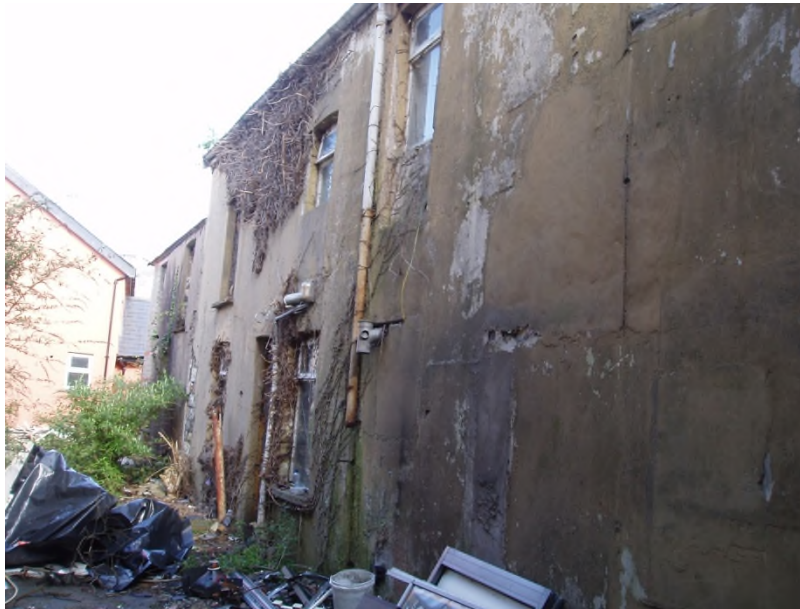
Looking along the front of the property and the yard

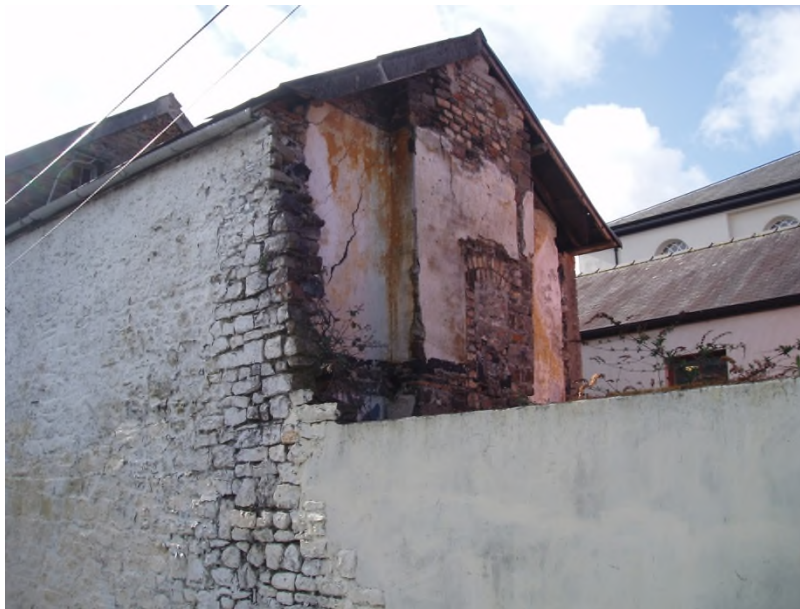
- 5.1 The building is stone built with solid walls and no cavity. A small section of number 4 to the rear has been consolidated, presumably following the collapse of the former cottage with a section of block work. There is a difference in ridge height between number 3 and 4 of approximately 0.5 metres. The buildings are thought to date from around 1830 although the differing ridge heights suggest construction over a period; indeed, inspection of the unrendered stonework shows them to be of two construction phases which are poorly tied in. All buildings would appear to date from the nineteenth century. Photographs of the buildings are given in Appendix 1.

Part of the extensive damage to the one end (nearest Nant Morlais) of the property

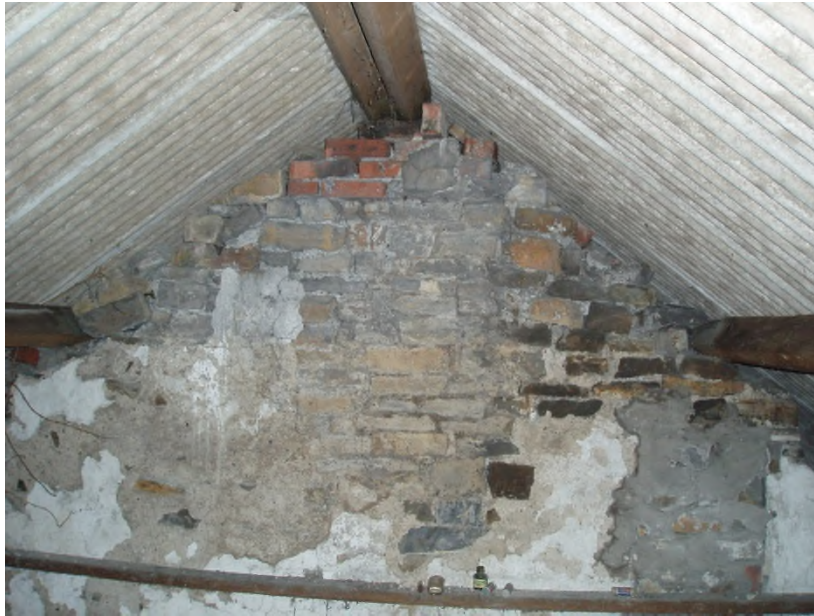
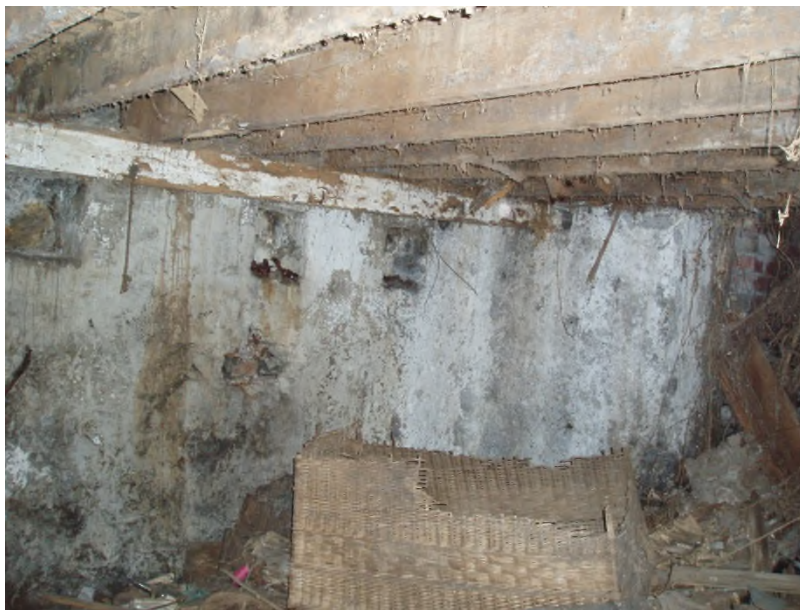
- 5.5 Internally, the building is largely in extremely poor condition with some fitting stripped out, rotting floorboards, many missing and damaged ceilings. Access was only fully available to the loft space above cottage number 3 but the other loft spaces could be seen to varying extents. In number 4, the ceiling is partially replaced and large gaps are present which allowed a close inspection, but the area above the shop was difficult to see and limited views only were had over the dividing wall. The roof construction is collar beam type construction in number 4 with a modified Queens post type roof in number 3 and the shop. Only the western pitch of the slate roof at number 4 is underfelt; this is with Type 1F woven bitumastic underfelt.

Internal views, loft space top (asbestos sheeted section), typical condition of rooms apart from the former shop, below.

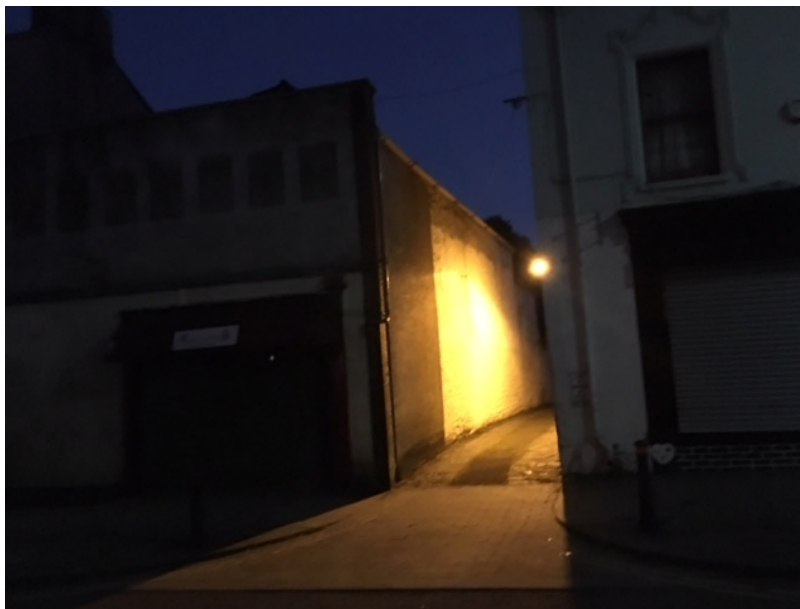
- 5.14 The dawn observation had an observer in the yard again but this time the other observer was on the High Street looking down Old Mill Lane. This was not a particular issue and the whole side of the building and roof was visible. Unfortunately, video equipment could not be used due to the bright street light in the lane (see Photos, Appendix 1).

- 6.3 The area at the rear of the building and the lower end of Old Mill Lane is dark; although a security light was noted it was on a timer and the Passive Infra Red trigger could be avoided. A bright sodium street light lit the upper area of Old Mill Lane. The bat activity was largely restricted the darker areas of Old Mill Lane whilst the yard provided good foraging conditions in conjunction with the adjacent Nant Morlais corridor.

The street light in Old Mill Lane
