**Bike Park Wales**

**Gethin Woods, Abercanaid, Merthyr Tydfil**

**Site Investigation Report**

12329/LW/19/SI

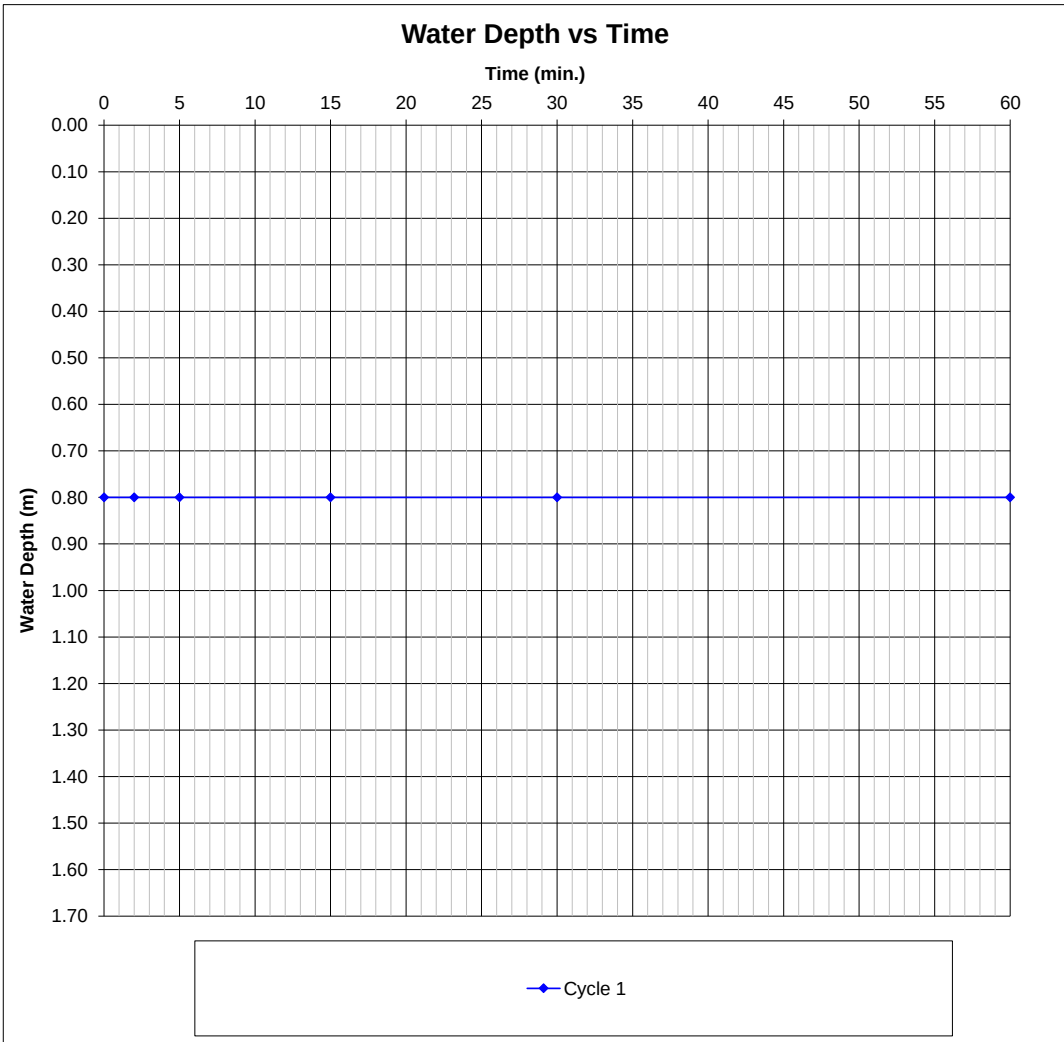
# BRE365 SOIL INFILTRATION RATE TEST - TP1

| Remarks |
|---|
| Infiltration not observed |

| Final Excavation Depth (m) | Cycle 1 | Cycle 2 | Cycle 3 |
|---|---|---|---|
| Over measured depth | 0.0E+00 | | |
| Over 75% - 25% effective depth | #DIV/0! | | |

No groundwater infiltration was recorded within TP1 and no infiltration rate could therefore be calculated at this location.

No groundwater infiltration was recorded during the soil infiltration test, and no infiltration rate could therefore be calculated at the location.

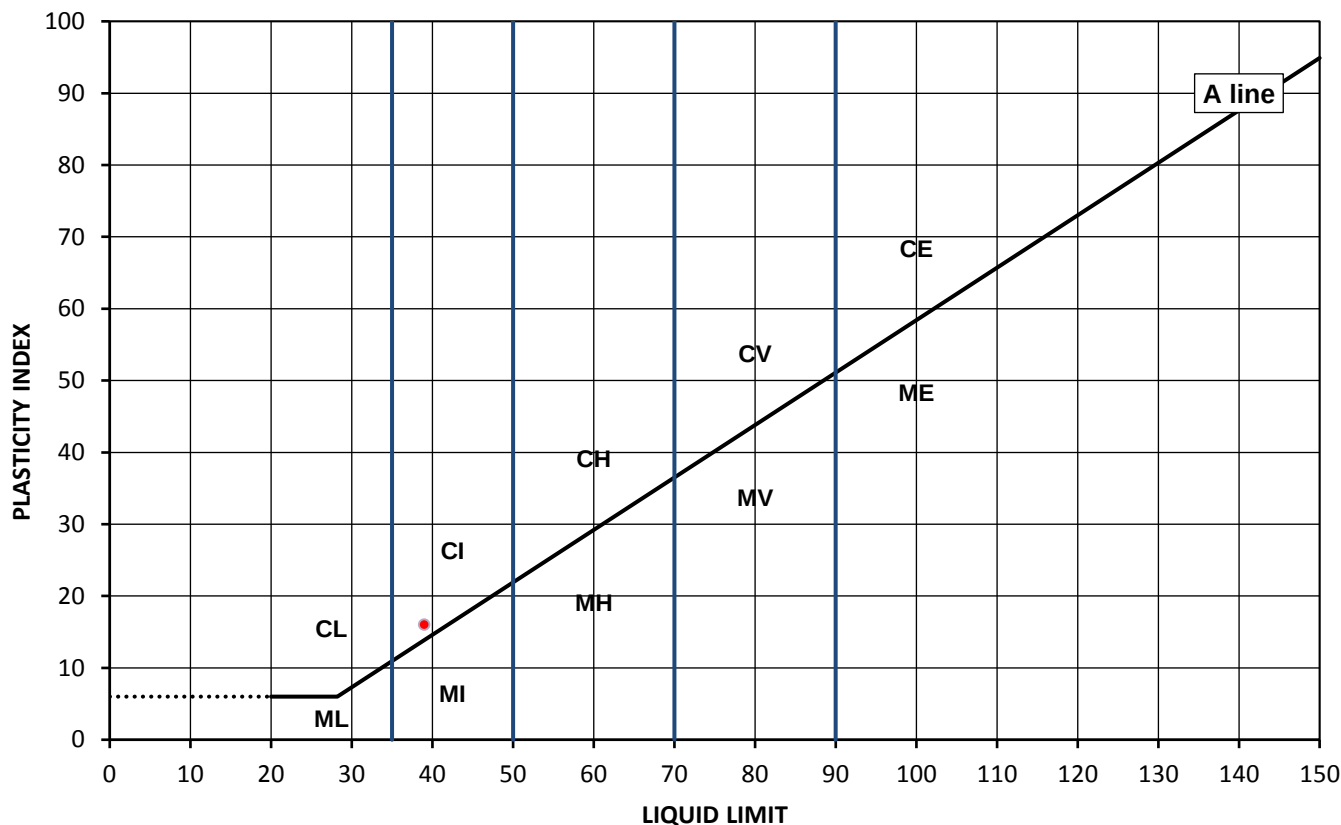
| As Received Moisture Content [%] | Liquid Limit [%] | Plastic Limit [%] | Plasticity Index [%] | % Passing 425µm BS Test Sieve |
| 24 | 39 | 23 | 16 | 97 |

Legend, based on BS 5930:2015 Code of practice for site investigations

Laboratory Atterberg Limits have been determined for samples of the glacial till deposits. The results show that the weathered strata is of low volume change potential. Footings should be deepened in accordance with NHBC guidance for low shrinkage for foundations adjacent to mature trees and hedgerows. The bedrock is regarded to be non-shrinkable.

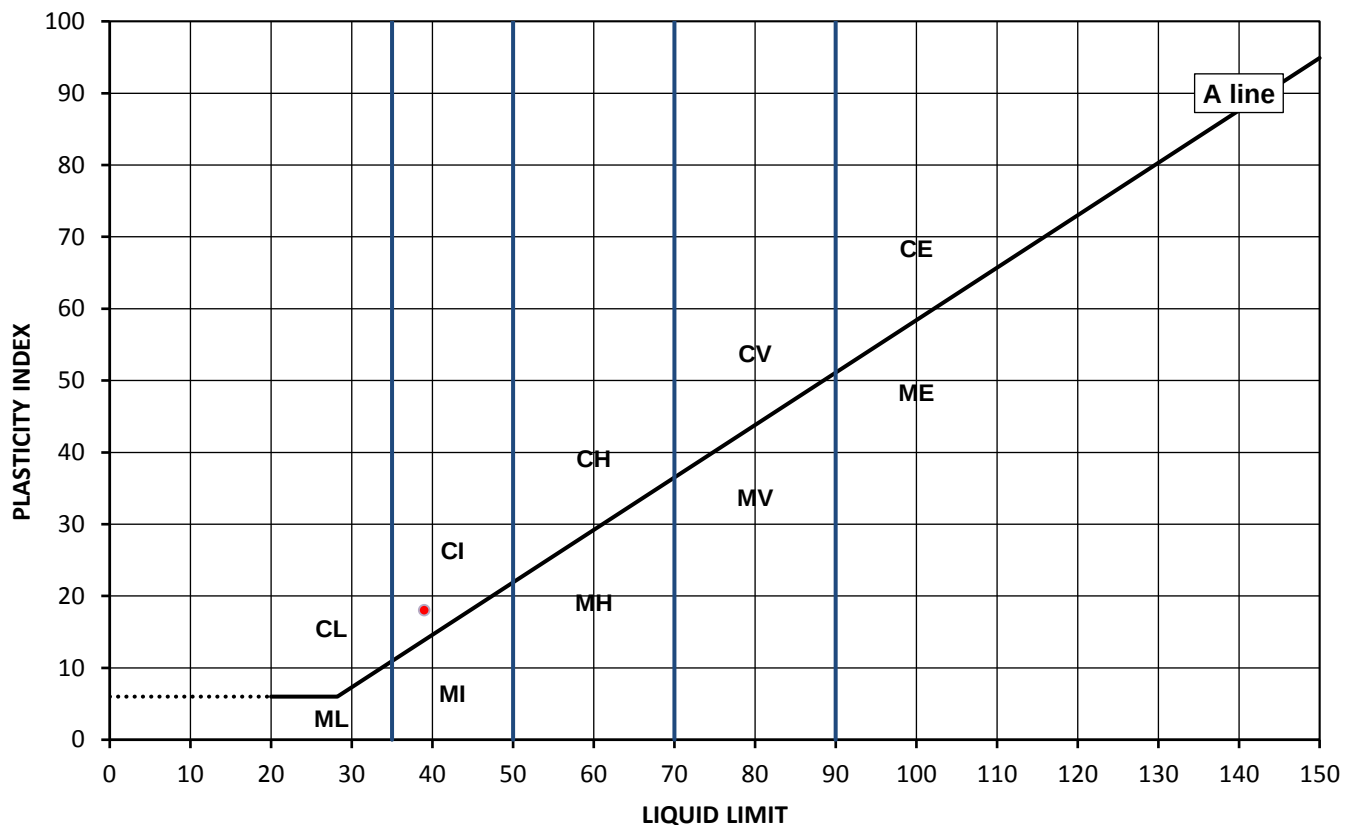
| As Received Moisture Content [%] | Liquid Limit [%] | Plastic Limit [%] | Plasticity Index [%] | % Passing 425µm BS Test Sieve |
| 20 | 39 | 21 | 18 | 86 |

Legend, based on BS 5930:2015 Code of practice for site investigations
