**12 GLYNCOED TERRACE, TRAMROADSIDE SOUTH,  
TWYNYRODYN**

**BAT SURVEY (INCLUDING BIRDS) ISSUE 1, VERSION B**

**MARCH 2025**

**Bat Survey Report**

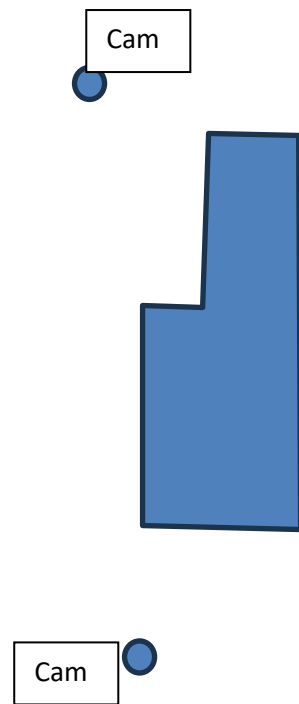
**Figure 3: Approximate surveyor/camera locations**

A dusk survey was carried out on 16<sup>th</sup> June 2025 using surveyors, positioned in such a way that as much of the building was visible to surveyors as possible. Surveyors were equipped with Batlogger M detectors and thermal imaging devices.

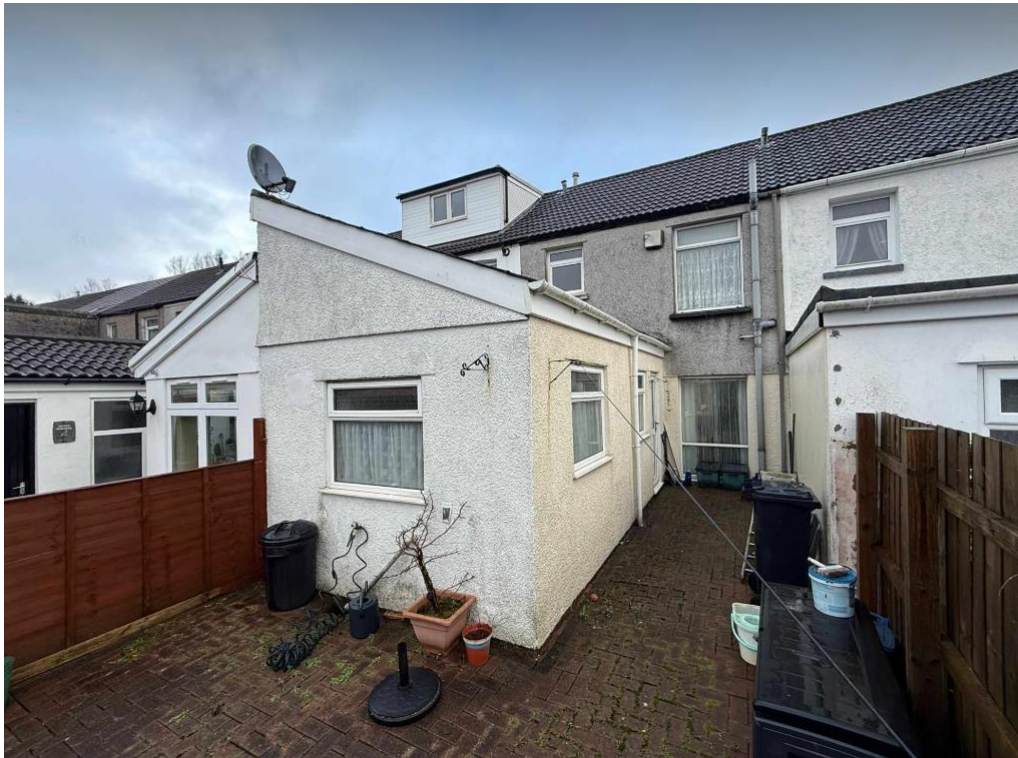
**Plate 1- photograph of extension**

There is a small single storey extension to the rear of the property that comprises of rendered brick beneath a mono-pitched slate roof.

There is no roof space within the single storey extension.

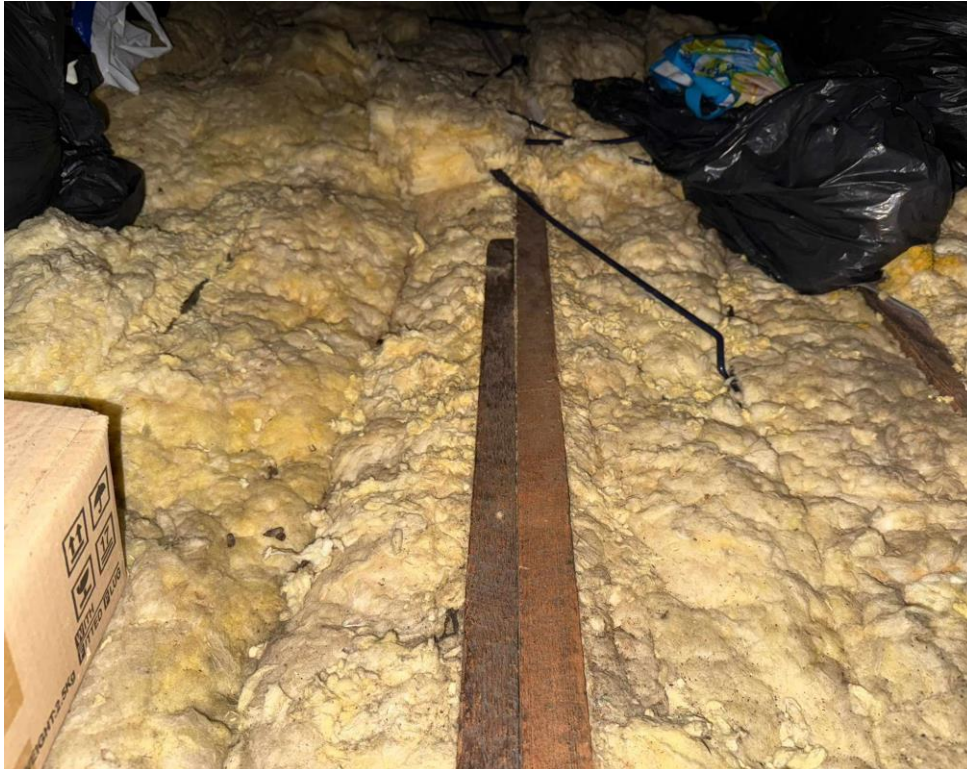
**Plate 2- rat droppings in loft**

Internally, the roof space is of a typical rafter and perlin construction. The roof is lined with bitumen felt and insulated at joist level with fiberglass insulation. The roof is currently used for storage. No obvious light ingress' were noted from the interior, however, a number of rat droppings were identified within the loft space.

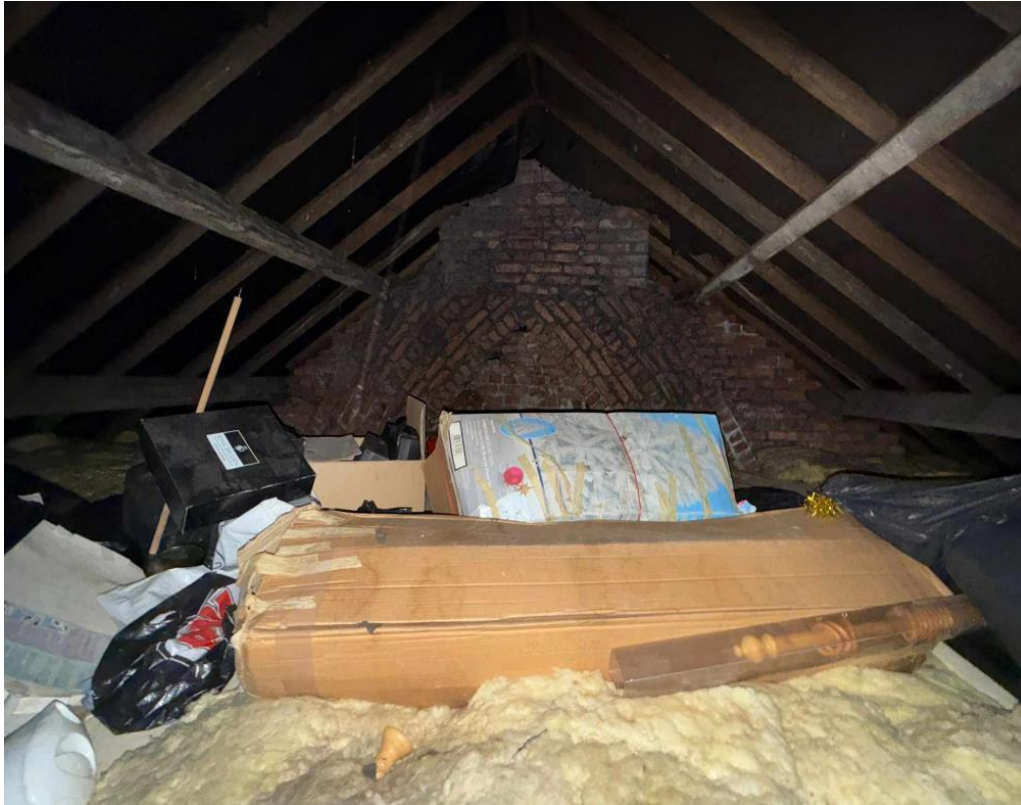
**Plate 3- photograph of roof void**

No bats or evidence of bats were noted. Please see appended plates for photographs of the roof space interior.

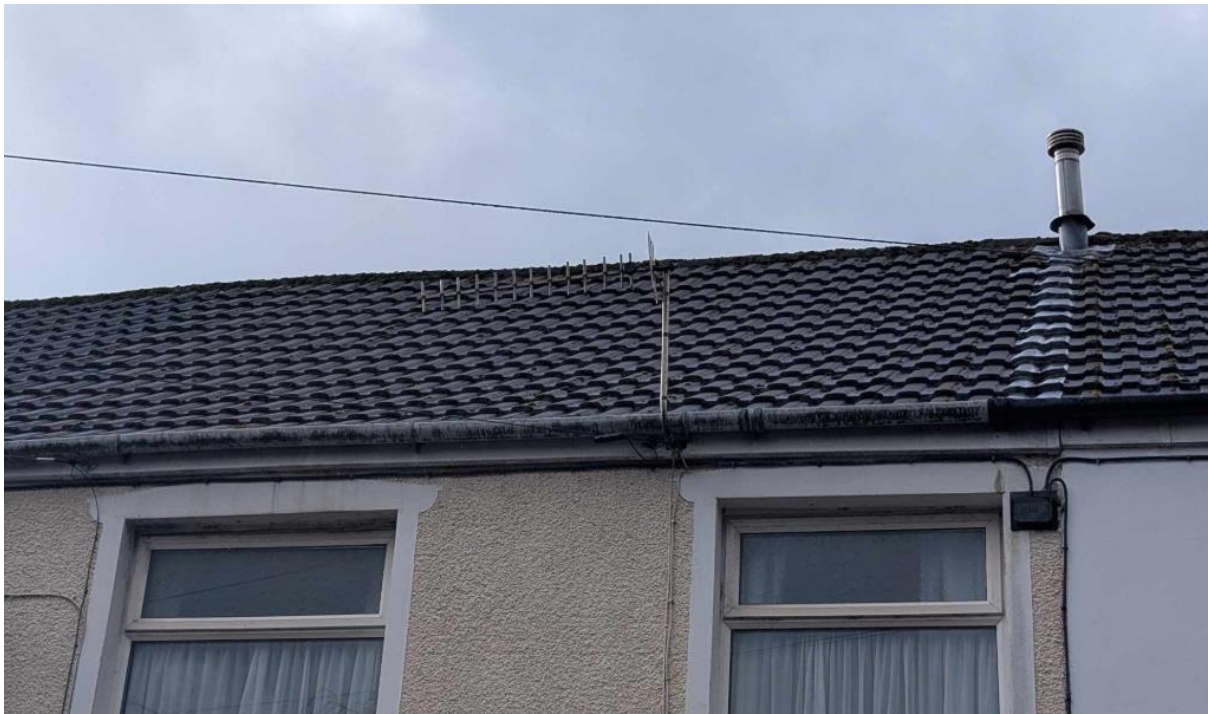
**Plate 4- Photograph of front elevation**

The building is a brick and block built rendered terraced property beneath a clay tile roof. The ridge of the property generally runs from north east to south west.

Those areas able to be viewed, appear to be in relatively good condition. Barge boards, fascias and soffits are a combination of timber and uPVC.

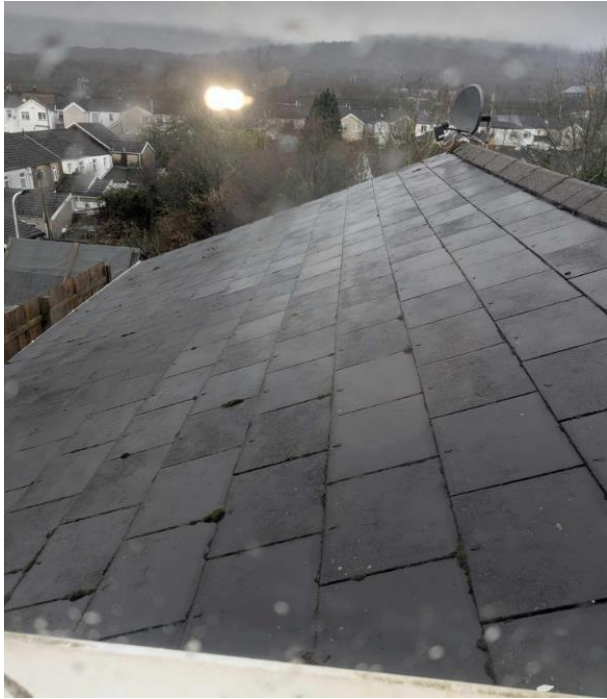
**Plate 5- photograph of extension roof**

Generally the tiles of the house and the slates of the extension appear to be tight fitting. No evidence of nesting birds was seen on the exterior.

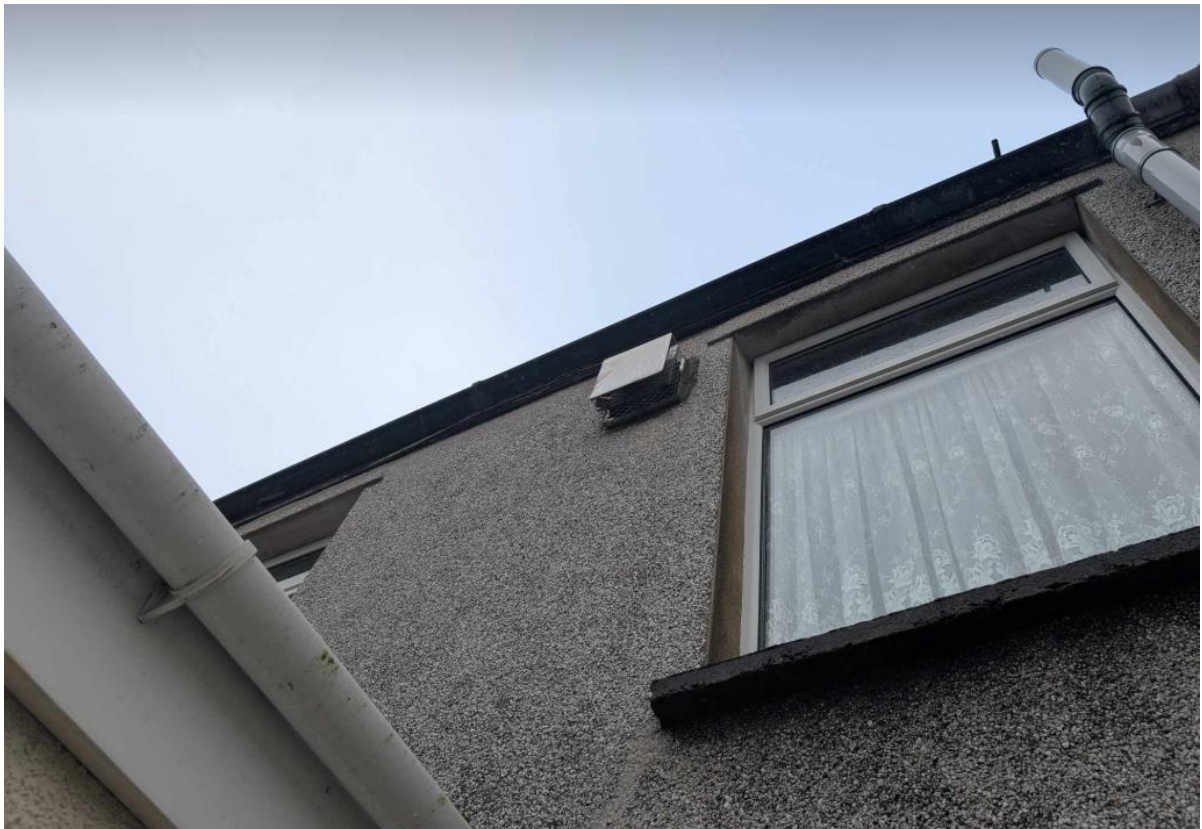
**Plate 6- Photograph of gap beneath rear fascia board**

The survey carried out by BE Ecological Ltd revealed no droppings or evidence of bats on the exterior of the buildings. Despite this, there is a small amount of potential present within both the house and the extension, namely;

- Small gaps beneath fascias

It is considered that given the small number of access points present, it is necessary to class the building as being at least of low potential for roosting bats.
