**Proposed works at Pengarnddu service reservoir, Dowlais Top, Merthyr Tydfil.**

**Notes following check for fungi, 29 October 2020**

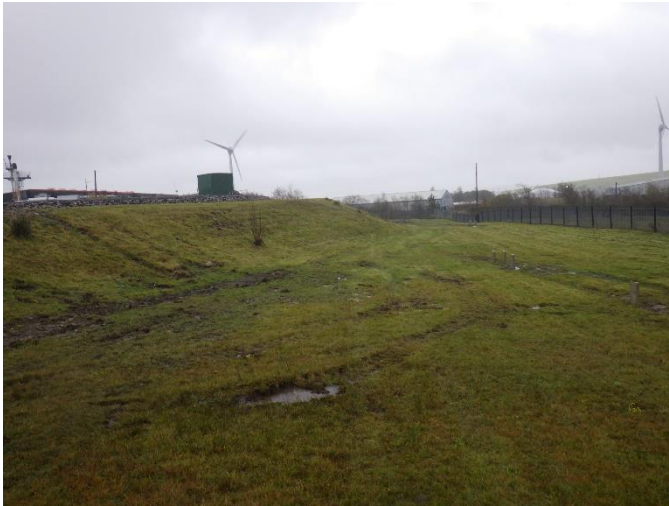
*The grassland within the compound was not accessed, but it appears to be mostly too damp and disturbed to be of high value for fungi, although small numbers of *Hygrocybe virginea* were observed through the railings.*

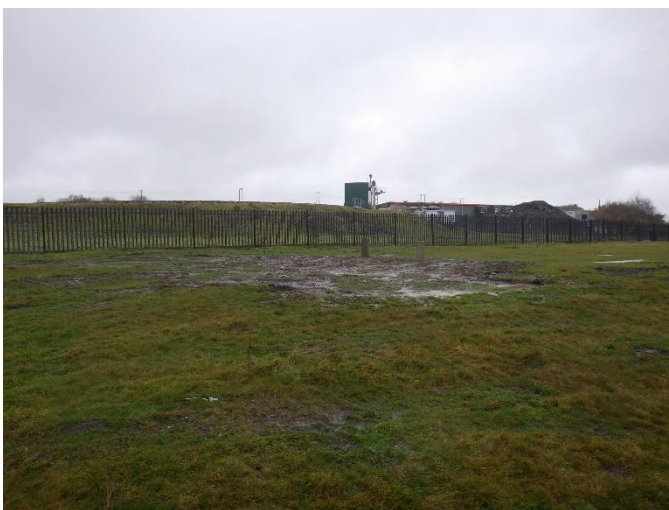
*Some of the grassland south of the reservoir compound fence has been subject to recent ground investigations. This would have removed any potential interest for grassland fungi from these areas.*

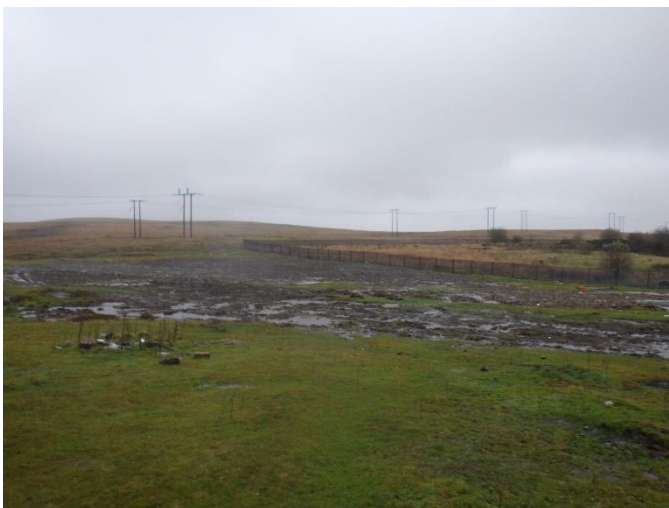
*Much of the proposed construction area west of the compound has been disturbed by recent earthworks. This would not be expected to support any grassland fungi and was therefore not included in the search area.*

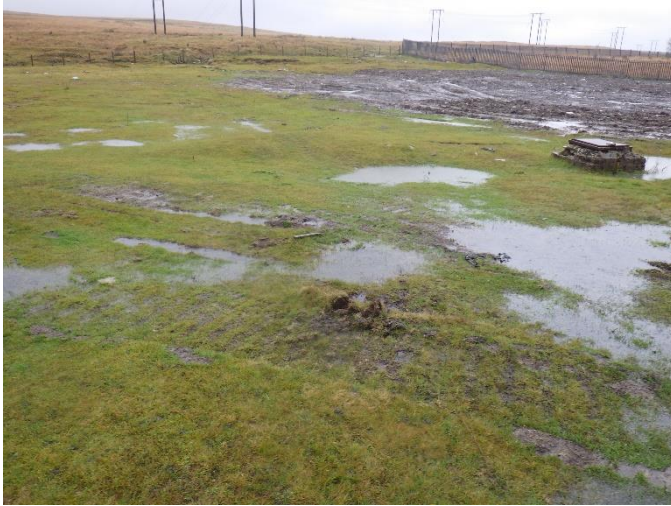
*Recent track marks from heavy machinery and puddles of standing water indicate that much of the construction area is disturbed, compacted and waterlogged, and so is unlikely to have value for grassland fungi.*

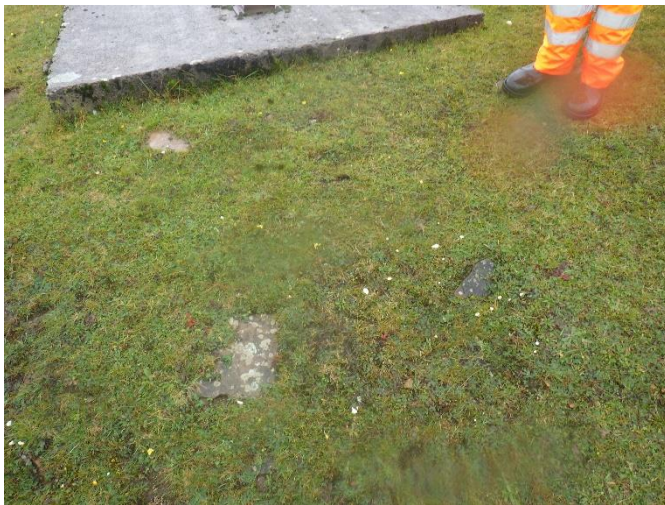
*Formerly disturbed ground in the south of the construction area has been colonised by small numbers of common grassland fungi, such as these *Hygrocybe virginea*.*

The southern part of the construction area does support a few common species, and I recommend that this should remain undisturbed if possible. This is because fungi populations only develop very slowly over time, and there may be species that are present within the soil that are not yet at the stage where they produce fruiting bodies. In particular, I hope that it would be possible to retaining the area immediately adjoining the eastern end of the compound fence, which was the only location for *Hygrocybe quieta* on today's survey.

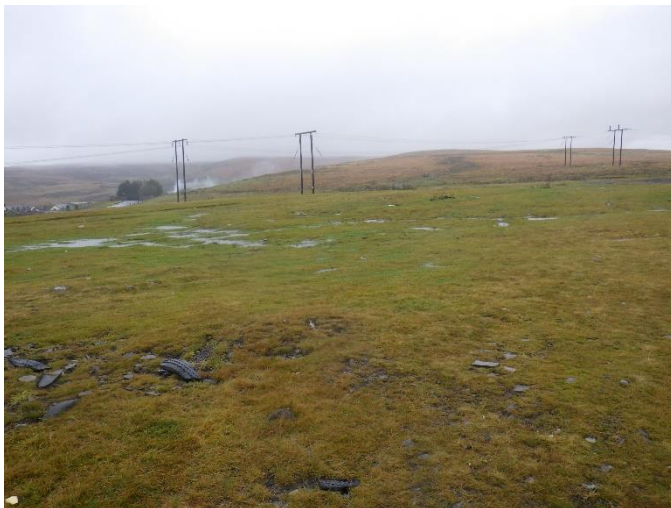
*The land to the west of the proposed reservoir supports very few fungi. Factors contributing to this may include water-logging, ground compaction, off-road vehicles and pollution (e.g. from burned out cars or fly-tipping).*

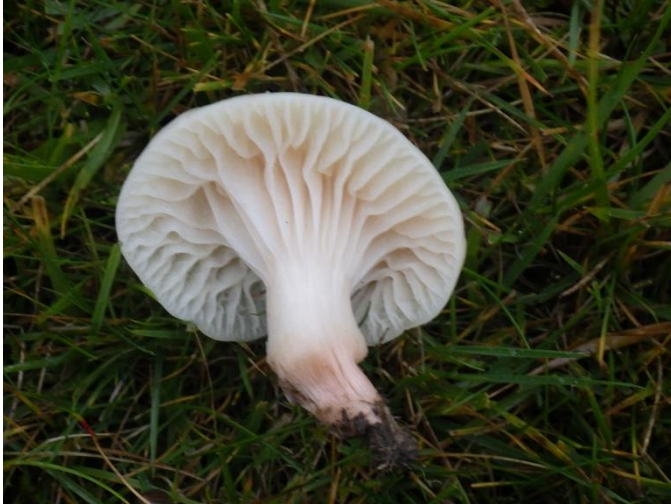
*Hygrocybe virginea* – *Snowy Waxcap*. A very common species, and the most frequent species in the construction area.

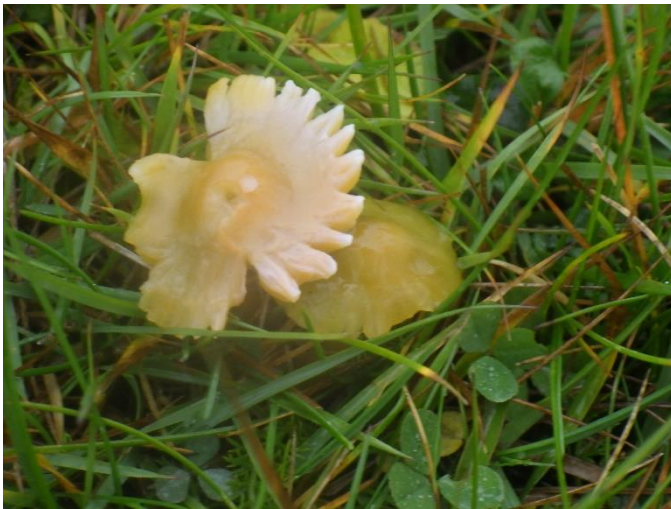
*Hygrocybe psittacina* – *Parrot Waxcap*. A very common species, present within the construction area.

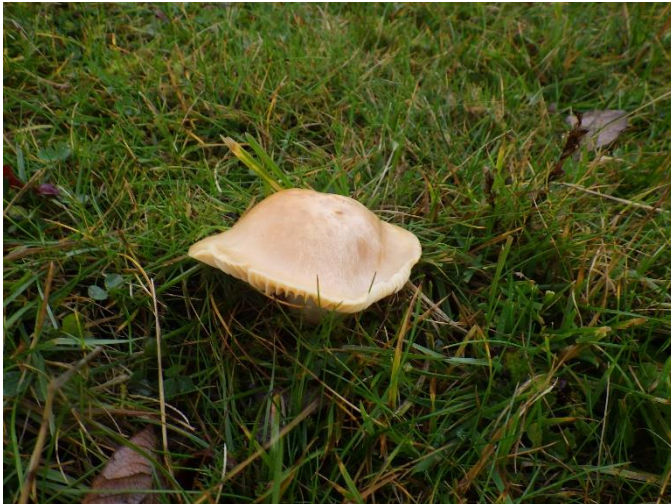
A large *Hygrocybe pratensis* specimen. This was one of the more frequent species south of the proposed construction area.

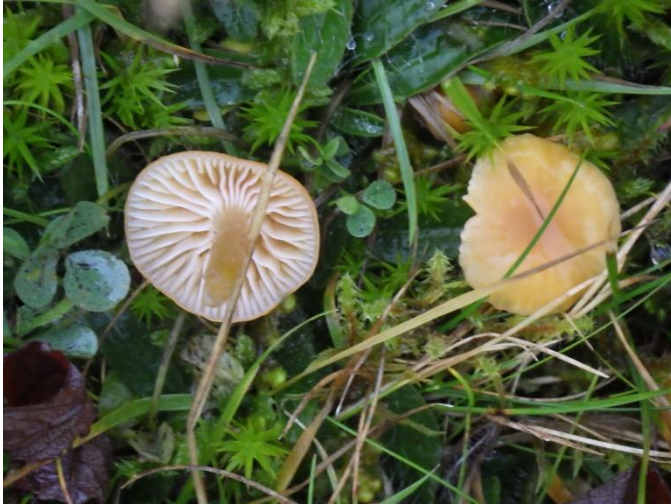
*Hygrocybe laeta* – *Heath Waxcap*.  
Found in several places south of the  
construction area.

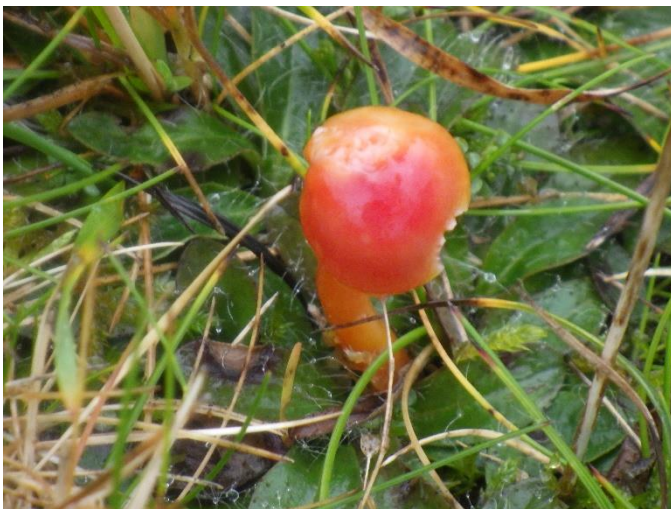
*Hygrocybe mucronella* – *Bitter  
Waxcap*. Only seen in 2 locations  
south of the construction area.

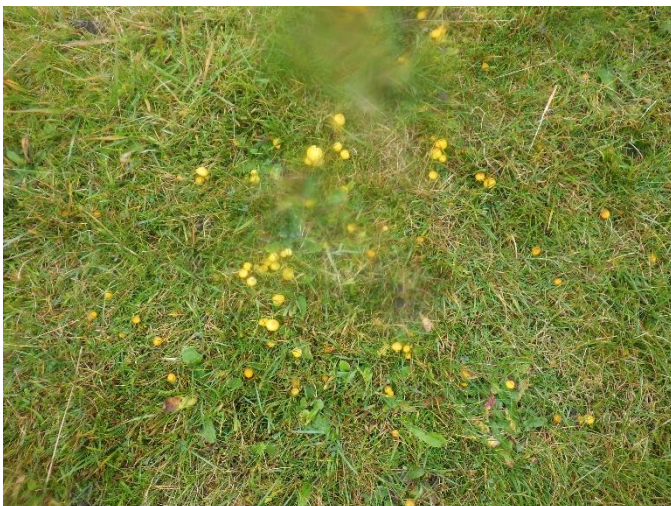
A patch of *Hygrocybe ceracea* south  
of the proposed works area.

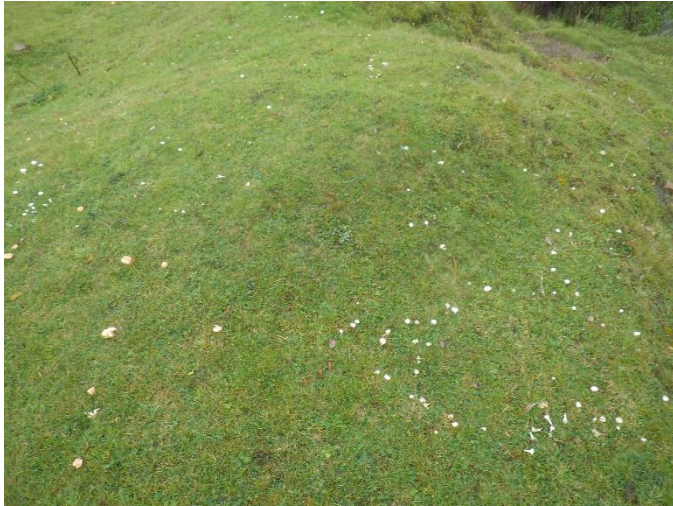
*A mix of Hygrocybe virginea and H.pratensis on old spoil heaps south of the proposed works area.*

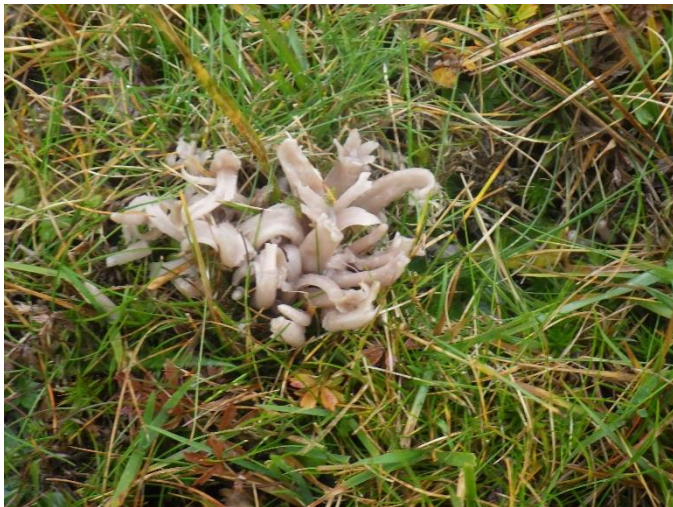
*A very weathered specimen of Clavaria fumosa (Smoky Spindles) south of the construction area.*

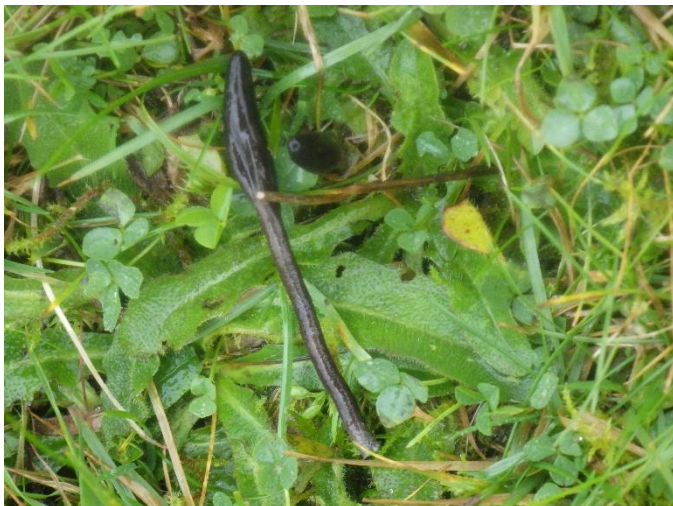
*Geoglossum fallax (an earthtongue), south of the construction area.*
