**SARDIS CHAPEL, STATION TERRACE, BEDLINOG**

**BAT ACTIVITY SURVEY**

**ISSUE 1, VERSION D**

**SEPTEMBER 2024**

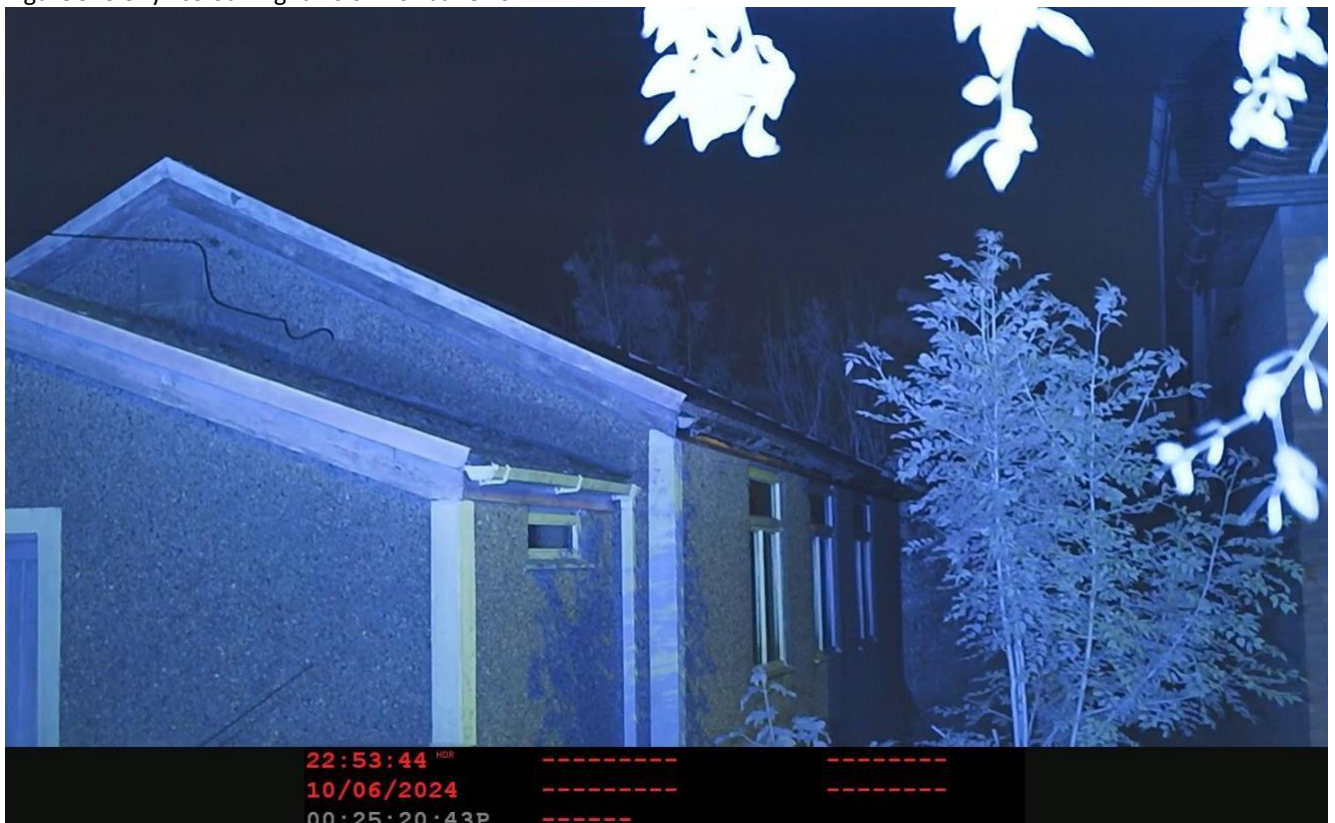
Figure 5- Sionyx colour night vision 10<sup>th</sup> June 2024

Figure 5: Sionyx Colour night vision

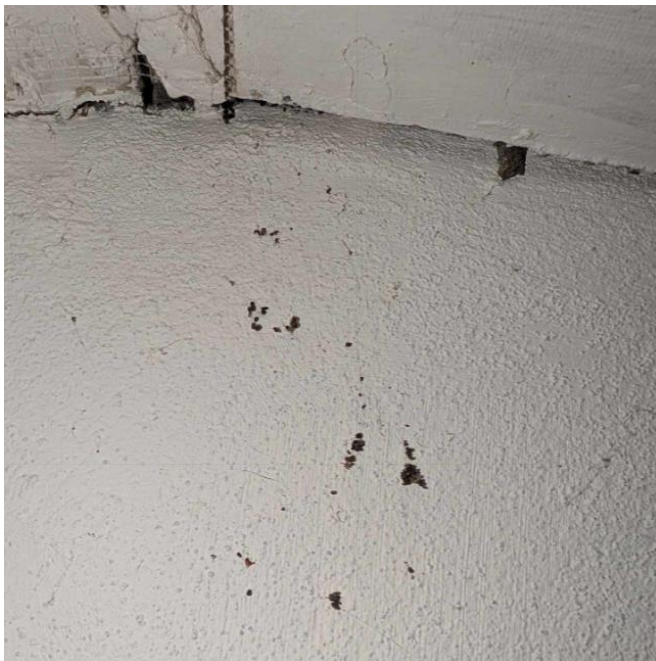
The Acer Ecology report for the site stated that bat droppings were found to be present, one on the exterior of the building and an aggregation above the porch door (directly behind where a sparrow was observed entering the building).

BE Ecological Ltd has since been to site to check the aggregation of droppings following a nil result from the surveys. It is unclear from what was present on the interior whether this aggregation was actually bat droppings. The “droppings” are too degraded should they be droppings to be able to send off for DNA analysis (not intact, swollen and very old debris). Please see below photographs and please cross reference photographs from Acer Ecology Report. The large clump present in the acer ecology report appeared to have fallen to the floor and broken up.

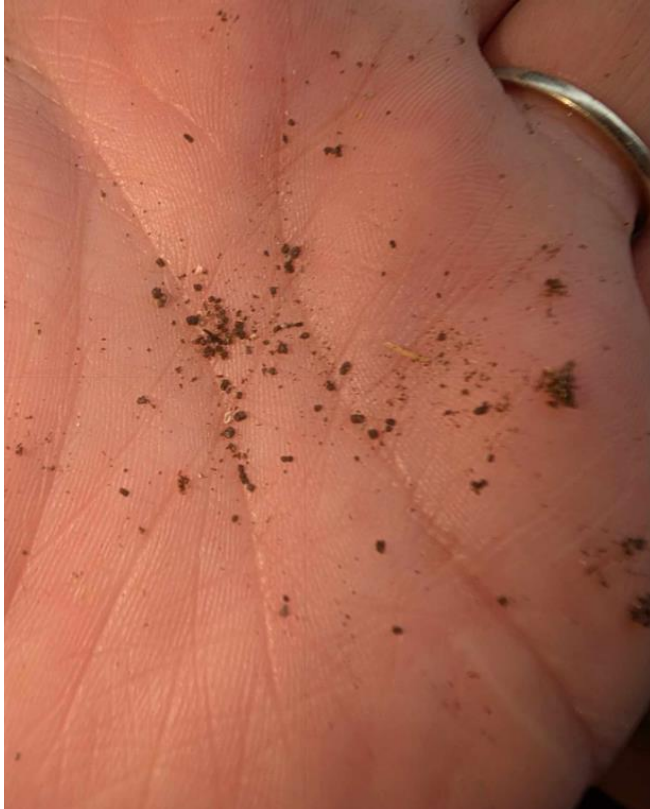
A lot of the debris that is there currently did not appear to be biological. When crumbled, those pieces that may have been (not intact or shaped like bat droppings) did break apart but they did not crumble into a fine dust as bat droppings usually would. A few of the pieces that were crumbled, crumbled to smaller fragments, some of which appeared to have occasional bits of vegetation present (please see yellow line in photograph below)

Having re-assessed the Acer ecology report, there is no convincing evidence from inside the building currently (close up of droppings etc) that this debris was in fact droppings. Please note, this was an easy misidentification and without further evidence (lack of bats during surveys, close up of droppings etc), BE Ecological Ltd would have possibly considered some of these to be droppings also in the first instance. It is noted that a licence cannot be granted due to insufficient evidence of a roost or species or numbers present. Static bat detectors cannot be placed above ceiling level due to lack of access and it would not be considered to be proportional to ask the client to undertake further surveys given the survey effort already undertaken at the site.

The client is happy to carry out the works at the least sensitive timing for bats (spring and autumn) and the client is happy to provide mitigation within the on site building. Mitigation would be no less than what the bats have access to currently. As a result it is proposed that the works are undertaken in line with a non-licensed method statement and ecological supervision. If at any point bats or evidence of bats are found, all works will cease, with NRW consulted. Further surveys and/or a licence may be required prior to works re-commencing.
